**CPAT Report No 89**

**CONSULTATION DRAFT**  
*Powys Metal Mines Survey 1993*

**by M Walters**  
January 1994

**The Clwyd-Powys Archaeological Trust**  
7a Church Street Welshpool Powys SY21 7DL  
tel (0938) 553670, fax 552179  
© CPAT 1993

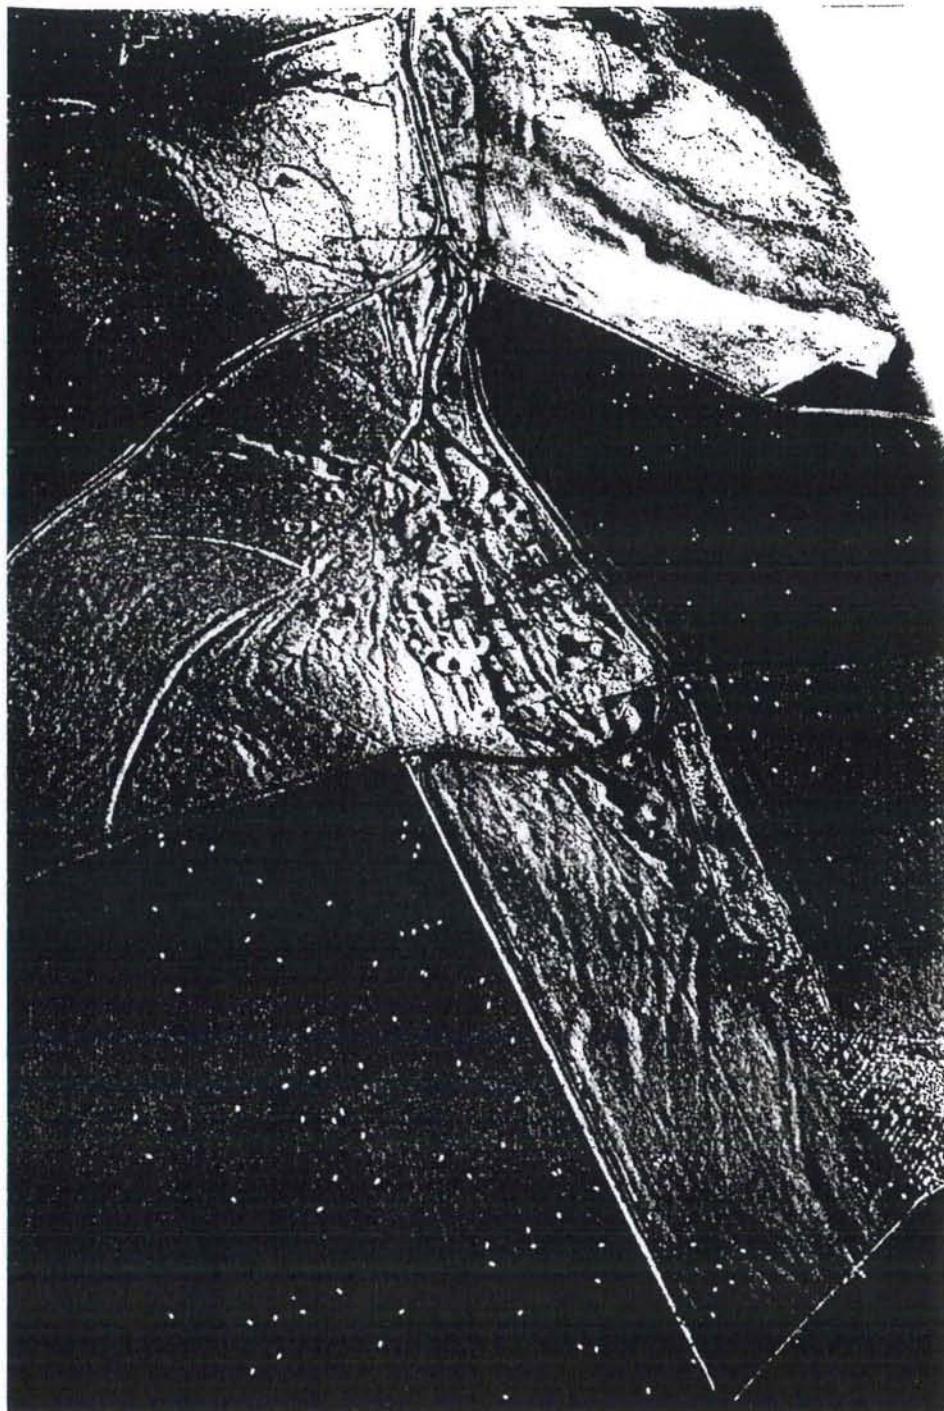
Fig. 1 Gwestyn Mine (PRN 5943). A complex mixture of 19th century mine-related earthworks and earlier non-industrial features. The shaft-mounds are all located on the main E-W lode. Photo: C R Musson, RCAHWW (925089-65)

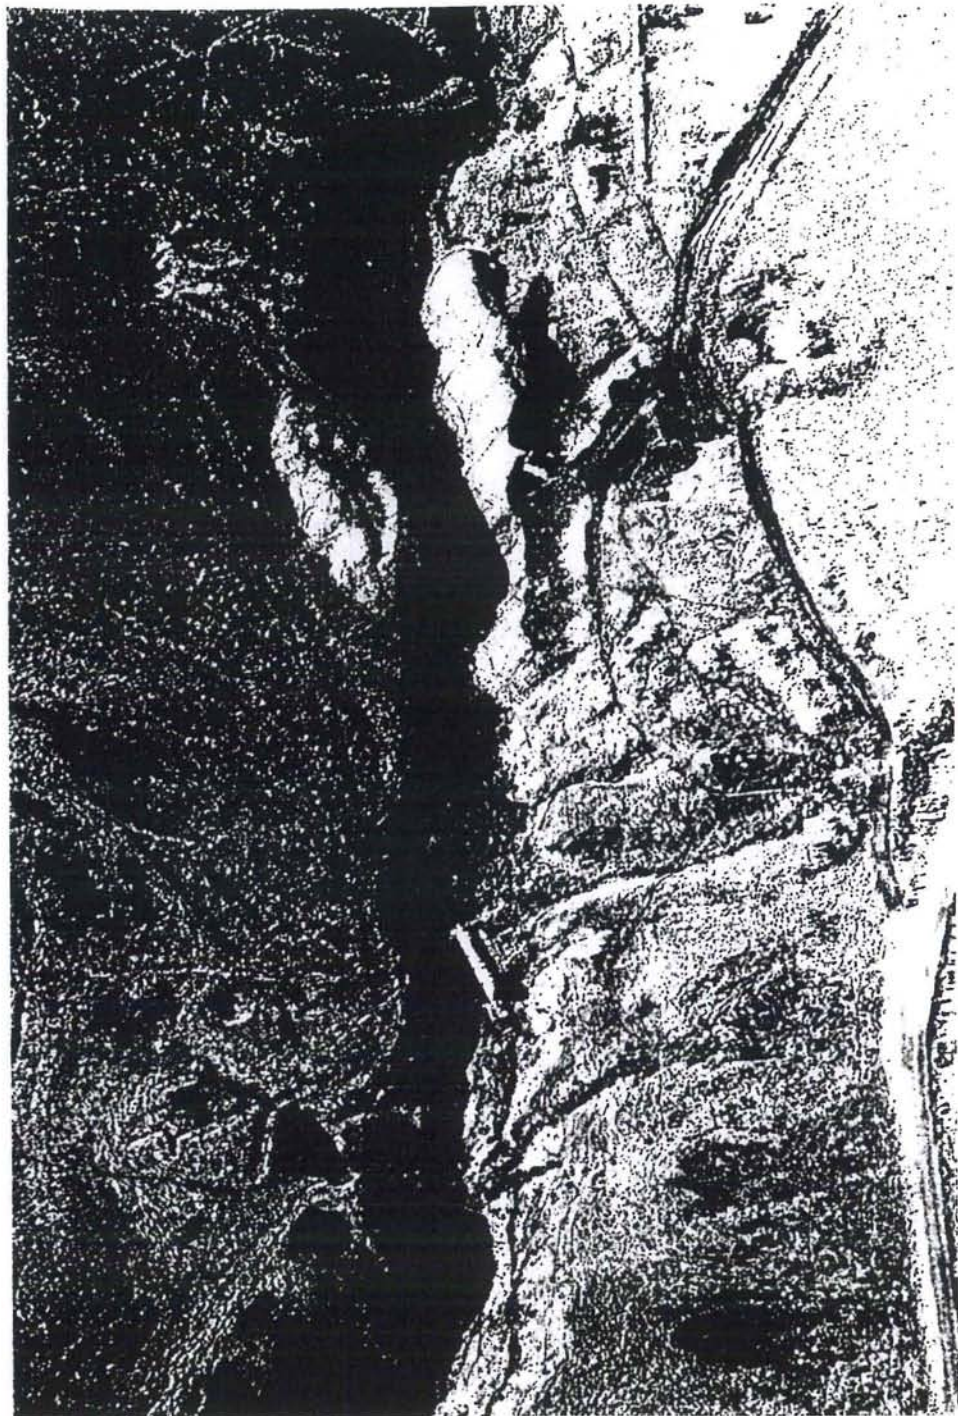
Fig. 2 Cafartha/Nantddu Mine (PRN 8497). Mid-late 19th century remains in this aerial view include the pumping wheelpit (bottom centre) from which the shallow flat rod communication trench extends to the open whim shaft at the top. Also visible are mine administration buildings (centre right) and the engine shaft (upper centre). *Photo: C R Musson, RCAHWW (925319-8)*

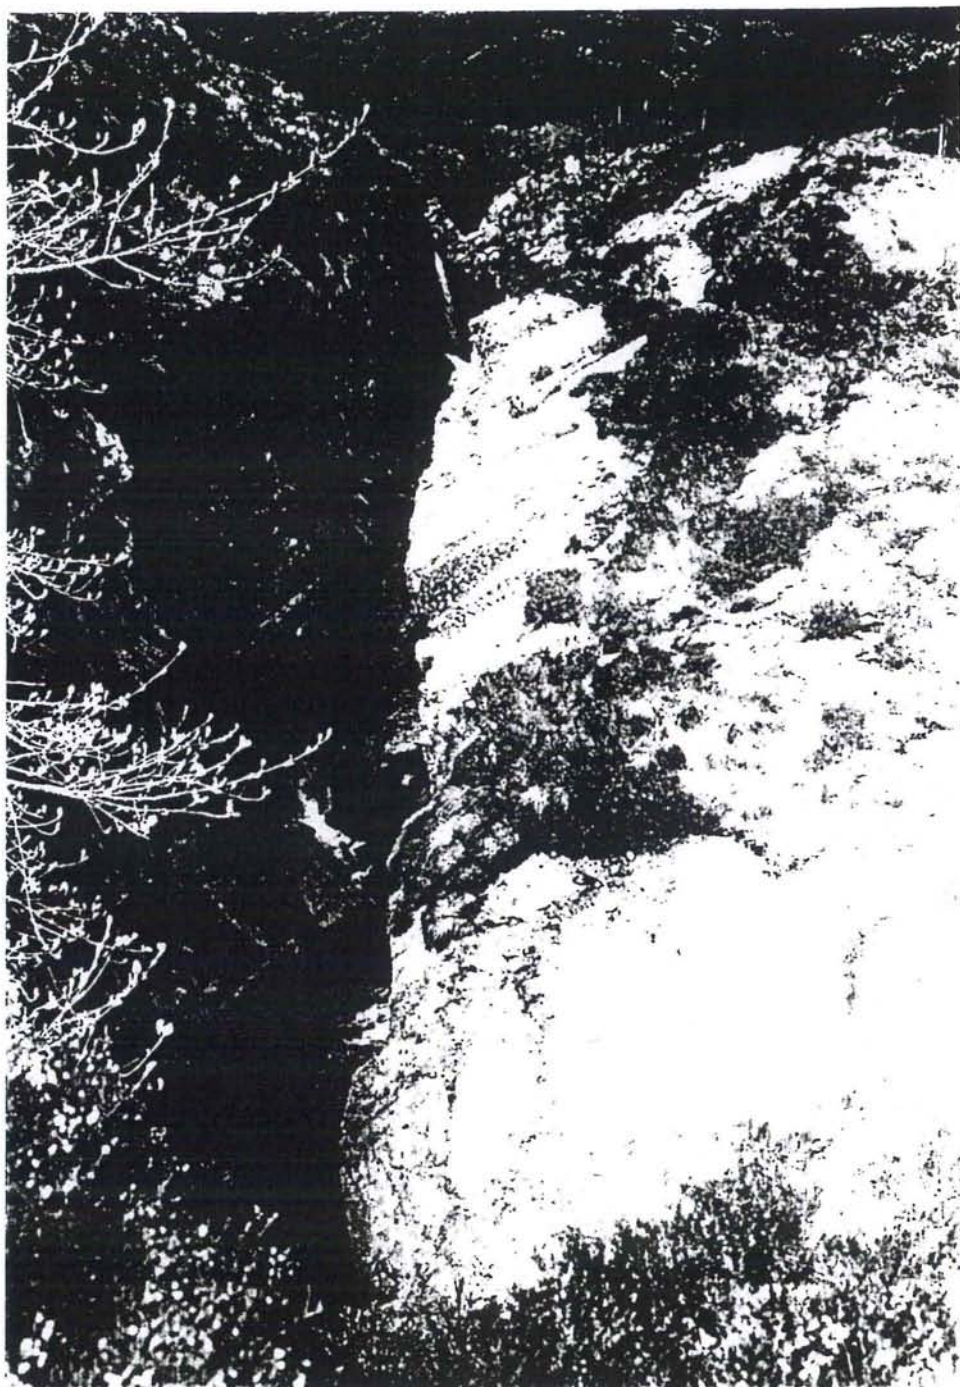
Fig. 4 Nant-yr-Eira Mine (PRN 725). The prehistoric opencut situated to the north of the 19th century dressing floors. The prehistoric tiops, which have been partially excavated, run along the fence line (top right). Many stone hammers and evidence for firesetting techniques have been found here. *Photo: CPAT 92-145-02*

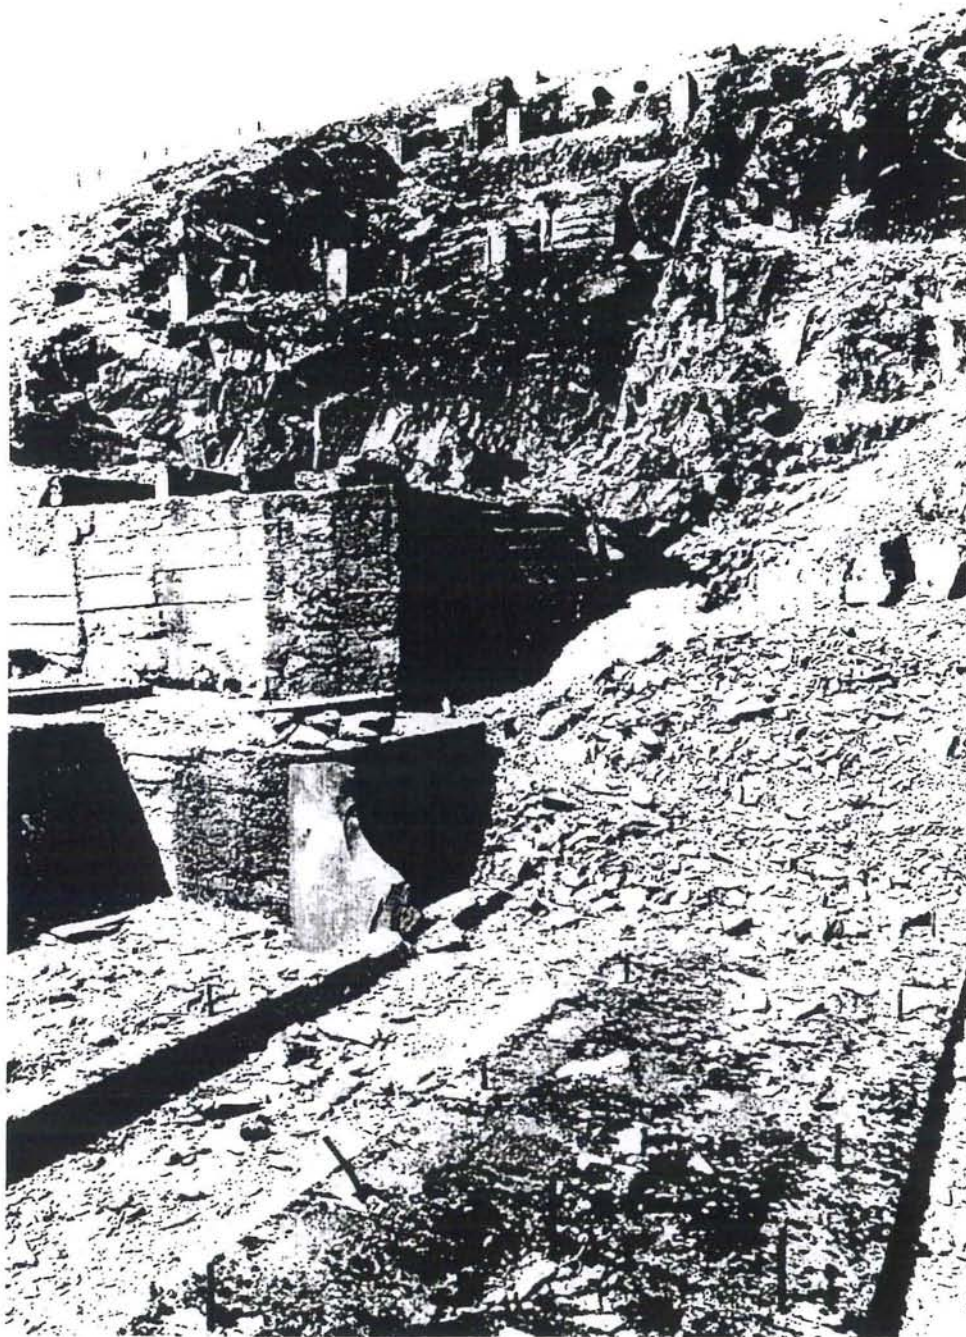
Fig. 5 Dyfnwgwm Mine (PRN 5942). The substantial concrete base loadings of the 1935 Hirnant Minerals Ltd processing mill. Here all of the dispersed concentrating machinery of the 19th century dressing floors to the east has been modernised and placed under one roof. The tiered structure was purposely built to aid gravity separation methods of concentration. *Photo: CPAT 92-155-23*

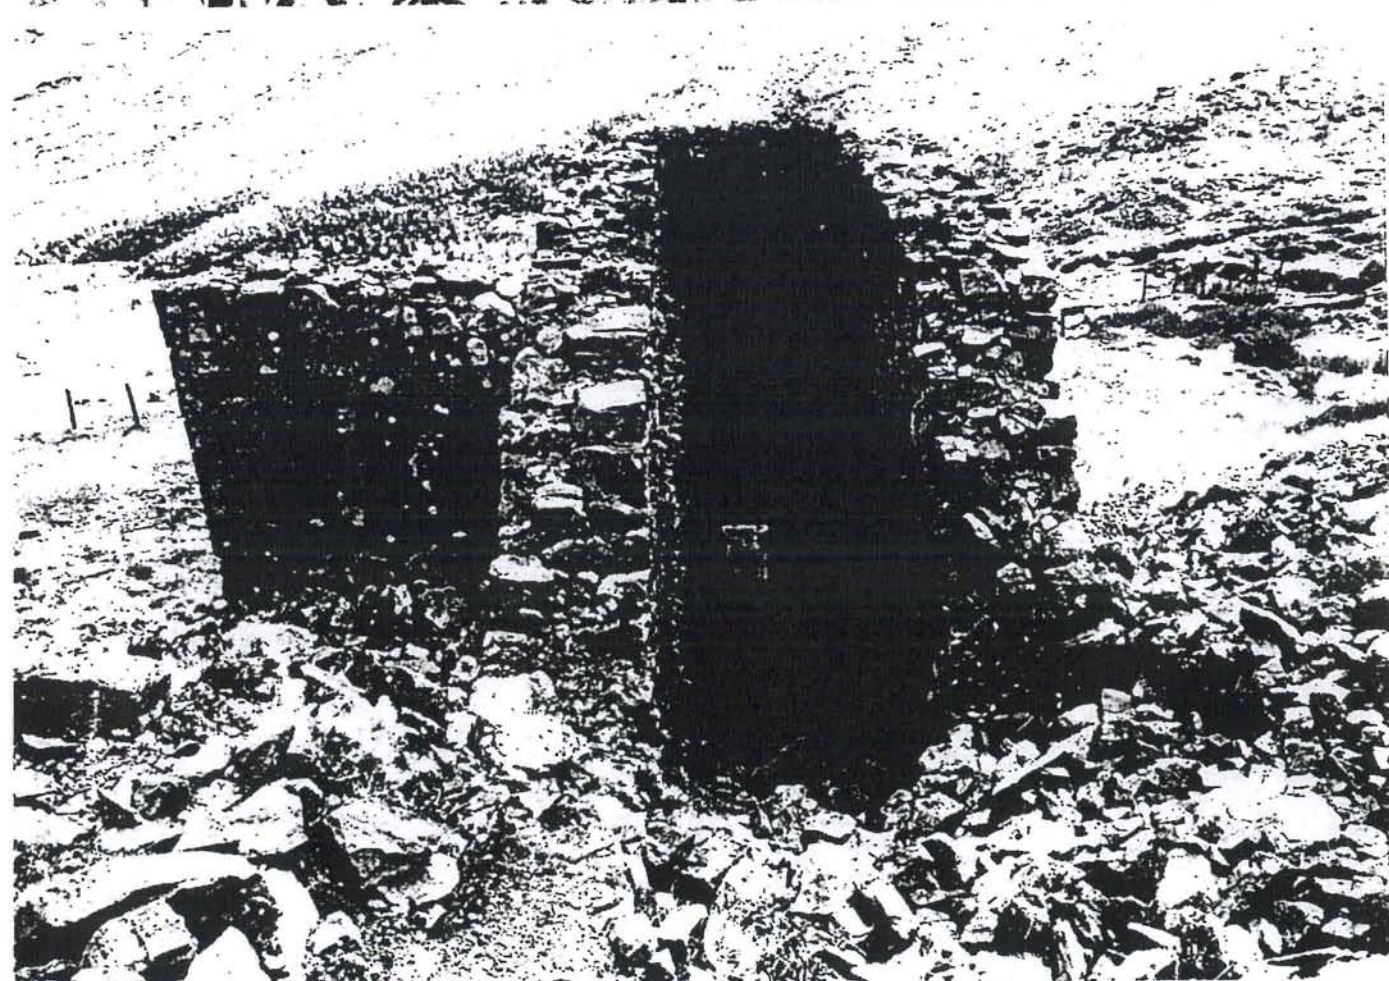
above Fig. 6 Nantiago Mine (PRN 5944). Remains of the collapsed headframe in the top of the engine shaft. Photo: CPAT 92-144-08.

below Fig. 7 Nant-yr-Eira Mine (PRN 725). The 1858/9 crusher house showing the 38x3ft water wheel pit and the 24in crusher rolls housing to the left. Photo: CPAT 92-146-28

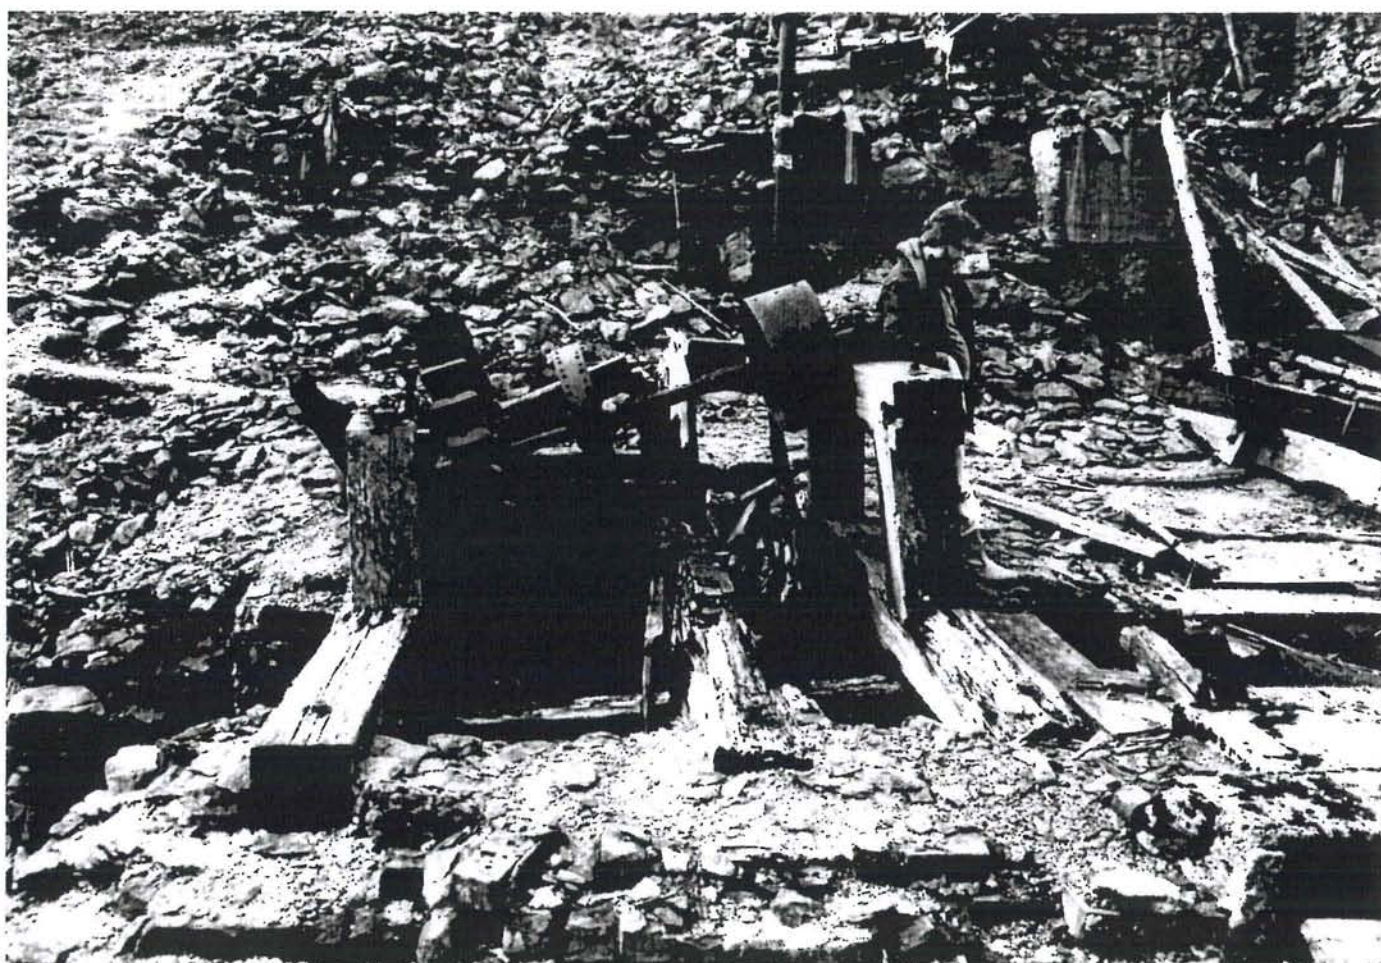
above Fig. 12 Nantiago Mine (PRN 5944). The c 1900 three-storey hydraulic processing plant showing one of the two pelton wheels which drove machinery. Photo: CPAT 92-142-34.
