Ty-draw, Llanarmon Mynydd Mawr, Powys:

INTERIM REPORT ON SURVEY AND EXCAVATION IN 2002/03

W J Britnell
May 2003

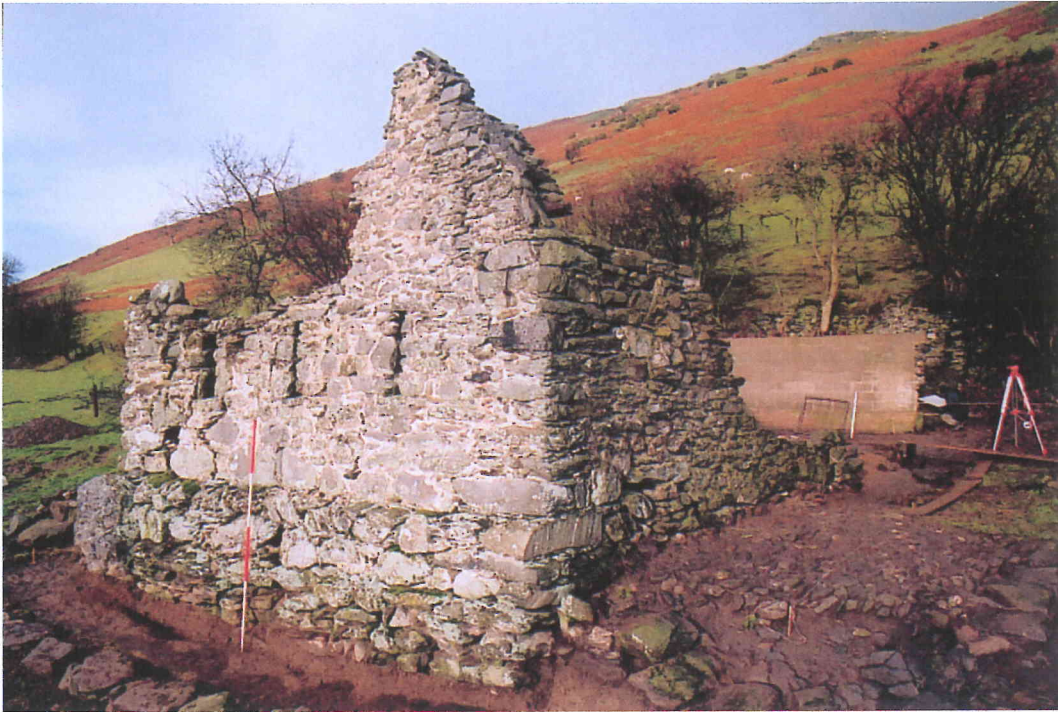
Fig. 5 South end of building showing ruinous ?18th-century stone gable overlying earlier stone sill of the 15th-century cruck-framed hall. The stone sill was dug into a pre-existing field lynchet, the large stone to the left perhaps being a natural boulder. *Photo CPAT 1319.15.*

- 3.3 Two or possibly three phases of stonework are evident in the surviving structure. An earlier phase is represented by the now ruinous southern stone gable, which was originally pierced by two tiers of ventilation slits, largely built from newly-quarried stone bonded with lime mortar. There is evidence to suggest that the stone gable is earlier than the remaining stonework and was added in perhaps the 18th century while the reframed (see below) timber-framed outer walls were still standing.

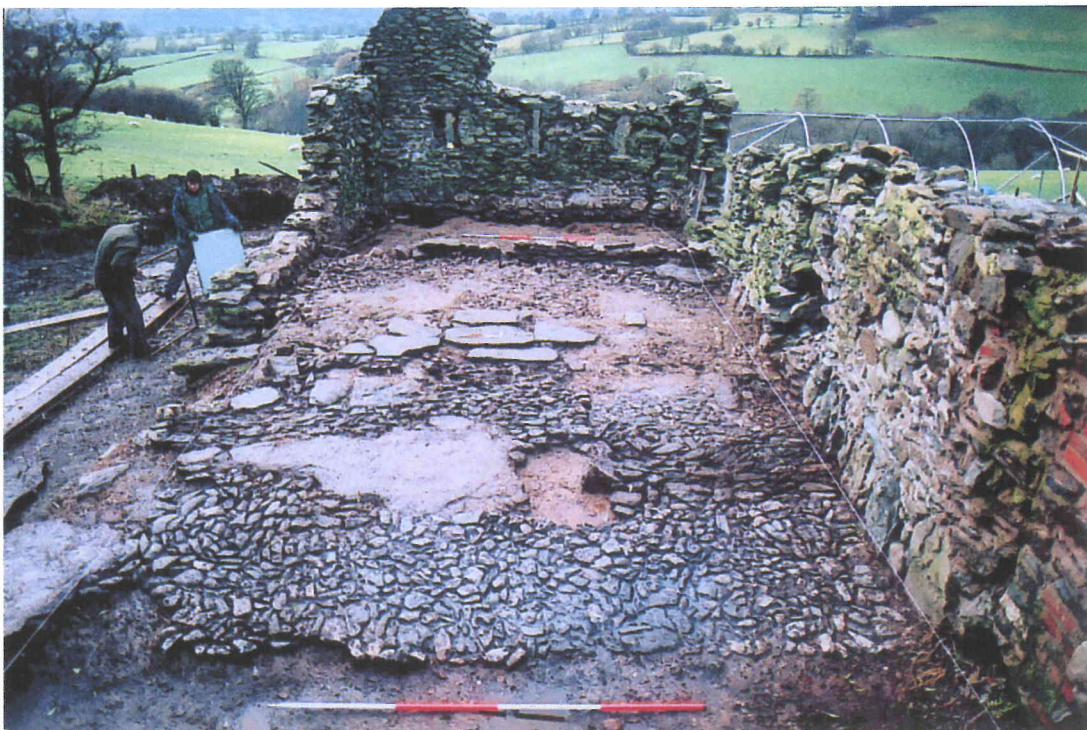
Fig. 6 Interior of the house during the course of excavation, showing cobbled floor contemporary with the inserted ?17th-century chimney. *Photo CPAT 1319.2.*

- 3.13 The fireplace was subsequently demolished down to the level of the contemporary cobbled floor on its northern side. The cobbled floor and chimney base were then overlain by a low sill wall, which supported a sill beam for a partition inserted between the open cruck of truss C. The southern bay of the original two-bay hall was provided at this period with a cobbled floor partly bonded with reused lime mortar derived from the demolition of the chimney. This floor surface remained virtually intact, and had been overlain in places by a number of large slate slabs, which appeared to have been reused from elsewhere. The cobbled floor in the northern bay of the former hall had been repaired on a number of occasions, most recently by patches of cement mortar. A series of later postholes were identified, some of which belonged to a hay-rack set up on the partition on the line of truss C.

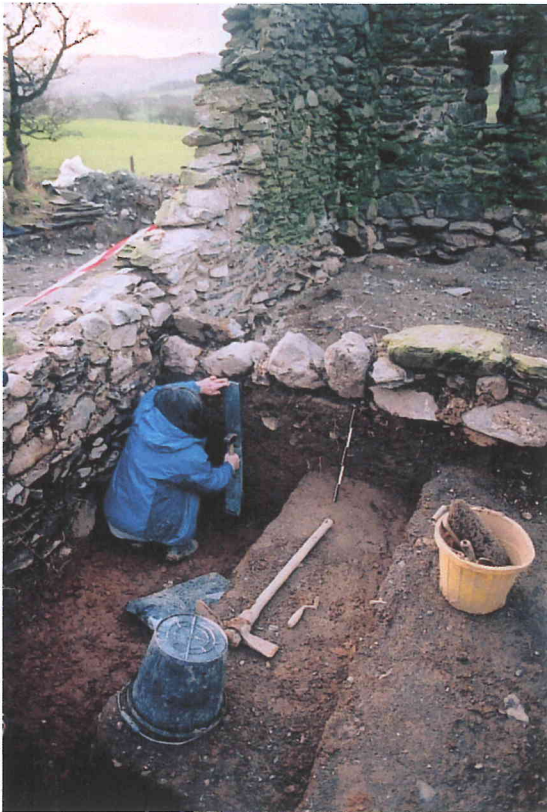
Fig. 7 Monolith 1. Photo CPAT 1321.0A

Fig.8 Monolith 1. Photo CPAT 1321.3.

The general location of the monolith is shown on the sketch plan on page 12, on the photographs on page 14 and on the section drawing A. The monolith was taken with two cans, one on top of the other, the upper one being 0.4m tall and the lower one 0.5m tall. The sampled profile lay below the stone sill wall (306) which supported Truss B of the medieval longhouse and extended from the built up platform (233/234) underlying the sill wall down to the surface of the underlying subsoil. The observed stratigraphy was as follows.

0-5cm	platform make-up (234=302), yellowish brown silty clay (10YR 5/6)
5-37cm	upper buried soil (261=311), more humic soil (10YR 4/4)
37-84cm	lower buried soil (262) less humic soil (10YR 4/6)
85cm	subsoil (263) surface (10YR 4/5)
