Llanidloes Link Road, Powys

ARCHAEOLOGICAL WORKS

CPAT Report No 738

R Hankinson and R J Silvester
November 2005

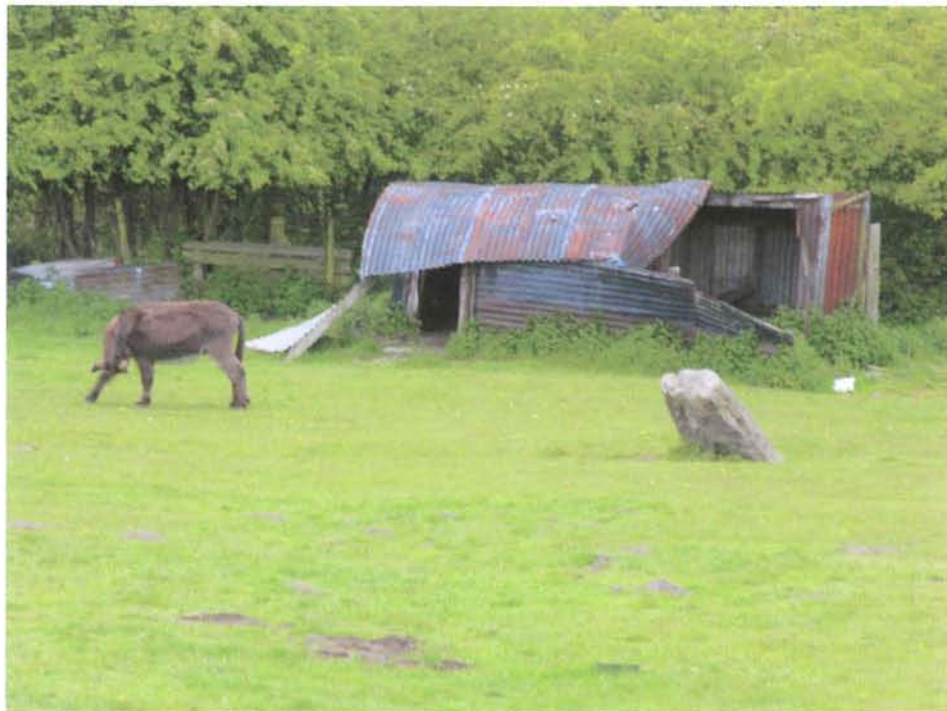
Plate 1: Site 7, stone, prior to excavation

northern end, the standing stone, site 7 (see below) was erected on this bank, reinforcing the view that it functioned as a boundary or mere stone.

- 4.6.1 The stone was originally identified in the archaeological assessment of the proposal (CPAT Report No 583), where it was considered likely to be a 19th-century addition to the landscape, if only because there appeared to be no record of it in the antiquarian literature of the 18th and 19th centuries. A small amount of relatively modern graffiti was incised on the upper surfaces of the stone. Nevertheless, in view of its imposing appearance, a much earlier date could not be ruled out entirely. The excavation was carried out to ascertain whether this assumption was correct.

4.6.5 The finds confirmed the original hypothesis that the stone had been erected in the 19th century and was not of prehistoric origin. An appropriate hypothesis is that the stone was erected as a marker or mere stone to aid in the definition of a boundary during the time when the nearby Gorn Hill was enclosed.

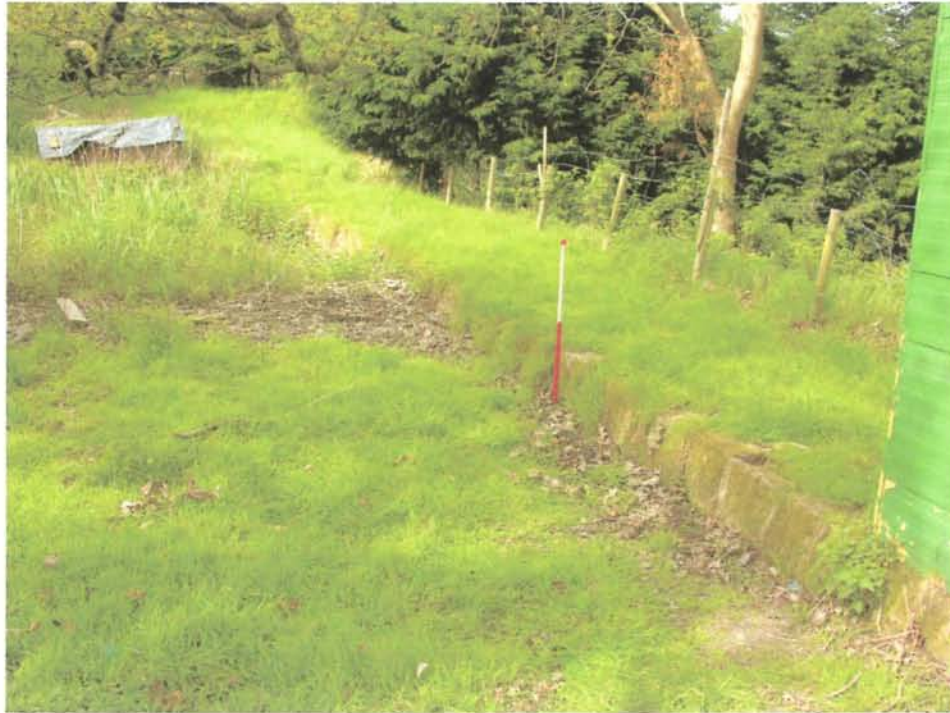
Plate 2: Site 5, reservoir, showing the dam wall

- 4.4.1 The reservoir was held back by a dam, which was 28m long, almost straight on an east-south-east/west-north-west alignment, though with a slightly bowed appearance (see plate 2). At 18.4m from the east-north-east end the dam wall was interrupted by the mouth of the spillway. It is effectively a revetment wall with soil piled up behind it to create a barrier.

- 4.4.2 The dam wall is constructed of shaped and tight-fitting freestone blocks, only one block deep and of varying sizes. Those measured varied from 460mm to 760mm long with depths in excess of 300mm. Heights, where measured, were 640mm.

- 4.4.3 The overall height of the wall is unknown, as is the depth of the reservoir, because of the quantity of silt that has accumulated against it. Unfortunately, it was not however possible to maintain a watching brief at the time that some of the silt deposits were removed by machine during construction works, which might have helped to clarify the issue.

- 4.4.4 The spillway is 2.65m wide, with quoins or corner stones on either side. Immediately to the north-east of the spillway a concrete block 2040mm long and 440mm deep is built into the top of the dam wall. It contains two mortise slots, now voids.

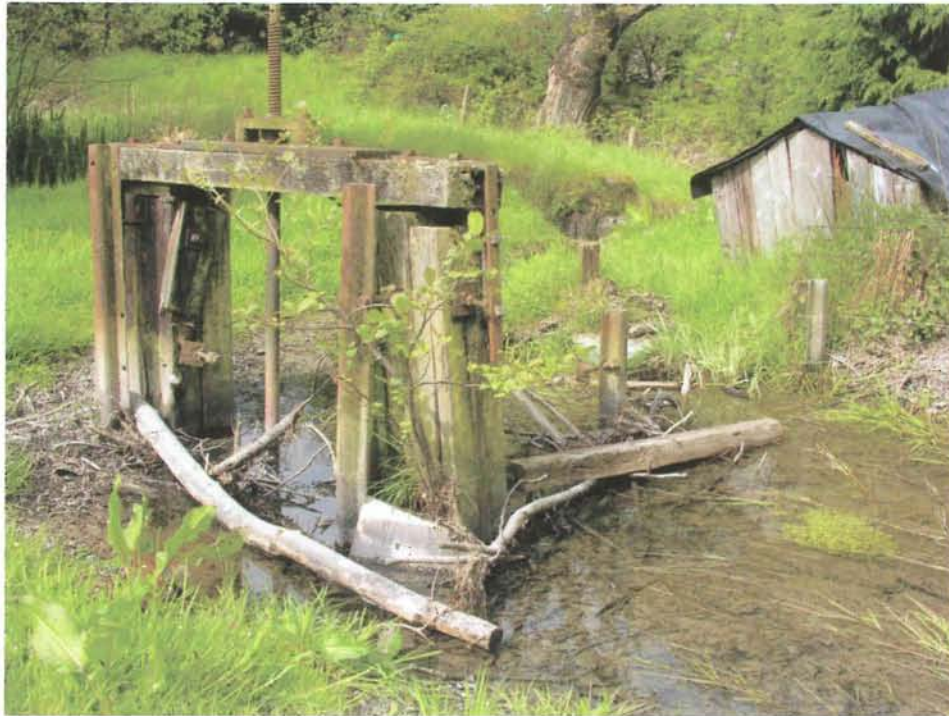
Plate 3: Site 5, reservoir, showing the sluice gate and stanchions

- 4.4.5 Lying back from the spillway in the reservoir was a sluice gate (plate 3), the visible height of which (excluding the screw) was 1220mm, its width 1970mm and its depth 620mm. Behind it (towards the spillway) are two pairs of iron stanchions which presumably supported a superstructure (now gone) that gave access to the sluice mechanism. It was not possible to preserve these features in situ because of the construction requirements.

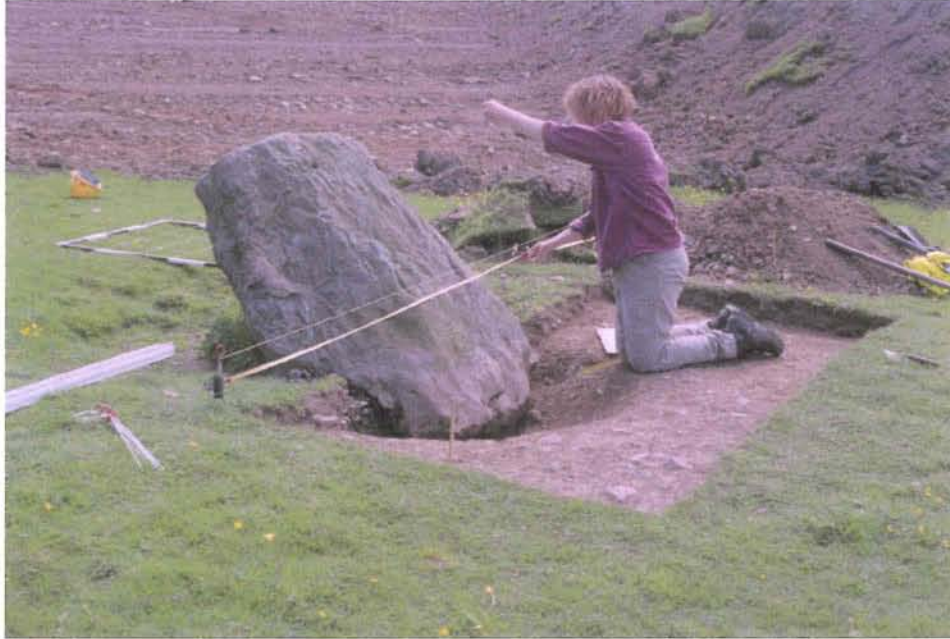
Plate 4: Site 7, stone, during excavation and recording

- 4.6.2 An area, 2.8m east to west by 1.45m north to south, was excavated by hand on the north side of the stone to uncover the pit or socket which it was assumed had been dug in order to take the stone, and to recover any datable material that might be contained in the fill of the pit. A portion of the stone itself was included within the excavation to allow its inclusion in the drawn section of the deposits which were encountered (plate 4) .

- 4.6.3 An initial topsoil layer of mid grey-brown loamy silt (1), up to 0.07m thick, was removed, revealing an underlying layer of gravelly stone in a matrix of mid-grey silt (2). Layer 2 proved to be up to 0.10m thick and contained finds dating to the 19th and 20th centuries. At this point the socket cut (5) for the erection of the stone (4) and its fill (3)

became visible. The socket was 1.4m in diameter, but only 0.4m deep, its shallowness explaining the reason for the lean of approximately 30 degrees to the vertical exhibited by the stone. The stone measured 1.43m in total length, and its cross-section was 0.81m by 0.75m.

4.6.4 Finds recovered while excavating the sticky orange clay silt fill (3) of the socket were entirely 19th-century in date. On completion of the section drawing, the stone was carefully removed by machine and the base of the socket examined. A number of pottery sherds were recovered from directly beneath the stone, all of which were again from the 19th century.

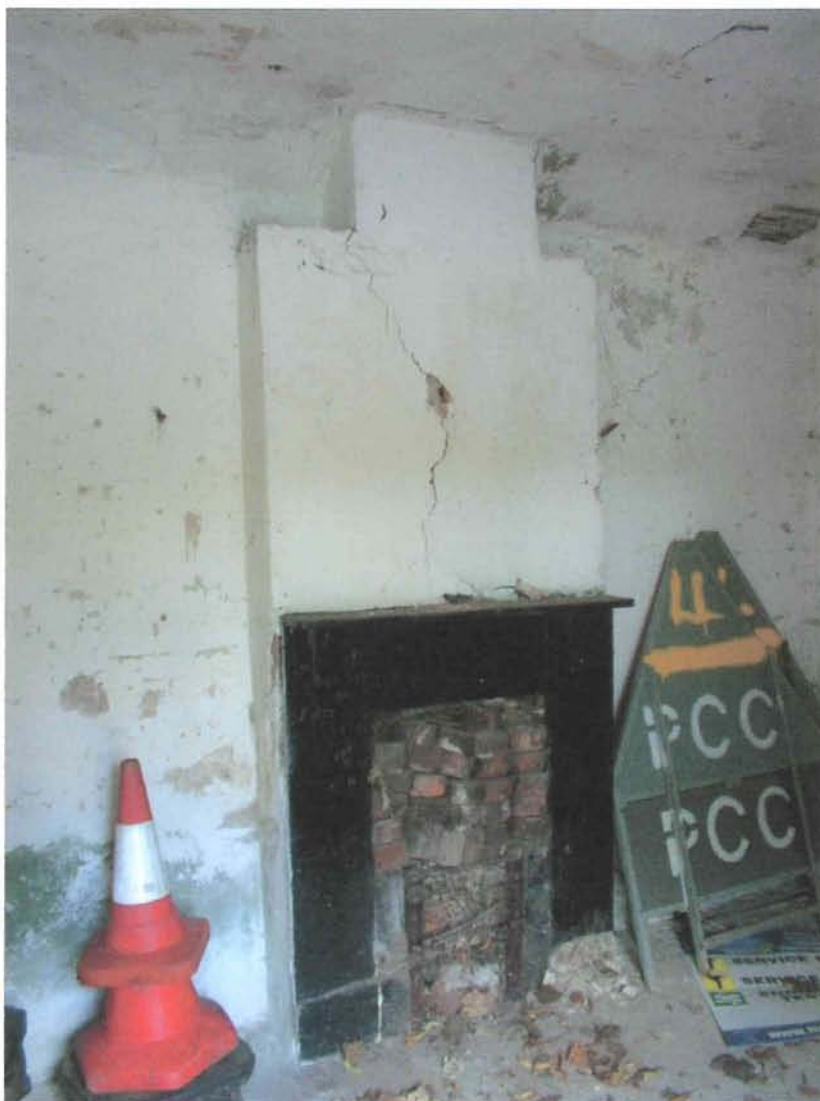
Plate 5: Site 10, weighing machine building, interior

4.7.1 The exterior of this brick building had been recorded briefly during the initial assessment of the development. Unfortunately, it was not possible to access the interior of the building at that time, and this had to be deferred until the commencement of work on site. The interior was eventually examined on 16 August, but was largely devoid of diagnostic features. Its function, as the housing for a weighing machine related to the railway depot, had apparently been confirmed to the site contractors by local residents. The interior contained a fireplace, with a late Victorian wooden surround and a chimney breast on its south wall, cracks in which demonstrated the poor condition of the building. The window fronting Victoria Avenue was covered by an external wooden shutter, but the glazing survived on the interior and it seems likely that the area behind the window

(the north-west corner of the building) was the location of the weighing machine base. The walls of the building were only 0.3m thick.
