***A40 Llansantffraed/Talybont-on-Usk  
Embankment Stabilisation  
and Junction Improvement, Powys***

ARCHAEOLOGICAL WATCHING BRIEF

CPAT Report No 841

R. Hankinson  
January 2007

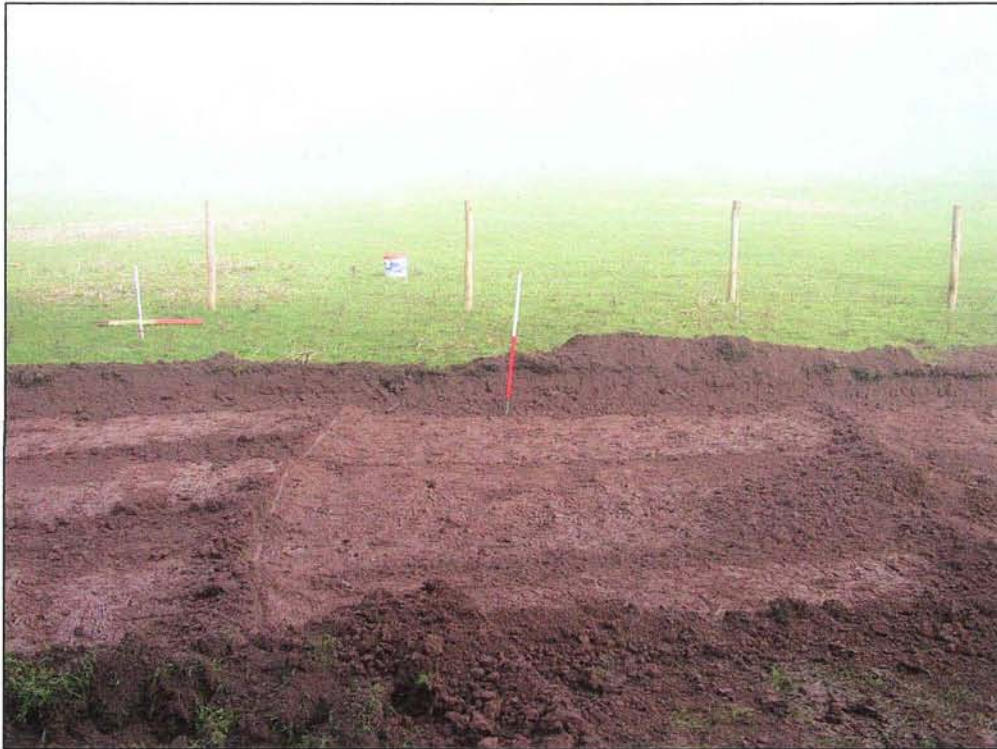
- 3.2 The line of Site 17, a redundant boundary bank, was crossed by a new section of access road leading to Llansantffraed village. Some disturbance to the earthwork was inevitable during the preliminary groundworks for the new road and these were examined when a 21m-long and 4m-wide section was cut across the bank at SO 12382335. The western end of the area examined commenced some 40m from the fence which defines the western boundary of the field. The excavation revealed that some of the appearance of the feature is due to the natural lie of the slope, but that the surface soils are a little thicker (a maximum of 0.5m instead of the 0.25m elsewhere) on its line. It may be that the feature is a lynchet or perhaps a ploughed-down boundary bank.

Plate 1 Section cut through the bank (Site 17), from SW (CPAT photo 2291-001)

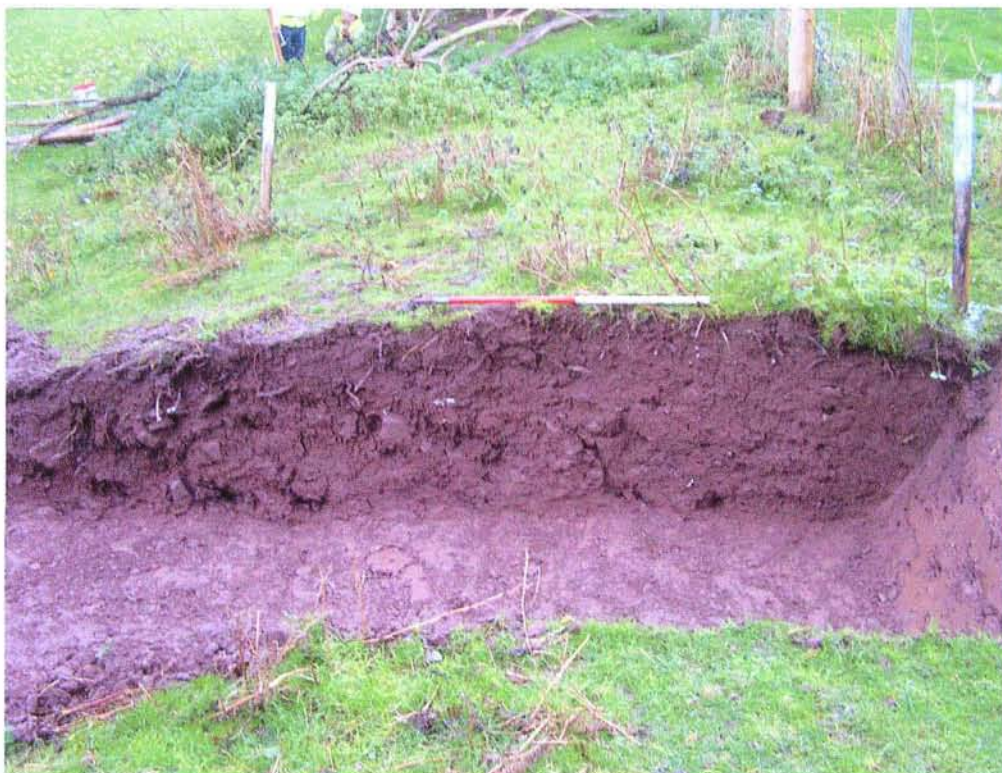
Plate 2 Section across the lynchet (Site 18), from SW (CPAT photo 2291-006)

- 3.6 A machine-cut section, up to 1.2m deep, was excavated across the affected portion of Site 18 under archaeological supervision, on the 15<sup>th</sup> November. The makeup of the bank was examined and found to consist of brownish-red sandy silt, up to 0.6m thick, with a cover of topsoil, generally 0.3m thick. An area of stones, individually up to 0.3m across and collectively up to 0.36m thick, lay against the western slope of the bank and could represent either cleared stone, or be a result of the agricultural methods used to create the earthwork. Examination of the section suggested that the site was most probably a lynchet, created during ploughing, although its period of origin could not be confirmed by any artefactual evidence.

- 3.5 On the 6<sup>th</sup> November, some minor surface damage to Site 18 (another lynchet or field bank), was noted, resulting from a machine being parked on the earthwork. The marks were re-turfed at the time under archaeological supervision to prevent the onset of erosion. Subsequently, it was realised that a revision to the line of the access road mentioned in para 3.2 was required, which necessitated the removal of the south-western end of Site 18, at SO 12412331.
