**Offa's Dyke, Keeper's Cottage, Ffrith,  
Flintshire**  
ARCHAEOLOGICAL WATCHING BRIEF

**CPAT Report No 660**

**P Jones**  
August 2004

Report for Flintshire County Council

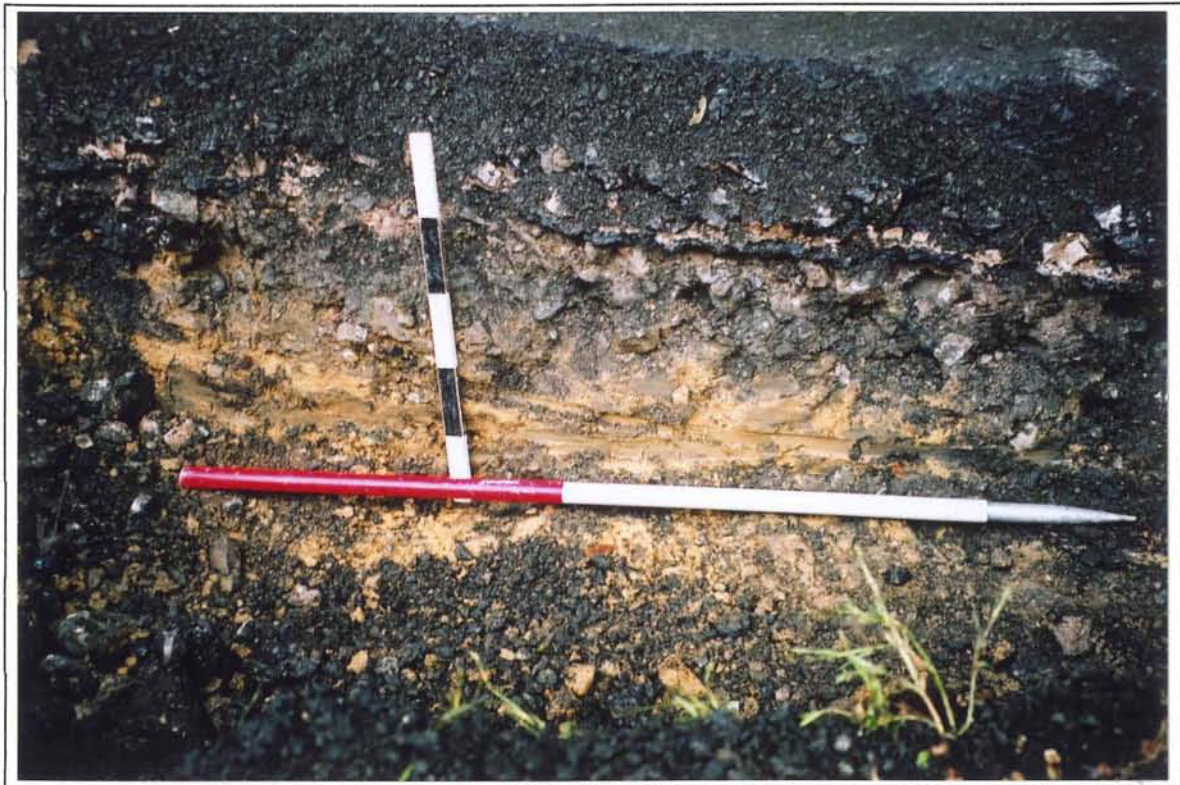
Plate 1. Trench 2. North-facing section of road where trench turns (CPAT 1750/14)

- 3.7 From the point where Trench 2 turned into the middle of the road the character of the road construction changed. Two layers of tarmac (205; 206) overlay a thin (25-50mm) layer of small stones in a pinky buff matrix (207). This in turn overlay a very thin layer of tarmac (208), beneath which was the base layer of road-stone (209 - same as 203). Where the road levelled out to its highest point (190.8m) a passing place has been built onto the southern edge of the road. Up to this point the road layers had resumed the earlier sequence of two layers of tarmac over a thick layer of road-stone on top of brownish yellow clay. Just to the east of the westernmost passing place the thickness of the road layers began to vary considerably, as did the thickness and depth of the clay. At the east end of the passing place the entire north-facing section (0.45m) was taken up by road layers although within a few meters this had changed to 0.25m of road layers overlying 0.2m of yellow clay. Continuing east the clay layer thinned out to a point where it was no longer visible in section or plan. The clay layer reappeared, rising to a thickness of 0.20-0.25m but east of BT pole 4A, and for the rest of the trench, the variations in depth and thickness of layers decreased and became more even.

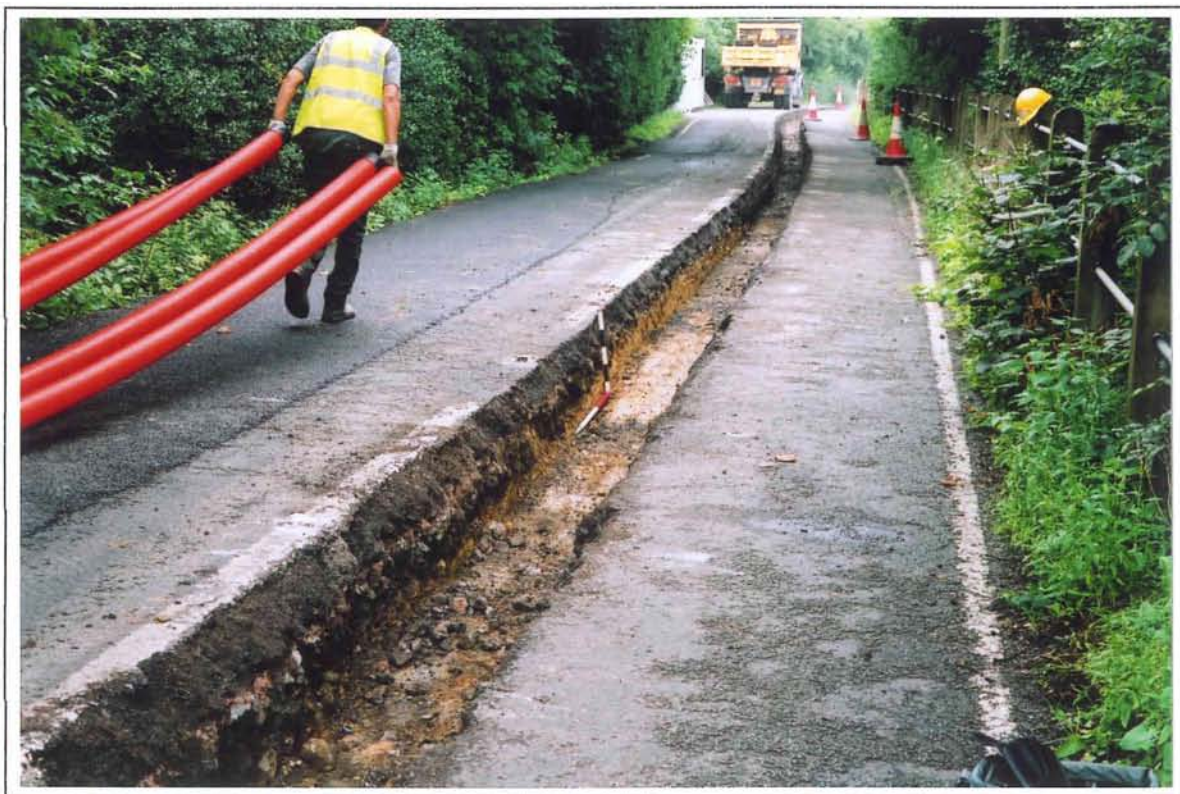
Plate 2. Trench 2. General view of undulations in the yellow clay A (CPAT 1750/19)

- 3.6 For most of the first 50m of Trench 2 the exposed sections were the same as the south and north-facing sections of Trench 1, with the exception of the brownish yellow clay which, because it was seen at a greater depth (0.7m) in Trench 1, was not present in either sections of Trench 2. Just before the trench turned into the middle of the road (at BT pole 2A), a brownish yellow clay (204) appeared in plan at the bottom of the trench and in the bottom 50-100mm of the north-facing section. Overlying this was a 0.15-0.2m thick layer of road-stone (203), overlain by 0.15m of tarmac (201; 202). The south-facing section was at this point made up entirely of the dark brown silty soil of the northern verge (the same as 101). The fact that the clay did not appear in the south-facing section indicates that the clay is sloping down towards the north.

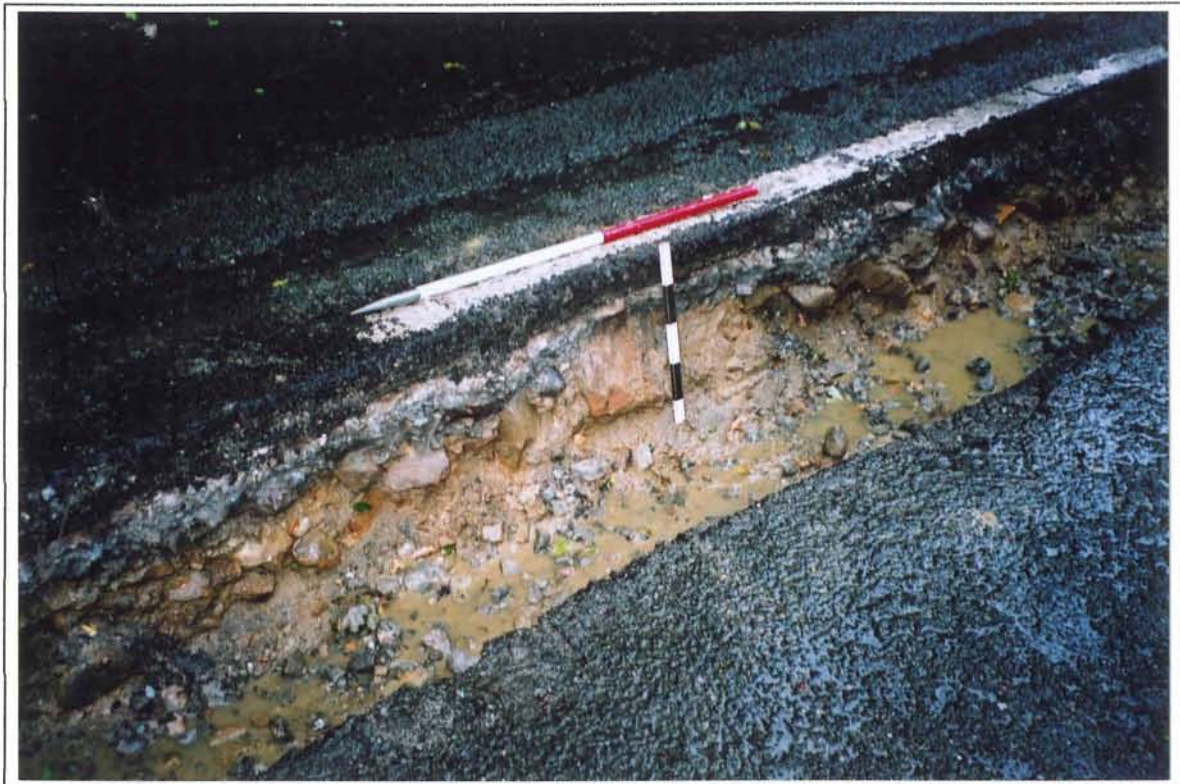
Plate 3. Trench 2. Larger stones (403) in north-facing section (CPAT 1750/22)

- 3.11 The construction cuts and connecting cable trench east of Keeper's Cottage consisted of a trench (400) 2.5m long, 1.5m wide and 0.7m deep on the north side of the road, a connecting trench (406) of 5m long, 0.7m wide and 0.45m deep, and a trench (412) 2.5m long, 1.5m wide and 0.7m deep on the south side of the road. On the north side the trench (400) showed a change in the character of the road layers. Whilst the tarmac (401) and road-stone (402) were the same as seen in Trenches 1, 2 and 3, there was another layer of larger stones (403) beneath the road-stone. Below this was a very thin layer of orange ash and clinker (404), which lay directly on the brownish/yellow clay (405), which was seen when hand cleaning the bottom of the trench. Pressed into the top of the clay was a ferrous object, either a long nail or spike probably from context 404.

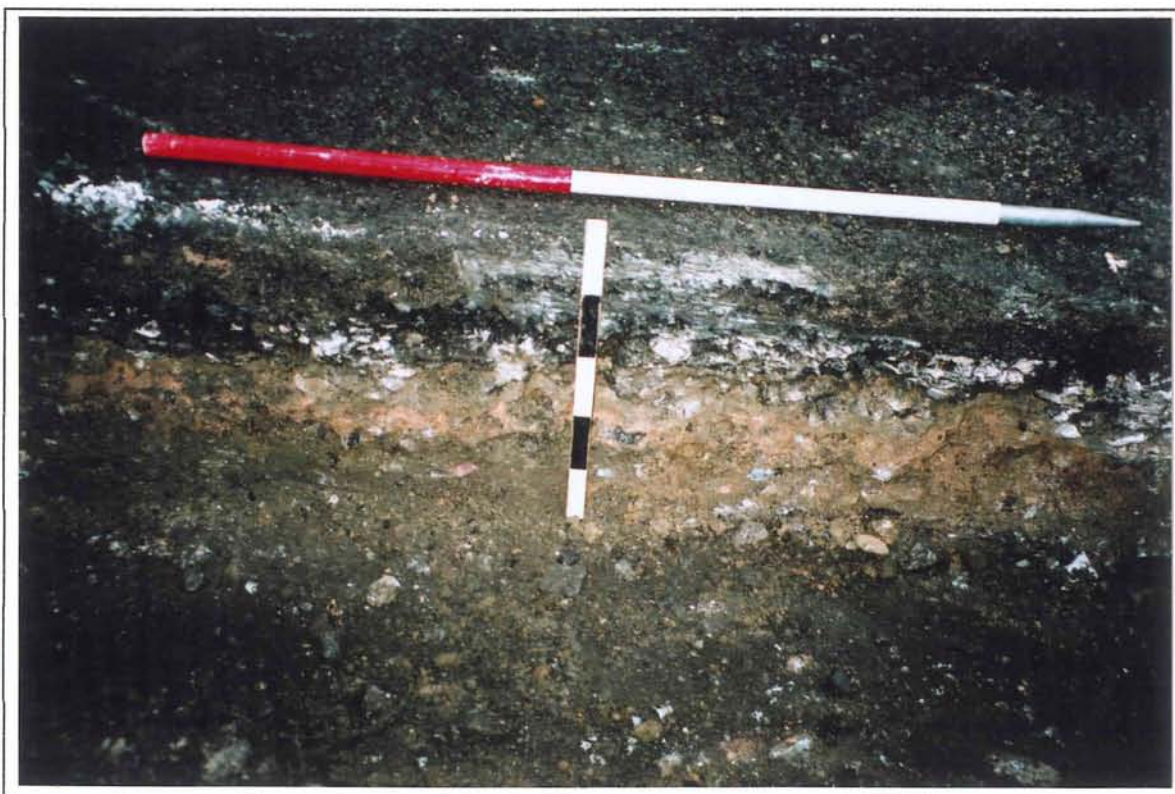
Plate 6. Trench 6. South-facing section (CPAT 1751/08)

- 3.15 Trench 6 (600) was the same as Trench 5, but extending east from the construction cut on the south side of the road at the east end of the scheme. The south-facing section revealed 0.2m of tarmac (601) above 0.2m of road-stone (602), below which was 50mm of dark grey stony silt (603). The yellow clay was not seen, except intermittently in plan at the eastern end of the

cut. The north-facing section revealed of 0.1m of loose tarmac and organic material (604) above kerb-stones (605) and the concrete setting for the kerb-stones (606).
