# FOUR CROSSES STW GROWTH ARCHAEOLOGICAL EVALUATION

## **CPAT Report No 874**

By I Grant August 2007

Report for Severn Trent Water Ltd

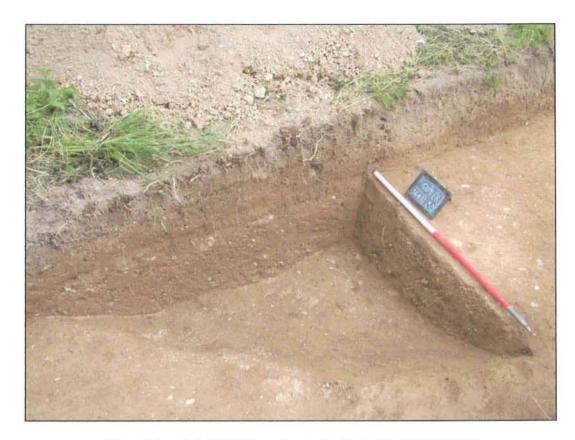
Plate 1 Trench 1, Pit 08 from the south. Photo CPAT 2369-008

- 4.5 Two large sub-circular, pit-like features (08 and 11) were identified at the northern end of the trench, both extending beyond the limits of the excavation. The pit 08, located on the western side of the trench at a depth of 0.4m below the ground surface, was 2.7m in diameter and 0.38m deep. It contained a single fill (07) of orange-brown silty clay (see Plate 1). The second pit (11) was located at the northern end of the trench. Its visible diameter was at least 2m with a depth of 0.55m. The basal fill (10), a soft orange-brown silty clay containing numerous river rounded pebbles, was sealed by a friable orange brown silty clay (09) 0.2m thick (see Plate 2). No dateable artefacts were recovered from the pits and it is possible that they were tree pits, though the possibility that they are prehistoric features of a different origin should not be discounted.

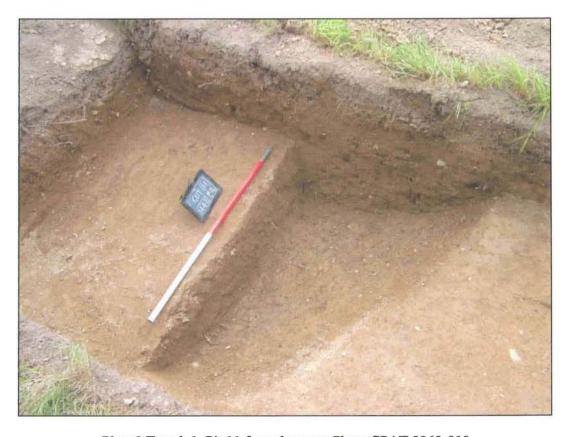
Plate 2 Trench 1, Pit 11 from the west. Photo CPAT 2369-010

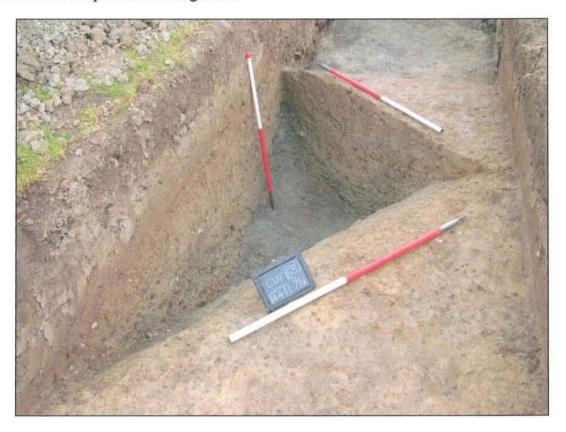
Plate 3 Trench 2, Ditch 63 from the south-south-west. Photo CPAT 2369-058

4.8 At a point midway along the trench, at a depth of 0.42m below the ground surface, a ditch (63) cut into the natural subsoil (66) (see Plate 3; Fig 3). The ditch was aligned east to west, and measured 2m wide and up to 0.9m in depth, with steep sloping sides and a fairly flat base, into which had been cut two shallow, irregularly shaped features (82 and 83). The lower fills of the ditch were characterised by lenses of blue-grey, sharp, gritty gravels and fine silty clay, consistent with the early phases of natural weathering of the ditch sides. Overlying these fills was a deposit of brownish grey clay (73) containing iron-panned, mineral staining throughout. This was sealed by two brownish clayey silt and clay deposits (71 and 72), up to 0.5m thick, and a deposit of orangey-brown silt clay (62), which was similar to the fill (40) (containing Roman pottery) within the corresponding ditch revealed in Trench 4. On the southern, presumed internal, side of ditch 63 was a deposit of modified yellow clay (70), which may be the slumped remnants of the internal bank associated with the ditch. The deposits on the northern side of the ditch had been severely truncated by the modern rubbish pit (69).

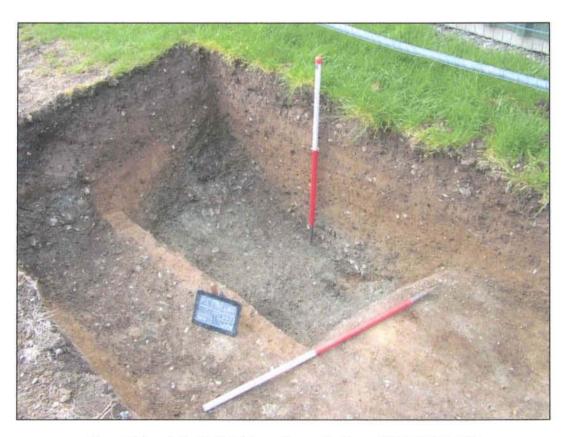
Plate 4 Trench 3, Ditch 34 from the north. Photo CPAT 2369-043

- 4.11 At the south-eastern end of the trench a ditch (34) was revealed cut into the natural subsoil. The extent of the feature went beyond the limits of the excavation, to the west and the south-east, and unfortunately the eastern side had been truncated by a modern service trench (30), up to 0.9m wide, which traversed the length of the evaluation trench. The ditch measured 1.7m wide and 0.54m deep, and had relatively steep sides with a slightly concave base and contained four fills. The primary fill (31), a yellowish-grey mix of clay and gravel 0.1m thick, probably resulted from slumped bank material as it appeared to have been originated primarily from the south-east side of the ditch. Overlying this was a deposit of greyish-yellow, soft, silty clay (32/33), 0.2m thick. Both of these fills were truncated by a later re-cut (55) of the ditch, 0.83m wide and 0.26m deep, which contained a single fill (54). The upper-most deposit (56), a yellowish brown silty clay 0.3m thick, sealed all of the underlying deposits within the ditch. No dateable artefacts were recovered from the ditch but its profile might suggest that it is of Romano-British or possibly earlier origin (see Plate 4 and Fig. 4).

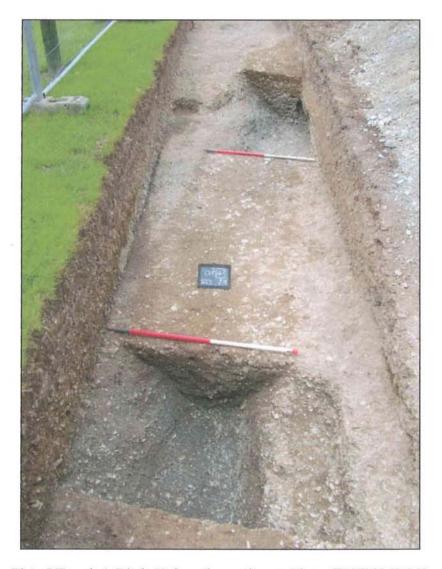
Plate 5 Trench 4, Ditch 43 from the south-east. Photo CPAT 2369-048

4.14 From the south-east corner of the trench to a point centered on the north-western side, a ditch (43) was cut into the natural subsoil. The extent of the feature went beyond the limits of the excavation, to the south-east and north-west, and the north-western end had been truncated by a modern service trench (37), almost certainly the same service utility (30) previously noted in Trench 3. The ditch measured 1.5m wide and up to 0.65m deep, and had relatively steep sides with a slightly concave base and contained seven fills. The primary fill (87), a yellowish-grey mix of clay and small rounded pebbles 0.17m thick, survived only on the eastern edge of the ditch, having been truncated elsewhere by a later re-cut (88) of the ditch, 1.1m wide and 0.65m deep, containing six fills. Other early fills (86/85 and 84) consisted of fine pea-grit, pebbles

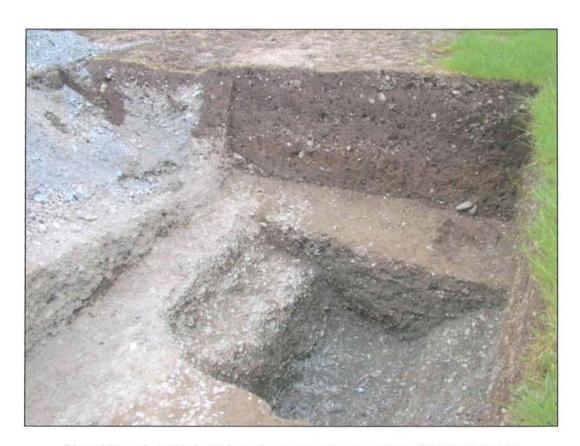
Plate 6 Trench 4, Ditch 43 from the west-north-west. Photo CPAT 2369-056

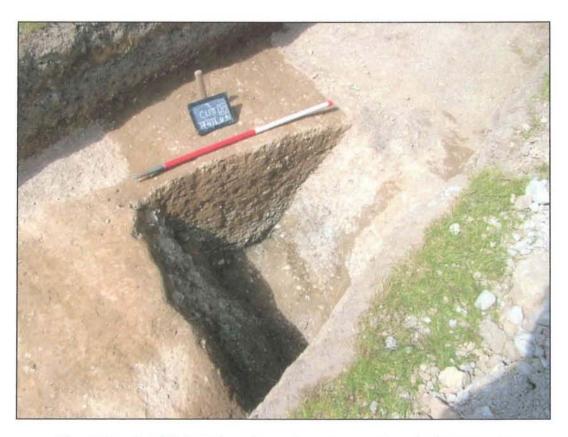
Plate 7 Trench 5, Ditch 20 from the south-south-east. Photo CPAT 2369-032

4.19 1.5m from the north-east end of the trench, at a depth of 0.5m below the ground surface, a ditch (20) cut into the natural subsoil (22) and the remains of an old ground surface of light grey clay (57) (0.1m thick). The deposit 57 was only observed in section and appeared to survive on the inner side of the enclosing ditch (20) (see Plate 7; Fig 6). The ditch was aligned north to south and measured 2m wide and up to 0.75m in depth, with steeply sloping sides and a fairly concave base. The lower fills of the ditch (19/18) were characterised by lenses of soft blue-grey silt and mottled iron-panned clay mixed with gritty gravels and small rounded stones. The combined thickness of these two fills was 0.35m. The upper fill 18 was sealed by a deposit of light brown sandy clay (17), 0.2m thick, which was in turn sealed by a firm fill of orangey brown silty clay (16), 0.2m thick. No dateable artefacts were recovered from the ditch but its profile might suggest that it is of Romano-British or possibly earlier origin.

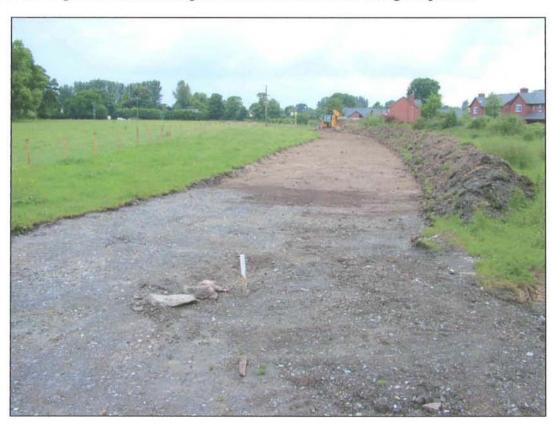
Plate 8, Topsoil stripping of wayleave. Watching Brief. Photo CPAT 2369-066

- 5.3 The removal of topsoil along the remainder of the route was undertaken on 14 and 15 June. The topsoil and underlying ploughsoil deposits were stripped to a maximum depth of 0.2m. The depth of stripping was such that remnant ploughsoil deposits, of 18<sup>th</sup>/19<sup>th</sup>-century date, remained along the entire length of the 9m-wide wayleave, effectively masking any potentially earlier archaeological features which may have been present (see Plate 8). Due to severe weather conditions which altered the scheduling of on-site groundworks at short notice, the excavation of the pipe-trench, which was 0.6m in width, was only partially monitored as part of the watching brief. No archaeological features were identified during this process.

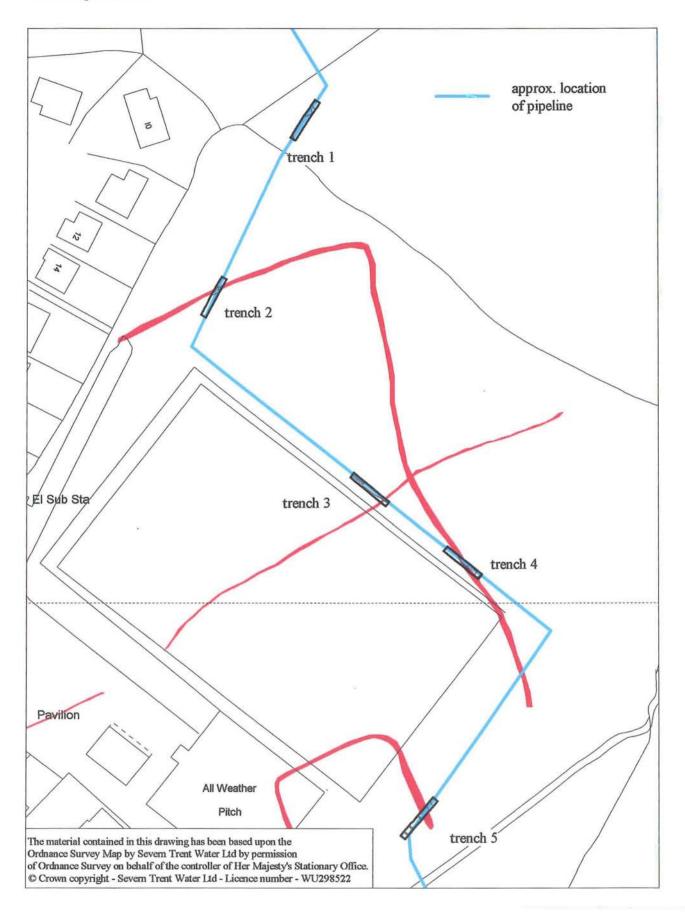
Fig. 1 Trench locations and cropmarks, scale 1:1,000

- 2.1 The proposals relate to the construction of a new 1.3km-long pipeline across land to the north-east and east of Four Crosses, between SJ 27681842 and SJ 27331969, within a 10m-wide working width (Fig. 1).

4.1 The excavations consisted of five trenches (Fig. 1) which were located to examine a group of anomalies identified by the geophysical survey, together with a series of ditches revealed from cropmark evidence. The trenches were positioned along the line of the pipeline, rather than specifically focussed on the archaeological features. In each trench the overburden was removed by machine under close archaeological supervision, with all cleaning and subsequent excavation being undertaken by hand. A full drawn, written and photographic record was maintained throughout, details of which are provided in Appendix 1. Numbers in brackets in the following text refer to individual context records in the site archive.

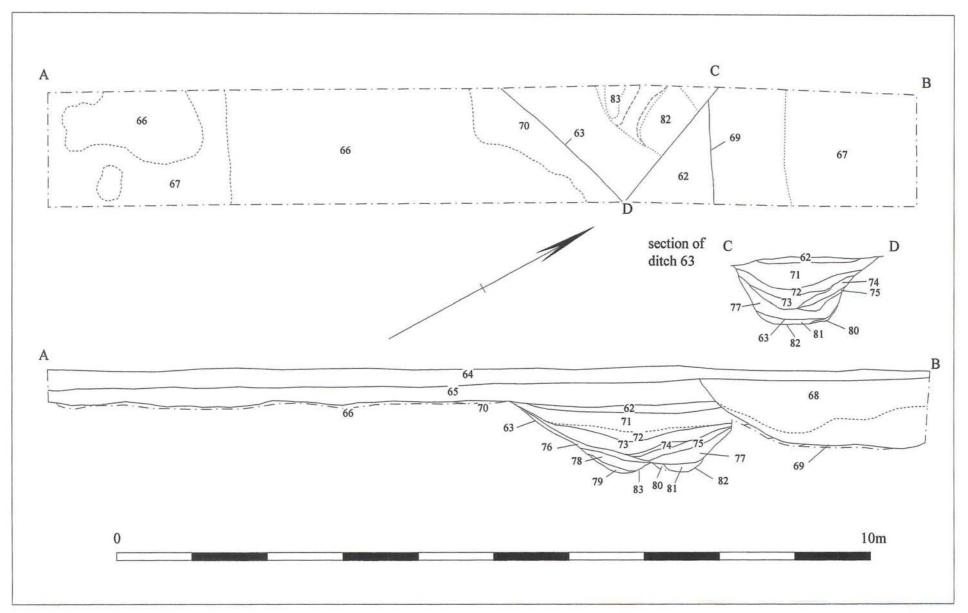
Fig. 3 Trench 2 plan and section, scale 1:50

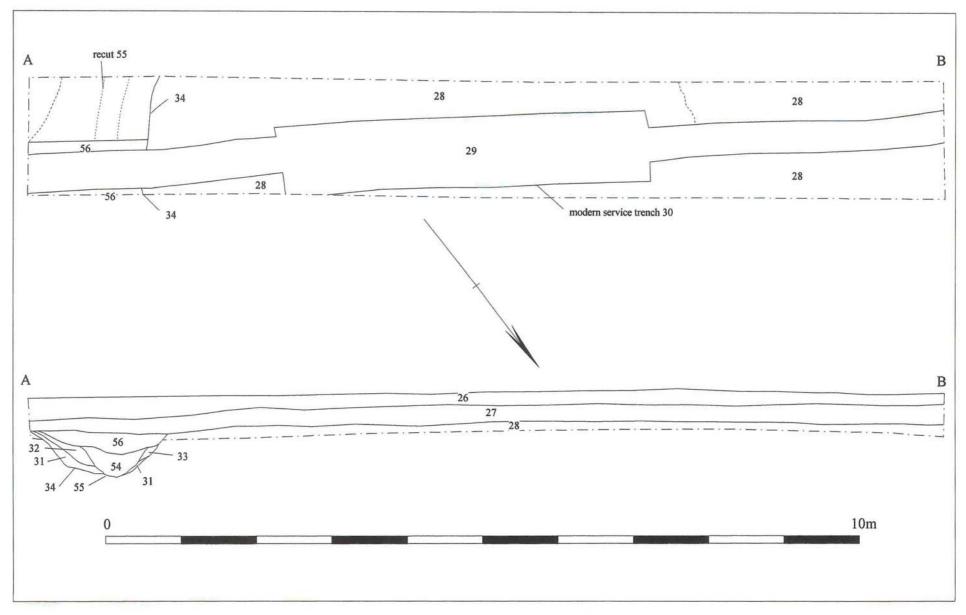
Fig. 4 Trench 3 plan and section, scale 1:50

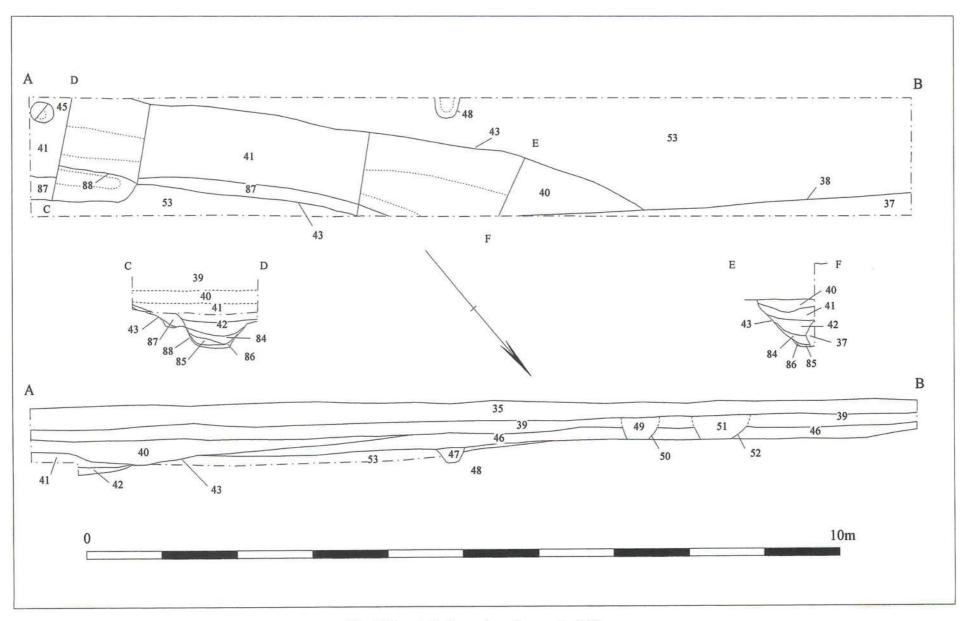
Fig. 5 Trench 4 plan and section, scale 1:50

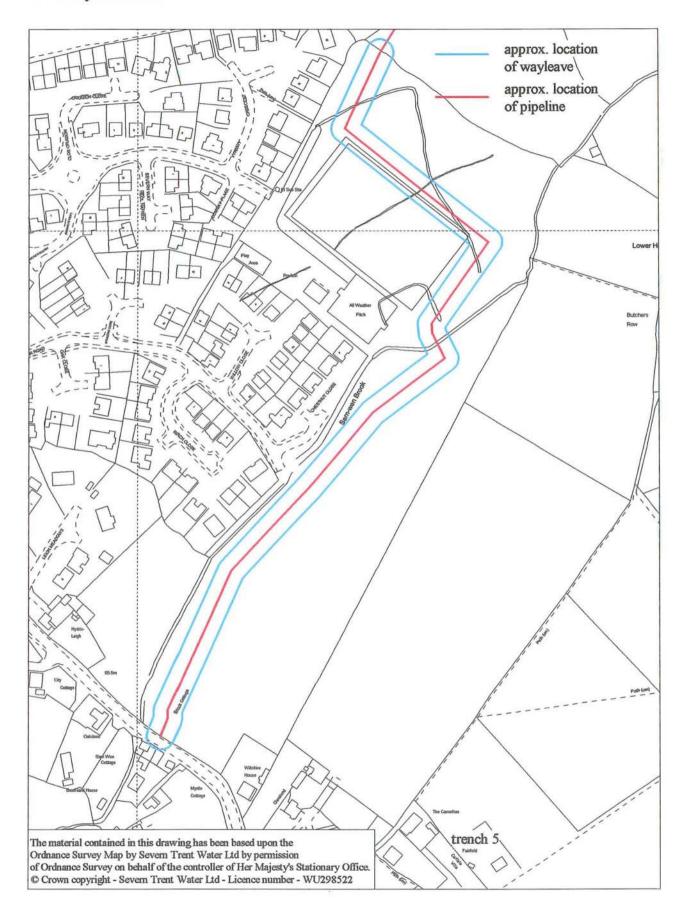
Fig. 7 Southern section of pipeline, scale 1:2,500

- 5.1 Following the completion of the excavations a watching brief was requested by the curator during the removal of topsoil along the south-eastern side of the playing field, and along the entire 9m-wide wayleave in the field to the south-west, a distance of approximately 320m (see Fig. 07).
