*Bryn Siriol Reservoir, Pant Quarry, Halkyn,
Flintshire*

ARCHAEOLOGICAL EVALUATION

CPAT Report No 830

I Grant
December 2006

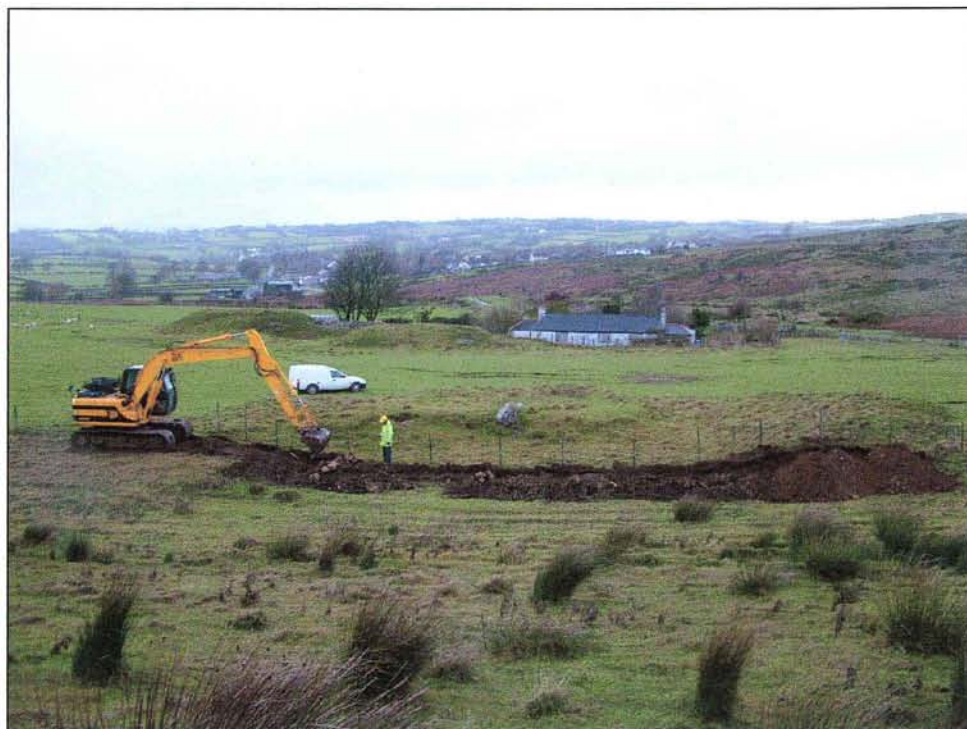
Plate 1. Excavation of the trench across the reservoir, viewed from the quarry screen bund in the south-east. Photo CPAT 2281.005

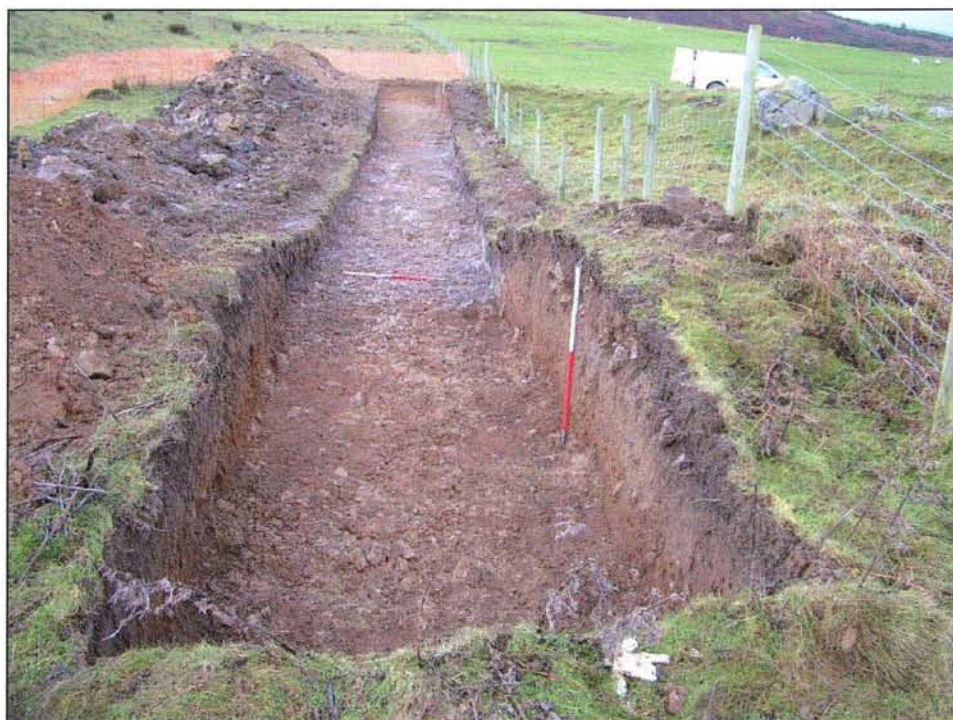
Plate 2. Trench viewed from the north-east, post initial cleaning. Photo CPAT 2281.015

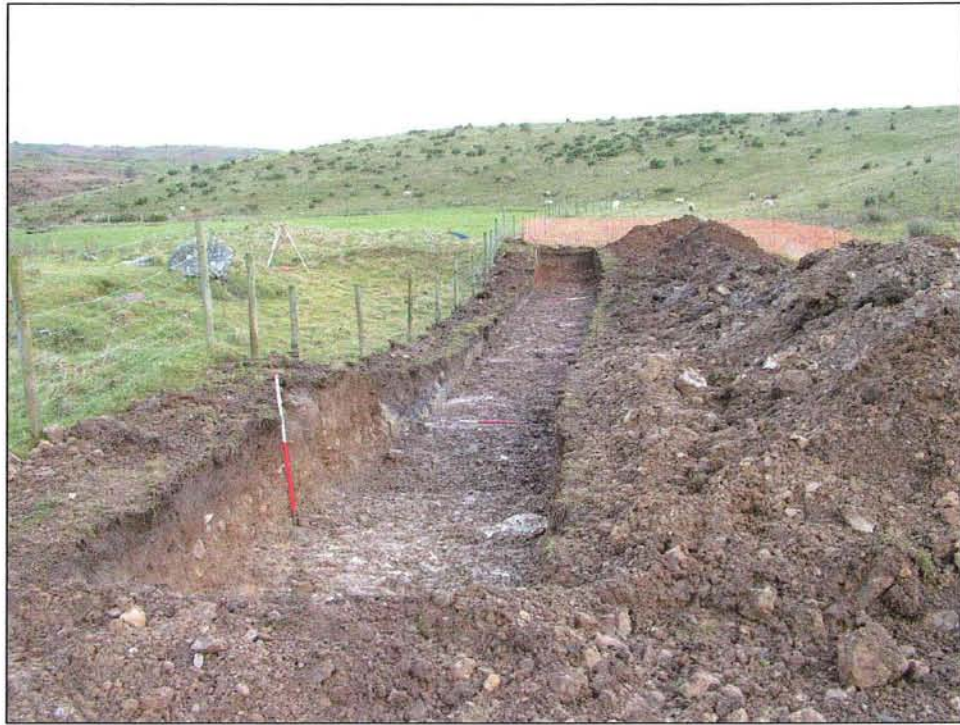
Plate 3. Trench viewed from the south-west, post initial cleaning. Photo CPAT 2281.016

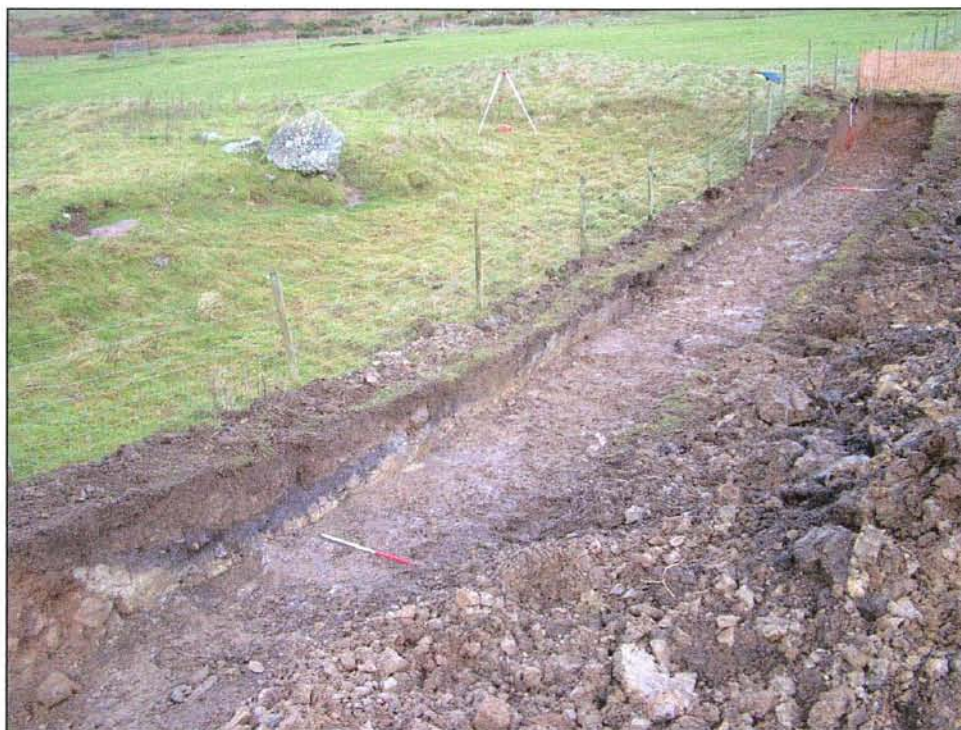
Plate 4. Cross-section of the clay-lined reservoir tank, viewed from the south-west
Photo CPAT 2281.022

- 4.4 On removal of the internal fill within the reservoir it was possible to record, in section, the depth, width and nature of the tank. The overall width of the internal structure (20), north-east to south-west, was 17.5m, the edges of which were revetted with crude blocks of limestone (29, 30), approximately 0.4m in width. The revetment and base of the tank was clay-lined with a firm yellowish-grey clay (19), 0.2m thick. Overlying the clay deposit were the remains of the reservoir's primary settling deposit (18), a black, fine silty clay 0.1m thick. No dating evidence or industrial residues were recovered from this deposit. The overlying deposits (17,16 and 10) indicate the stage at which the reservoir fell into disuse. These were in turn, truncated by a number of post-holes (24,26 and 28), possibly associated with recent agricultural use of the site. The overall depth of the reservoir, including the 20th-century overburden, was no greater than 0.6m (see Plate 4).

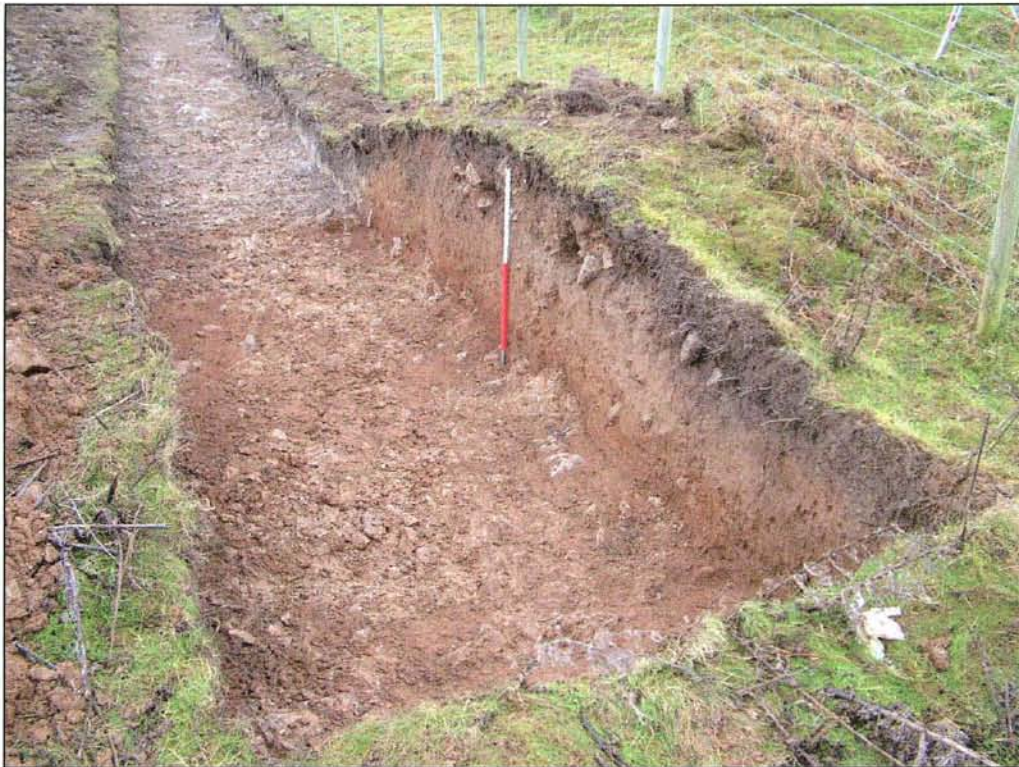
Plate 5. South-east facing section through the reservoir embankment (north-east end).
Photo CPAT 2281.022

- 4.5 Both the north-eastern and south-western embankments were constructed from a series of earthen deposits excavated from the immediate vicinity. The north-eastern bank consisted of six deposits, the lower of which were characterised by soft orange-brown clay silts. The upper layers included fragmented blocks of limestone. When viewed in section the bank survived to a height of 1.1m, with a basal width of 6m and the upper width (above the present ground surface) being 4m (see Plates 5 and 6; Fig. 4).
- 4.6 The south-western embankment survived to approximately similar dimensions. The construction also paralleled that of the opposite embankment although the lower deposit, 15, was characterised by a greyish gritty clay containing fragmented limestone throughout. No dating evidence was recovered from any of these deposits (see Plate 7; Fig. 4).

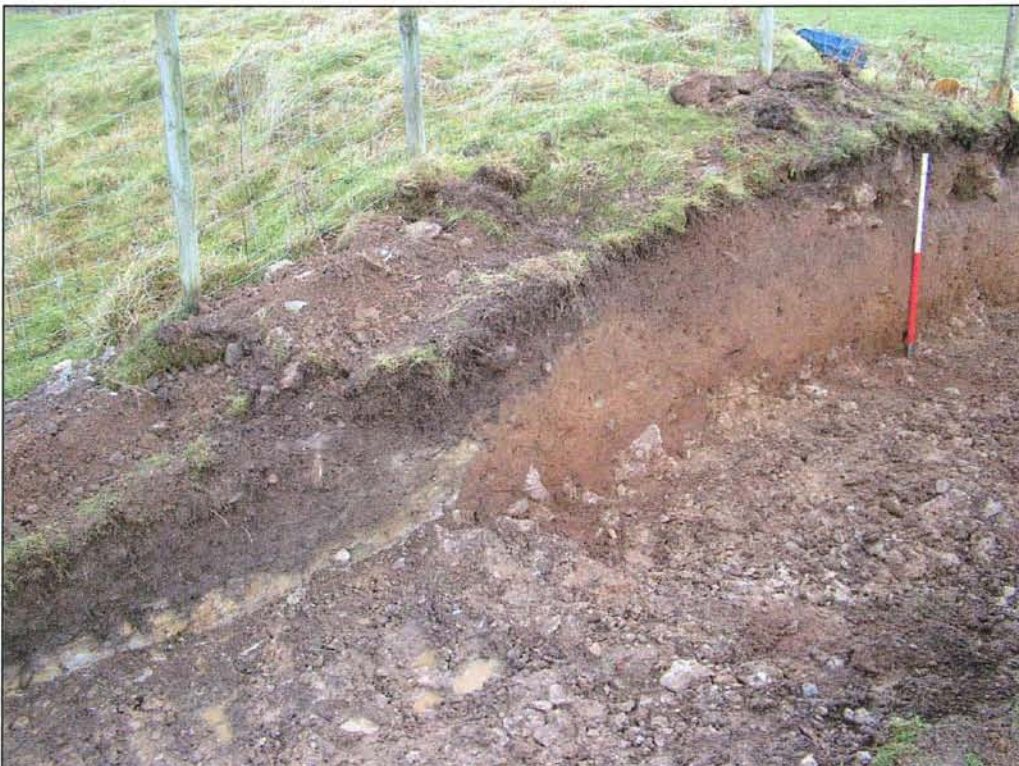
Plate 6. South-east facing section illustrating the clay-lined tank. Photo CPAT 2281.022

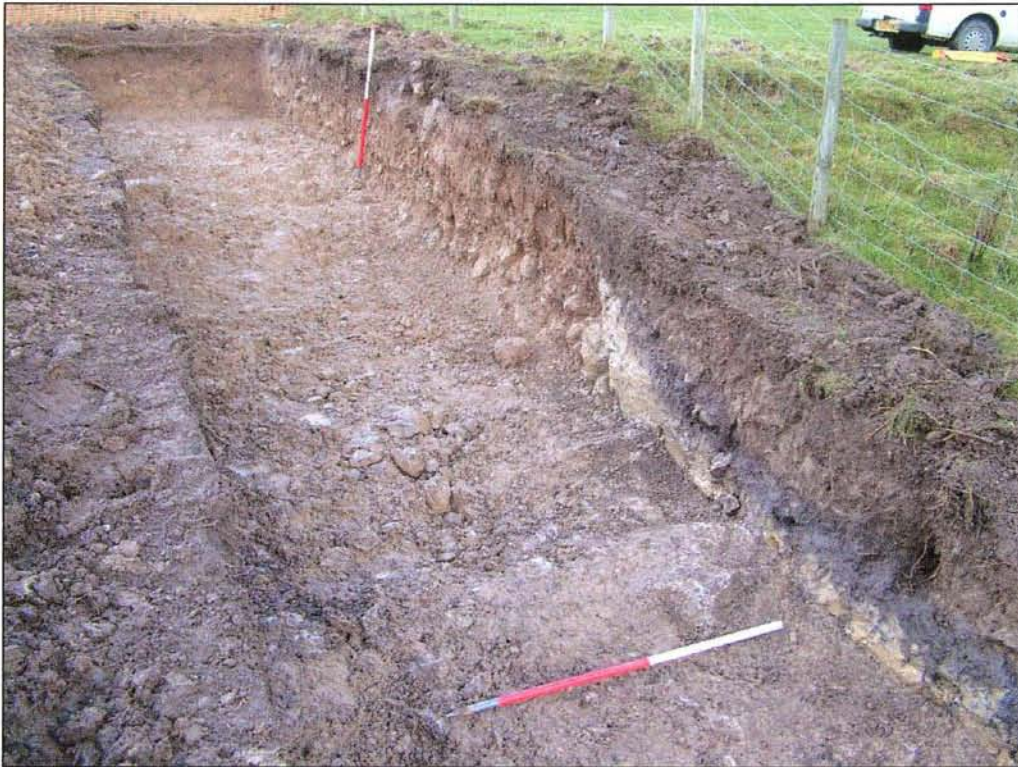
Plate 7. South-east facing section through the reservoir embankment (south-west end), illustrating the clay-lined reservoir tank. Photo CPAT 2281.022

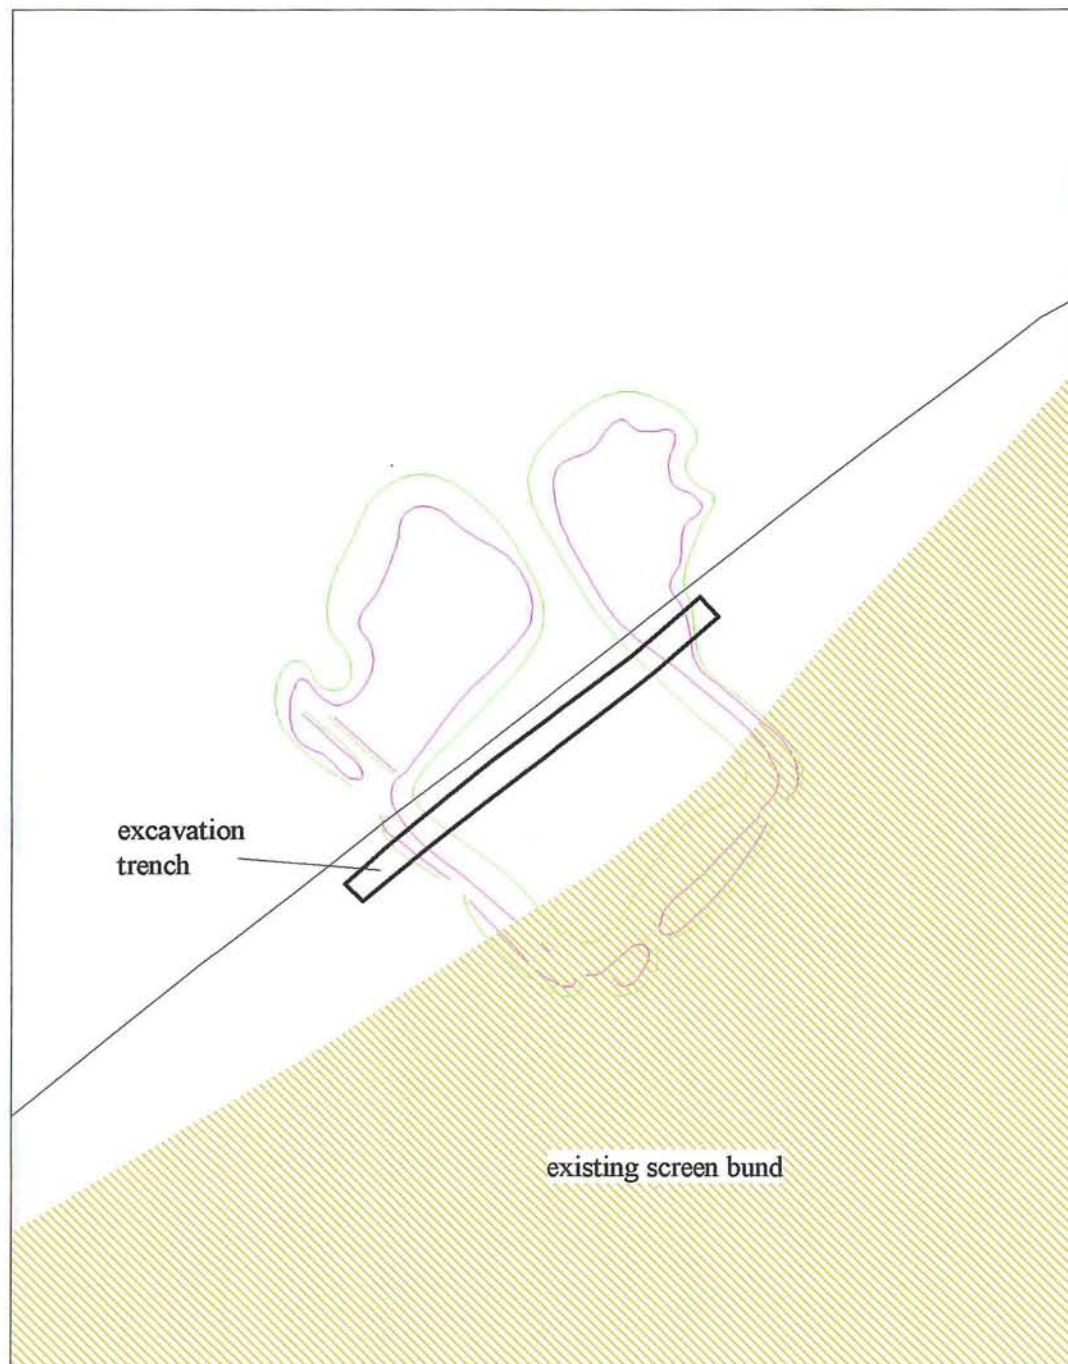
Fig. 3 Bryn Siriol Reservoir, trench location, 1:500

- 2.2 Since the initial archaeological survey of the site, undertaken by CPAT in 2000 (Jones 2000), the south-eastern portion of the reservoir has been buried by the lower slopes of the quarry screen bund (see Fig. 3) and what now remains of the earthwork is bisected by a recently erected boundary fence, orientated north-east to south-west.

- 4.3 The trench was aligned north-east to south-west, and was located along the south-eastern side of a recently erected boundary fence (see Fig. 3). Removal of the overburden and reservoir retaining banks, together with the surviving deposits within the limits of the known reservoir, revealed a varying surface of natural subsoils across the length of the trench, all of which overlay large fragmented blocks of limestone (04) (see Plates 2 and 3). At the north-eastern extent of the trench the subsoil consisted of a reddish-brown soft silty clay (03). A similar deposit (22), but more gritty and patchy, covered some of the central parts of the trench.

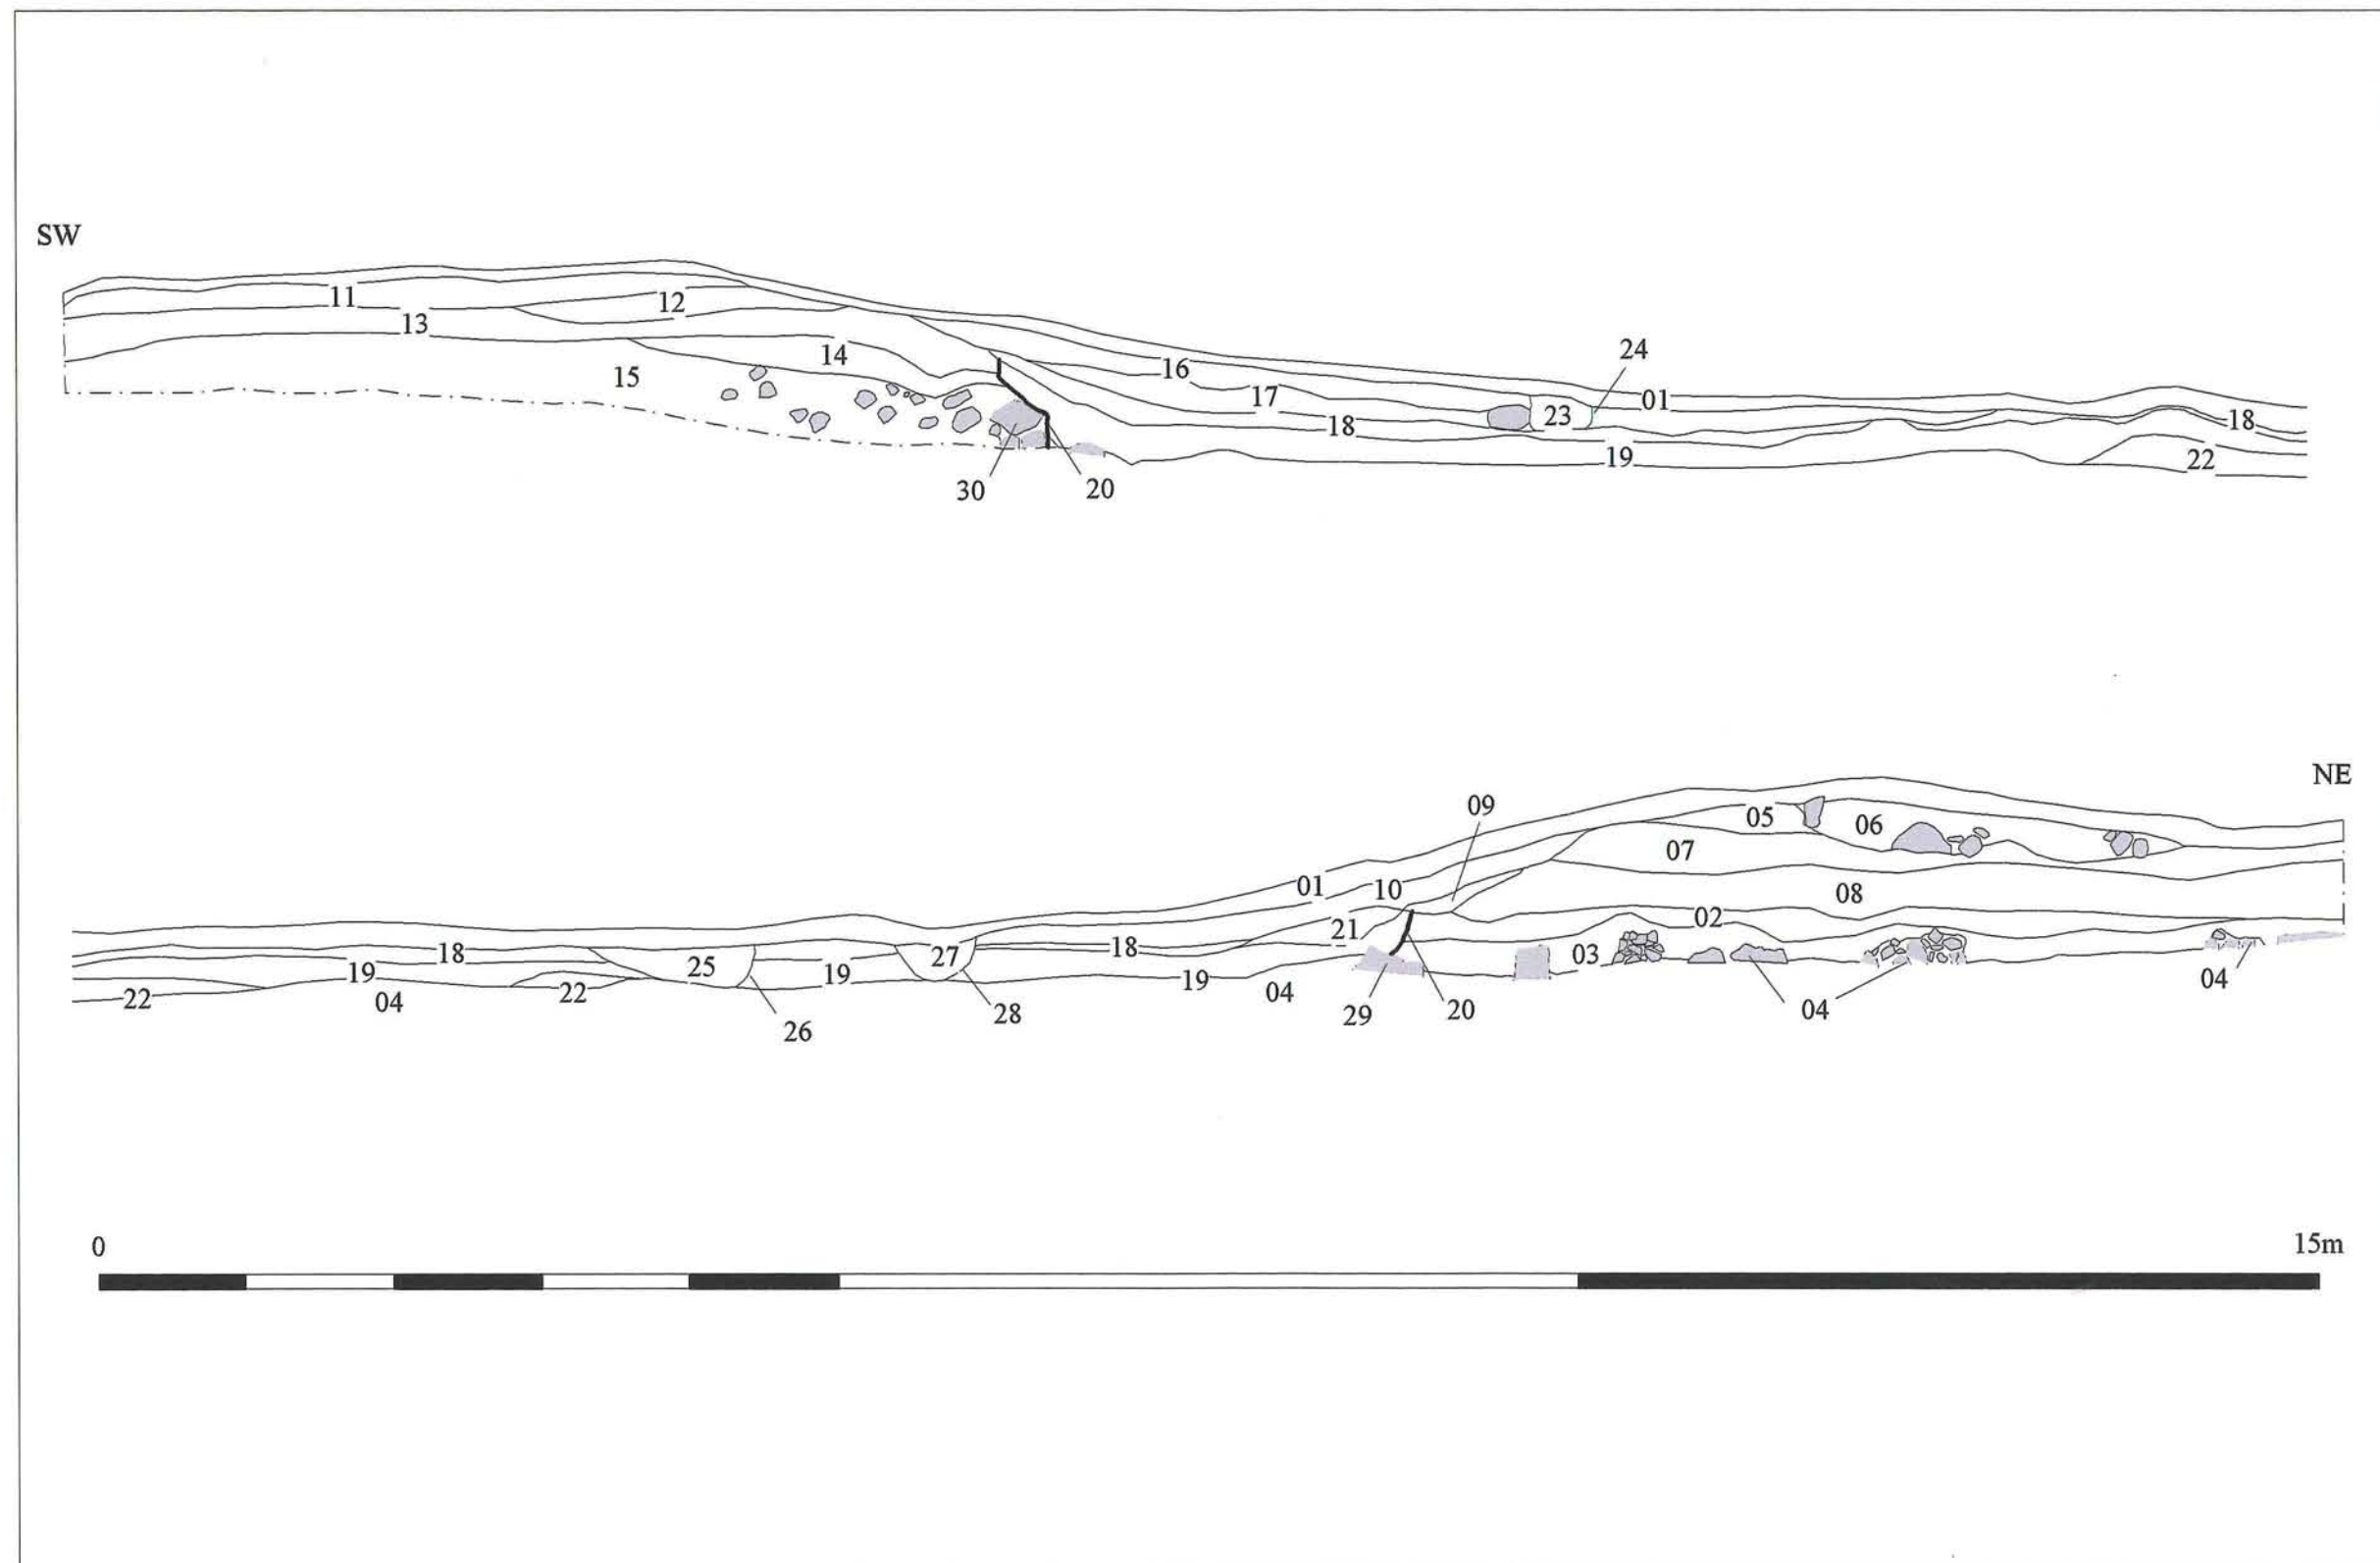
Fig. 4 Excavated section through Bryn Siriol Reservoir, scale 1:50
