St Michael's Church, Abergele

REPORT ON ARCHAEOLOGICAL EXCAVATIONS

CPAT Report No 775

I Grant
June 2006

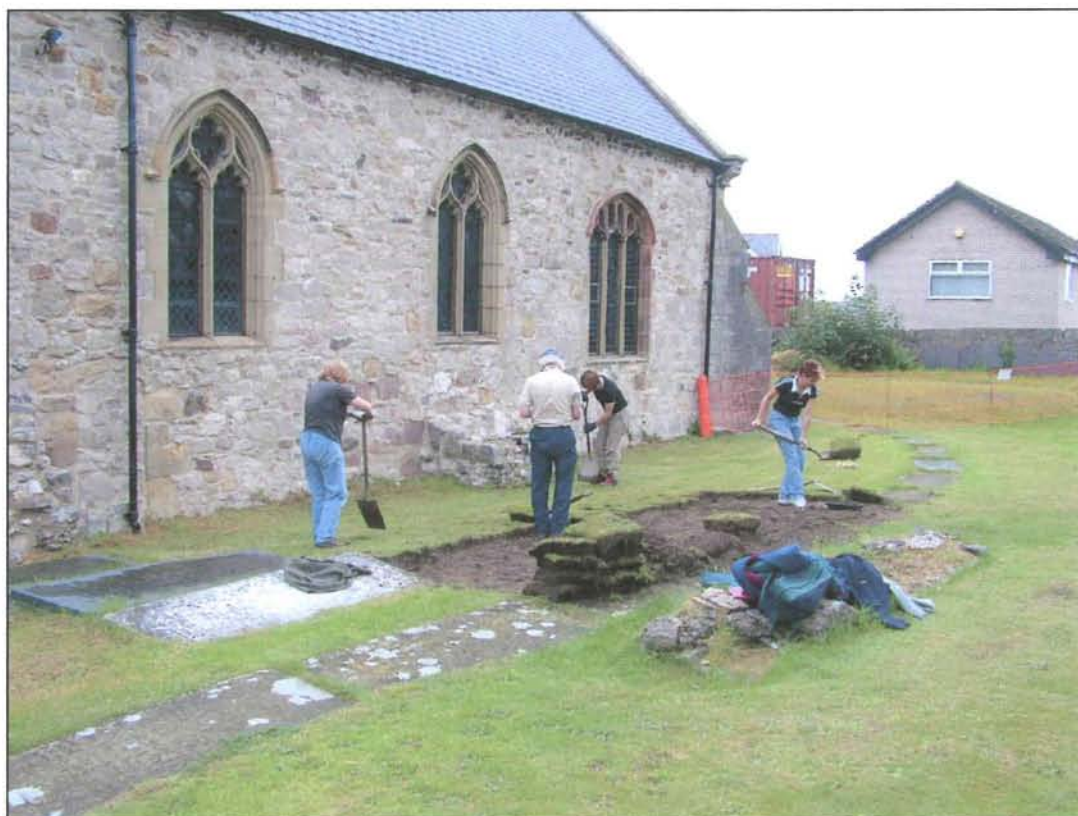
Fig. 3 Removal of turf. Note the in-situ burials and the footpath that dictated the layout of the site excavation – Areas A and B. Photo CPAT 2007-001

- 3.4 The process of excavation within a churchyard can be quite sensitive owing to the obvious (and not so obvious) presence of human burials. Consequently site etiquette required that all of the excavated material had to be removed by hand. This included the time-consuming task of removing and storing on site the turf and other excavated materials for reconsolidation (Fig. 3).

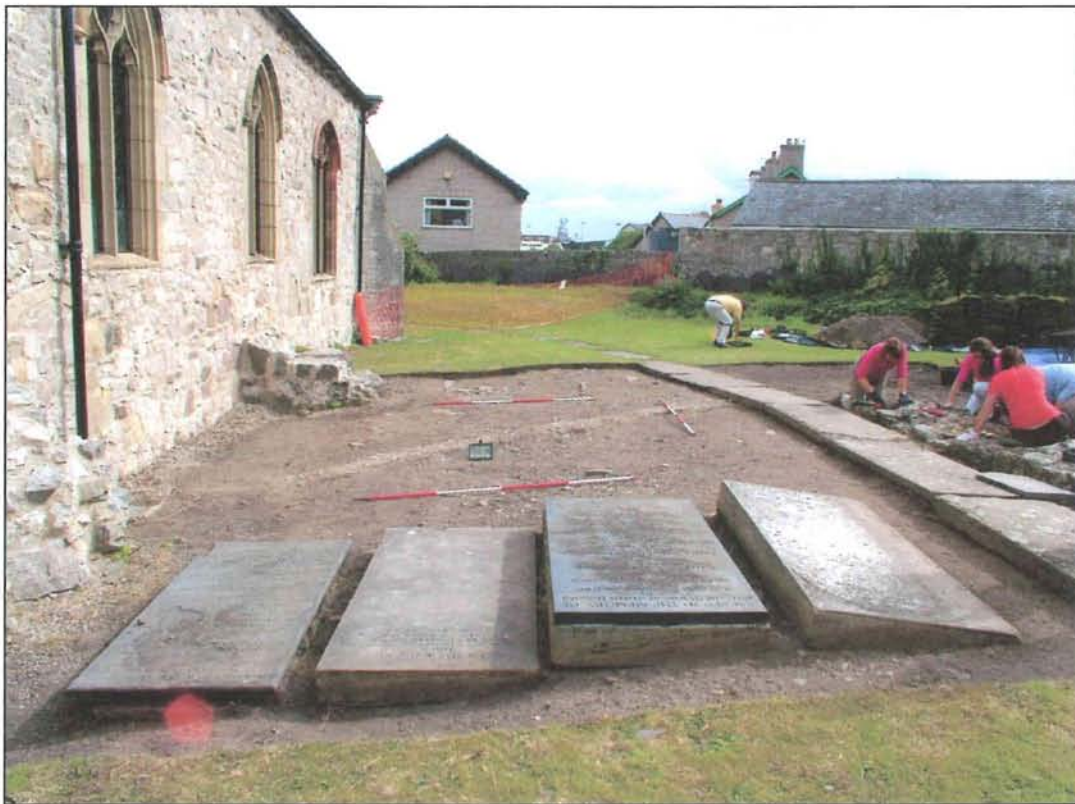
Fig. 4 Memorial stones (13-16), Area A. Modern drainage (04) can be seen in the background
Photo CPAT 2007-010

- 3.5.3 Alongside the western edge of Area A there were four 18th-century grave memorial stones (13-16), all in their original positions south of the stone buttress (06) (Fig. 4). Their impact upon the surrounding deposits needed to be isolated and so all subsequent debris and backfill was removed from around them. At this point we still did not know the full extent of the burial disturbance in the area. Large quantities of silty sand and stone up to 0.15m in depth (02), had to be removed off site. Although this material was of post-medieval origin, reflected in the large quantities of ceramics and pipe clay recovered, it contained also a quantity of finds (detailed in section 4) covering earlier periods of occupation; possibly Roman, early medieval (9th/10th-century), medieval (13th/14th-century) and early 17th-century. Removal of this spread of material revealed fragmented sandstone and limestone within a matrix of light grey silt (33) covering a further six burials (25-30), of post-medieval origin. At least two of these (28 & 30), located immediately south-east of the stone buttress (07), were marked by the remains of slate plinths containing positioning slots, presumably for the attachment of since removed upstanding memorials. The fragmented layer appeared to resemble the construction material of both the wall (08) and the buttresses (06 & 07) indicating possible disturbed demolition layers of medieval material.

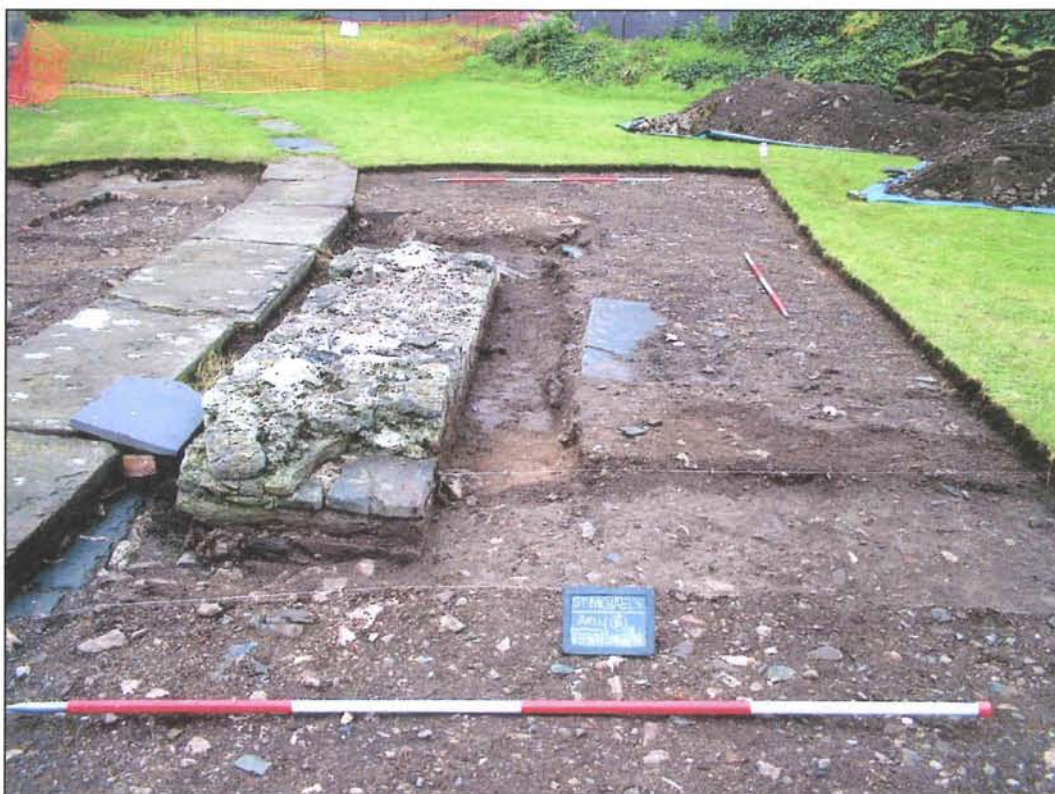
Fig. 5 Medieval (?) masonry wall (08) and sondage, Area B, Phase one 2005. The slate memorial stone (31) can be seen in the centre. Photo CPAT 2007-025

- 3.5.4 In Area B the initial cleaning process improved the definition of the isolated east to west wall (08) and exposed further masonry at the east end of the wall with no indication of a terminal to the structure. At this stage the structure consisted of three exposed courses of stonework, constructed predominantly from slate with a mixture of limestone and sandstone core bonded with lime mortar. A sondage (or test pit) excavated at the west of the wall revealed further courses of stonework, indicating a possible west end, although further excavation would have to be undertaken to clarify this (Fig. 5). One more post medieval grave (31) was identified during this process.

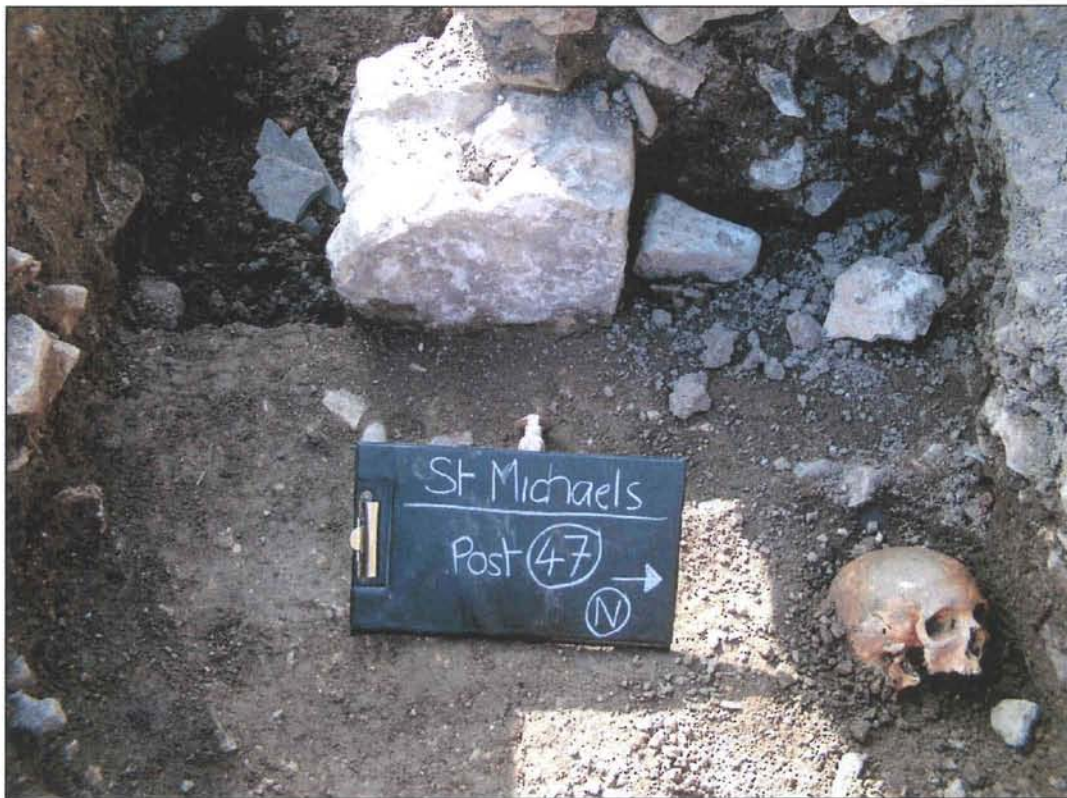
Fig. 6 In-situ articulated burial (60). Medieval masonry block, top centre, underpinning the later 18th-century tombstone (16). Area A (2006). Photo CPAT 2007-059

- 3.6.2 Within Area A an underlying deposit (47), up to 0.4m thick, of fine grey silt mixed with occasional slate roofing tiles of medieval origin, 17th-century coinage and ceramics suggested an earlier build up of demolition layers disturbed by post-medieval burials. The process of selective removal of these deposits continued, focusing on the areas to the south of the 'buttresses' (06 and 07). Further test pits revealed another demolition/burial deposit (56) underlying the 17th-century soils. One in-situ, articulated burial (60), of unknown date, was recorded at this level. Located to the south-west of the burial was a large fragment of masonry, of probable medieval origin, that had been re-used to underpin the 18th-century tombstone (16) (See Fig. 6). Unfortunately, no further evidence of the 'buttresses' were recorded in this area and a similar test pit at the east end of the site failed to establish a satisfactory Medieval ground level across the central area of Area A, owing to the quantity of post-medieval overburden.

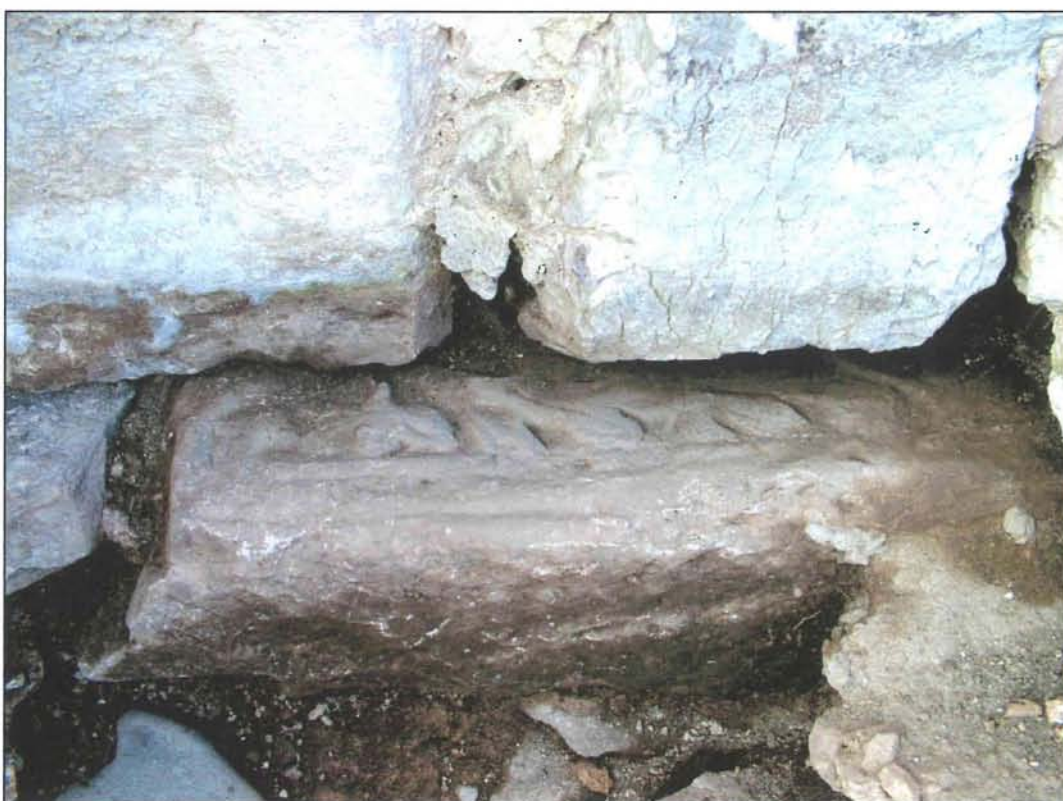
Fig. 9 Detail of the inscribed medieval artwork (probably 12/13th century in origin) on the memorial stone (61). Photo CPAT 2007-064

- 3.6.4 Whilst recording the position of the burial in relation to the 'priests door' (54) a remarkable chance discovery was made. Underpinning the blocked-up doorway was a previously unrecorded inscribed grave slab of medieval origin. The sandstone block (61), re-used as a threshold for the doorway, displayed decorative carvings consisting of an interweaved vine/floral pattern terminating in at least one 'tulip' style head. The decoration, consistent with 13th-century medieval gravestone carvings, was only partially visible (0.56m x 0.17m x 0.2m thick) and one can assume that a sizeable proportion of the memorial stone remains intact at the base of the doorway (See Fig. 9). Before the test pit was backfilled the carved stone and adjacent ground surface were covered with protective geotextile to facilitate future study.

- 5.3 The medieval carved memorial stone (61), detailed in section 3.6.4, has been tentatively attributed to the 13th century. If this is correct then we now have a construction date for the south nave wall of St Michael's post-dating the late 13th century. This would imply that the 'priests door' was possibly blocked up some time after the 14 or 15th century. Any associated external buildings would then have become surplus to requirements and subsequently demolished. Was this the fate of the postulated 'priest's chapel'?

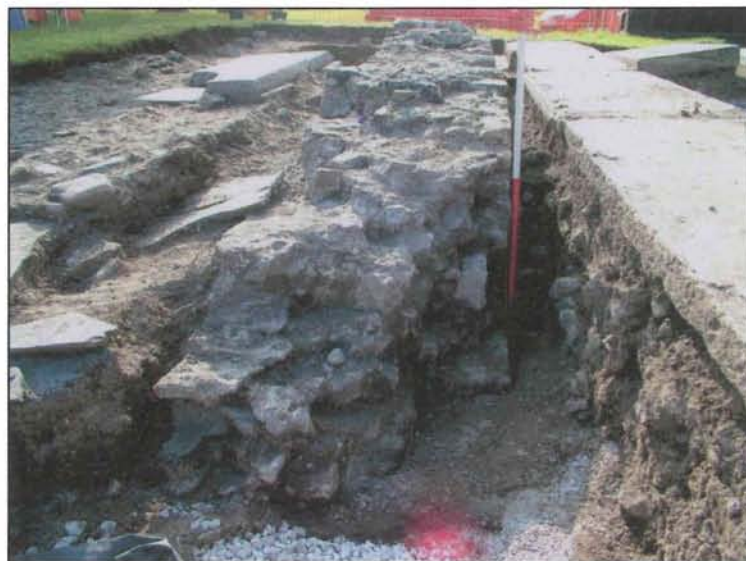
Fig. 10 Extent of the excavations around the east end of the medieval wall (08). In-situ post-medieval burial deposits left and right. Modern soakaway pit (51) in the foreground. Photo CPAT 2007-074

- 3.6.7 The excavations around the 'medieval wall' (08) did afford the opportunity to further record the dimensions and build of the structure, although it must be stated that the extent of the structure, including the depth of the footings, has yet to be established. At the final stage of our excavations the structure could be seen to consist of six exposed courses of stonework, constructed predominantly from slate with a mixture of limestone and sandstone core bonded with lime mortar. The wall stood to a height of 0.6m at the west end and 0.8m in the east. The overall width was 0.87m with a visible length of 6m. The curious terminal to the west end remains and there was no visible return either north or southwards. The possibility of the existence of a doorway at this end of the wall needs to be considered. The answer as to how much of the east end of the wall survives lies somewhere in or around the late post-medieval brick feature 53 and, unfortunately, this may be another 18/19th-century brick vault that has removed a large part of the medieval archaeology of St Michael's.

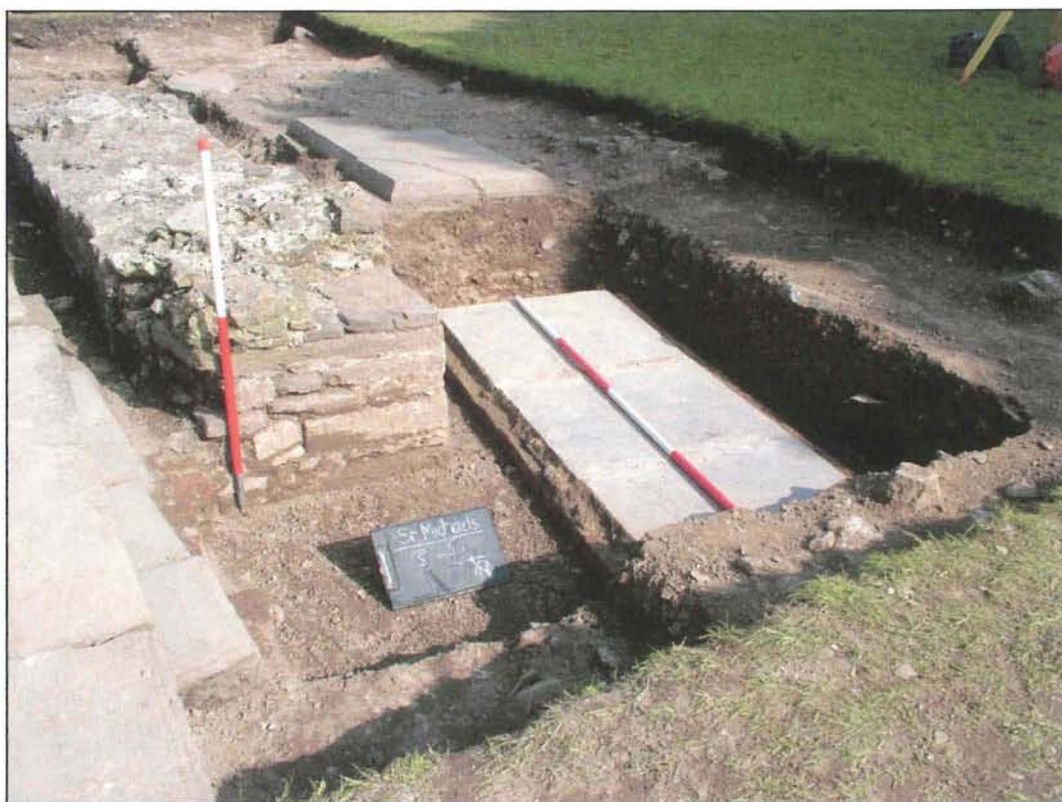
Fig. 11 Extent of the excavations around the west end of the medieval wall (08). Area B (2006). In-situ post-medieval burial (48) on the right. Photo CPAT 2007-65

- 3.6.6 At the western end of Area B the sondage (test pit) that had been dug in Phase one of the excavations was widened and continued to a depth of 0.5m below the original ground surface. Unfortunately, another 18th-century brick vaulted burial (48) was discovered abutting the south-west corner of the wall (08). This was cut through a deposit of fine grey silt interspersed with fragments of roofing slates (49), very similar to the deposit 47 in Area A. Although fragments of early window glass and three sherds of medieval 13/14th-century pottery were recovered from this deposit the additional discovery of a coin dated to around 1699 revealed this to be an in-situ 17th-century demolition/burial deposit (See Fig. 11). Because of the limited available, no further excavations were carried out in Area B.

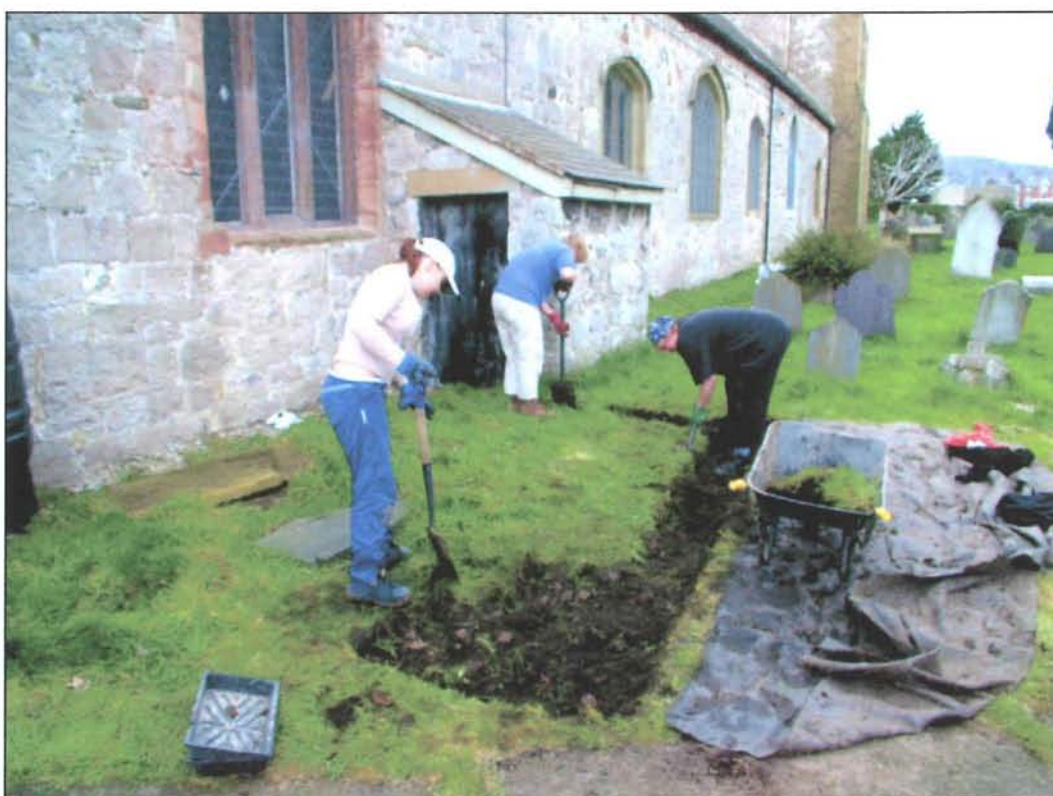
Fig. 12 Removal of turf in Area C, viewed from the north-east. North wall of the north nave and chancel of St Michael's in the background. Photo CPAT 2007-038

- 3.7.1 As previously stated, Phase two of the excavations included a separate area of excavation located at the east end of the north side of the church focusing on an area of vaulted masonry, previously unrecorded until uncovered by workmen in 2005. Consequently an area of 4.5m² (Area C see Figs 1 and 2) was excavated with the aim of establishing the extent and nature of the structure together with its relationship to the adjacent church masonry. As with Areas A and B, all of the turf and excavated material was removed by hand and stored on site (See Fig. 12).

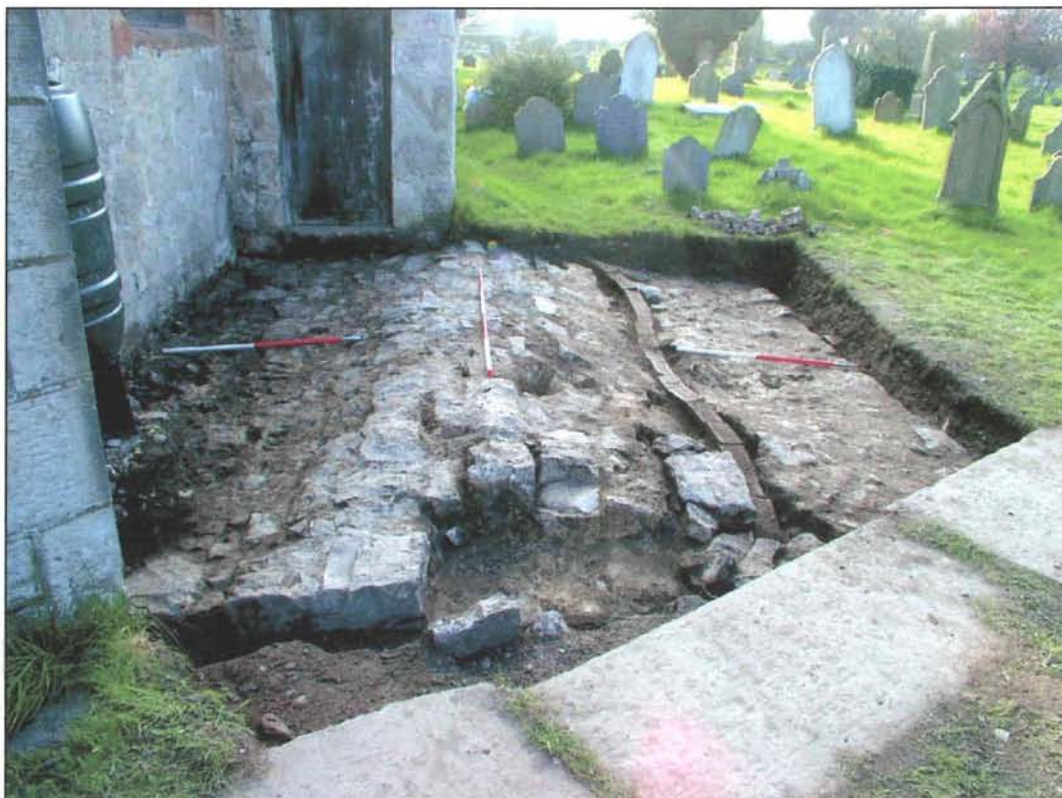
Fig. 13 View of barrel vaulted structure (40), post excavation Area C (2006), as viewed from the east. Photo CPAT 2007-079

- 3.7.3 The external width of the vault (north to south) was 4.2m and the length was 4.5m east to west. With the aid of laser distance measuring equipment used inside the vault the length of the internal structure increased to 5.5m, extending beyond the western bounds of the limit of excavation and therefore demonstrating, not surprisingly, that the upstanding boiler house on the outside of the north aisle of the church was built over the top of the structure. Running along

- 3.7.4 The lower courses of stonework on the north chancel wall have been 're-pointed' and unfortunately this had obscured the relationship between the southern edge of the vault and the church. Presently it is not possible to determine whether or not the upstanding chancel is contemporary or later in date. Curiously, there is an area (1.2m x 0.7m) of disturbed/fragmented stonework (65) on the southern edge of the vault. Further investigation of this area in the future might well furnish some answers to the 'building phases' of the vault but for the time being the integrity of the structure (it is presently sealed from the outside elements) must be maintained.

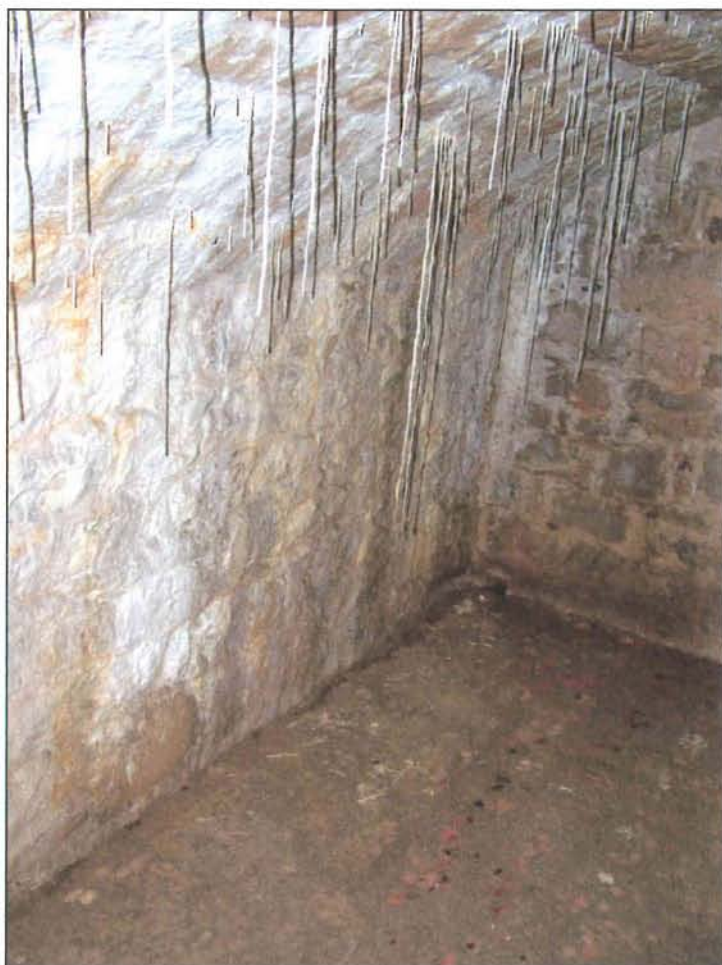
Fig. 14 View of the inside of the vault (40), south-west corner. Area C (2006)
Photo CPAT 2007-091

- 3.7.5 Using a combination of digital flash photography and a laser distance measuring device it was calculated that the internal area within the vault measured 5.5m from east to west and 2.5m from north to south (corresponding with the width of the barrelled roof). The height of the structure was approximately 2.2m. In plan the width of the structure appeared considerably larger, 4.2m to be exact. This implied that each of the supporting walls for the vault was almost 1m in width. Access to the vault could not be achieved, but it is believed that there is an entrance below ground level at the eastern end. Photographic evidence appears to show a securely blocked up entrance, up to 1m in width (See Fig. 15). On the floor of the vault there appeared to be evidence of a red-tiled floor or fragmented ceramics of a similar colour. This would imply a post-medieval date for the vault, although the re-use of a substantial medieval structure should not be entirely discounted.

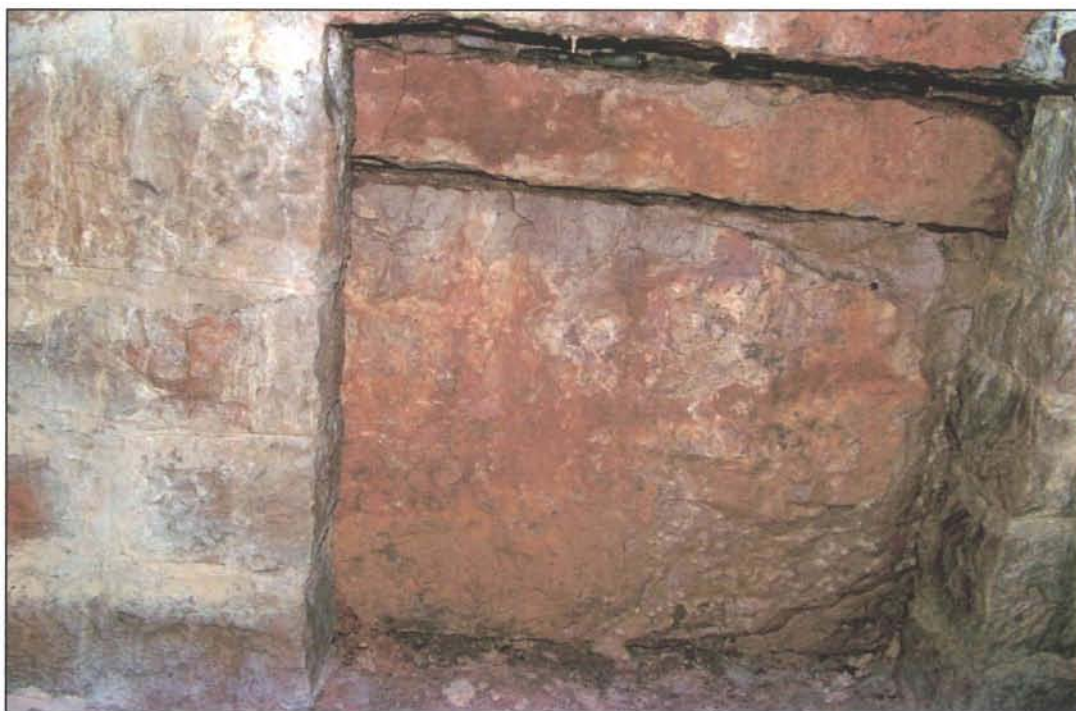
Fig. 15 Internal view of the east end of the vault (40), illustrating the possible blocked entrance.
Area C (2006) Photo CPAT 2007-100

- 5.4 The stone constructed vault revealed in Area C remains undated although we now know that the structure is approximately less than 5m² and 2.2m deep, and could be contemporary with, if not earlier, than the adjacent portion of the north chancel. The entrance is probably at the eastern end (and is almost certainly blocked up). The fact that the vault is empty implies a re-use of the structure probably during the early post-medieval period. The construct and dimensions of the masonry might indicate that the vault is of medieval origin. However, further work would be required in and around the immediate environs of the vault in order to establish its true provenance.

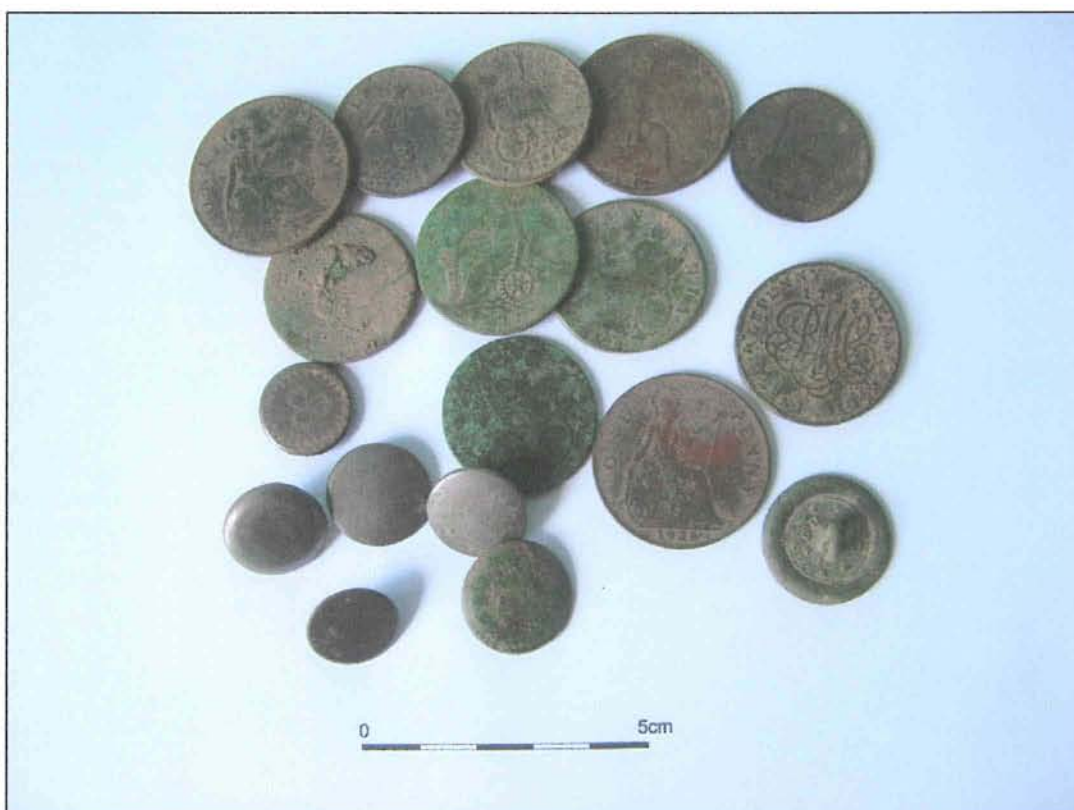
Fig. 17 Assemblage of coinage, tokens and pewter coat buttons retrieved from the excavations.
Photo CPAT 2007-114

- 4.3 Other artefacts from the post-medieval period included large quantities of funerary nails, pipe clay, bottle glass, coins and pewter buttons. A broad period of coinage was recovered ranging from c.1699 to 1929 (See Table 1 Appendix 1). Specific attention should be drawn to two fine examples of late 18th-century mining tokens; one from the Anglesey Mining Company of c.1785/95 and the other from the Macclesfield Town Mining Company of c.1791. The coins were so numerous as to suggest a form of tradition associated with human burial. Of similar note were the number of pewter coat buttons recovered, again almost certainly associated with earlier disturbed burials (See Fig 17.)

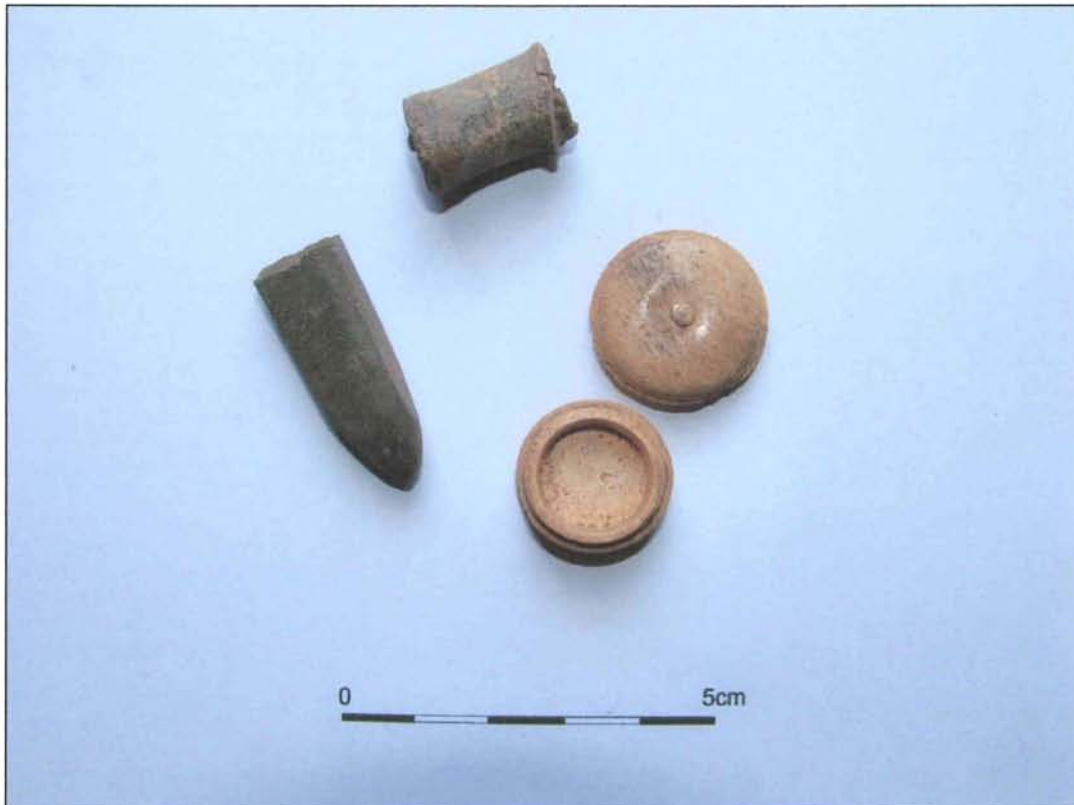
Fig. 18 Assorted small finds recovered from Area A and B. Clockwise; Lead (fishing?) weight, bone carved trinket/snuff (?) box and lid, and broken tip of slate stylos/pen. Photo CPAT 2007-115

- 4.4 Three other noteworthy items recovered were a lead (possibly fishing) weight, the broken end of a slate stylos/pen, a small bone carved trinket/snuff (?) box (complete with screw-threaded lid) and fragments of early stained glass (See Fig. 18).
- 4.5 Although no secure stratified medieval or earlier deposits were identified during the excavation, with the possible exception of the deposits abutting the medieval grave slab (61), described in detail in section 3.6.4, a small assemblage of medieval pottery and a single sherd of 1st-century AD Roman Samian ware was recovered from deposits that ranged from the topsoil to the earliest recorded levels (17th-century). A total of fourteen sherds of medieval pottery were retrieved ranging in date from the 13th to the 15th-century. The earlier pottery was unglazed and

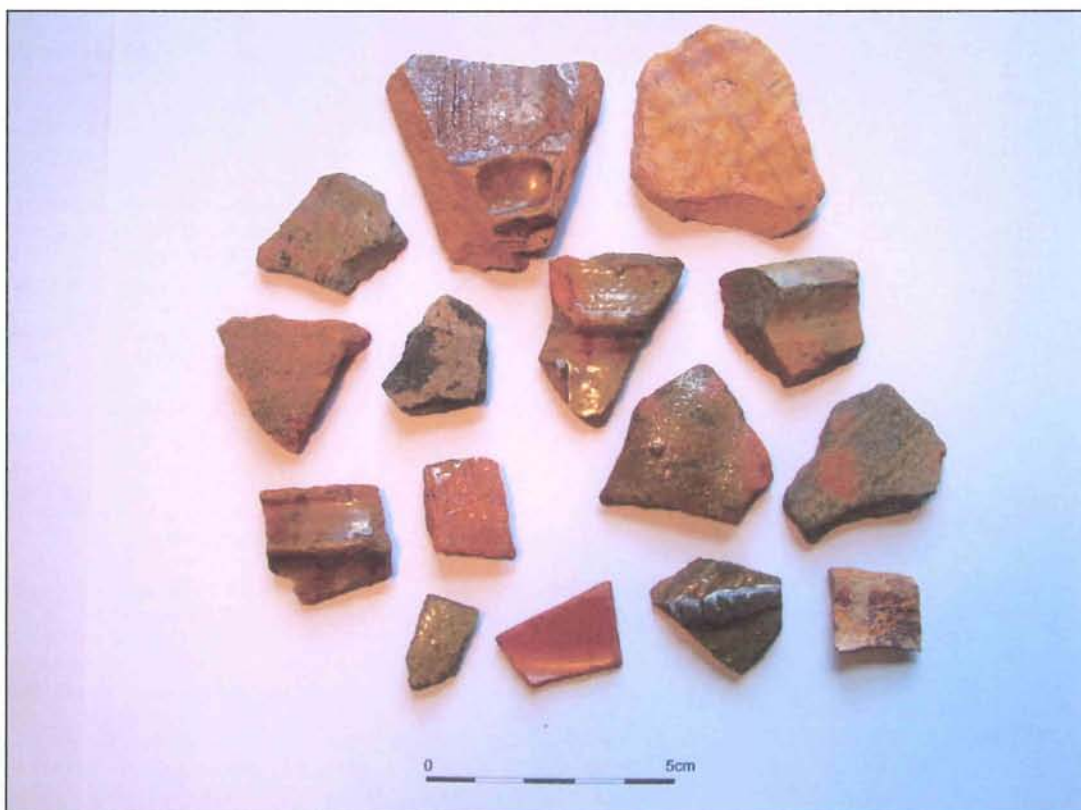
Fig. 19 Assemblage of Medieval ceramics c. 13th-15th-century. Photo CPAT 2007-117

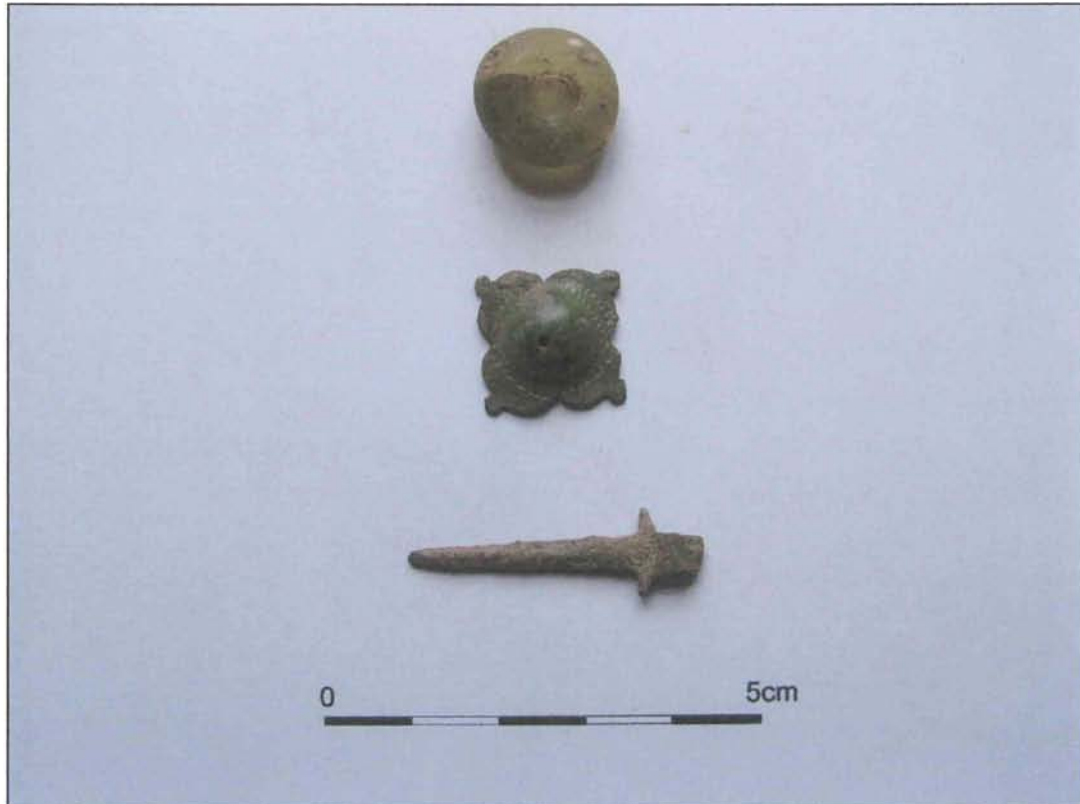
Fig. 20 Top to bottom; 1st-century AD glass bead, 13th-14th-century belt mount and a 13th-century annular brooch pin. Photo CPAT 2007-116.

- 4.5 To conclude, three items of specific note were recovered during Phase one of the excavations. They have since been identified by Dr Mark Redknap (National Museum of Wales, Cardiff) as a 1st-century AD Roman glass bead (of green/olive opaque form); a copper-alloy pin from a 13th-century annular dress/cloak brooch and a 13th-14th-century decorated copper-alloy belt mounting (See Fig. 20).
