St Asaph Cathedral: A Survey

CPAT Report No 809

R J Silvester
July 2006

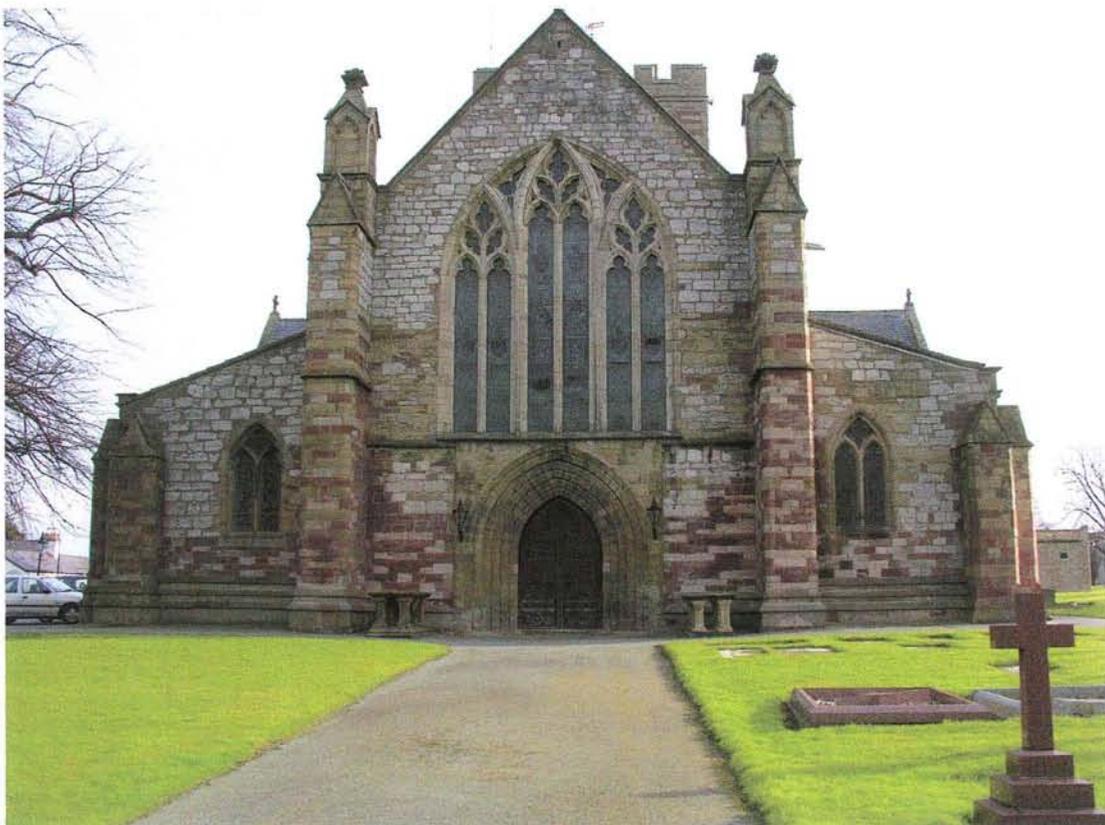
West wall: a truly heterogeneous fabric mix, with considerable colour variation, unmatched elsewhere in the cathedral. Seen from the side the wall has a slightly outwards lean at the gable apex. Three features: the west doorway, the big west window above it and a small slit immediately below the apex of the roof, in addition to which there are two buttresses.

- Foundation plinth, seemingly of purplish-pink sandstone ashlar which may be little more than a facing, topped by a double chamfered coping in 'A' and 'C'; all this looks to no older than Victorian. The wall to either side of the west doorway is a mix of 'A', 'B' and 'D'; there appears to be some largely unweathered 'B' in the lee of the northern buttress; then much of the fabric to both sides of the upper part of the door is 'D', surely indicating a rebuild, perhaps associated with the window and perhaps the doorway itself.

- The west doorway is in 'C' but the stonework shows variable weathering and it would not be surprising to learn that most of the architectural stonework is replaced and relatively late in date (?Victorian); two jambstones have been replaced in modern 'A'. The doorway is of six orders with flat sunken chamfers and has a two-centred arch, but there is little embellishment. Pyramidal stops to the outermost jambstones.

- The window above has beneath its two-centred arch six cusp-headed lights in three pairs, the central pair the longest; traceried foil lights above with daggers and mouchettes (Curvilinear style). All look to be in 'E' and Victorian, but the form is authentic.

- The apex of the gable supports a cross finial.

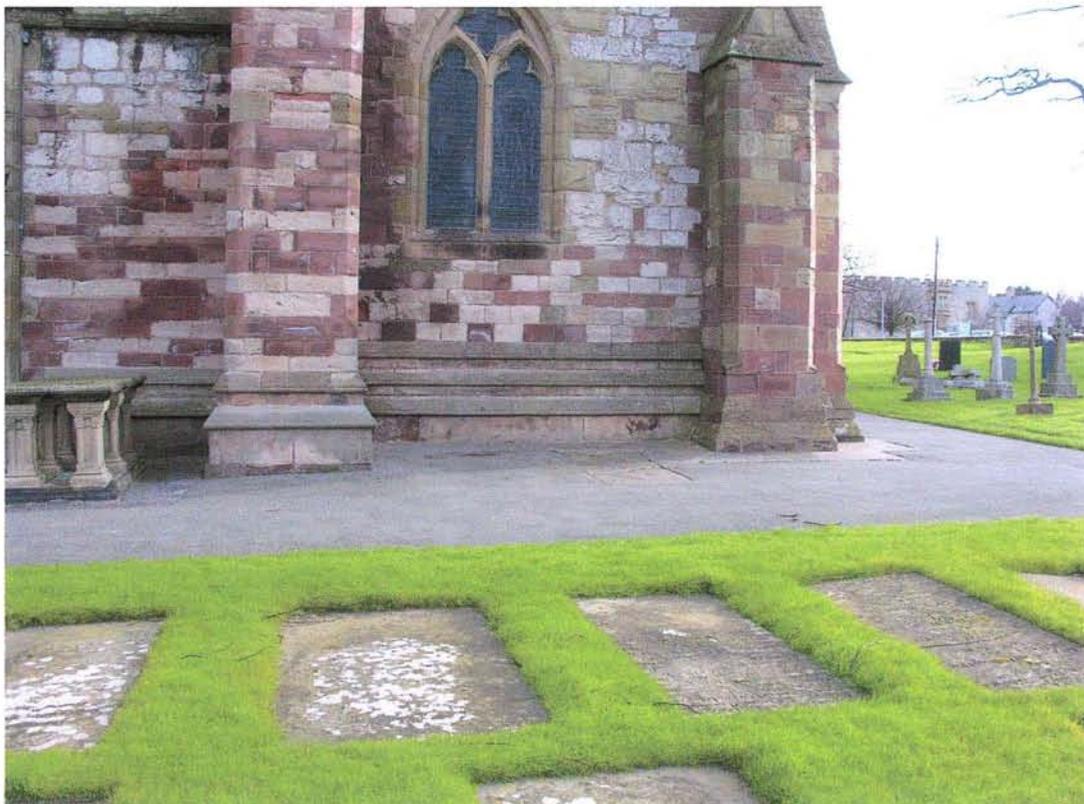
- To either side of the door are buttresses. The coped plinth is carried around these and then the rectangular buttress with its chamfered edges rises to another moulded coping but at a higher level than that forming the stringcourse over the west door. It continues to rise further. The buttress to the north of the doorway has stonework that can be classed as 'A', 'B', much 'C' and

'F' but in line with the change in the west wall 'D' becomes prevalent in the buttress too, though 'C' is used for decorative banding. The buttress to the south of the doorway consists of 'A', a little 'B', some 'C' and 'F' at higher levels, and again 'D' in line with the west wall change. Decorative banding in 'C' at higher levels. Both buttresses are topped by pitched gables backed by ornate acroterions which look no older than the 19th century.

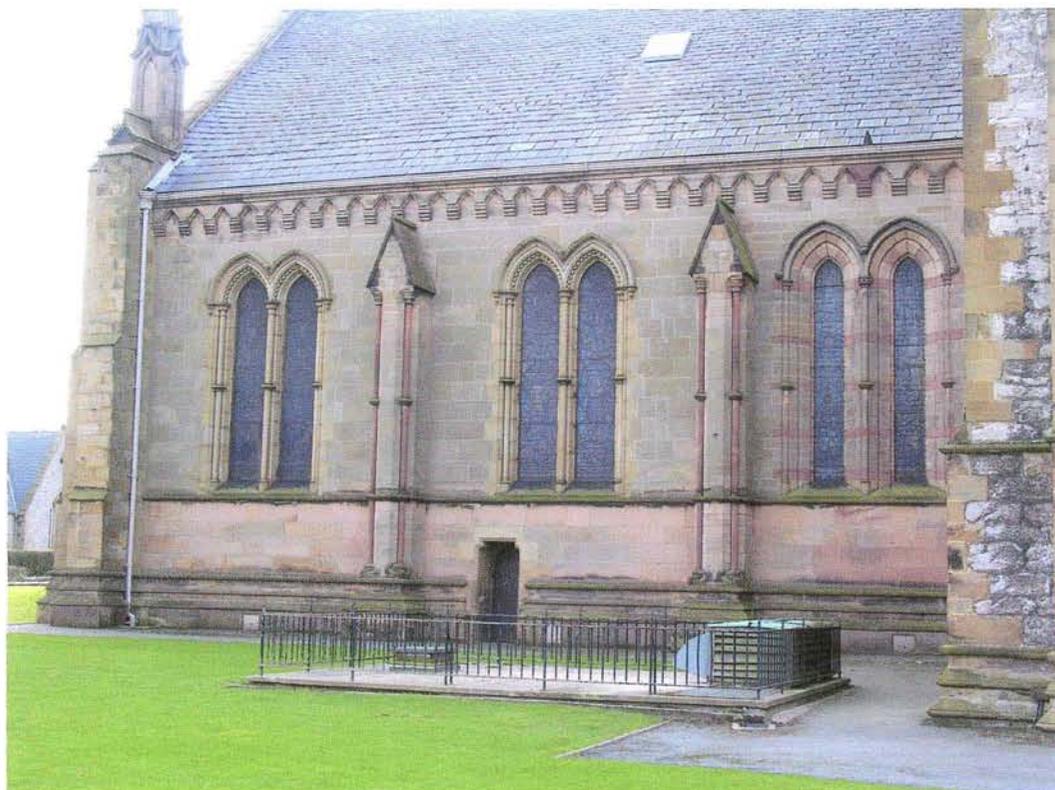
- The door is set in a deeply recessed embrasure, the outer archway pretty well a Caernarvon arch, while the inner arch over the door is round-headed and is reputedly original.
- The two most easterly windows are of two orders with simple, paired two-centre arched lights, in pale buff sandstone. Decorative detail is provided by small shafts on each side of each window with rings (pseudo-capitals) half way up. Between the two orders an arch of dog-tooth ornament. This, however, appears only on the two more easterly windows. A continuous hoodmould arches

over both lights with ball-flower ornamented stops, and a boss above the point where the two lights join. The third window to the west is different. Its form is the same with paired lights, but stone of type 'A' has been used as a decorative device in the jambs and arches (cf interior walls of aisles), and the pseudo-capitals and hoodmould stops are subtly different. Also the stonework around the window is different with smaller blocks of 'C', although they are of standard form below the stringcourse. Apparently Scott identified traces of the original windows in the chancel as he worked from east to west. His most westerly windows were truer to the originals immured in the chancel walls, but he could not undo what had been done further east.

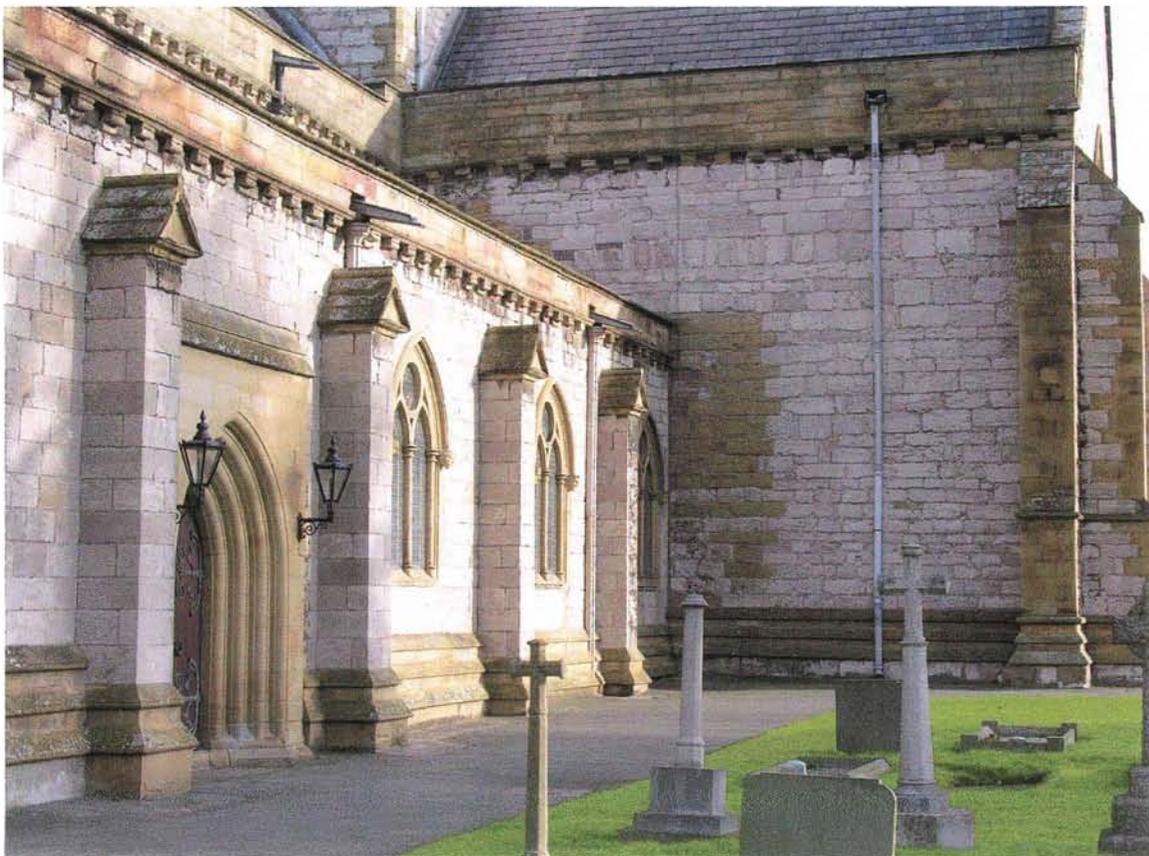
- Moulded corbels beneath a plain parapet, a clear continuation to that that runs along the top of the south nave face.
- In the angle of the transept and the nave there is evidence of subsidence.

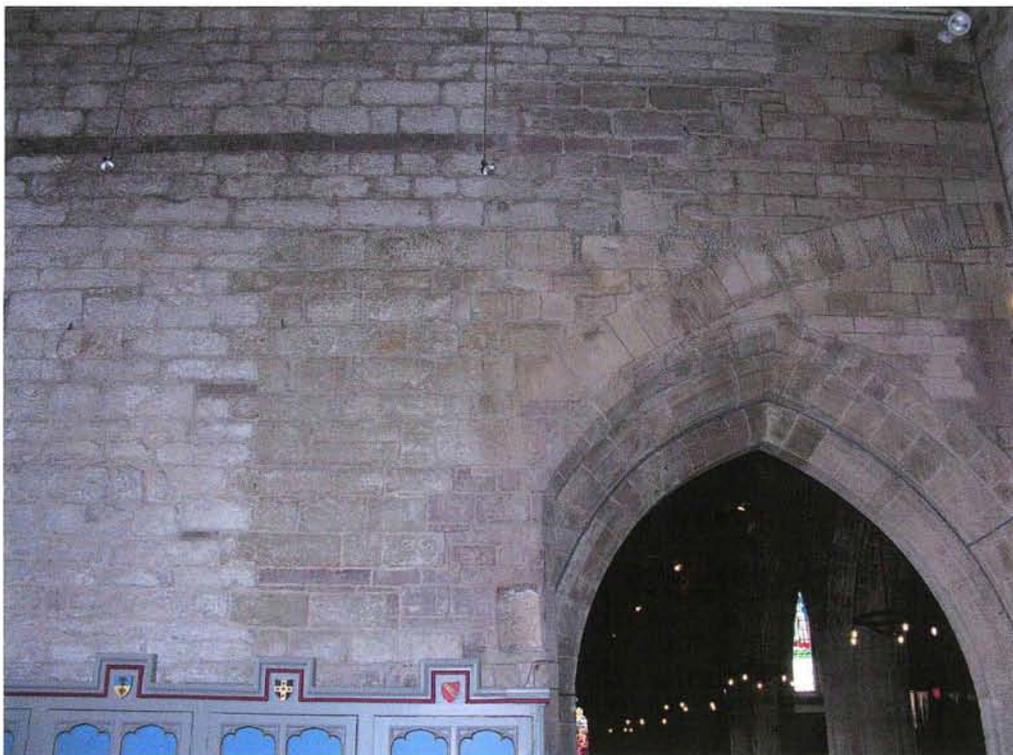
- the west wall sports a two-centred asymmetric arch of three orders leading into the south aisle. There is a relieving arch above it of modern buff sandstone and the infilling below it is also modern as is some of the stonework above it.
- Much of the lower wall to the south of the arch is hidden by cupboards. Above these the fabric is a mix of olive and purplish-pink sandstone (B), the surfaces incised in criss-cross fashion to take plaster as in the north transept. A vertical stop indicates the corner of a former aisle. Southwards, the fabric is all limestone (D). But curiously about 5/6 of the way up the wall is a course of

- brownish-pink sandstone: its significance is uncertain but it runs across the whole wall face and has been renewed or inserted where it crosses into B. Could it mark the base of a wall plate? That the entrance to the aisle is a later insertion is suggested by the poor dovetailing of the arch jambstones with the stonework beside it.

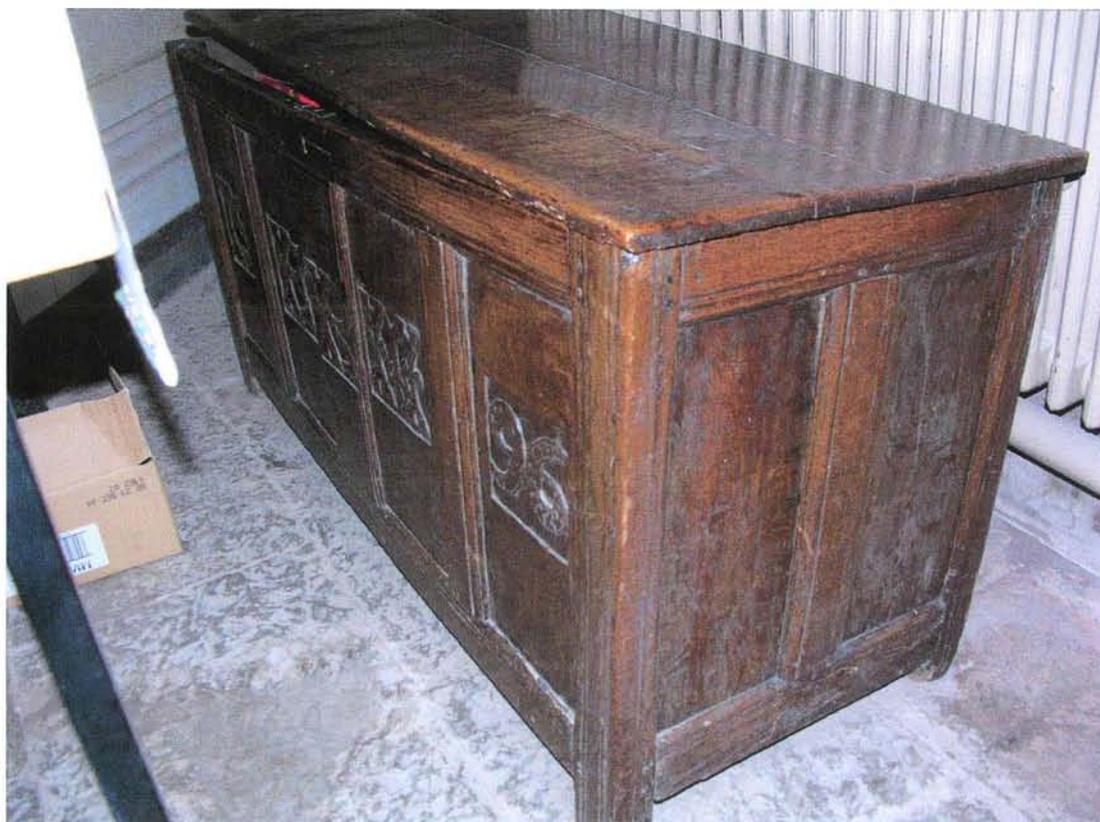
Iron chest: dates from 1738, the work of Robert Davies of Croes Foel, near Wrexham. Now used for visitors' offerings.
