# **Parliament House, Machynlleth, Powys**

**ARCHAEOLOGICAL EVALUATION**

**CPAT Report No 674**

Report for The Owain Glyndŵr Institute

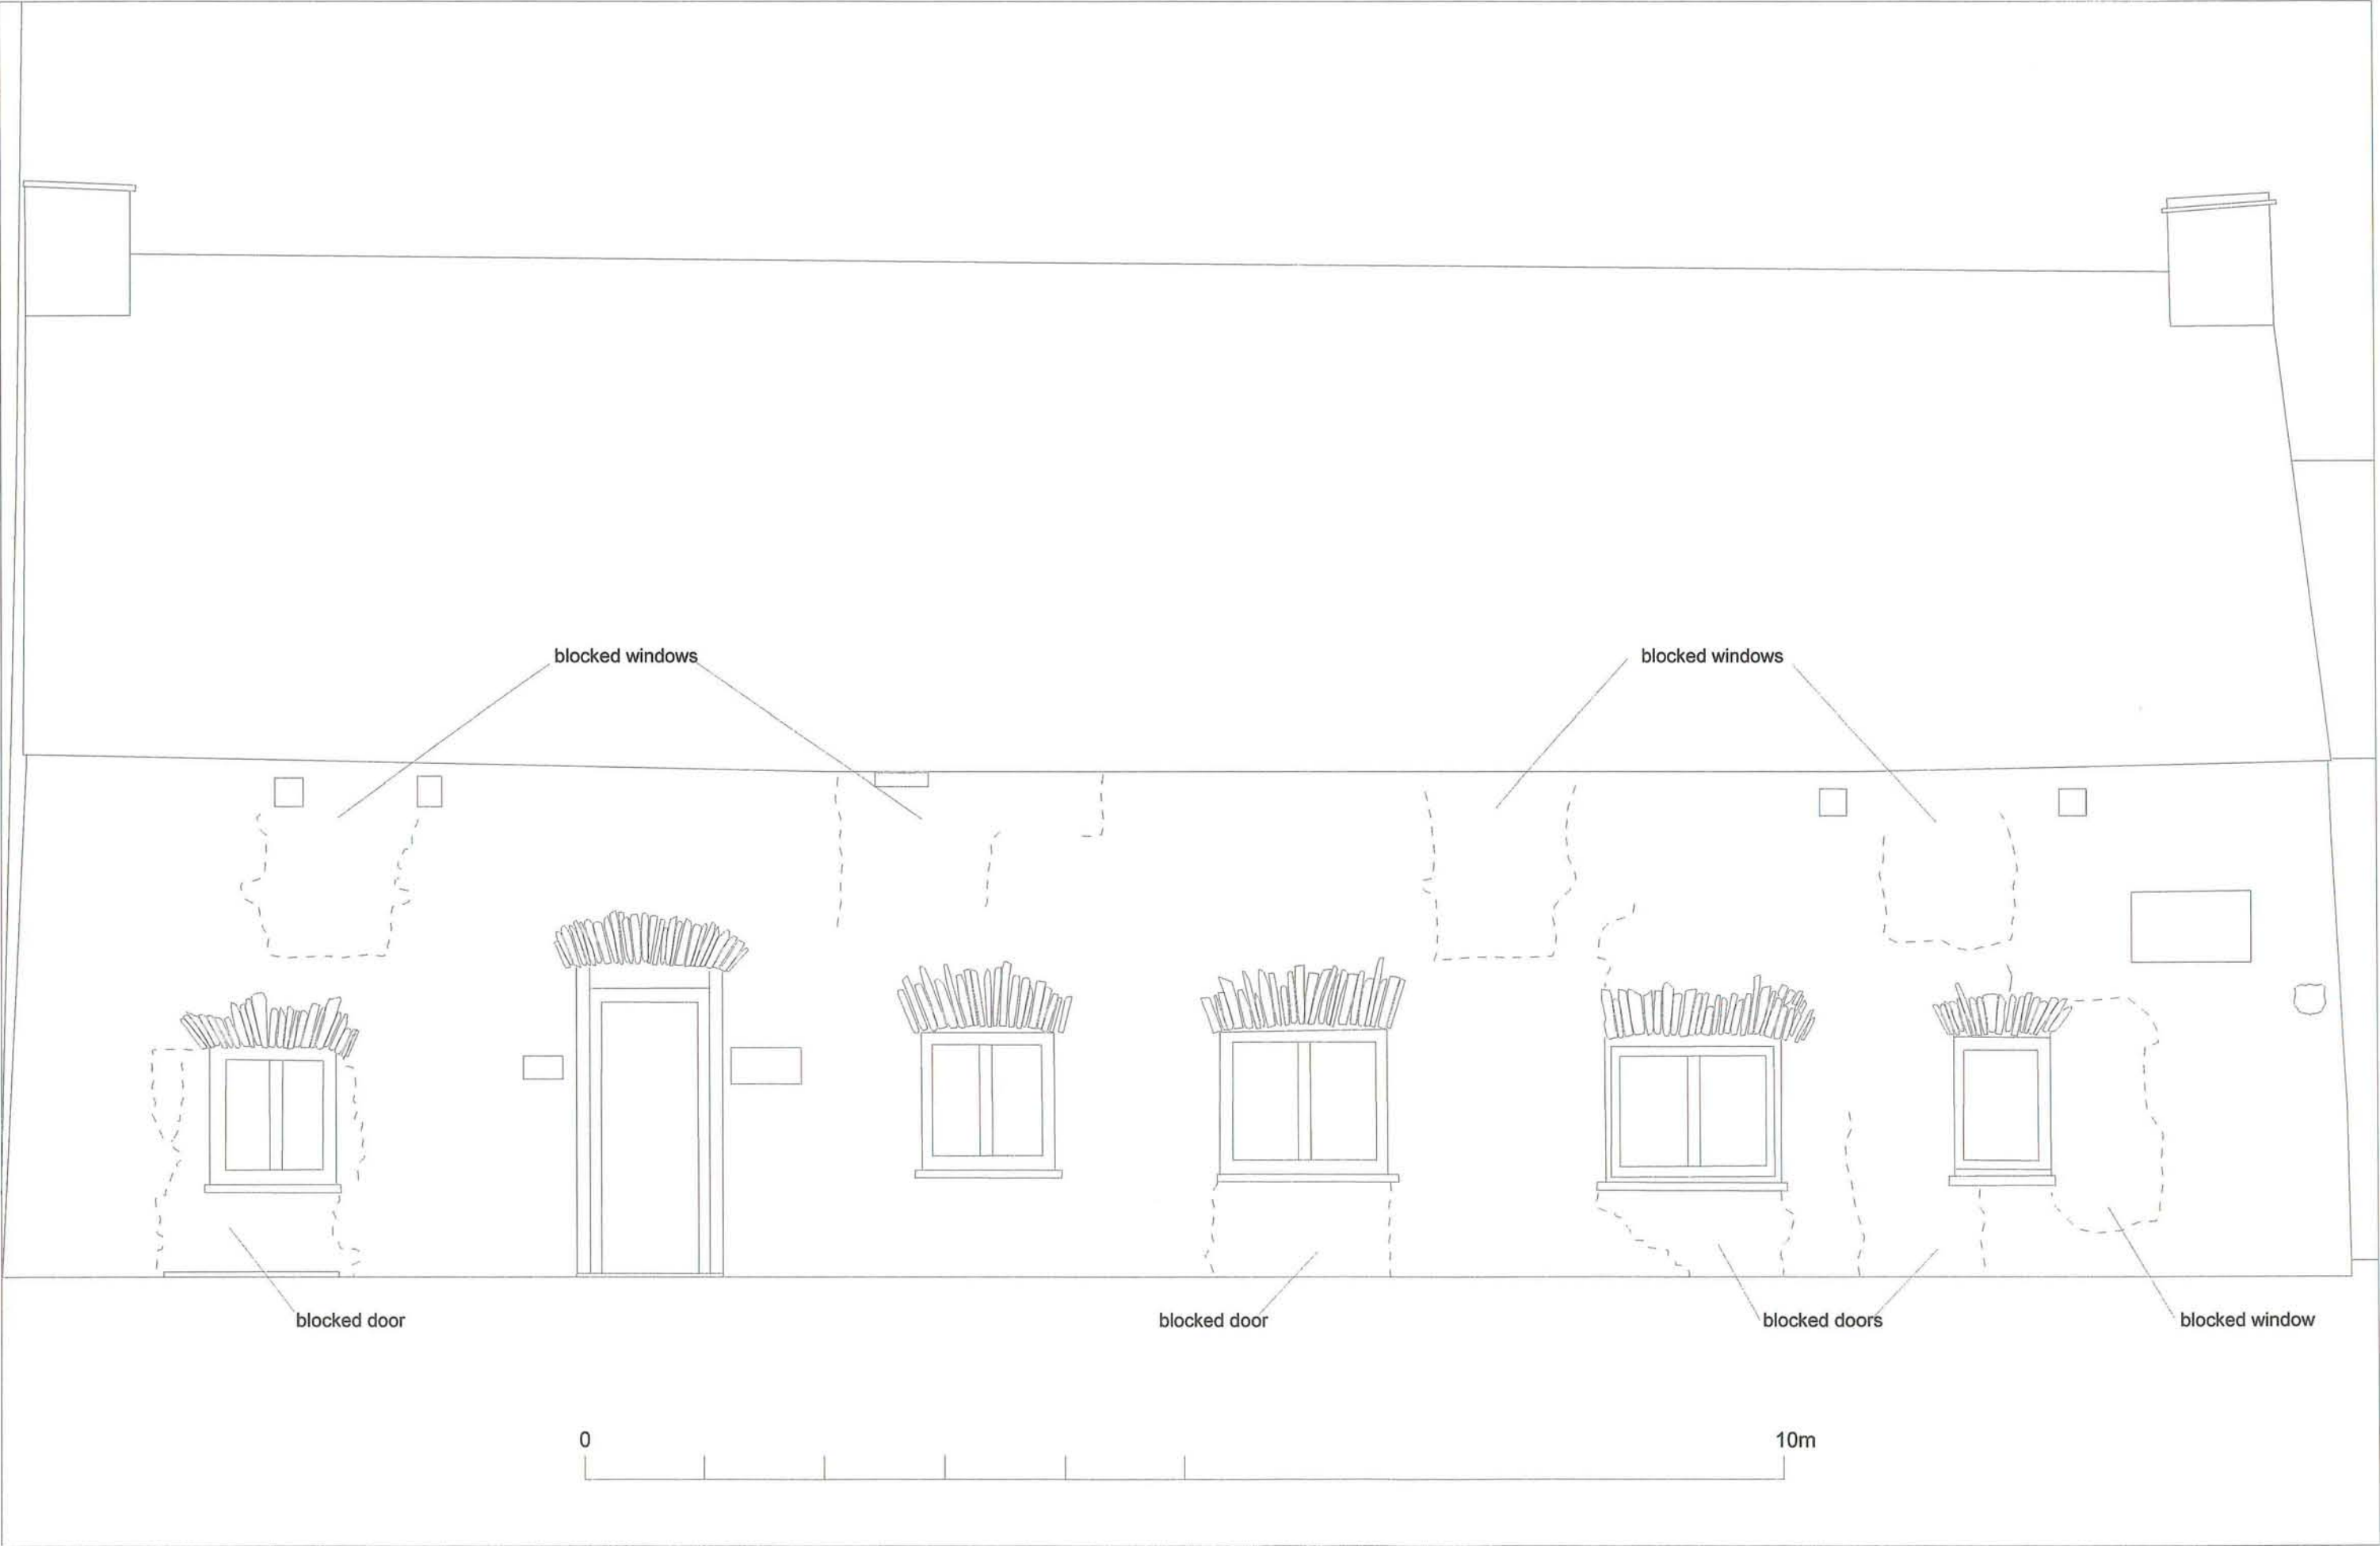
Fig. 8 South elevation, scale 1:50

- 4.4 The south elevation, fronting Heol Maengwyn, displays a single storey in local slate rubble, with several blockings indicating former ground and first-floor openings. The present elevation is that of the early 20<sup>th</sup>-century restoration with a single entrance towards the west end, a tall boarded and studded door and five windows, each with diamond leaded glazing. The doorway and windows all have matching stone segmental arches.

- 4.5 The window to the west of the doorway is set within the blocking of a former doorway, the threshold stone for which is still visible. The blockings for three other doorways are visible to the west of the present entrance, two beneath existing windows, and the third between the easternmost windows. An early 20<sup>th</sup>-century photograph (Plate 7) shows two adjacent doorways at the eastern end, with a window alongside, the blocked opening for which can still be identified. What is interesting is that the stone segmental arch of the present eastern window is clearly visible in the photograph between the eastern doorway and window, indicating the existence of an earlier window which was subsequently restored. Although the building presently has a single-storey elevation, blockings for four first-floor windows can be identified, all of which are also shown in the photograph.

- 4.6 Set back to the east of the building is a pointed arched gateway, with pitched slate roof and boarded gates linking the Parliament House to the Owain Glyndŵr Institute.

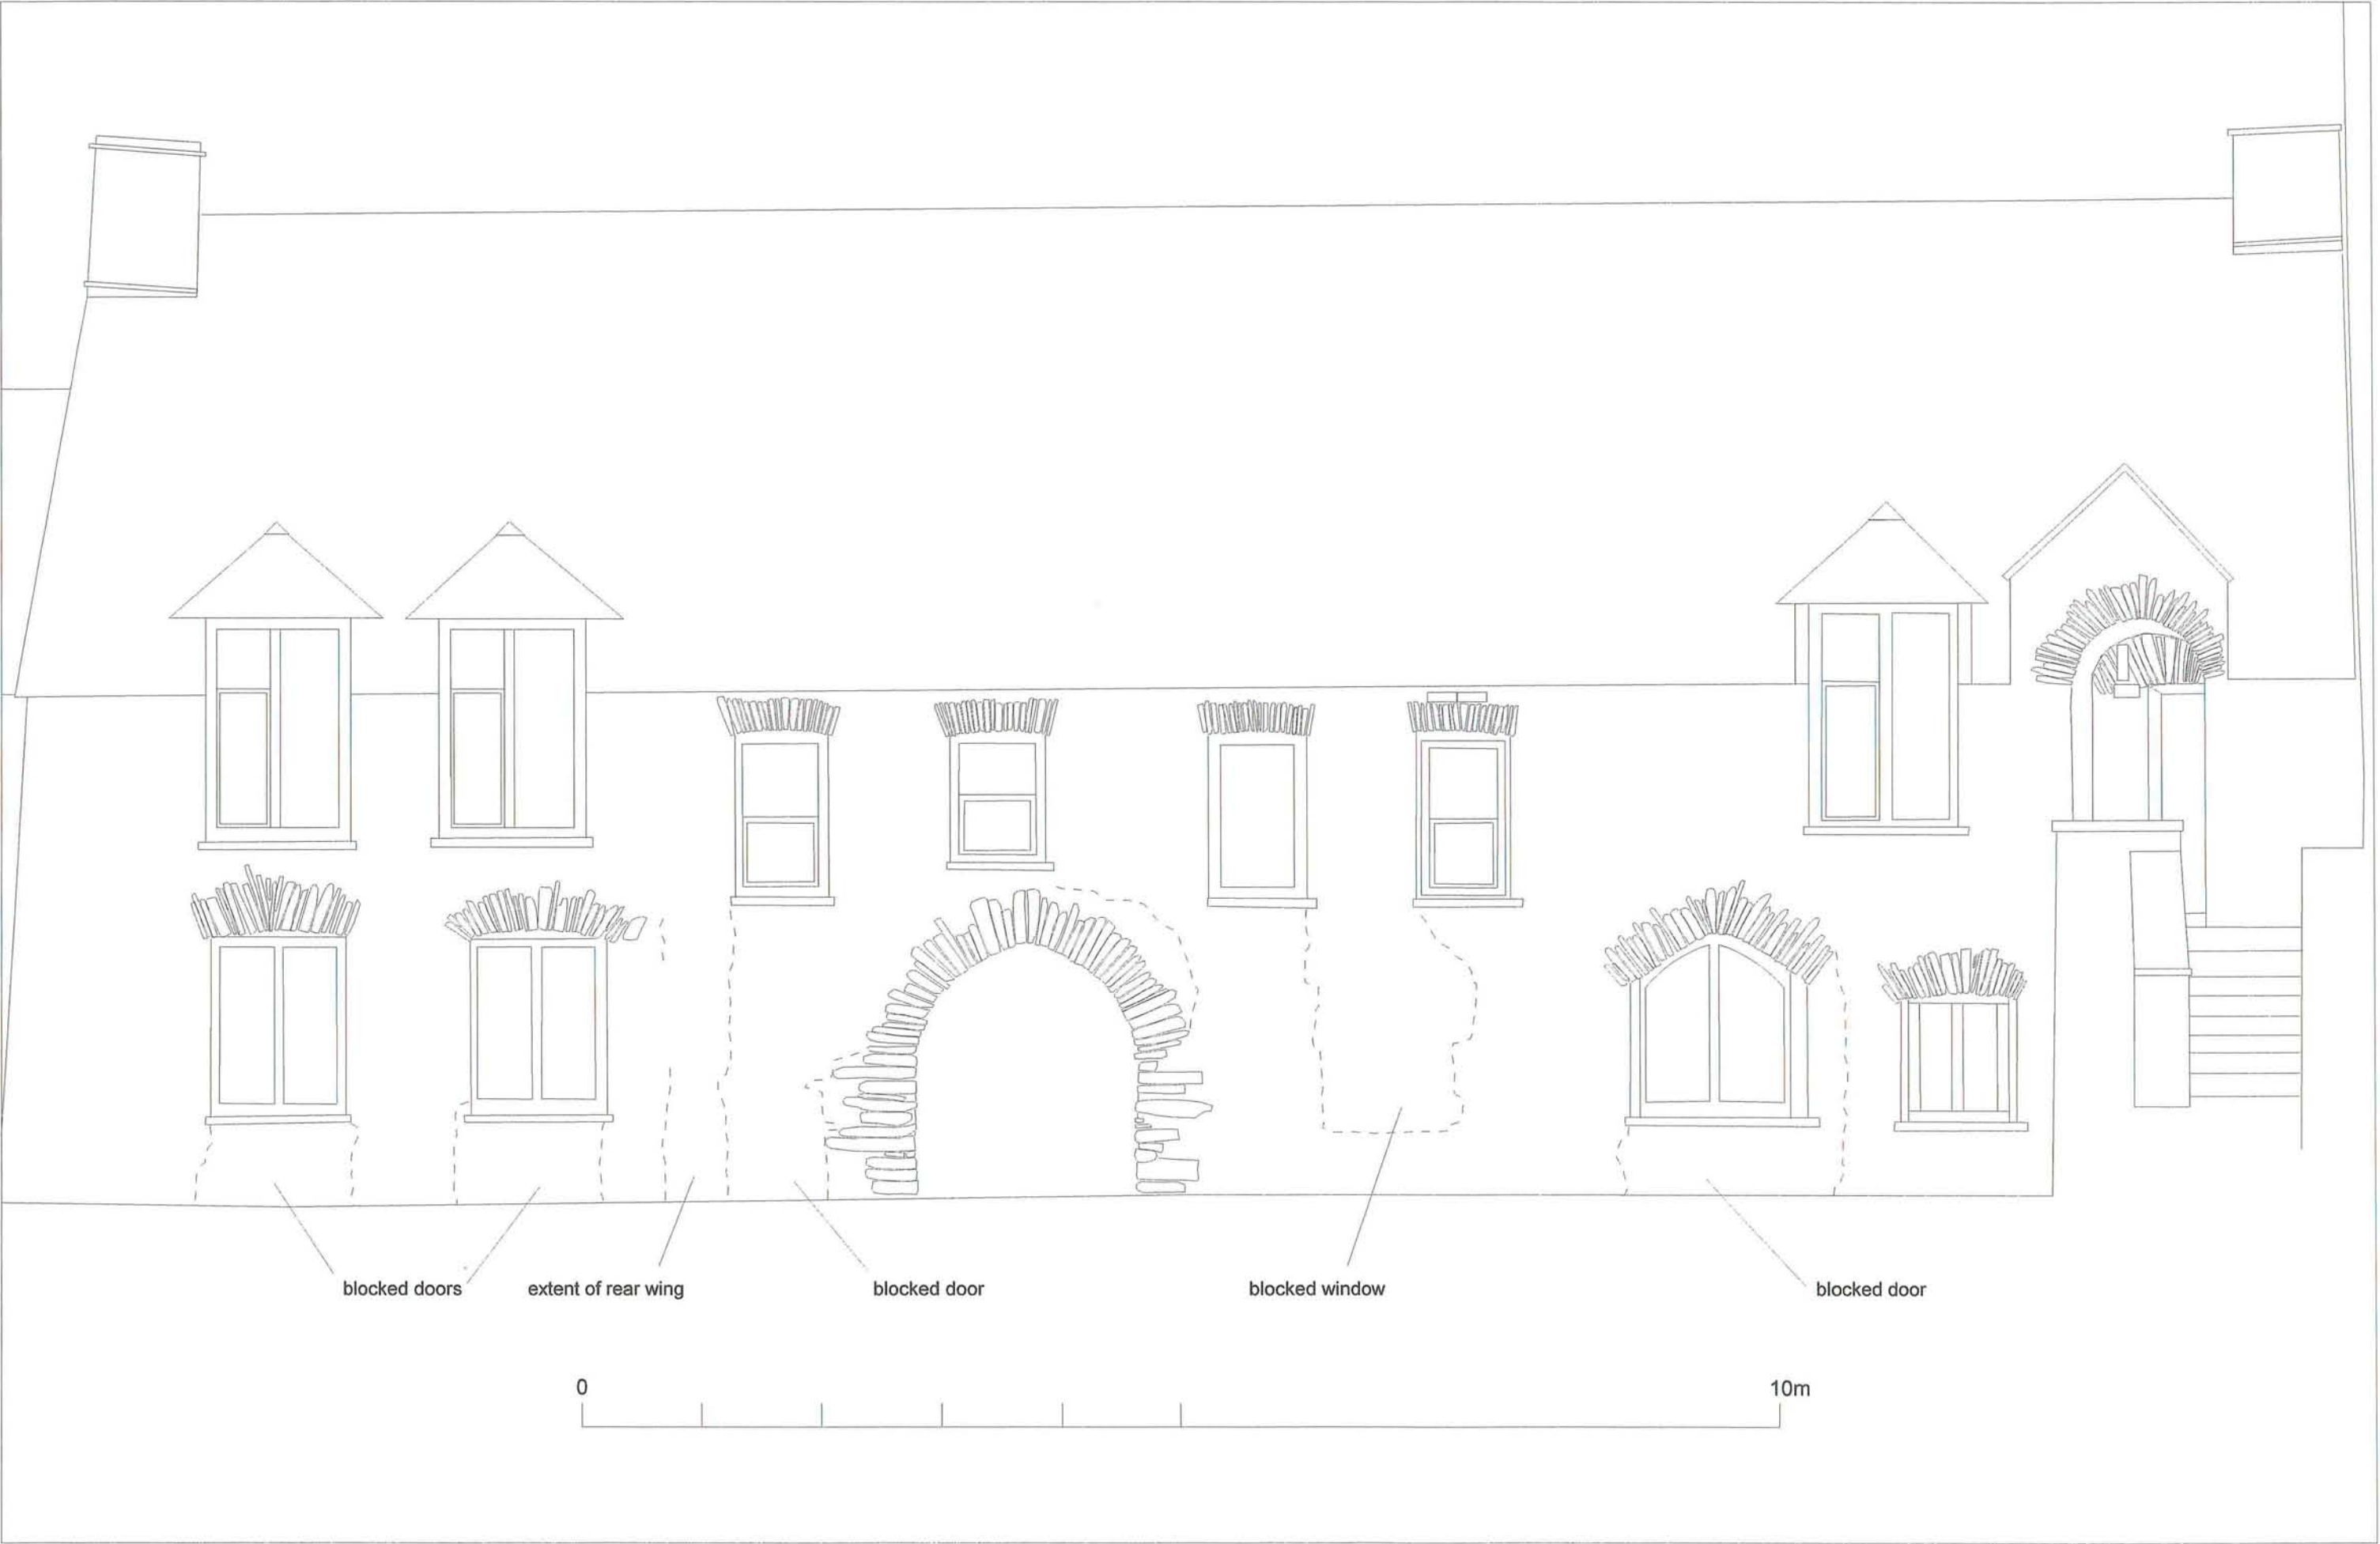
Fig. 9 North elevation, scale 1:50

- 4.7 The northern, rear elevation is also is that of the early 20<sup>th</sup> century restoration, with two-storeys and several blockings indicating former ground-floor openings. The pre-restoration appearance of the building is indicated by the early 19th century drawing (fig. 2), which shows a dormer and three small first-floor openings, the evidence for which has since been lost. The roof is shown with stone slab coping on either gable.

- 4.8 The large double-doored arched entrance to the east of the centre had previously been partly blocked and a window inserted. To the east of the entrance is a blocked doorway and two windows with stone segmental arches, each having been doorways at some point. These were presumably associated with a rear wing which is depicted by the Ordnance Survey in 1889 and is shown in the sketch of 1907 (fig. 6). There is now little evidence for the rear wing, although a vague line in the masonry to the east of the main rear entrance may indicate the point at which it was tied in to the main building.

- 4.9 To the west of the entrance is a blocked window with two windows beyond, both with pitched stone lintels, the eastern window, with a two-centred head, having previously been a doorway. At the western end is a flight of stone steps leading to a first-floor entrance with a gable above. The date of the steps is uncertain, although the early 19<sup>th</sup>-century drawing shows a lower flight rising from the east, along the face of the wall, to a low doorway below first-floor level which presumably led to an internal staircase. The present steps may well have been in place by the 1880s as a structure is indicated here on the Ordnance Survey 1st edition 1:2,500 map.

- 4.10 The first floor has hipped dormer roofs over three tall windows, two at the east end and one at the west, with four smaller windows in the centre, each with stone segmental arches.

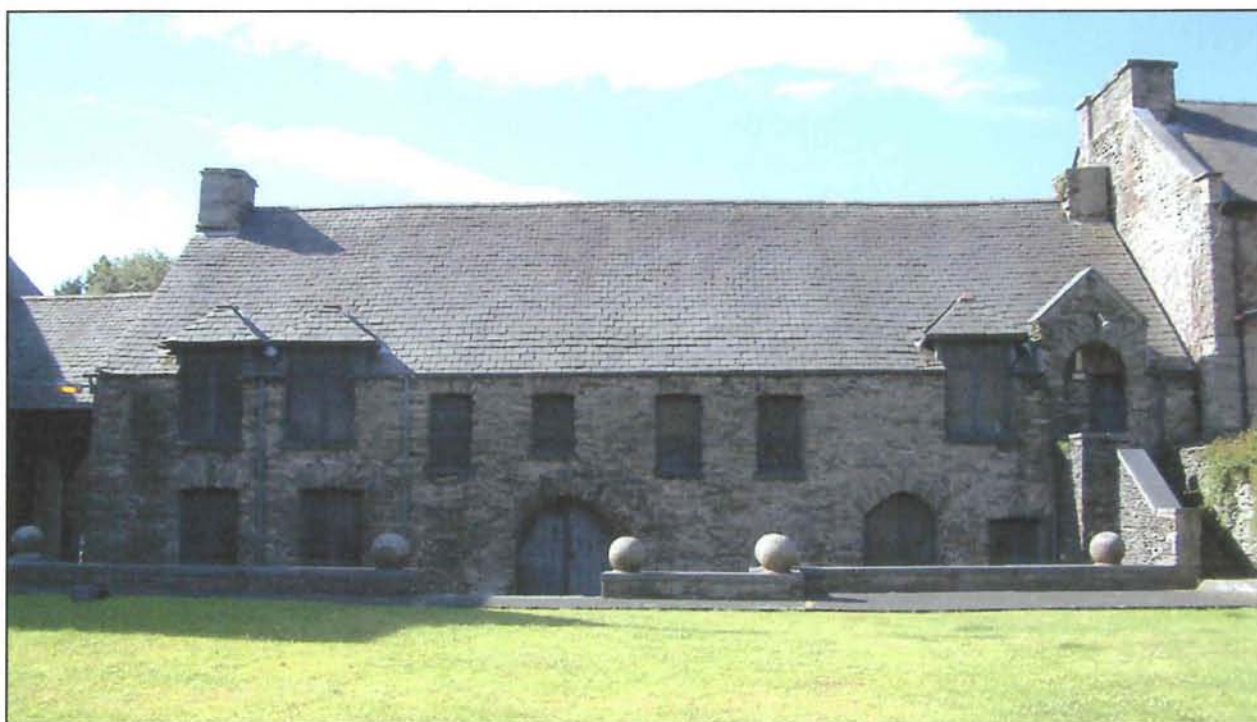
Plate 2 North elevation (Photo CPAT 1694. 31)

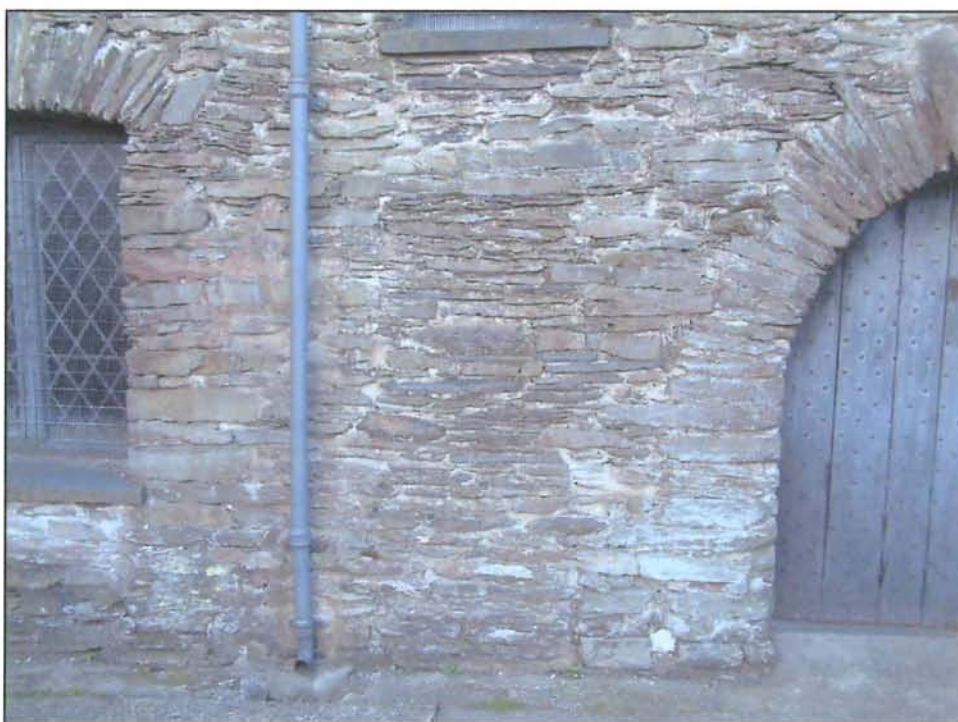
Plate 4 Blocked door in north elevation. Drain pipe marks location of rear wing (Photo CPAT 1694. 43)
