## **Spite Inn Farm, Tirabad, Powys**

**ARCHAEOLOGICAL SURVEY**

**CPAT Report No 899**

Report for Defence Estates

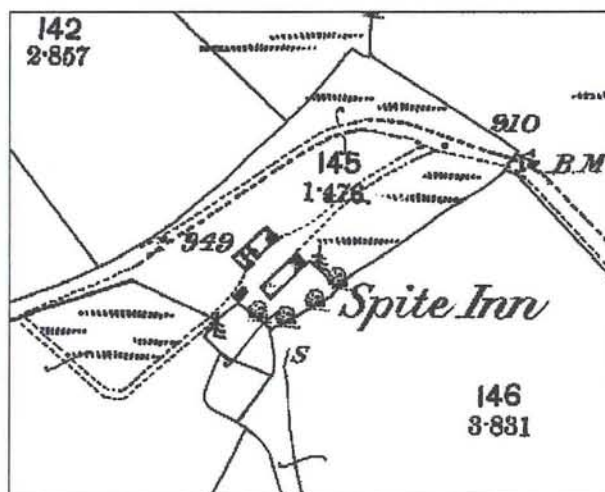
Fig. 1 Ordnance Survey 1<sup>st</sup> edition 25" map of 1888

- 3.11 By the end of the 19<sup>th</sup> century the individual elements of the holding were shown on the larger scaled Ordnance Survey maps with up to eleven fields on the Spite.
- 3.12 In conclusion we can suggest that the farm was probably a smallholding established in the post-medieval era, perhaps even as late as the 18<sup>th</sup> century, and there is no evidence of any predecessor and certainly nothing of medieval monastic origin. Its original name seems to have been Tyrgorse and the English appellation, Spite Inn, was probably added when it started to be used by the drovers.

5.4 A barn was later added to the south-western gable of the farmhouse and the complex retained this form during the late 19<sup>th</sup> and early 20<sup>th</sup> centuries, as depicted by the Ordnance Survey in 1888 and 1905 (Figs 1 and 2).

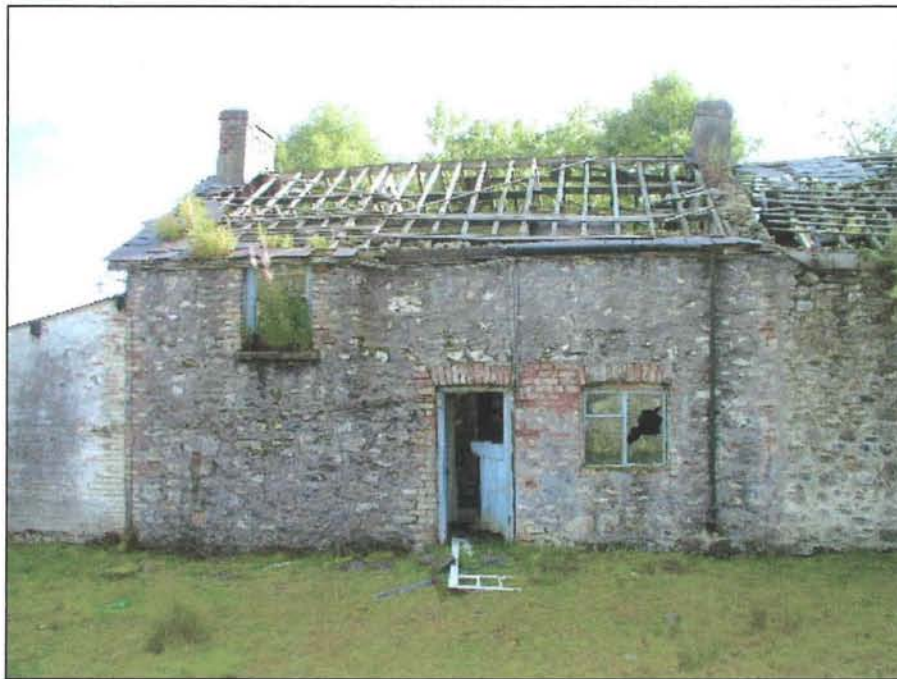
Plate 2 Spite Inn Farmhouse, north-west elevation

- 5.8 The farmhouse (1) was originally constructed in lime-mortared, random stone rubble with brick used to form the chimneys, quoins, window and door reveals and sills, and ground-floor door and window arches. The roof has now collapsed but was slate-covered with ceramic ridge tiles, supported on two trusses with one purlin on either side. The house measures 8.45m by 5.6m and comprises two floors, the first floor being accessed by a timber staircase rising from a hallway inside the front door. The ground floor is divided into two rooms, separated by the staircase and hallways inside the opposing front and rear doors. The larger, north-eastern, room measures 4.6m by 4.1m and has a single window in the south-east wall which retains its original sash window. There is a central fireplace against the gable wall, which now has an inserted fireplace of possible 1950s date. No detail is now visible of the original fireplace which has been infilled. It was clearly substantial, however, extending into the room by 0.45m, and may have included a bread oven on the north-west side. The other room, presumably the parlour, measures 4.6m by 2.4m and has windows in either wall, both of which now have alloy frames. Interestingly, there is no sign of a fireplace, although there is a chimney built into the south-western gable end.

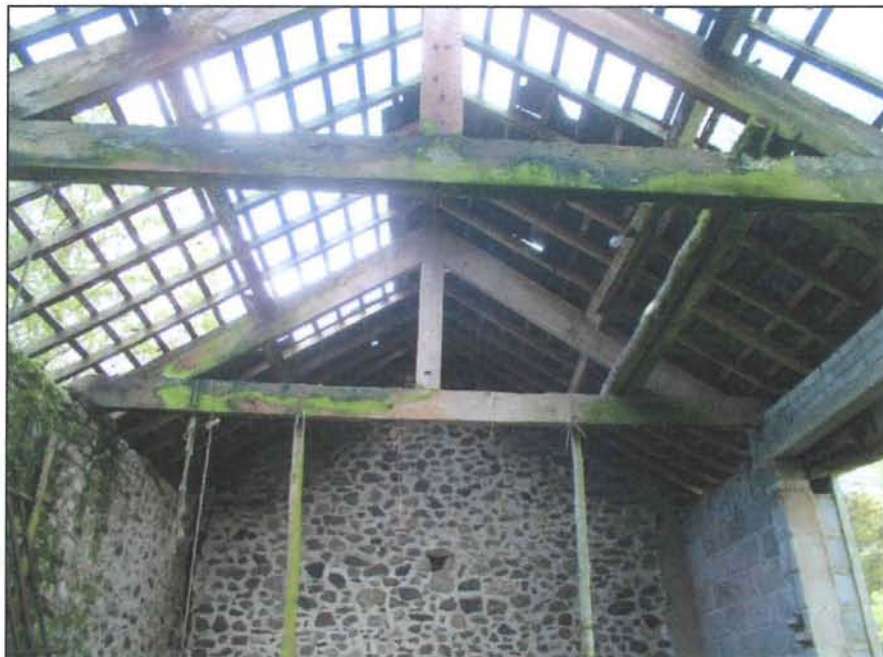
Plate 3 The interior of the barn adjoining the farmhouse

- 5.10 A barn (20) was later added to the south-western end of the farmhouse, also of random stone rubble construction with a slate roof and ceramic ridge tiles. A pair of simple roof trusses supported single

purlins on either side. The barn measures 8.15m by 5.6m externally and has large, opposing, central doorways. The south-western end of the north-west wall has been replaced in concrete block, presumably following a collapse. The south-western gable wall is of particular interest as it appears to have been raised to match the height of the farmhouse. The side walls, however, show no such alterations and it is therefore possible that the gable wall is a remnant from an earlier building.

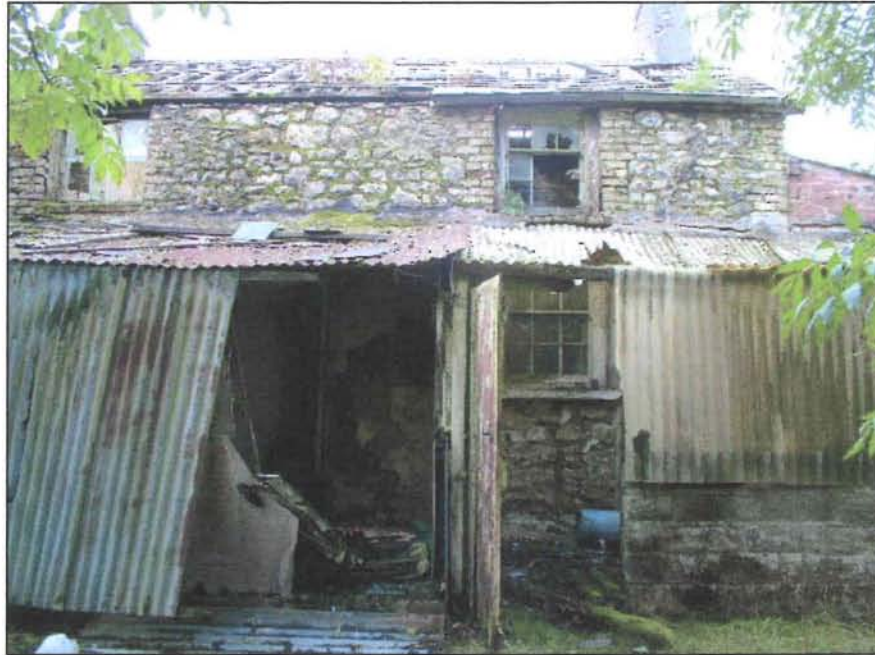
Plate 4 Spite Inn Farmhouse, rear elevation showing lean-to extensions

- 5.11 During the 20<sup>th</sup> century the farmhouse was extended in four phases by the addition of a series of single-storey, lean-to structures, the earliest of which is likely to be a corrugated iron structure which was added to the south-eastern corner. This measures 5.5m by 2.5m and contains an old Rayburn stove, suggesting that this may have been added as an external kitchen. A large brick-built room with a corrugated asbestos roof was later added against the north-eastern gable, measuring 5.35m by 5.6m, with no direct access from the original house. This extension had a central door in the north-east wall, flanked by windows, with a rear door in the south-east wall. The original chimney within the stone-built gable wall was used by a cast-iron range set off-centre to the north-west. The structure was later enlarged by the addition of a pantry and bathroom on the south-east side, built in concrete block, again with a corrugated asbestos roof. A porch was added to the north-eastern door, perhaps at the same time. The space between the original kitchen extension and the later structures was infilled with a rather make-shift lean-to in timber and corrugated plastic, resting on a low concrete block wall.

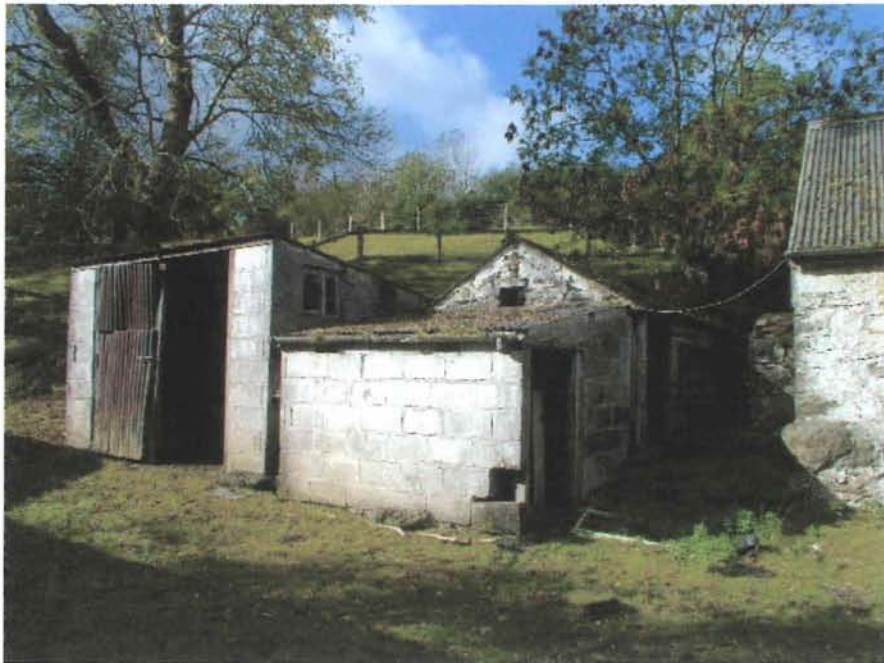
Plate 6 Spite Inn Farm pigsty

- 5.14 The stone-built pigsty (4) appears to be contemporary with the farmhouse. The pigsty originally measured 4.7m by 2.75m, and was divided into two bays, although an additional bay was later added to the south-east end, built of concrete block. The original roof has been replaced throughout with corrugated asbestos. A small, free-standing building (5) of concrete block construction with a corrugated iron roof lies immediately to the south-west, with double doors opening onto the farmyard and a feeding trough against one wall. This may have been used as a shelter shed.

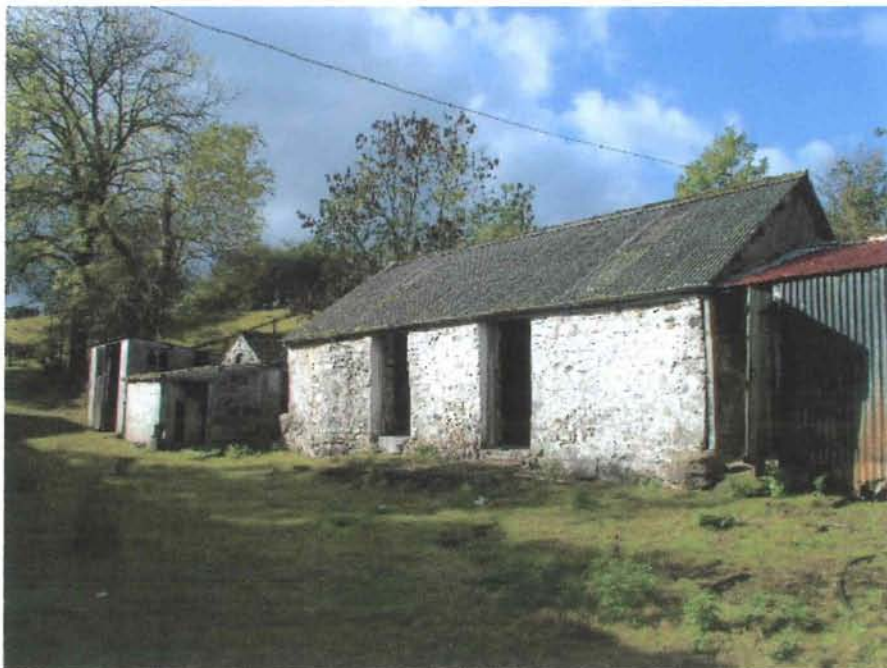
Plate 7 Spite Inn Farm cow house

- 5.15 Like the pigsty (4), the cow house (6) appears to be contemporary with the farmhouse. It is somewhat irregular, measuring 10m in length, but increasing from 5.5m wide at the south-western end to 5.75m. The building has two narrow doors facing the farmyard and no windows. Internally, concrete block walling has been used to form five feeding stalls, with a passage along the rear wall, suggesting the that this was used as a cow house, although this may not have been its original function. The roof trusses have been replaced and the building is now covered with corrugated asbestos, although the base of two original trusses are visible embedded in the rear wall.

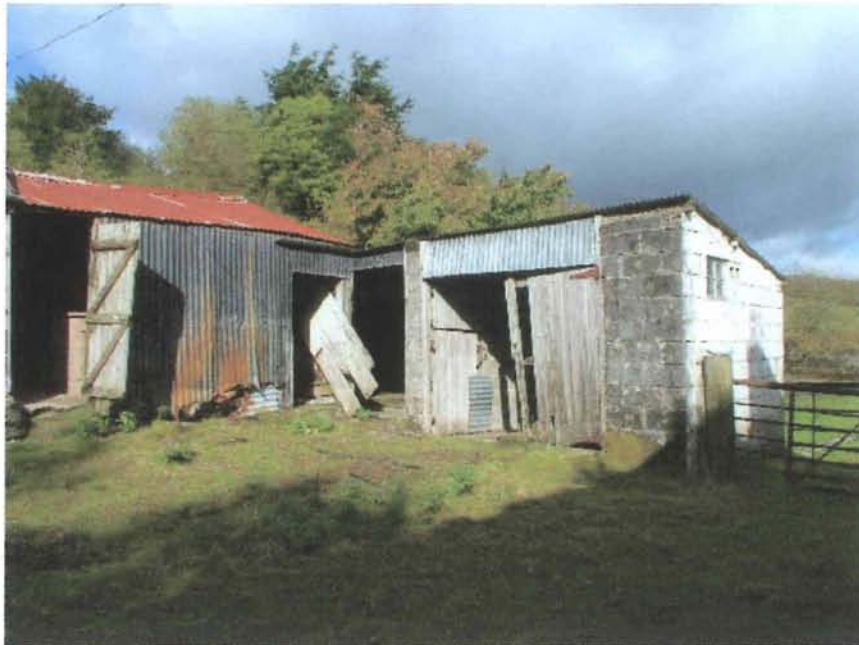
Plate 8 Spite Inn Farm - later cow house and outbuildings

- 5.16 A further cow house (7) was added to the north-eastern end of the building, of corrugated iron construction, and measuring 5.75m by 4.45m. Two doors open onto the farmyard, one giving access to a feeding passage against the gable wall of the original building, and the other leading into three feeding stalls.

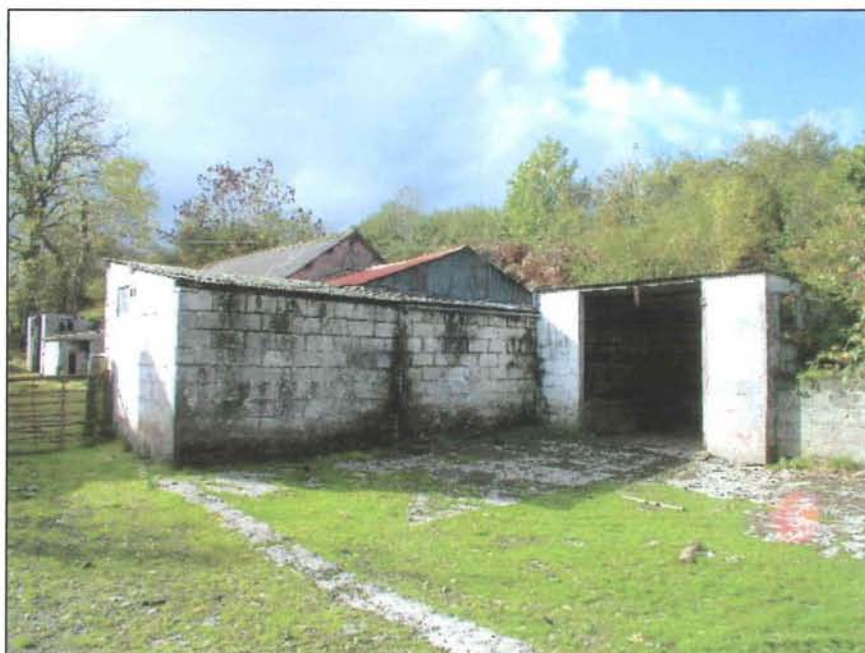
Plate 9 Spite Inn Farm outbuildings

- 5.17 A range of outbuildings (7), possibly shelter sheds, was added at right-angles to the main range, built in concrete block, and initially comprising a single building measuring 7.15m by 4.55m, with a later extension measuring 3.5m by 3.5m. Both have feeding troughs and are roofed with corrugated asbestos. A further structure was added to the north-east, measuring 4.55m by 4m, with a feeding trough and a wide doorway opening onto an extension to the farmyard, which is enclosed by a concrete block wall.

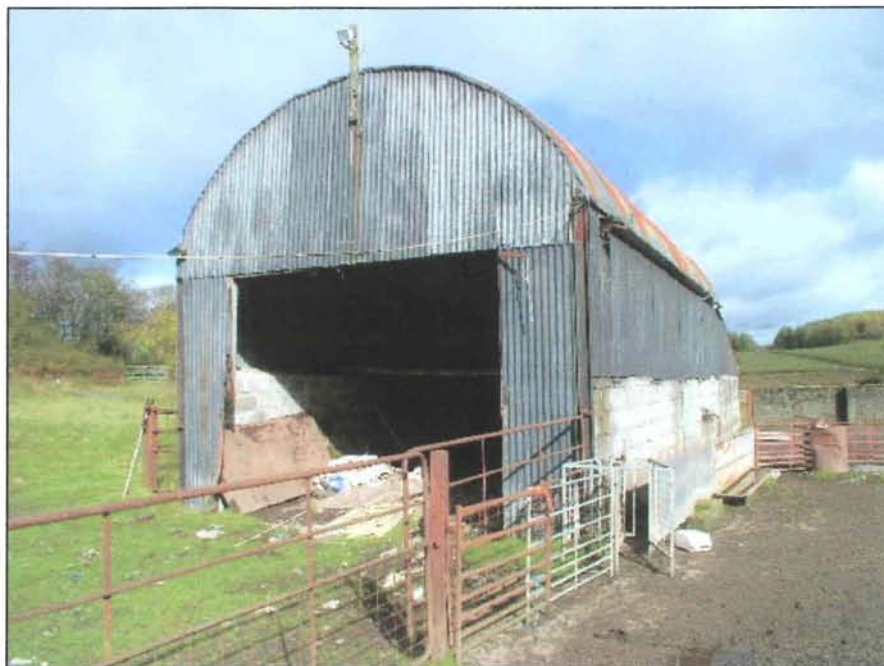
Plate 10 Spite Inn Farm – later barn/shearing shed

- 5.18 At the north-eastern end of the complex, close to the road, is a large barn (9) measuring 11m by 5.55m, constructed of corrugated iron on a low concrete block wall. The original function of the barn is uncertain, although more recently it has been used for sheep shearing. A 5.4m-long open-ended extension (10) may have been a cart shed or garage, and bears a date of 1963.

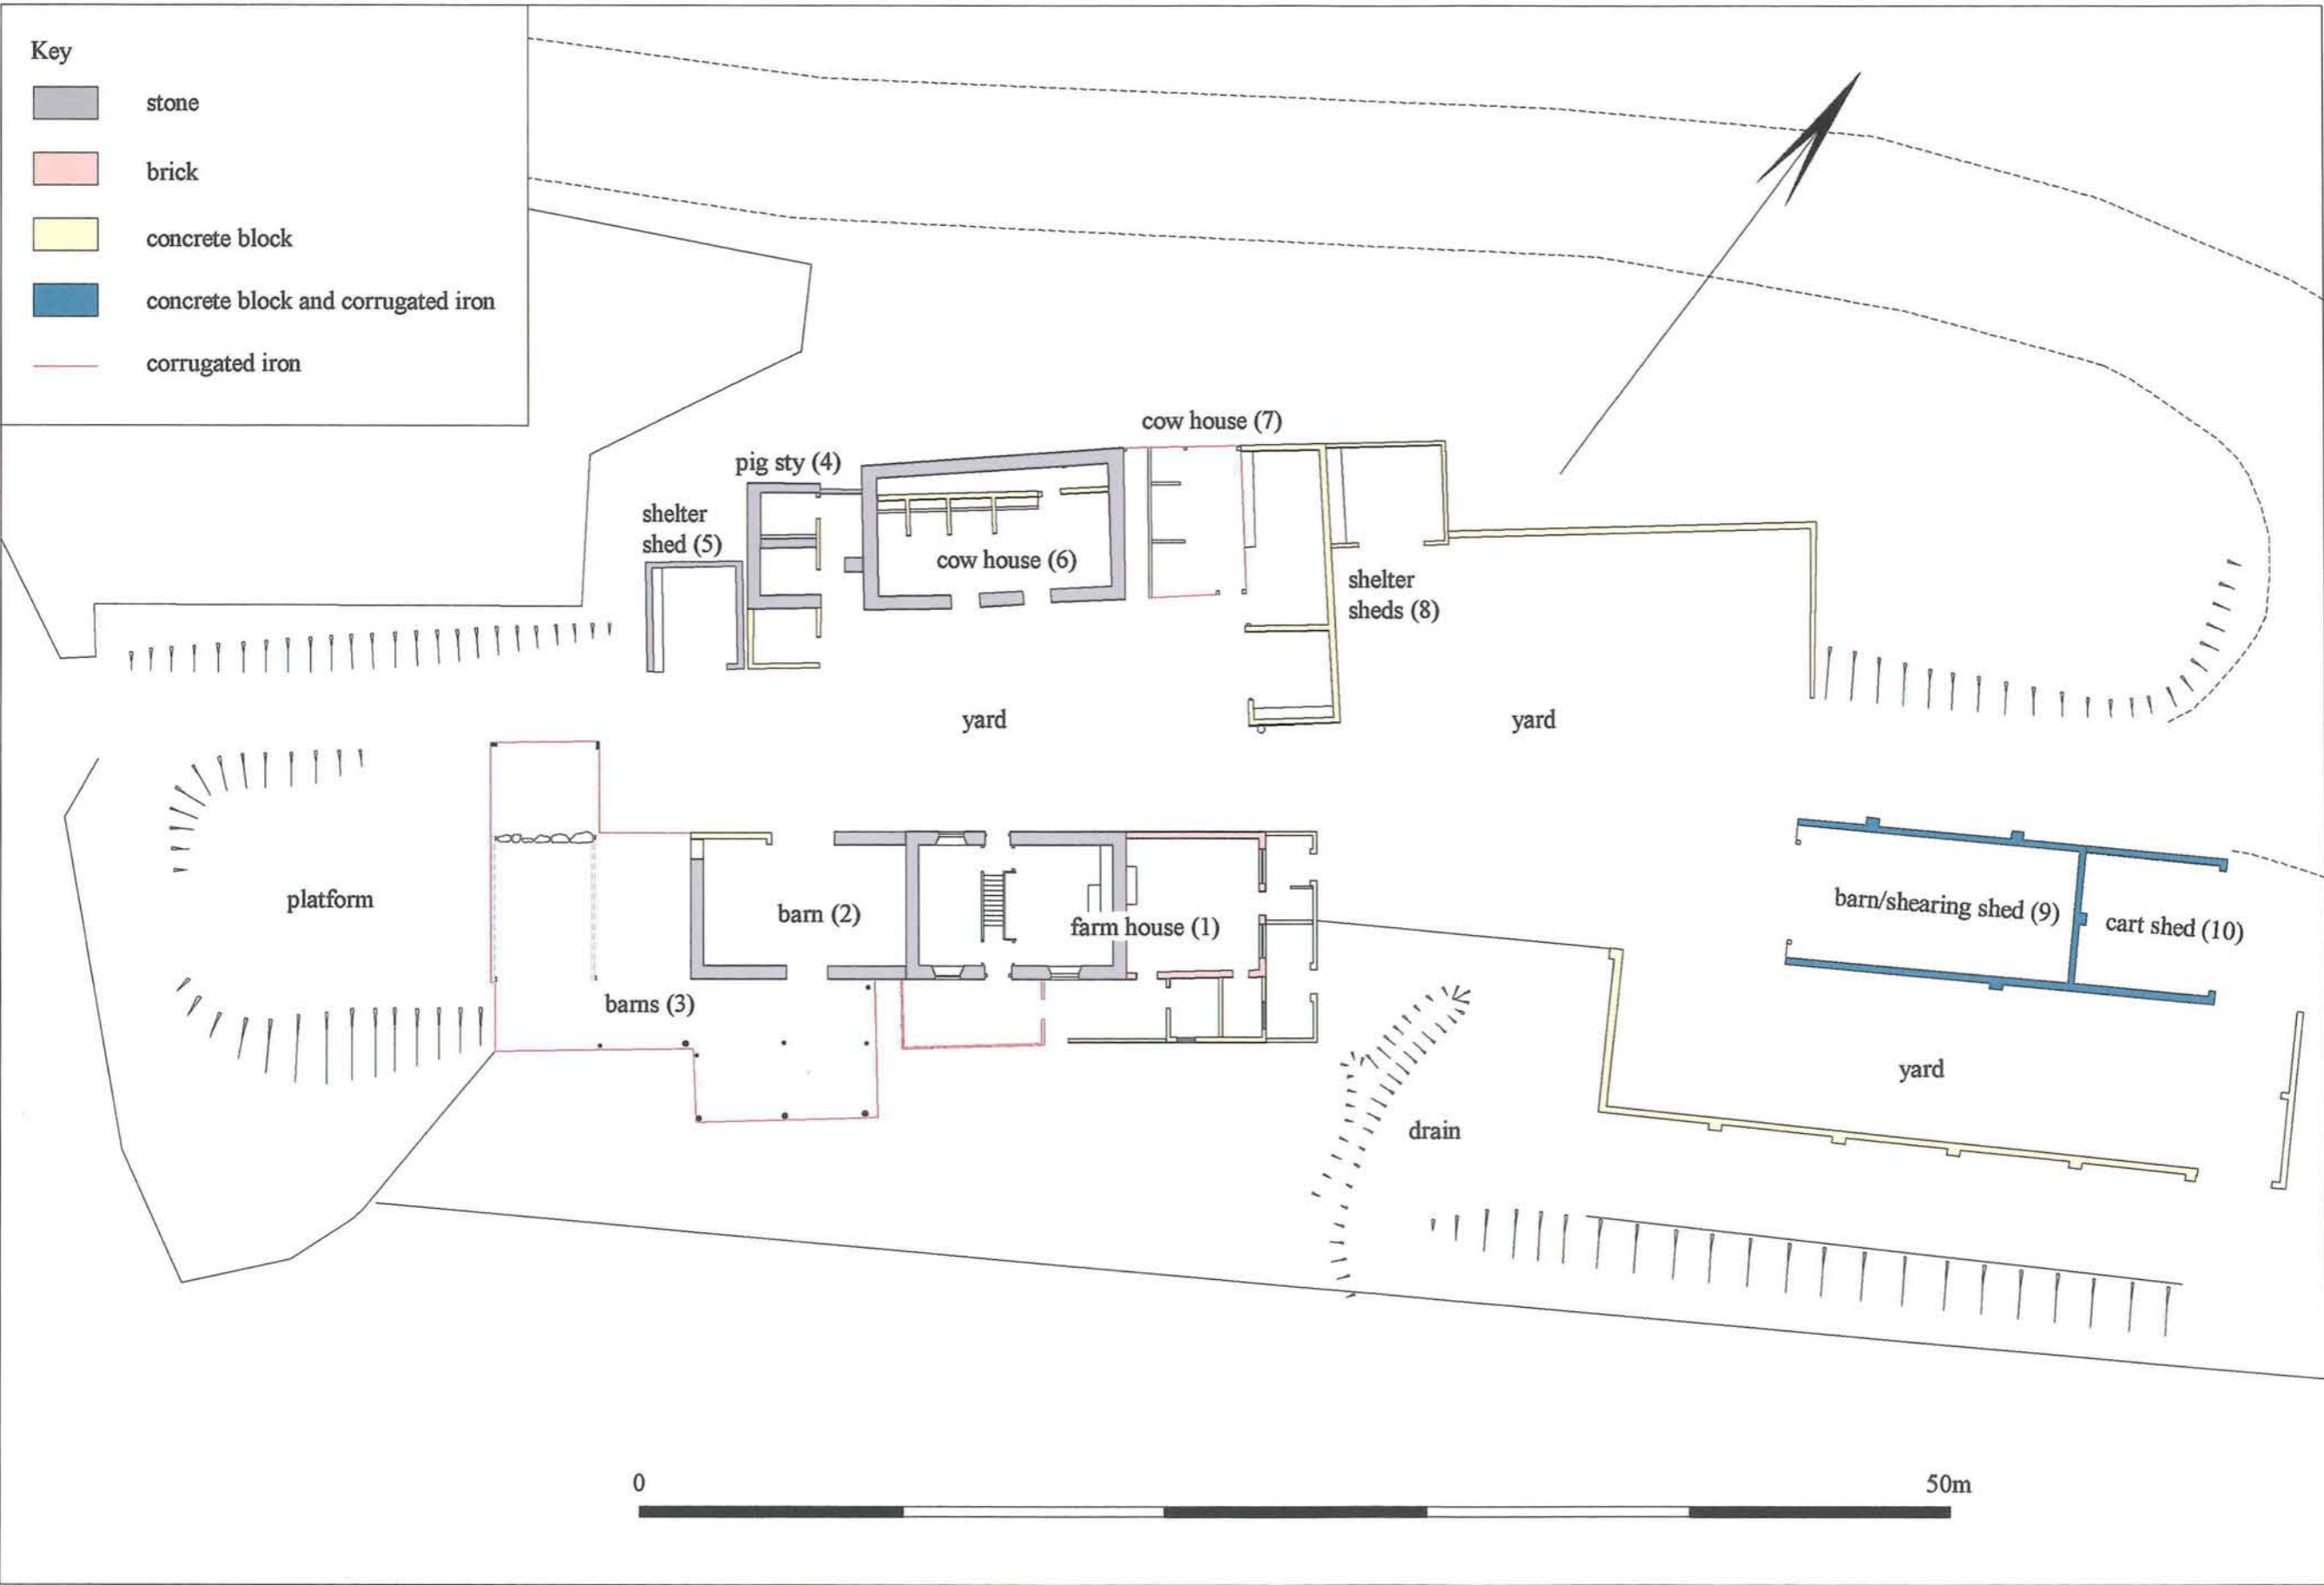
Fig. 3 The complex of buildings at Spite Inn Farm

5.3 Based on cartographic evidence and information from the building survey it is clear that the farm complex originally comprised the farmhouse with a barn or cow house and a pig sty on the opposite side of the track which ran through the farm. The Ordnance Survey 1<sup>st</sup> edition 25 inch map of 1888 also depicts these buildings, as well as a small building on the south side of the track, just to the west of the farmhouse, of which there is now no trace.

5.5 Further additions to the complex may be broadly divided into two constructional styles: post-built structures with corrugated iron cladding and roofing; and concrete block construction, with corrugated asbestos roofing. Although there is no supporting evidence, it seems likely that the former dates to the early 20<sup>th</sup> century and includes the barn appended to the south-west end of the farmhouse range, while the latter is possibly from the 1940s or later, and includes a variety of small additional buildings.

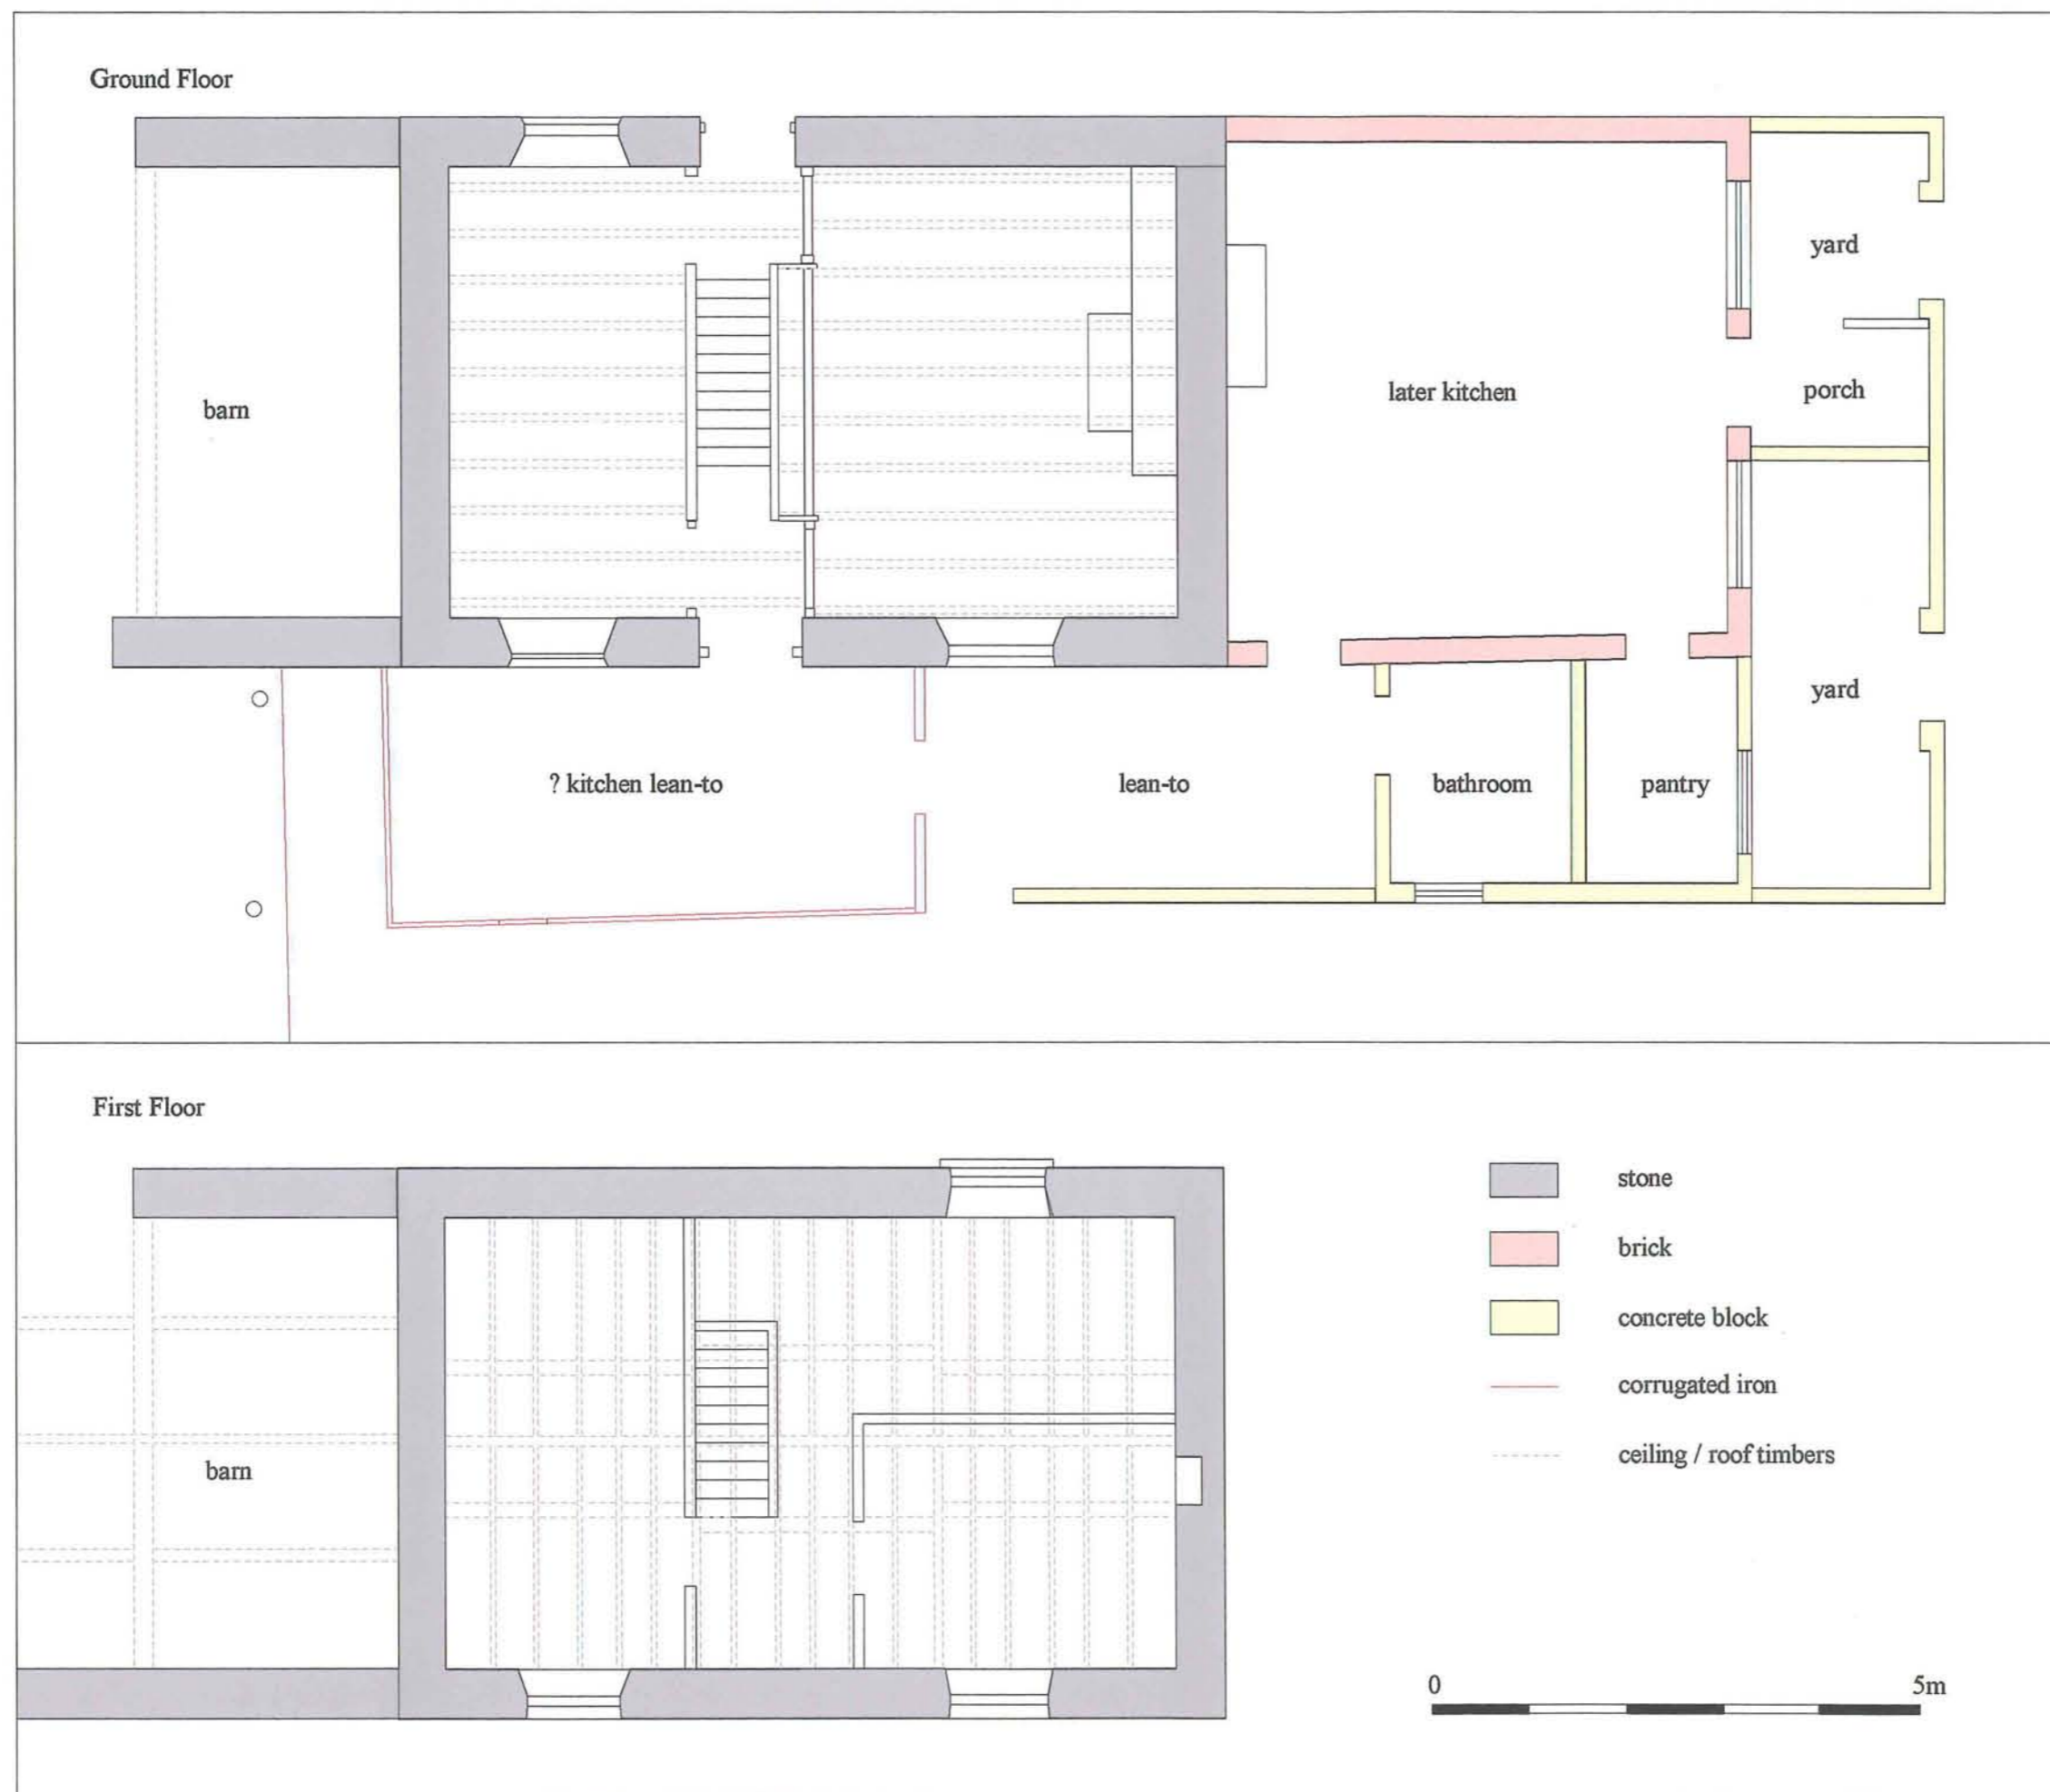
Fig. 4 Spite Inn Farmhouse. Ground and first-floor plans

- 5.9 The first floor is divided into three bedrooms, the larger of which is on the south-western side of the stairs, measuring 4.6m by 2.45m, with an original sash window in the south-eastern wall. As with the room below, there is no evidence for a fireplace. The other two rooms measure 4.1m by 2m, and 3.2m by 2.6m, each with an original sash window, while the south-eastern room has a small fireplace.
