# **Tan House, Pool Quay, Powys**

**ARCHAEOLOGICAL RECORDING**

**CPAT Report No 810**

**N Jones**  
July 2006

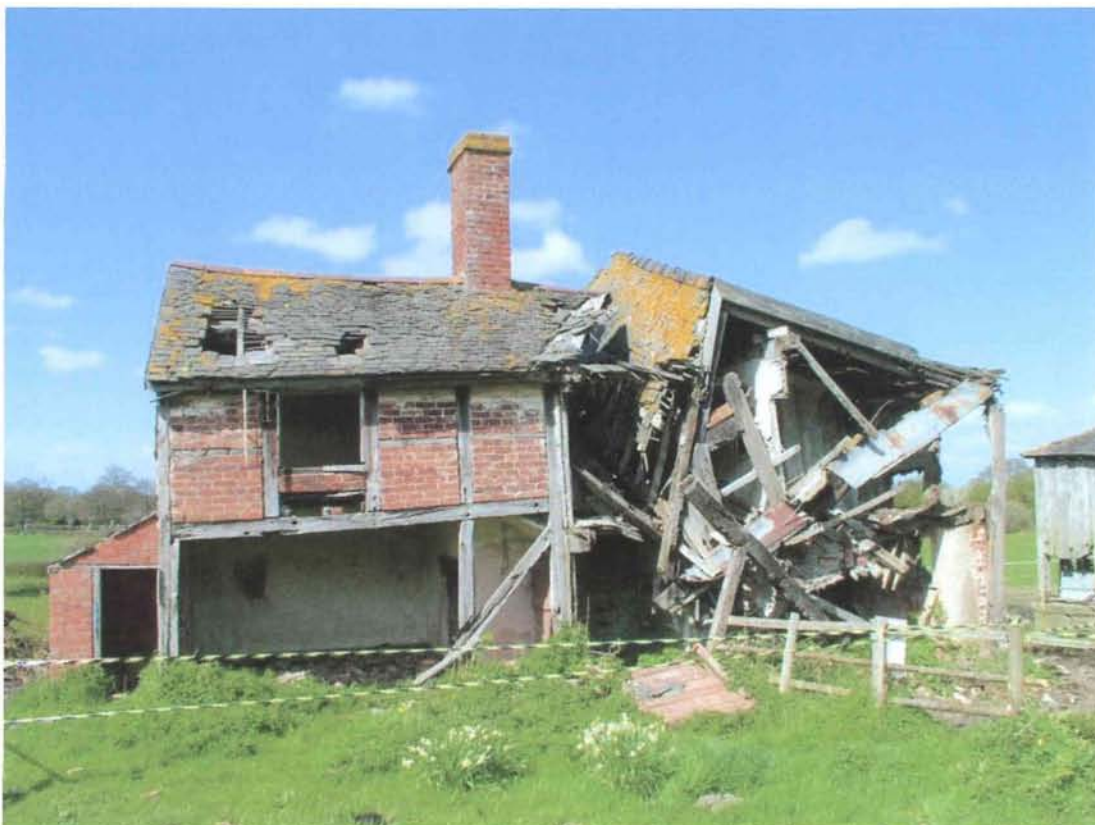
- 4.5 It was not possible to make a full record of the timber framing as none of the elevations was complete and accessible. The southern elevation (Fig. 6; Plate 1) revealed that the trusses were formed by jowled posts with a substantial tie beam and principal rafters above, each with a pair of purlins. The purlins each had joints indicating the former existence of matching purlins for at least one further bay to the south, for which no visible trace survived. In addition, the framing above the tie beam clearly formed a door at attic level, rather than a window.

- 4.8 The building was extended, probably around 1800, by the addition of a timber-frame wing on the western side of the northern two bays (Plate 1). This implies that by this time the southern part of the original building had already been lost. The two-storey extension had a single room on each floor and was constructed in a noticeably less substantial box frame than the original, with brick infilling rather than wattle and daub. The extension measured 4.4 x 4.3m and was founded on a sill beam resting on a low stone plinth. At ground-floor level three of the elevations had slanting struts in each corner, while the eastern side, against the original building, had a brick chimney stack with a fireplace on each floor. Access was directly from the original building with a door on the ground floor to the south of the chimney and on the first floor via three steps rising from the landing. The surviving first-floor window in the south elevation had the original cast-iron casement. The roof trusses were formed by a tie beam and principal rafters with single purlins supporting a slate roof with ceramic ridge tiles. A brick-built privy was later added against the west elevation, possibly during the early 20<sup>th</sup> century.

Plate 1 South elevation showing collapsed southern gable and later box-frame extension

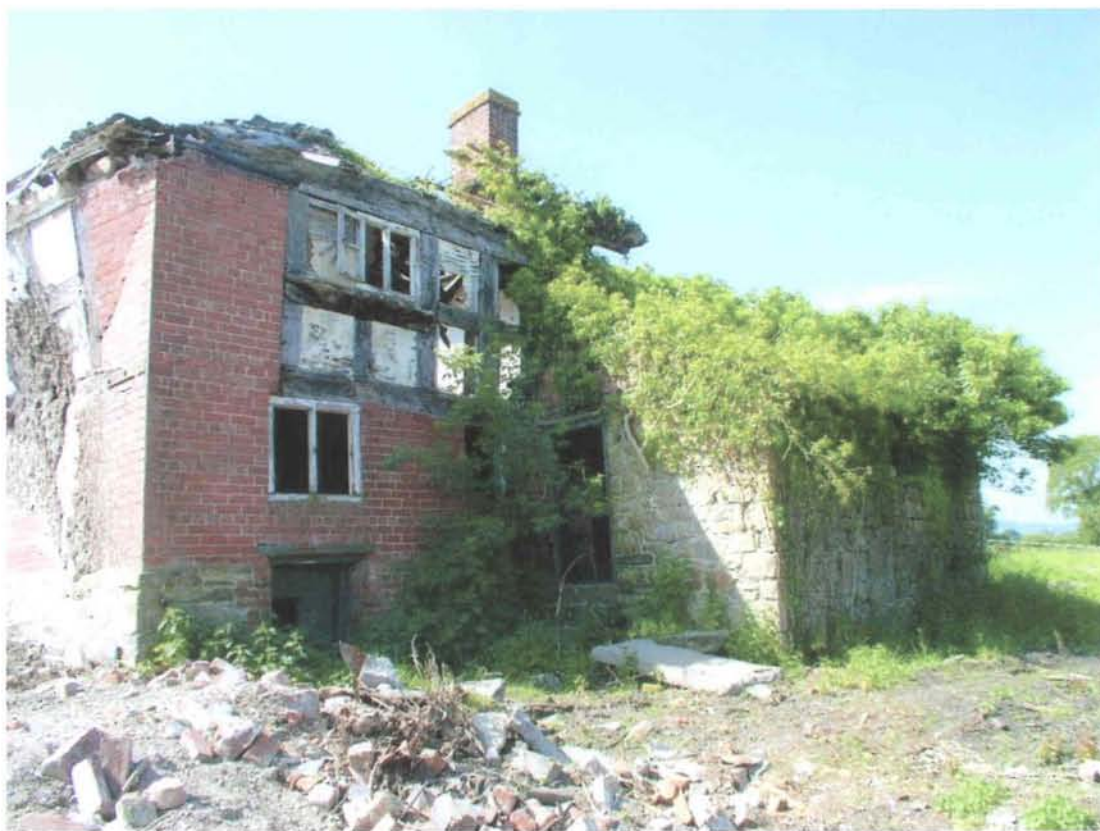
- 4.7 The northern elevation (Fig. 7; Plate 2) had also been partly replaced in brick although the surviving timbers provided a reasonable indication of the original construction. The box frame for the first floor included an original window opening, now partly blocked, which had a substantial moulded sill. The roof truss was similar to the southern elevation, although with a single window in the upper section of framing. An external door into the cellar had been inserted through the plinth, above which were two windows set within the later brickwork. The western side of the original building could not be accessed owing to health and safety considerations.

Plate 2 North elevation showing later kitchen range

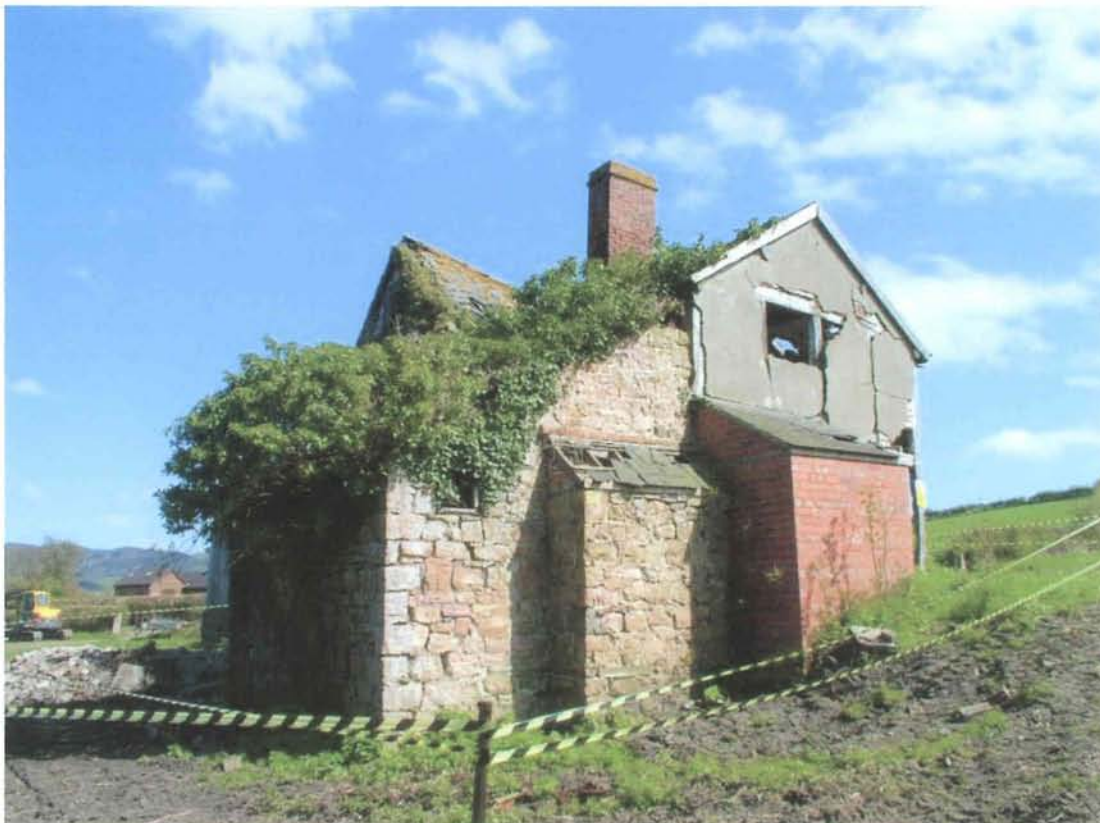
- 4.9 During the early 19<sup>th</sup> century the building was extended again with the addition of a lean-to kitchen range on the north-west corner, measuring 5.8 x 3.7m. This was of random stone construction with a slate roof, and included an oven which projected slightly from the western wall, with a boiler alongside (Plates 4 and 5). The extension had windows in the west and north walls with a door on the east side at the top of a flight of three stone steps. A doorway in the north-west corner of the original building provided the internal access.

Plate 4 West elevation showing the projection for the oven and later brick privy

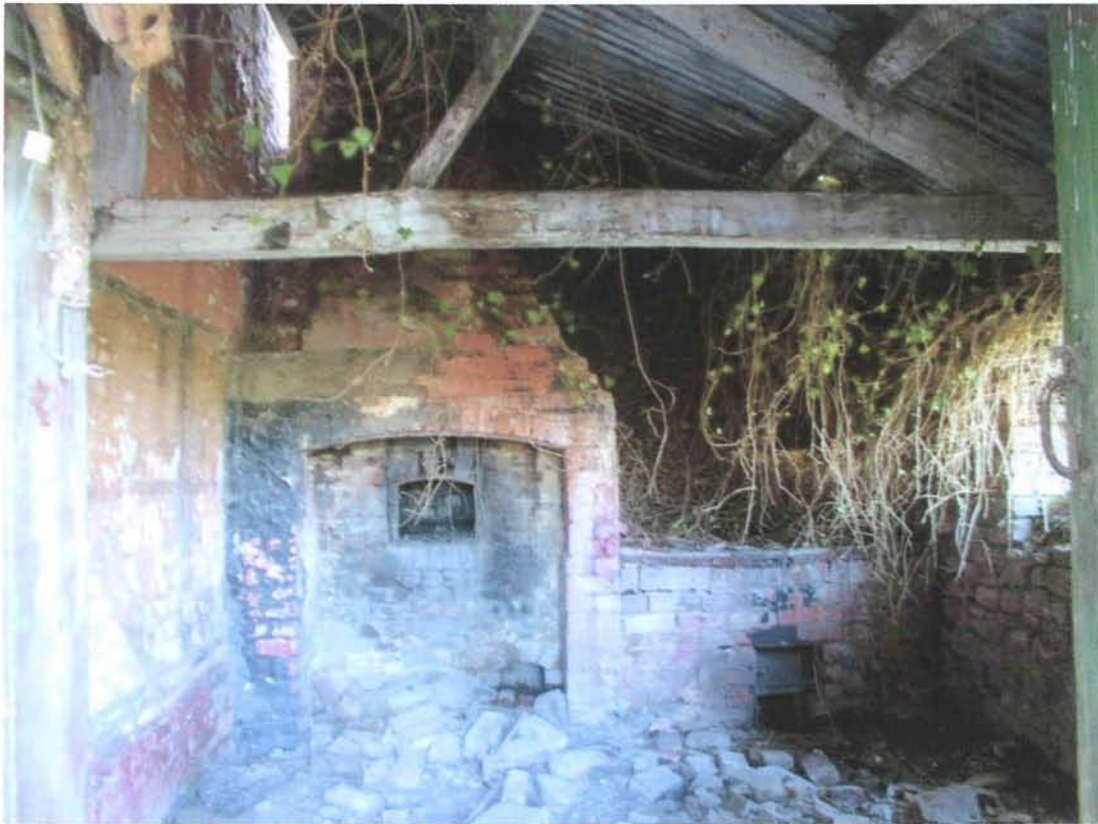
Plate 5      Oven with boiler to right

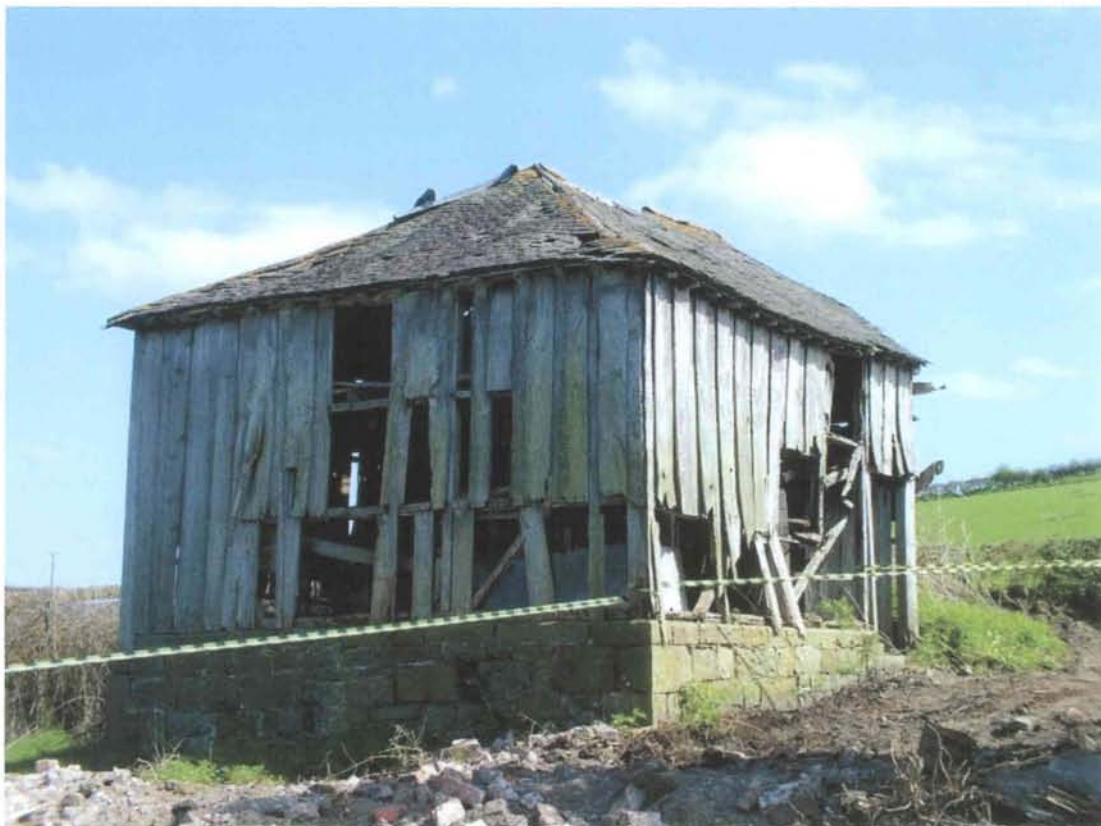
- 4.11 The later extension was also of timber-frame construction and stood on a platform revetted by dressed-stone walling which extended upwards to form a low plinth (Plate 6). The timber framing had a sill beam on top of the plinth with posts rising to support the first floor and wall plate and external vertical weatherboarding. The hipped slate roof was supported on two simple king-post trusses with a tie beam resting on the wall plate, principal rafters and central post with no struts (Plate 7). At ground-floor level the barn was entered via a door in the south-west corner, the interior being divided into two with a feeding trough running the length of the east wall (Plate 8). On the first floor the barn was open-plan with a loading door in the west elevation and a connecting door on the south side leading to the earlier barn.

Plate 6      Barn viewed from north-west showing stone plinth and hipped roof

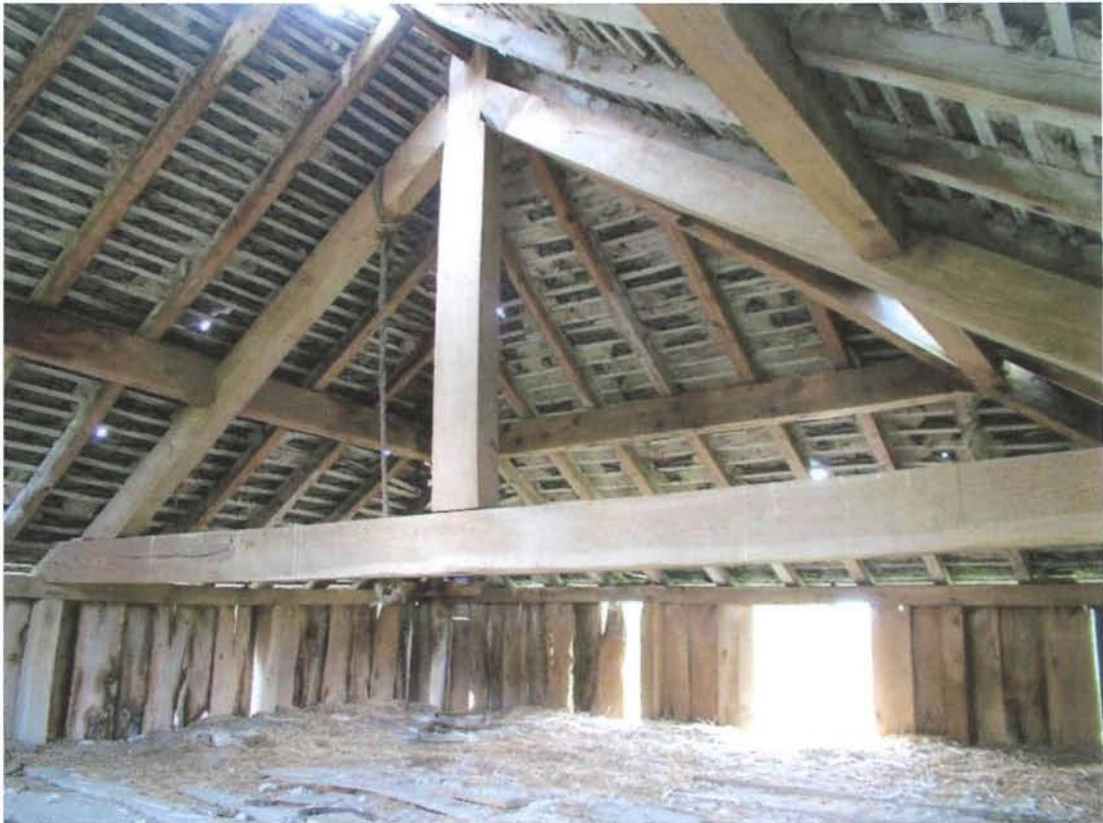
Plate 7 Barn first floor showing roof truss

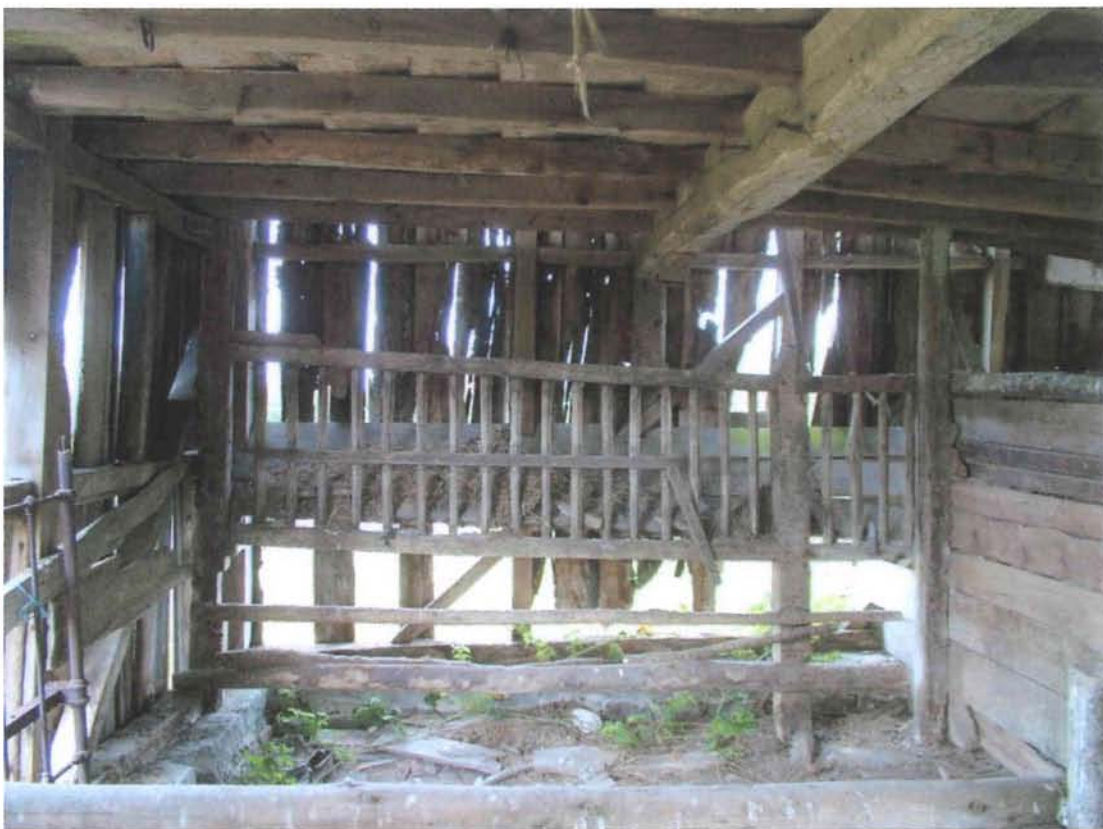
Plate 8 Barn interior showing northern end and feeding trough

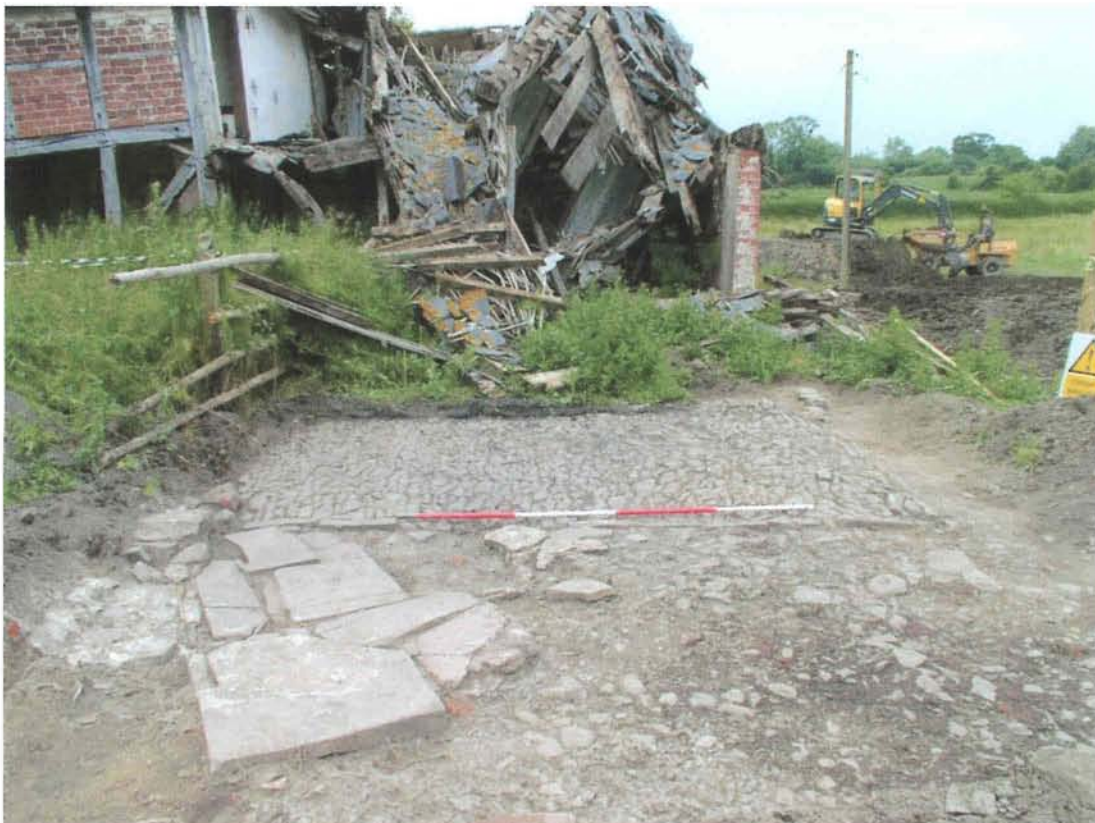
- 5.4 To the south of the cobbles there was a remnant of a rough stone surface (08) and a small patch of flat slabs (04), both of which also contained 19<sup>th</sup>-century artefacts. A spread of large slabs (05) had the appearance of a path, along the western side of which were the remains of a roughly-built lime-mortared stone wall (06).

Plate 9 General view of excavation showing path (05) and cobbled yard (02)

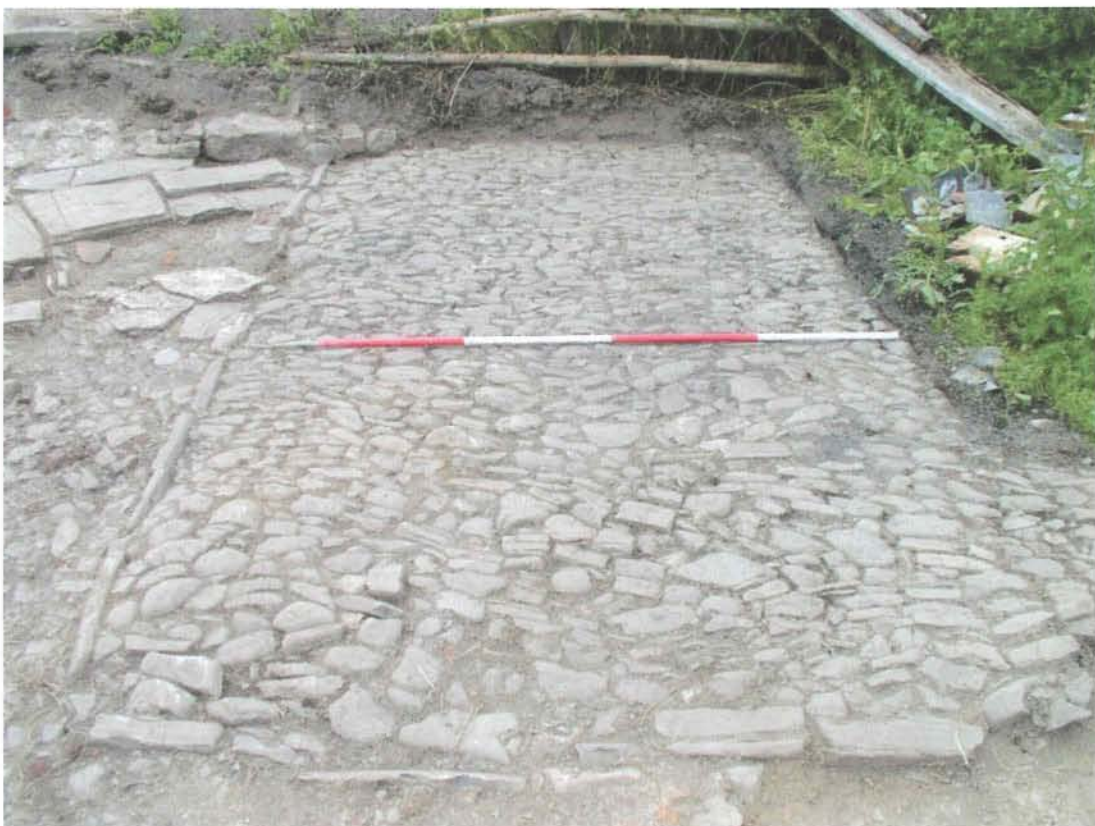
- 5.1 The trial excavation was undertaken on 29-30 June 2006 at the request of the curator to investigate the potential for buried archaeological remains relating to the lost southern part of the original building. An area measuring c. 4.6 x 4.3m was mechanically stripped of overburden under close archaeological supervision. Thereafter, all excavation was undertaken by hand. A full drawn and photographic record was maintained throughout and details of the Site Archive are provided in Appendix 1. Numbers in brackets in the following text refer to individual contexts recorded in the Site Archive.
- 5.2 In the northern part of the excavation, closest to the standing building, a well-made cobbled surface (02) was revealed immediately below the topsoil and rubble (01). This was composed of random edge-set cobbles with deliberate edging along the south and east sides formed by small

edge-set slabs. Artefacts recovered from amongst the cobbles included several sherds of 19<sup>th</sup>-century pottery which were not retained.

Plate 10 Cobbled yard (02)
