**A.P.A.C. Ltd.**

ARCHAEOLOGICAL

WATCHING BRIEF

**Glebe Farm Maes Ffynnon, Llanbedr.****Brecon Beacons National Park Authority****Planning Application No: 06/00458/OUT****08/02176/REM****CPAT HER**

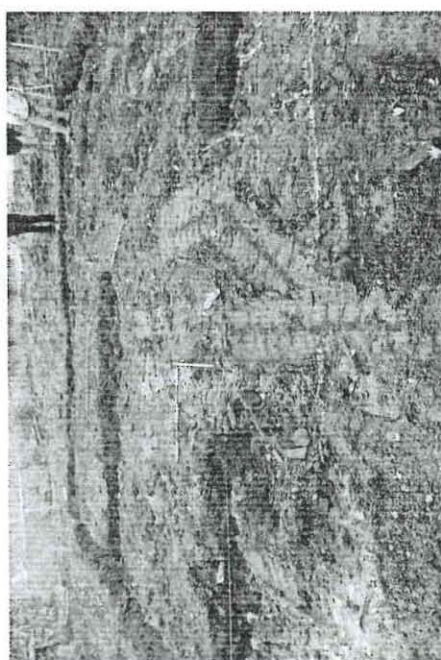
Plate 03: Trench Location, view east

Groundwork at the site entailed the excavation of a foundation trench house plot fig 02, Plates 01, 02 & 03. The trench measures approximately 10m x 10m x 1m wide with a maximum depth of 900mm.

The site and weather conditions for the first day of the watching brief were good and dry. Overnight rain however, preceding the second day turned the clay surface of the site into a sticky quagmire Plate 3.

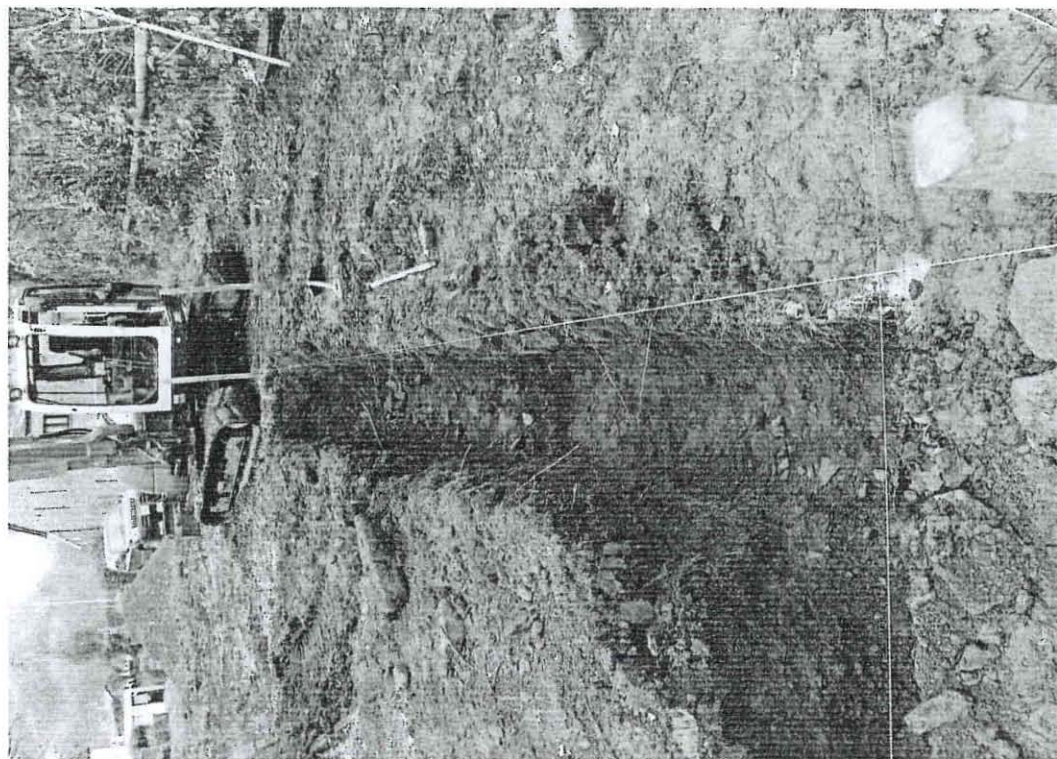
Plate 07: Northern edge of trench

Plate 07 shows a view along the northern edge of the trench. The stratigraphy visible shows a darker sandy soil overlaying a red sandy soil containing quantities of rounded cobbles consistent with a river terrace deposit.
