**CPAT Report No 952**

# **Commings Cottage, Trefeglwys, Powys**

## **ARCHAEOLOGICAL WATCHING BRIEF**

**R Hankinson**  
October 2008

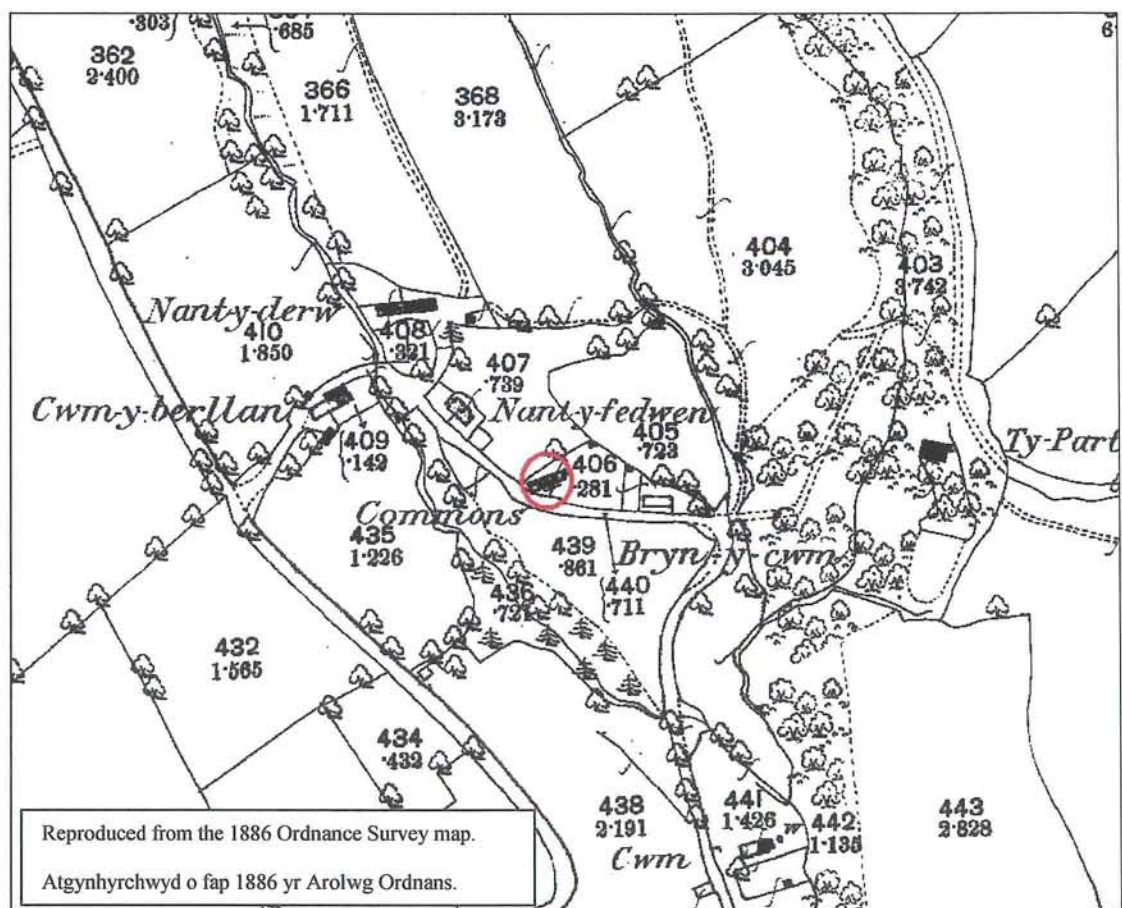
- 2.1 Commins Cottage lies approximately 1.2km to the north-north-west of Trefeglwys, and is sited on an interfluvium between two tributary streams which flow southwards into Nant Gleiniant. A number of houses are present in the immediate locality, thereby forming a small dispersed settlement (see Fig. 1).

Fig. 1 Ordnance Survey 1<sup>st</sup> edition 25" map, published in 1886

- 4.2 Examination of the north wall of the cottage further suggests that although the modern extent of the east-west range is broadly comparable with that depicted on the 1<sup>st</sup> edition Ordnance Survey map of 1886, it is actually of three different builds which abut each other. The central part includes the main entrance and the fireplace and is almost certainly the earliest, although it would only have covered an area of some 4.7m by 4.3m. Subsequent additions were then appended to its east and west ends to form the structure depicted in 1886.

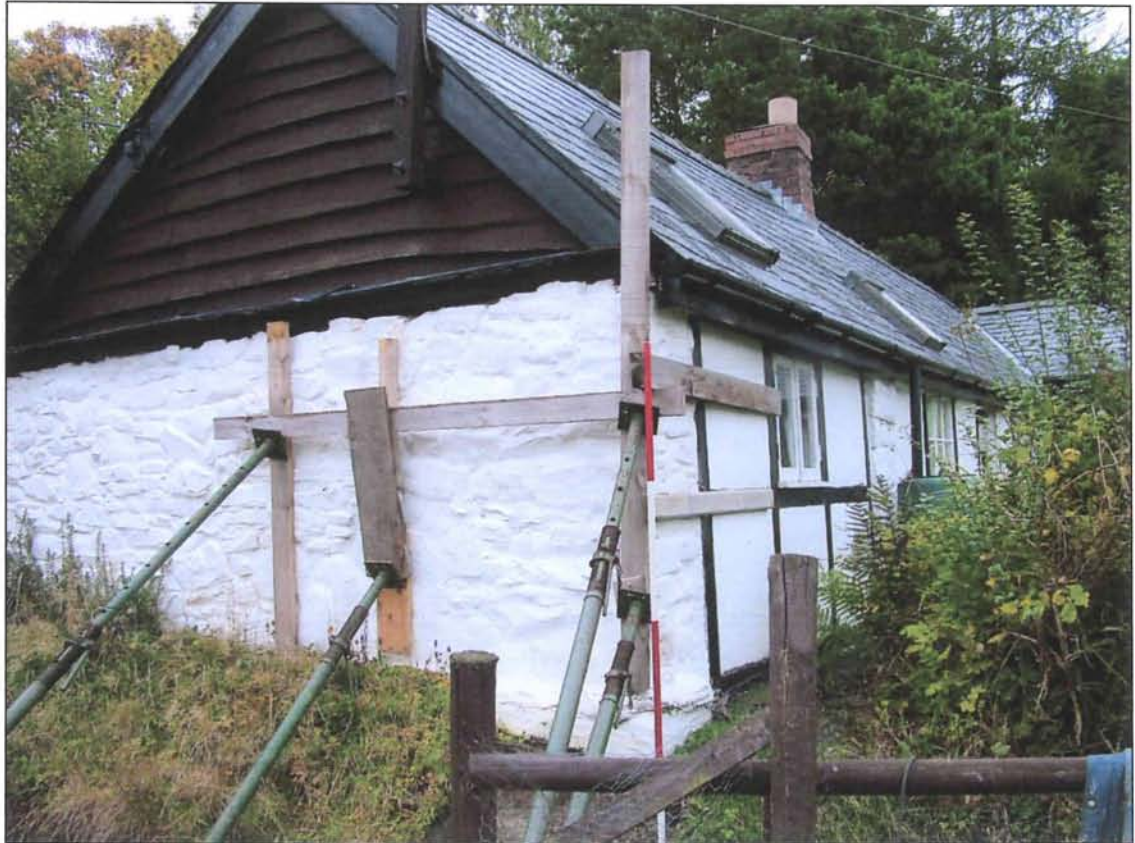
- 2.2 The house is partly constructed of stone, with timber-framing forming most of the south-facing elevation. It is almost certainly first depicted on the Ordnance Surveyors' drawing (No 321) of 1822, but is definitely shown on the Tithe map of 1848; no earlier sources were located. The listing information suggests that Commings has a 17<sup>th</sup>-century origin, but has been subject to some reconstruction and enlargement in both the 19<sup>th</sup> and 20<sup>th</sup> centuries, and it is interesting to note that it is named 'Commons' in 1886, perhaps suggesting that it and the adjoining dwellings were originally constructed in an area enclosed from the waste.

Plate 1 Commings Cottage from the south-west (Photo CPAT 2655-000)

- 2.3 The present west gable wall of the house was the one which required underpinning. This comprised a stone wall up to the height of the eaves with a weather-boarded upper portion, and it was the stone wall which appeared to have moved away from the timber frame of the south-facing elevation in a rotational movement centred at the base of the wall. The listing information suggested that this wall and the associated compartment was a later addition to the original dwelling.

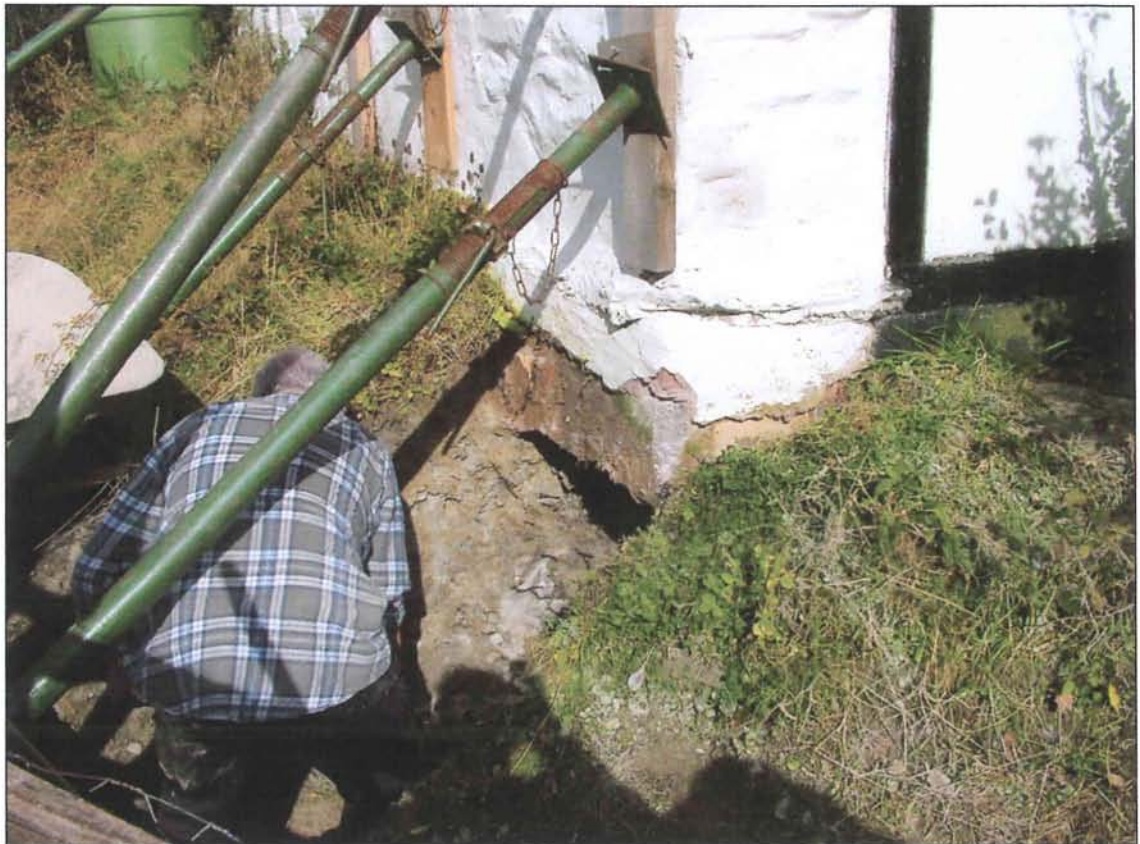
- 3.3 At the corner to be underpinned, the stone wall had already received some additional support from a cemented combination of concrete blocks and bricks which had probably been placed beneath it in the later half of the 20<sup>th</sup> century (see Plate 2). Examination of the junction between this previous underpinning and the wall showed that the ground level had been lowered by about 0.3m at some point after the wall was constructed, and this has presumably been a contributory factor in its instability.

Plate 2 The corner of the cottage showing the previous attempt at underpinning beneath the original wall foundation (Photo CPAT 2655-000)

- 3.4 The final process in removing deposits prior to the installation of the new underpinning was to remove the material used in the earlier attempt. This revealed some orangey-brown silt, on which the original wall foundation appears to have rested, although it was difficult to be certain whether or not this material was infill contemporary with the old underpinning. One fact which did emerge from the removal of this material was that the foundation pad at the base of the wall was formed from stones set in a hard cement mortar, probably dating to no earlier than the 1930s; it can have done no more than rest on the old ground surface.

- 4.1 No archaeologically significant features or artefacts relating to the early history of Commins Cottage were revealed by the watching brief, but some further possibilities can now be postulated. First must be that from the material which forms its base, the west wall of the cottage is plainly 20<sup>th</sup>-century in date, although map evidence suggests that this is probably a rebuild of a wall that was present in the 1880s. Its instability is highlighted by the previous attempt at underpinning and evidently is due to the lack of proper foundations, as a shallow pad at the base of the wall does no more than rest on the ground surface.

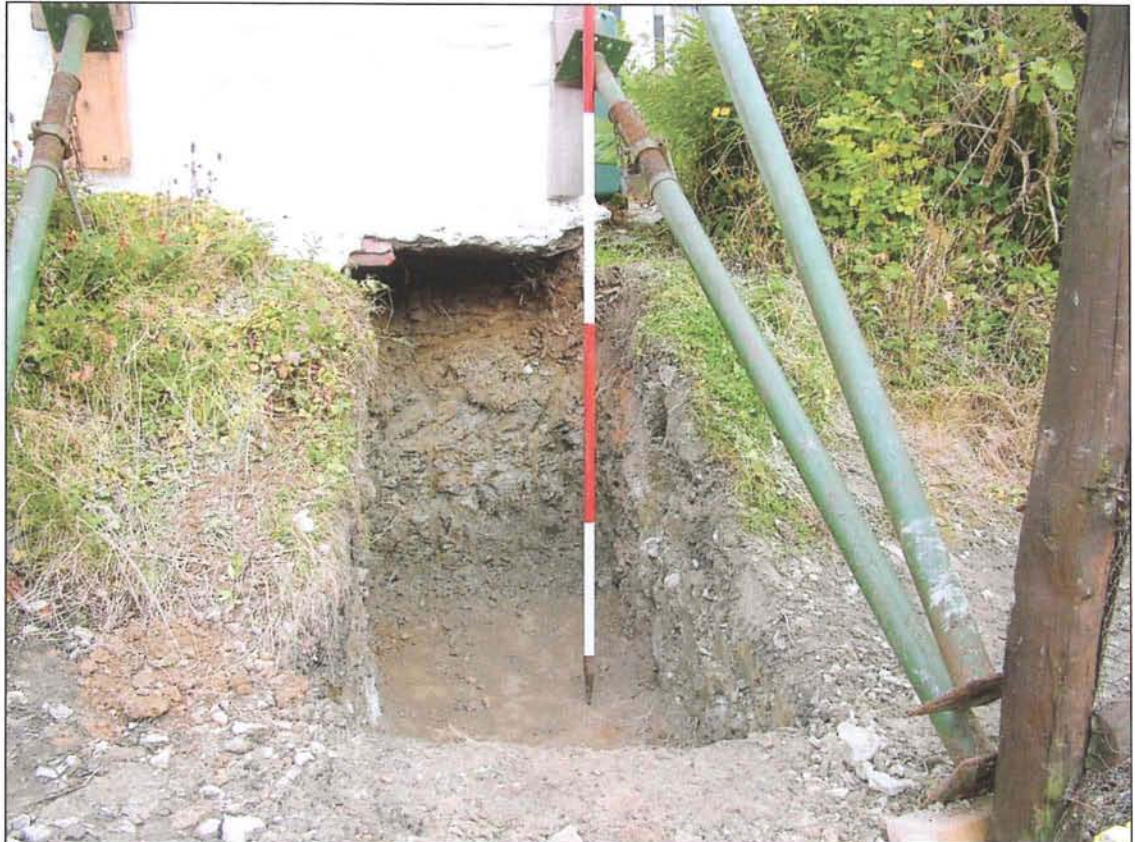
- 3.1 Groundworks consisted of the excavation of a hand-dug trench, 1.7m long (east-west) by 0.8m wide, which ran beneath the gable wall at its southern end. The base of the trench was level, but the steep west-facing slope of the ground adjoining the wall meant that trench depth varied from 0.5m to almost 1.2m.
- 3.2 Monitoring continued throughout the excavation of the trench, with particular attention being given to the possibility for earlier deposits or artefacts which might have provided useful

information relating to the construction methods used and the potential date of the house. Most of the excavated material was natural grey clay with iron-staining and a moderate stone content, this being of sufficient firmness to have apparently negated the requirement for strong foundations.

Plate 3 The trench excavated beneath the corner of the cottage prior to underpinning  
(Photo CPAT 2655-000)
