Rhydlydan Farm Stables, Aberhafesp, Powys

ARCHAEOLOGICAL ASSESSMENT

CPAT Report No 780

N Jones
February 2006

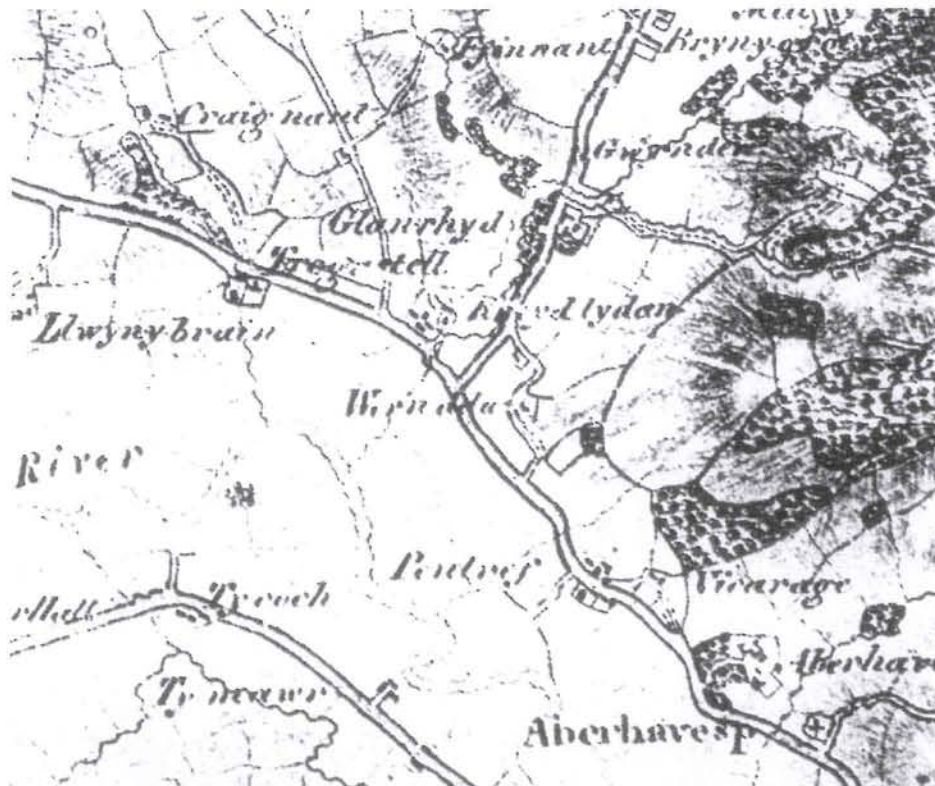
Fig. 2 Ordnance Survey Surveyors' Drawing 1817

- 3.6 The earliest available cartographic evidence is provided by the Ordnance Survey Surveyors' Drawing of 1817 (Fig. 2). Unfortunately, the scale of the map and level of detail mean that it is not possible to be certain about which buildings are depicted. It is clear that a building, probably a mill stood on the site of the present mill building, together with a group of four buildings. Although the accuracy of the map cannot be verified the configuration of these buildings does not match that of the existing buildings, and it is possible that these earlier structures which have since been replaced.

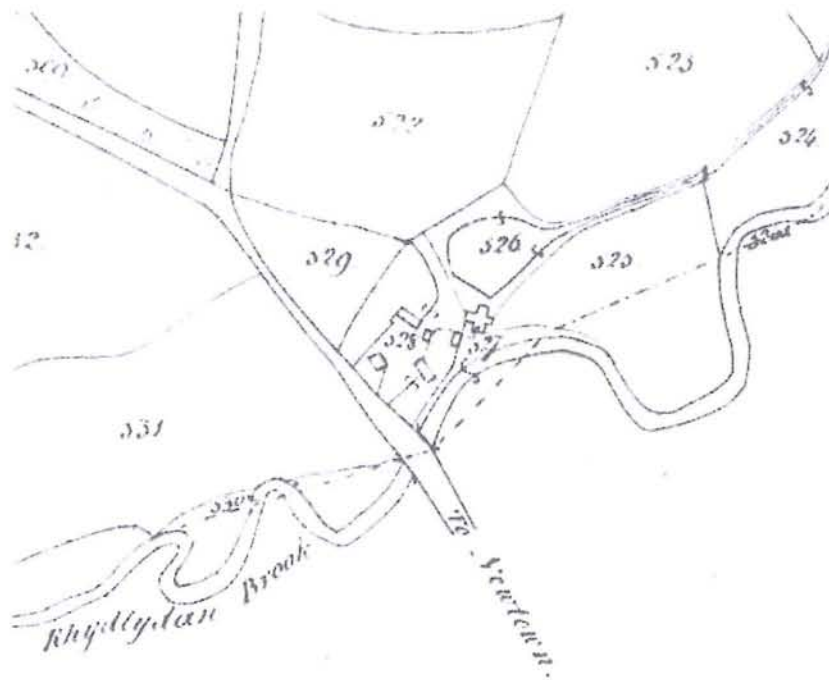
Fig. 3 Tithe Survey for Llanwnnog Parish, Esgob and Castle Township, 1847

- 3.7 The Tithe Survey for Llanwnnog Parish, Township of Esgob and Castle, dated 1847 (Fig. 3), provides more detail regarding the buildings at Rhydlydan. The mill and yard were then occupied by Thomas Benbow, while the farm was occupied by David Hamer. The survey depicts the mill and mill pond, together with the farmhouse, stables and three smaller buildings.

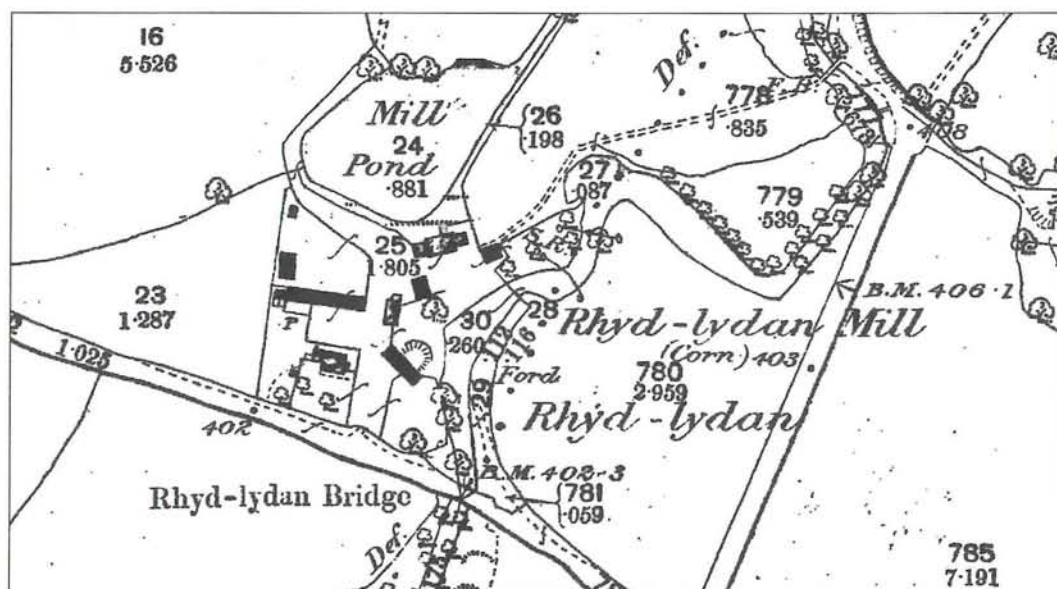
Fig. 4 Ordnance Survey 1st edition 25" map, published 1886

- 3.8 The earliest detailed depiction is provided by the Ordnance Survey 1st edition 25" map, published in 1886 (Fig. 4). The complex of buildings is largely the same as on the tithe survey, although the stables are more readily identifiable, and have been lengthened by the addition of an extra range and smaller building at the west end.

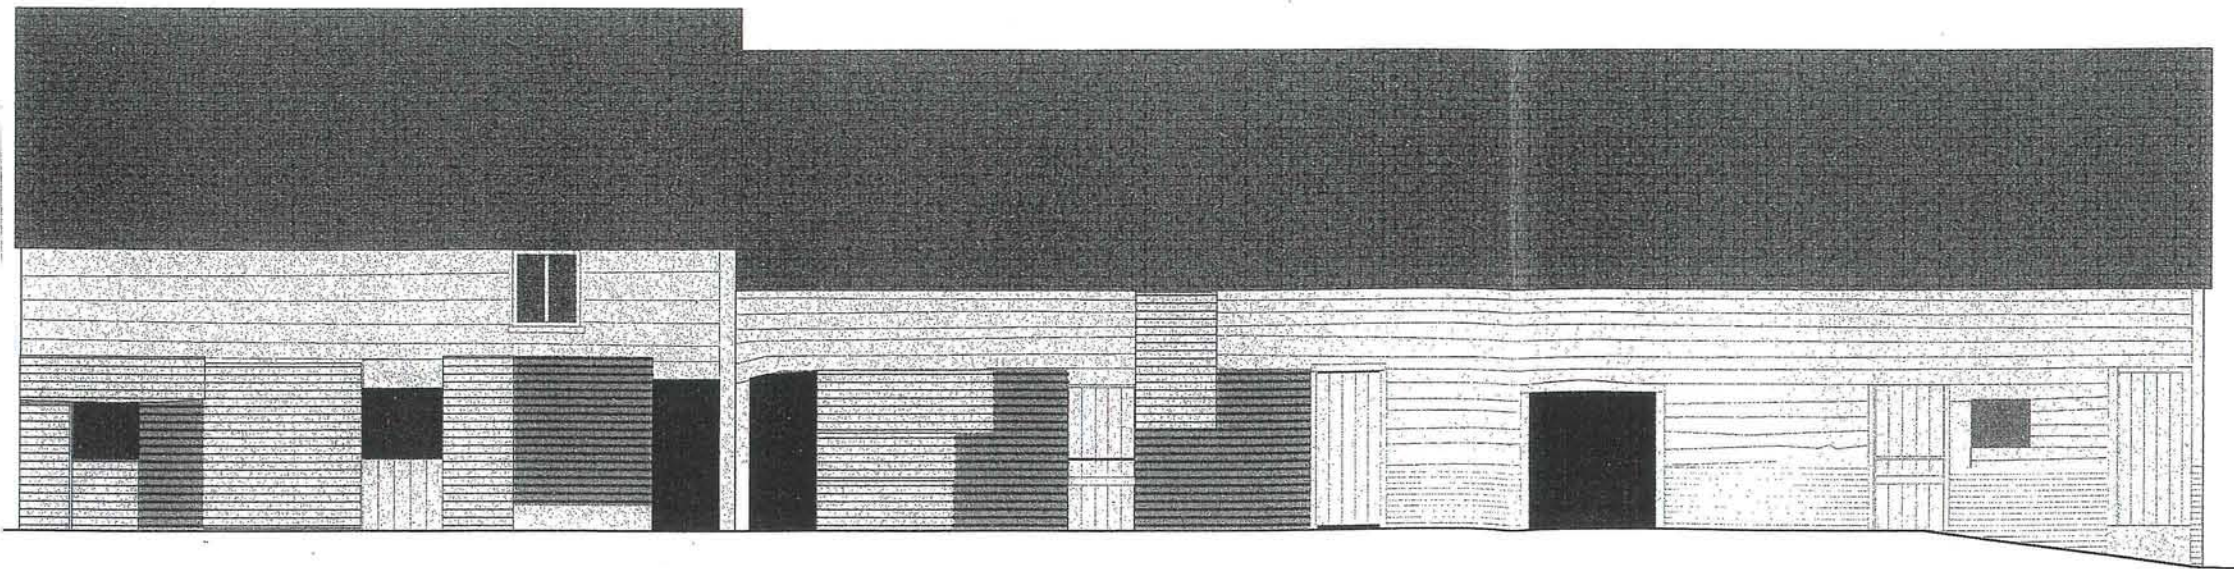
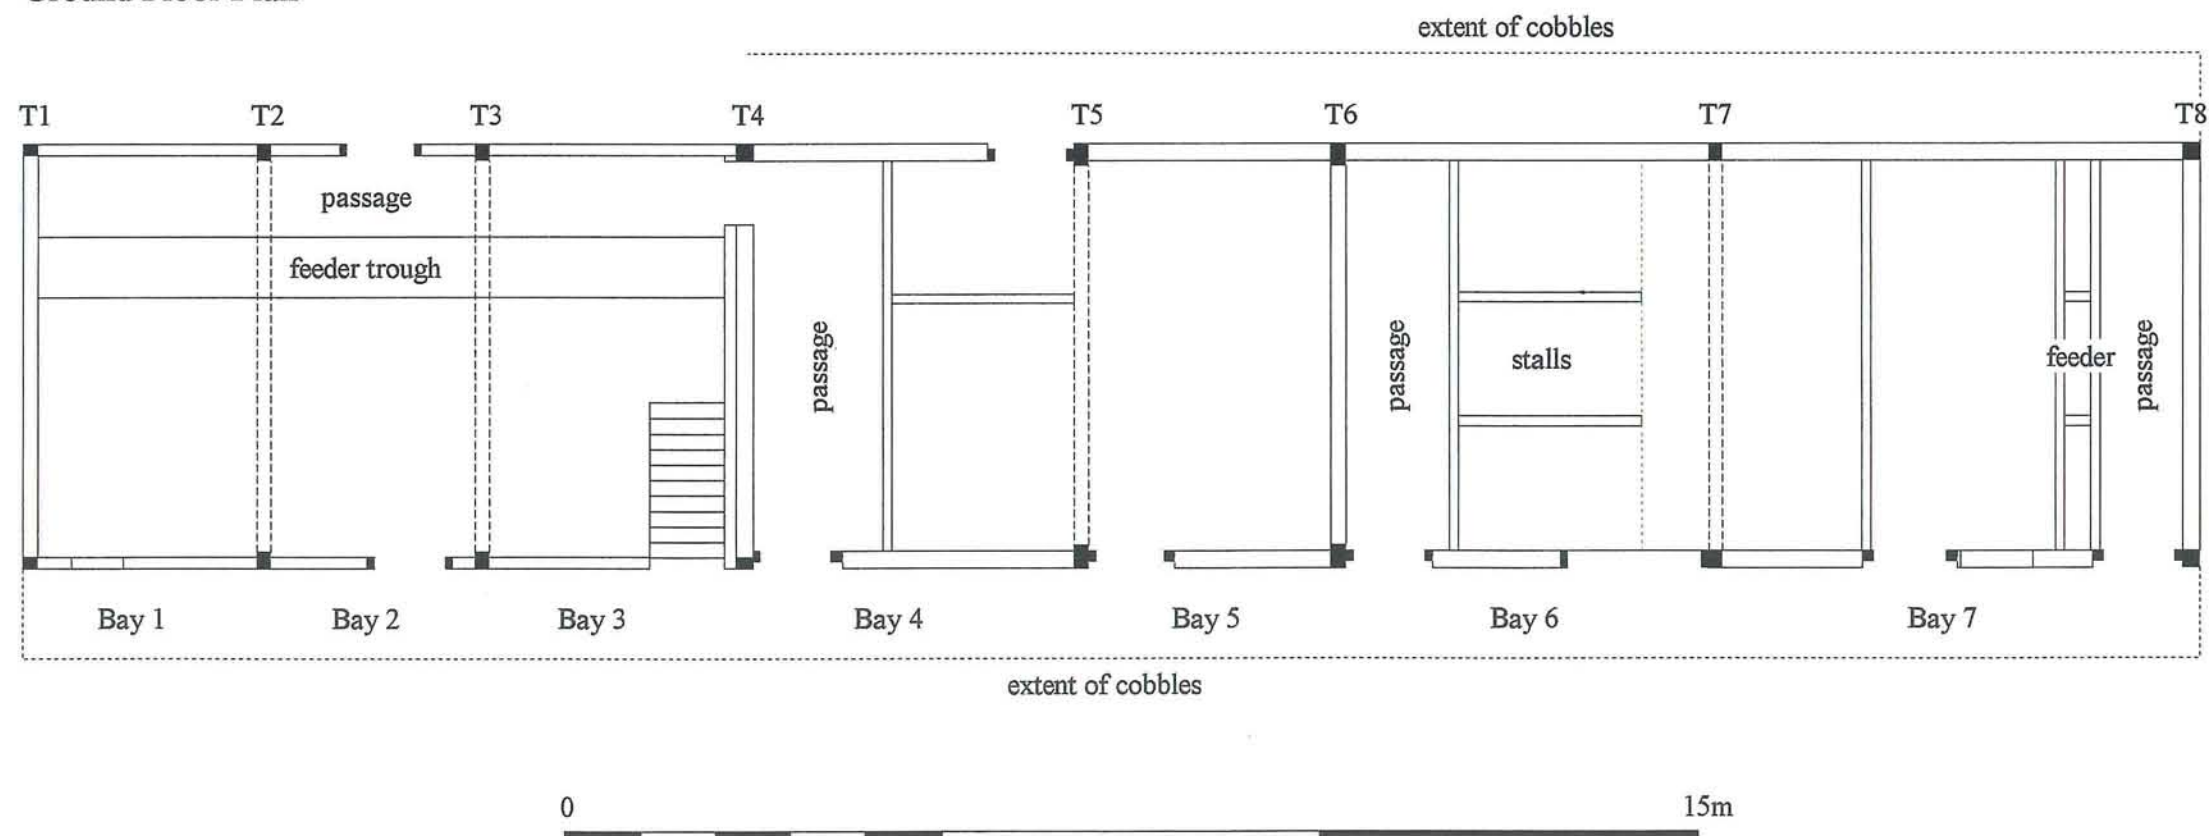
Fig. 5 Rhydlydan Stables: Ground Floor Plan and South Elevation

4 RAPID BUILDING SURVEY (Fig. 5)

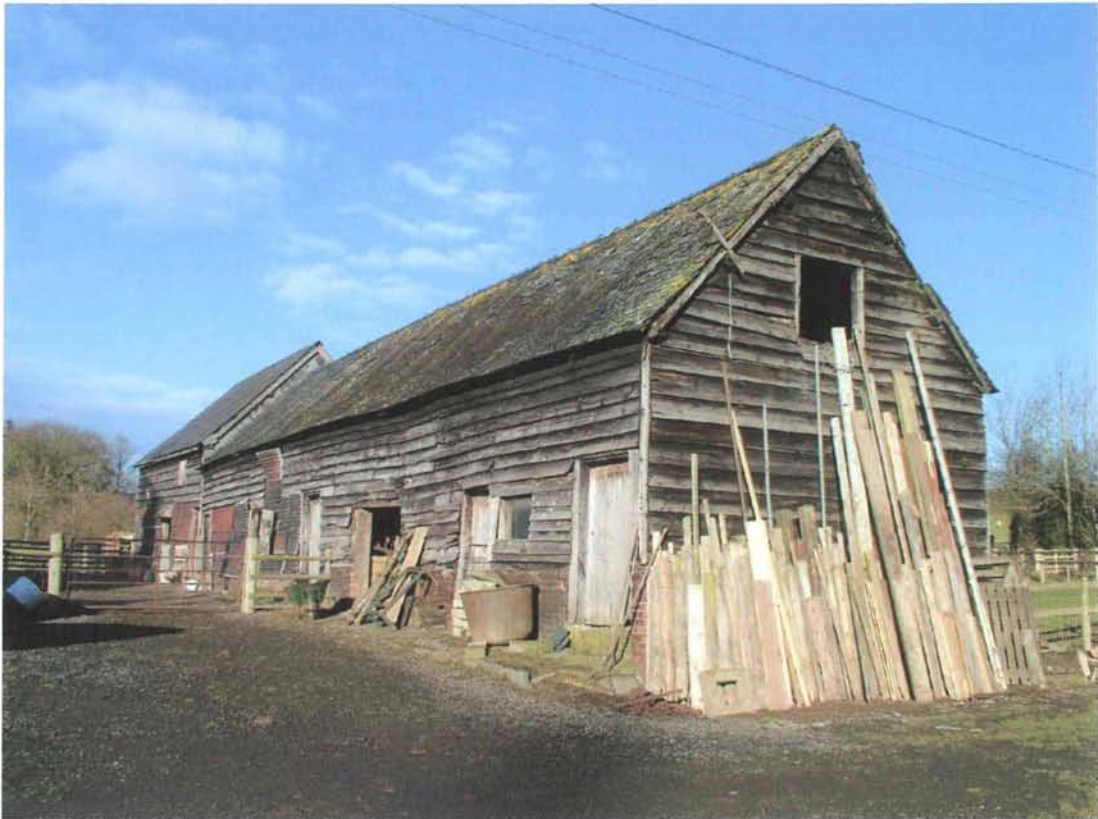
- 4.2 The stable range has two main phases of construction, originally consisting of a timber-framed barn with weatherboard cladding, a slate roof and ceramic ridge tiles (Plate 1). This was extended at the west end by the addition of a slightly taller stables building, of similar construction but with moulded timber barge boards and fascia boards (Plate 2), and a brick-built outbuilding which is now ruinous. An area of cobbling extends along the length of the range on the south side, and at least two-thirds of the north side. In the following description the stable range is described from west to east, with Bay 1 at the west end and Bay 7 at the east end.

Plate 1 Stable range from the south-east. Photo CPAT 2091-001

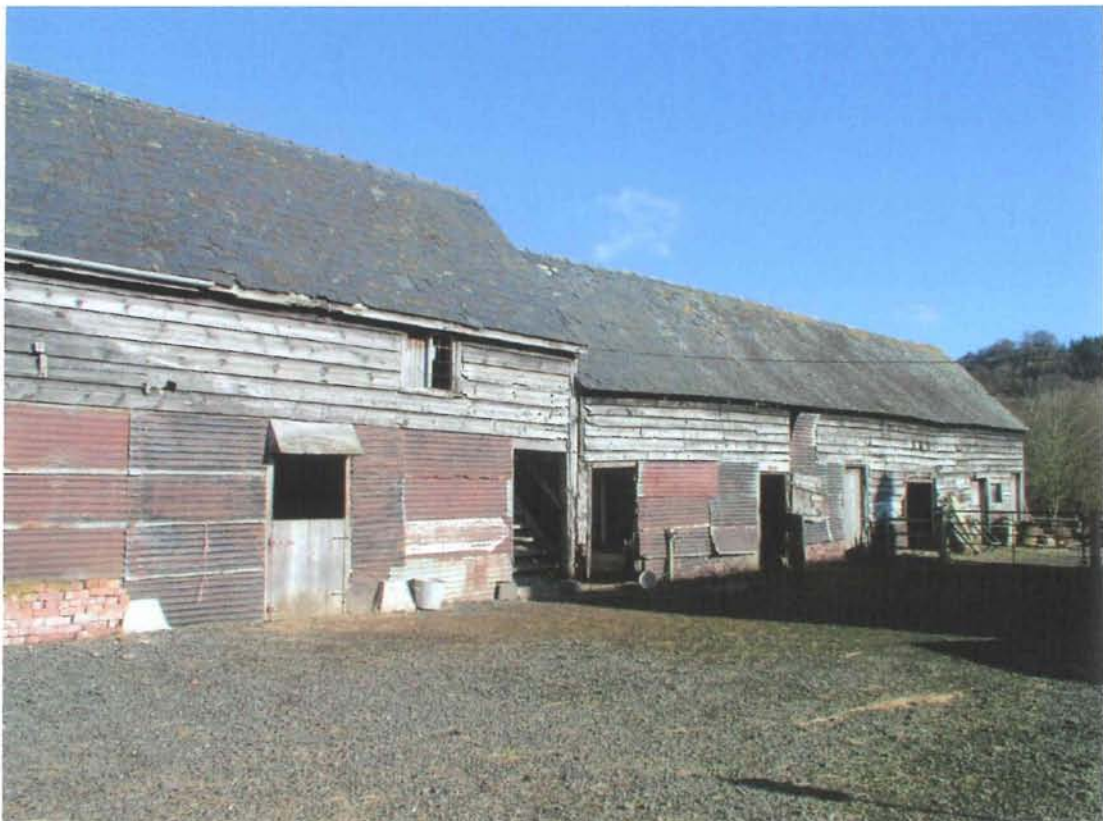
Plate 2 Stable range from the south-west. Photo CPAT 2091-027

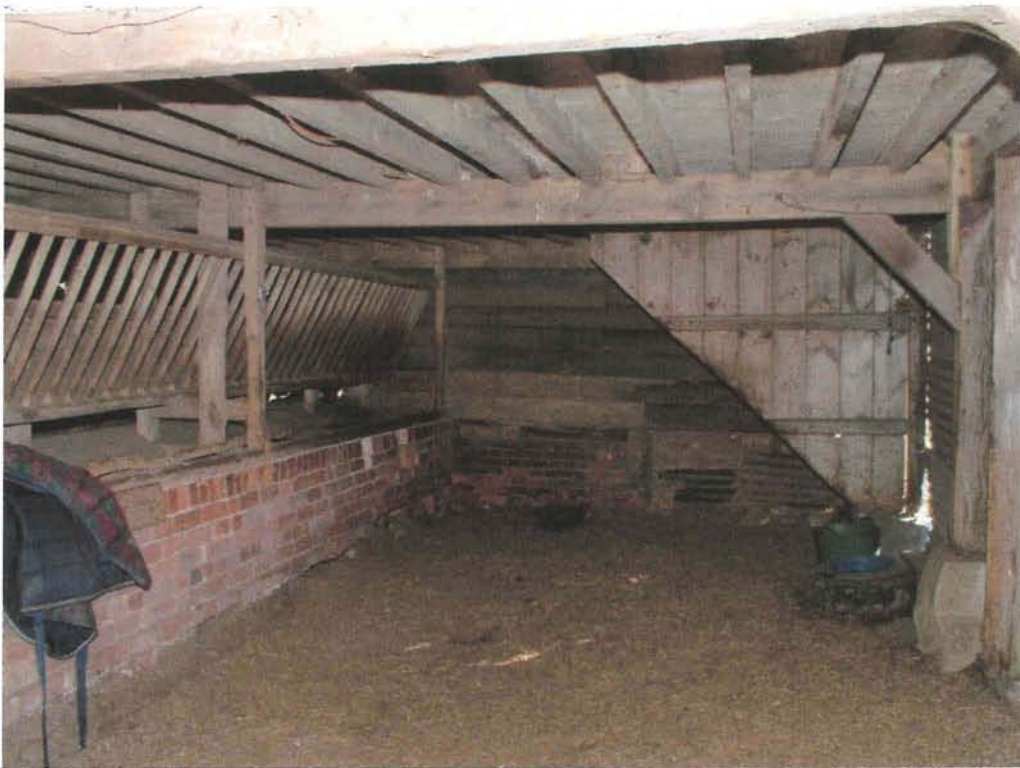
- 4.3 The later stables building is composed of three bays (Bays 1-3) which are open at ground-floor level, although divided longitudinally by a feeding trough of brick construction with a ceramic trough and timber frame surround (Plate 3). There is a single door on either side of Bay 2 giving access to the stables on the south side and a feeding passage along the length of the north wall. The floor level has been reduced to the south of the feeding trough.

Plate 3 Stable building showing feeding trough, lower part of Truss 3 and boarded stairs. Photo CPAT 2091-020

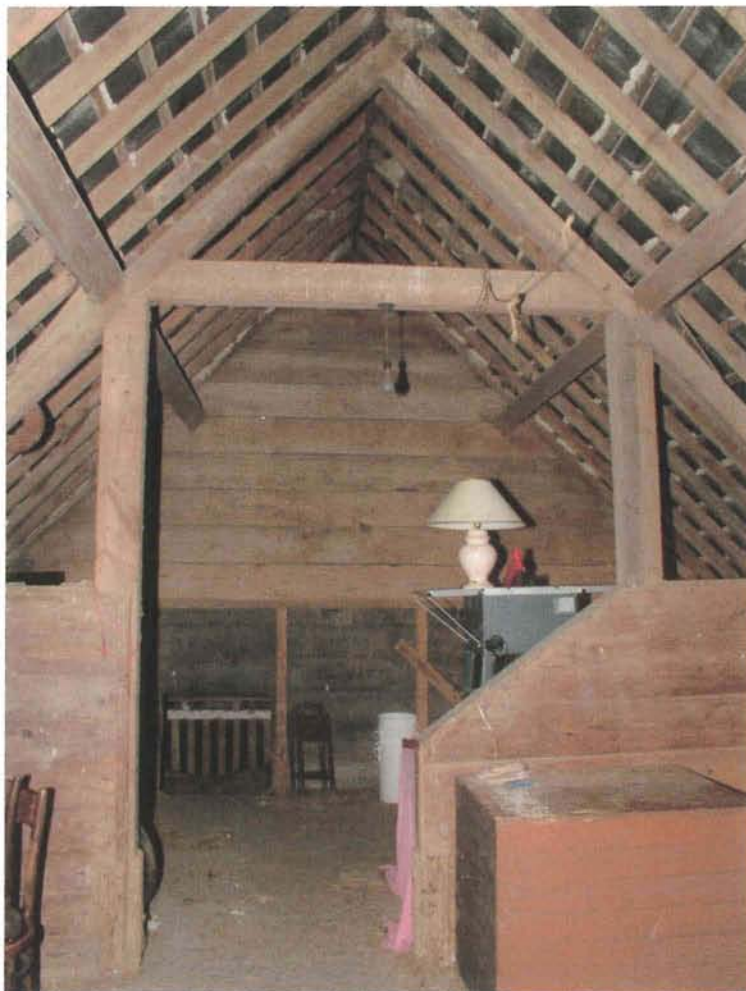
- 4.4 A timber staircase in the south-east corner of Bay 3 gives access to the first floor which is divided into three bays, with timber boarding against either side of the trusses to a height of 1.55m, leaving an access way off-centre to the rear (Plate 4). These were presumably designed to hold animal feed.

Plate 4 First floor of stable building showing Truss 3 and partitions. Photo CPAT 2091-014

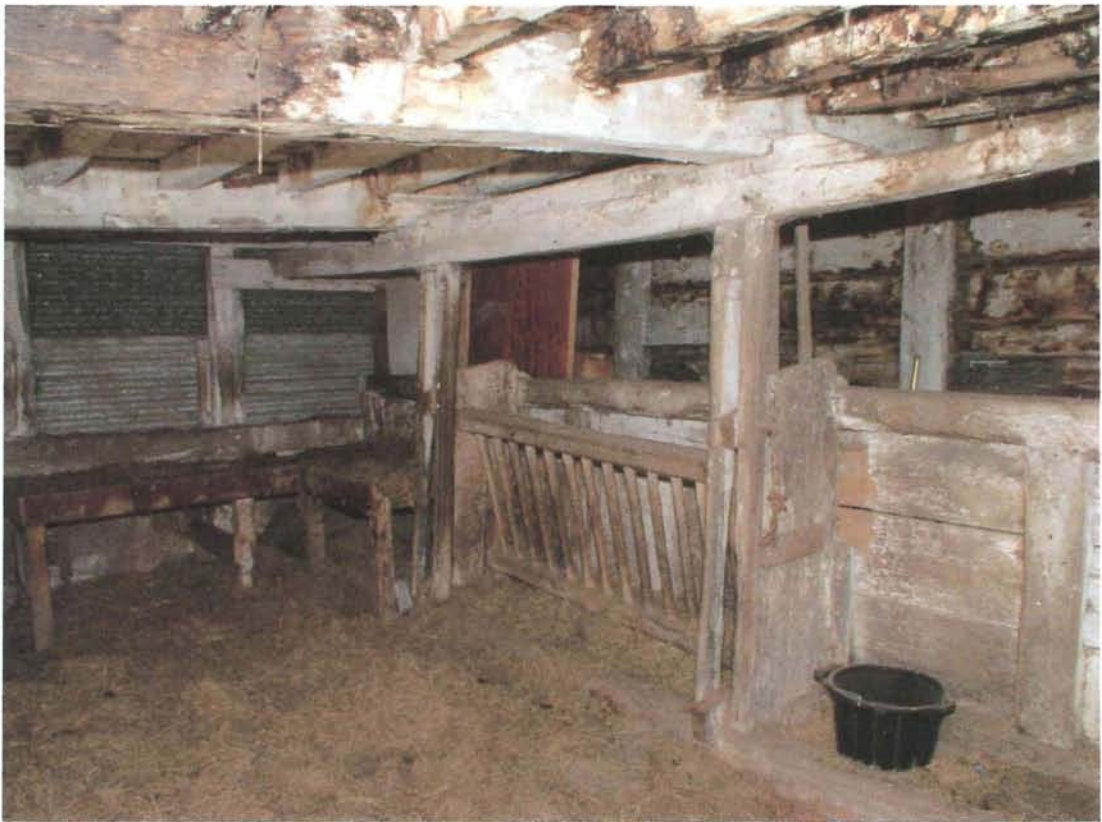
- 4.9 At ground-floor level, Bay 7 is divided into three units. The western end has been joined to Bay 6 and is largely open to the ridge, having been divided from the rest of the bay by a boarded partition formed of reused timbers. To the east of the partition the bay has a first floor (Plate 5) of the same construction as that in Bay 6, presumably taken from the same building. There is a feeder passage and trough along the eastern end of the bay. Interestingly, the first-floor beams were evidently not long enough to extend to the end of the bay and the original jointed ends of the beams are visible above the passage.

Plate 5 Bay 7 showing first-floor beams and joists. Photo CPAT 2091-015

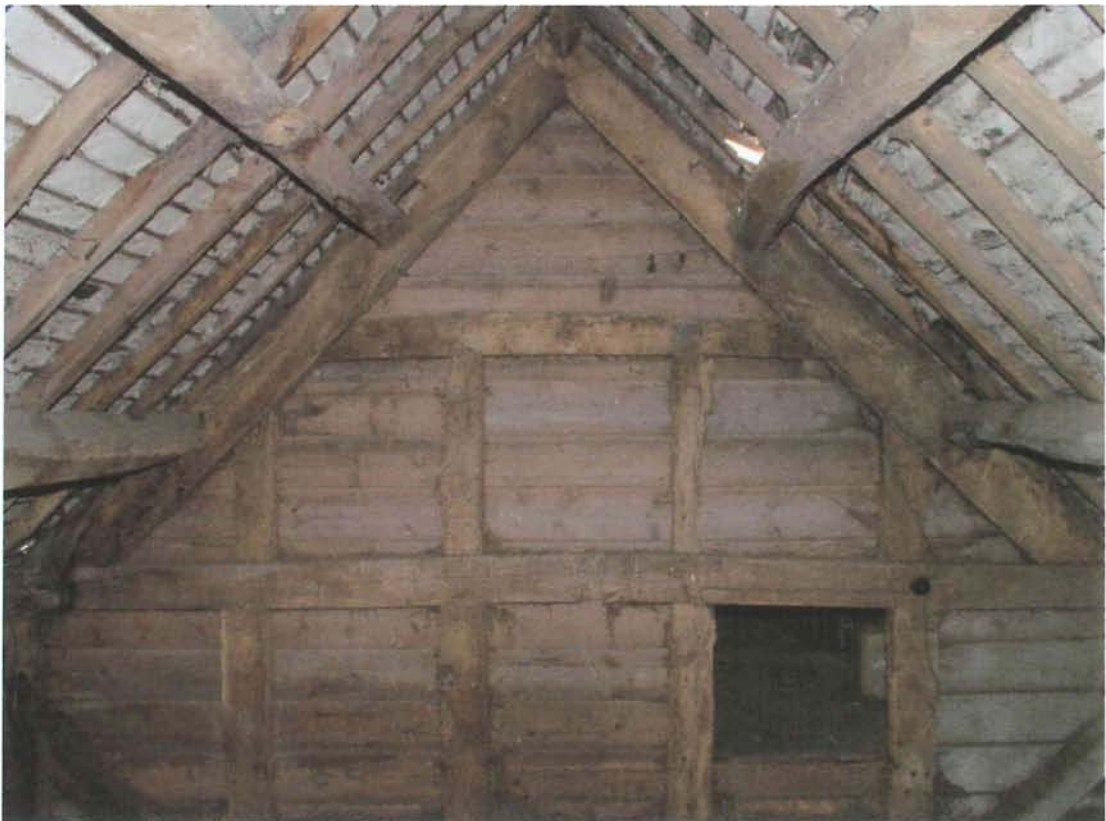
- 4.10 The roof trusses in the earlier barn are all different and include a significant number of reused timbers, suggesting that all may have been derived from another building. Trusses 4 and 8, however, at either end of the building, are very similar and probably originated from the same building. Both are typical of box-frame construction with tie beam and collar, Truss 4 having four posts above and below the collar (Plate 6), while Truss 8 has only two posts below the collar on either side of a window, and two slanted struts above. Both trusses also have pairs of through purlins on either side with wind braces on the lower purlins only. Each bay has paired purlins and a ridge pole, with slates hung on timber laths with iron nails. It is notable that Truss 4 includes the joints for further purlins to the west, indicating that this was not originally an end truss.

Plate 6 Truss 4 from the east. Photo CPAT 2091-012

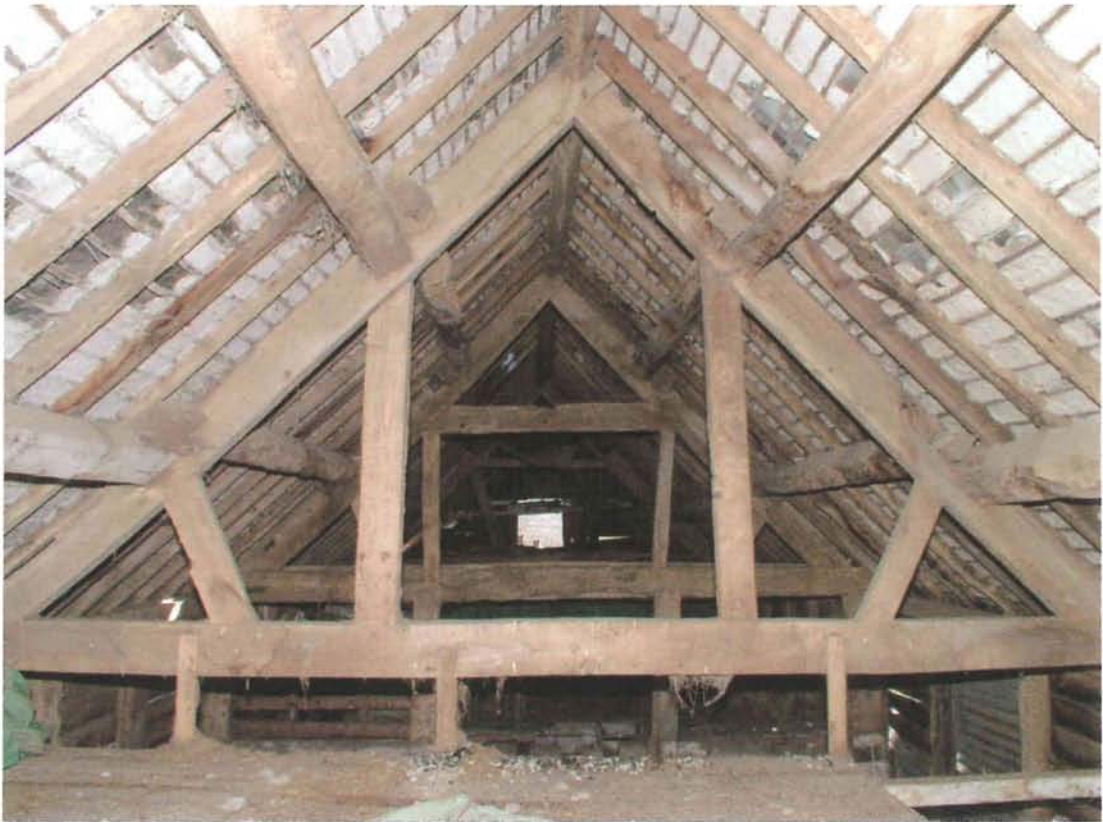
- 4.11 Truss 5 has been considerably altered with the collar missing and two posts inserted, together with two slanting struts (Plate 7). The lower purlins have windbraces on the west side, but not on the east. The lower framing below the tie beam has been removed.

Plate 7 Truss 5 from the west. Photo CPAT 2091-010

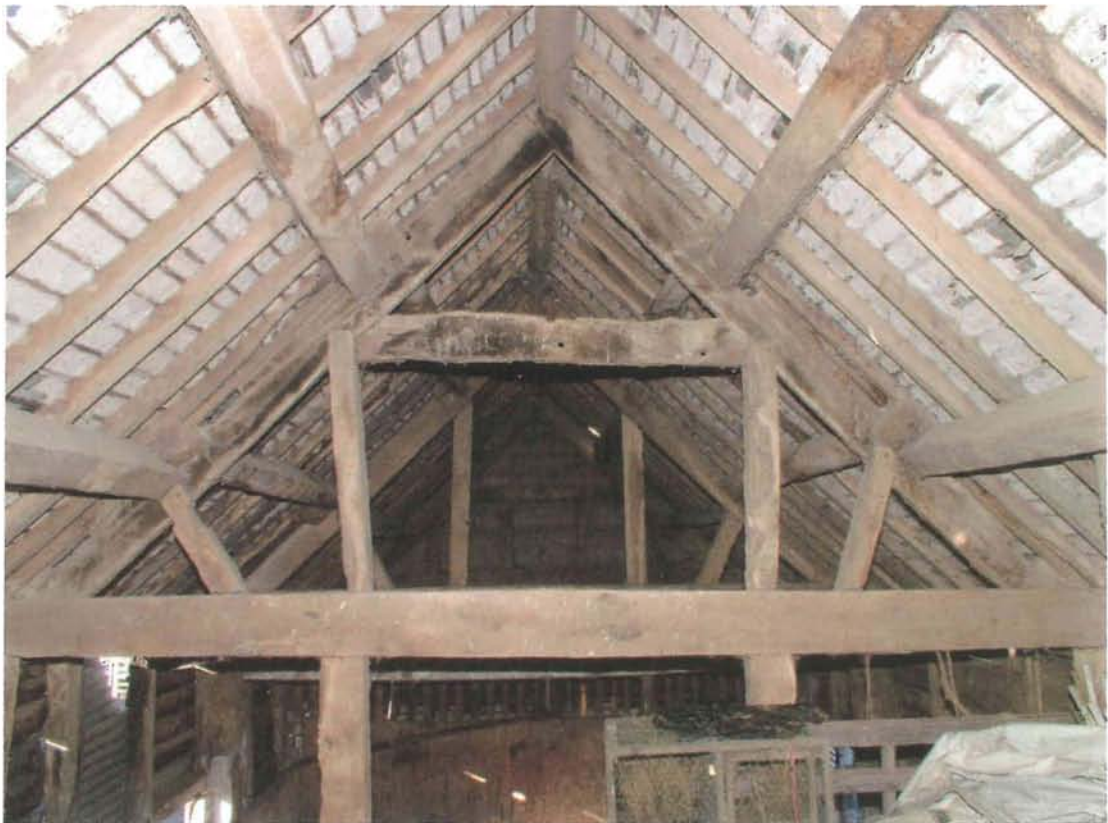
- 4.12 Truss 6 may originally have been similar to Trusses 4 and 8 with the collar surviving but the three posts below it have been removed to be replaced by a pair of rather slight posts and slanting struts (Plate 8). The upper part of the truss is badly weathered and peg holes for wattle and daub infill indicate that this was originally the end truss of another building.

Plate 8 Truss 6 from the east. Photo CPAT 2091-007
