Caersws to Machynlleth Gas Pipeline (Phase 2 Talerddig - Machynlleth)

ARCHAEOLOGICAL ASSESSMENT

R. J. Silvester January 2000

Report for RSK Environment Ltd on behalf of British Gas Transco

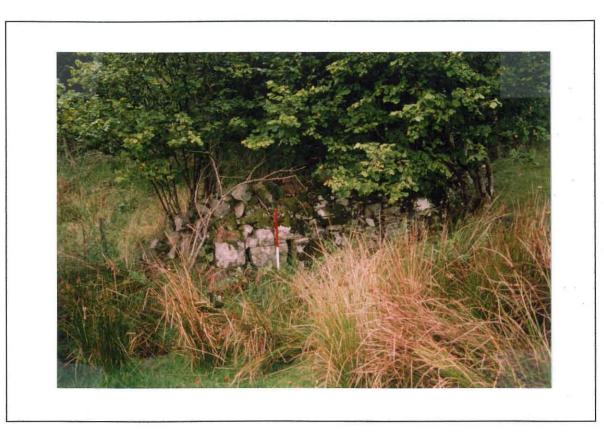
Plate 3: PRN 80275. Stone sluice below Allt Gau

Potentially vulnerable sites include a stone sluice (PRN 80275), a large earthwork (PRN 80292) which because of its size might well be affected by the wayleave, and for similar reasons the less well-defined earthworks north of the Dovey (PRN 80293), two small platforms (PRN 80288 and 80289), the site of a former cottage (PRN 80248) and a quarry (PRN 80290). The integrity of the stone pile (PRN 80284) is uncertain.

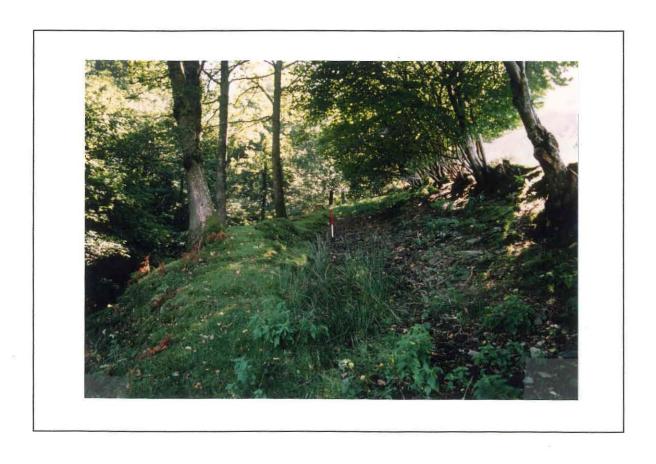
Plate 8: PRN 80281. Leat near Braich Odnant

Sites where a direct impact is predicted include a trackway (PRN 21974), the line of a railway (PRN 80099), leats (PRNs 80281 and 80094), cultivation ridges (PRN 80815) and perhaps two stone walls (PRNs 80816 and 80817). The integrity of the earthwork (PRN 80283) and a quarry (PRN 80098) as archaeological sites with a man-made origin remains uncertain, and nothing appears to survive of the footbridge (PRN 80095) or the small building near Llanwrin (PRN 80257).

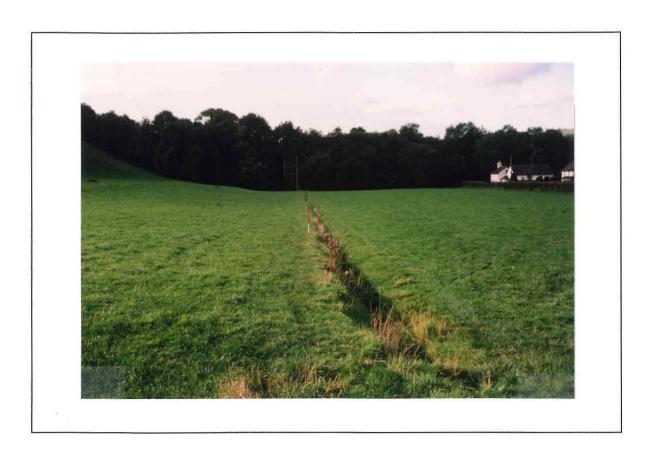
Plate 9: PRN 80094. Mill leat at Dafarn Newydd

- 6.5.3 Watercourses. Most watercourses follow natural courses and are thus outside the remit of this study. The exception are the two leats, one of which (PRN 80094) certainly served a mill in Llanbrynmair, the other (PRN 80281) whose function is less clear-cut. Both would be difficult to avoid without a fundamental replanning of the pipeline route.

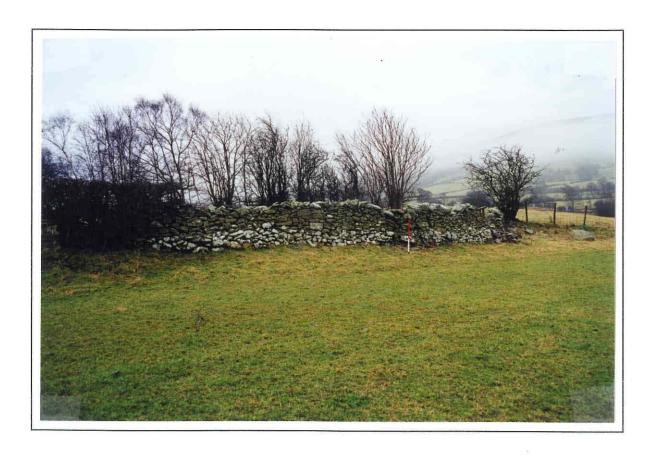
Plate 18: PRN 80816. Stone wall near Talerddig siding

80816 T SN93249934	Falerddig siding enclosure wal	Wall	Post-medieval?	С			
A short stretch of stone wall, drystone with both quarried and waterworn rubble in it; about 20m long and over 1m high. Gives way to a thorn hedge both to S and N. However, the presence of another, longer stretch of wall on the W side of the field (SH 15939946) implies that there may once have been a stone-walled enclosure here though the differential survival is curious.							
80817 F SH92380011	Fron wall	Wall	Post-medieval?	С			
Short stretch of stone wall about 1m high and perhaps 20m long, replaced elsewhere by a fence.							
80818 F SH92460017	Fron clamps	Root store	Post-medieval	С			
Two potato clamps showing as earthworks with linear hollowed centres and banks running down each side. One about 8.5m long, the other about 5.5m long and both 3.5m-4.0m wide. The could be two other examples nearby, both rather more disturbed.

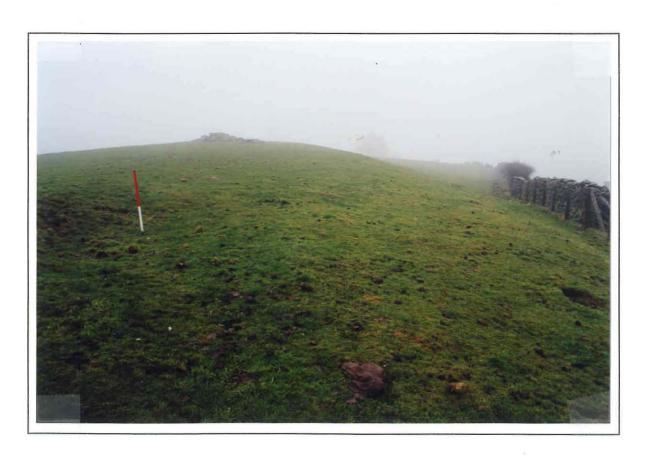
Plate 20: PRNs 80819 and 80817. Platform and stone wall at Fron

80819 F SH92370010	Fron platform	Platform	Unknown	E

A small platform set at the end of a rock outcrop that shows as a rocky spine. The platform is about 4m by 2m internally with a fan at the rear about 0.7m high. Its function is uncertain - it could be a quarry scoop though it does look rather regular.
