*Ruabon Business Park
near Wrexham*

ARCHAEOLOGICAL and HISTORICAL ASSESSEMENT

CPAT Report No 783

R J Silvester
March 2006

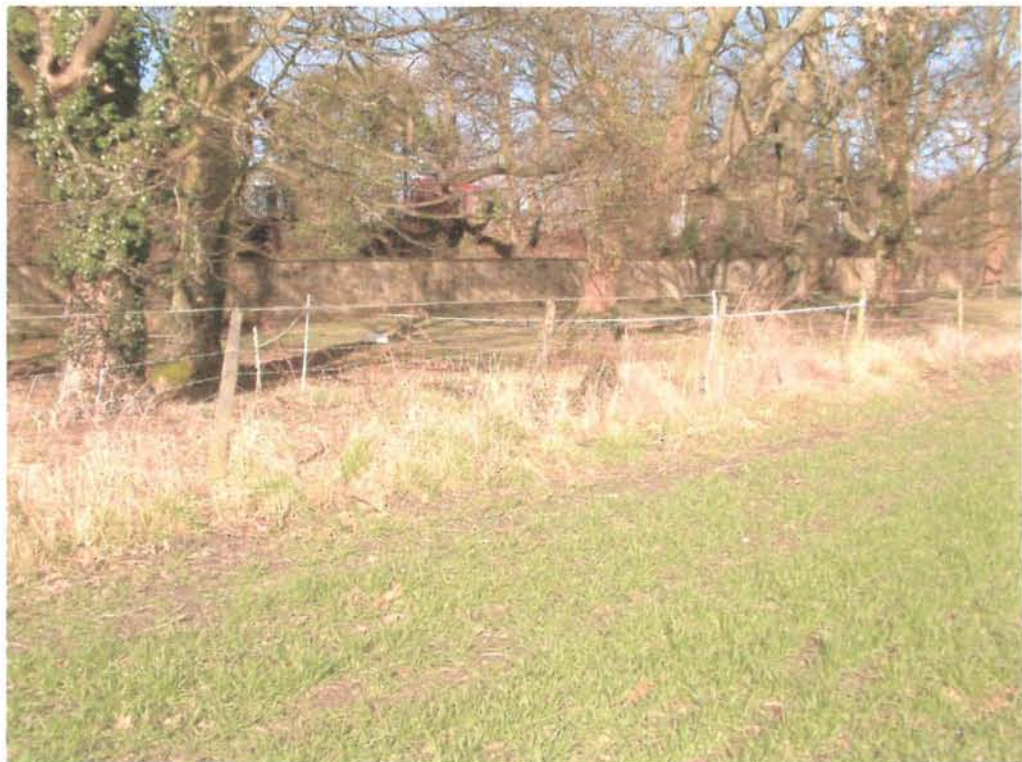
Plate 1. The park wall

For a distance of less than 200m on the west side, to the north of Green Lodge, the development area runs up to the park wall and incorporates the shelter belt that has been set within it. A very low bank, possible the original shelter belt boundary lies about 5m inside the modern fence. The wall itself is of rubble stone and is in generally good condition.

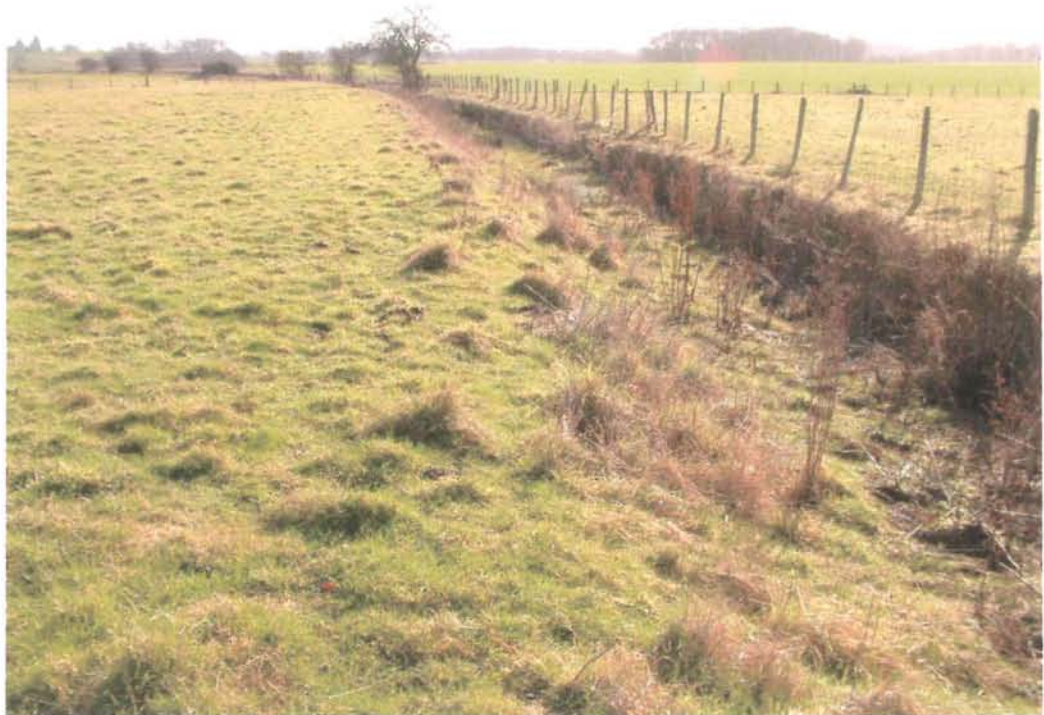
Plate 2. The ha ha or enclosure boundary on the southern side of the development area

The boundary on the southern and eastern portions of the development area consists of an inner ditch, sporadically wet, about 1m deep and 3-4m wide with a substantial rubblestone wall revetting its lower, outer side. This stands to a height of 1m-1.5m and is more pronounced in the eastern sector. It has been breached in several places, but the causeway across it on the south at SJ 29734298, may be original for the alignment of the ha ha here is offset and the causeway is itself revetted. Another stone sluice, still functioning, runs through the ha ha at SJ 2955 4301.

4.1.4 The ha ha. Condition 13 on the planning approval requires a 10m exclusion zone to be fenced off from the inner, northern edge of the ha ha. A plan showing its position to be submitted to the local planning authority by the developers' consultants. Fencing (in

accord with the aforementioned plan and in advance of any works on site) to be supervised by an approved archaeologist.

- 4.2.1 The *ha ha* has several thorn trees growing out of it, the roots of which are causing gradual damage to the stone wall. It is recommended that these trees, though not the other deciduous species that have occasionally colonised the bank, be removed to preserve the feature. No new trees should be planted on its edge.
- 4.2.2 *Wall and shelter belt* inside it. These features should be preserved, and a policy drawn up to replant deciduous species as necessary.
- 4.2.3 *The pond*. This should be preserved. Its southern sluice might be cleaned out and tidied.

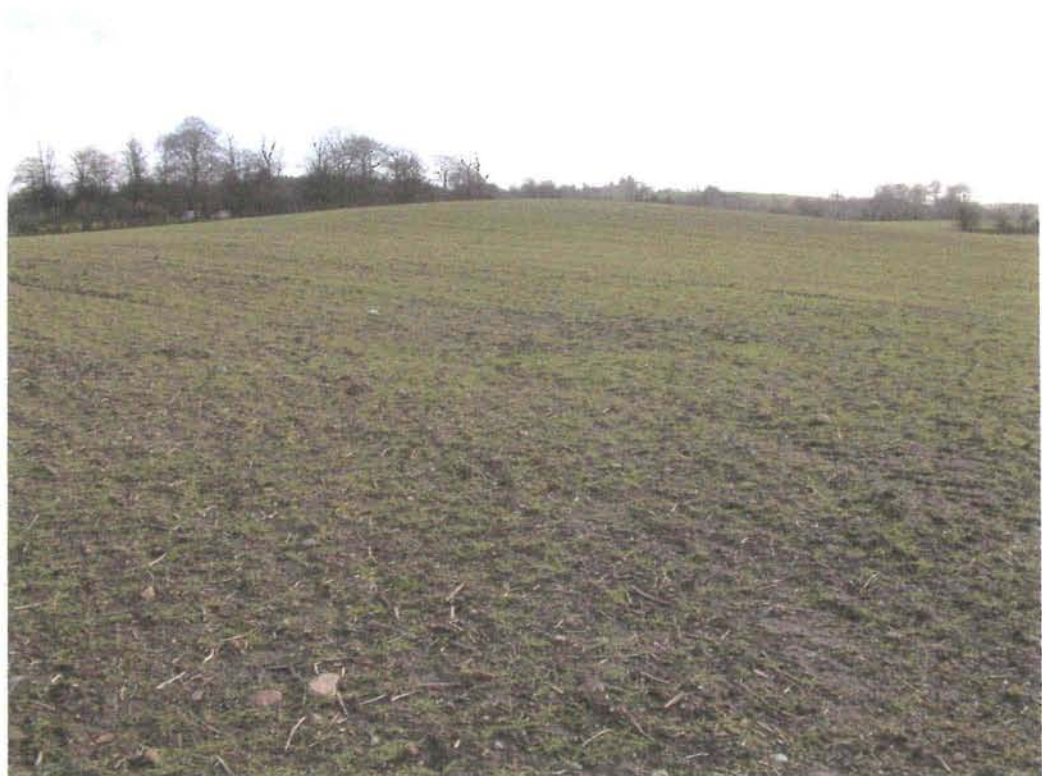
Plate 3. The knoll on the east side of the pond.

Immediately to the east of the pond at NGR SJ29874331 is a gravelly knoll. This is a distinctive feature, visible as a low eminence from all directions. At 64m ENE/SWS by 58m NNW/SSE it is probably too large to be a Bronze Age barrow, and a through examination of all available aerial photographs has not provided any convincing support for such an interpretation. However, a smaller barrow lies just over one kilometre to the south, and the possibility that such a distinctive natural knoll was used for burial purposes in the prehistoric period should be considered.

- 4.1.7 The knoll. It is suggested that a watching brief be maintained on all groundworks that take place on and immediately around the knoll. In the event that prehistoric burial deposits are identified, full excavation could be required.

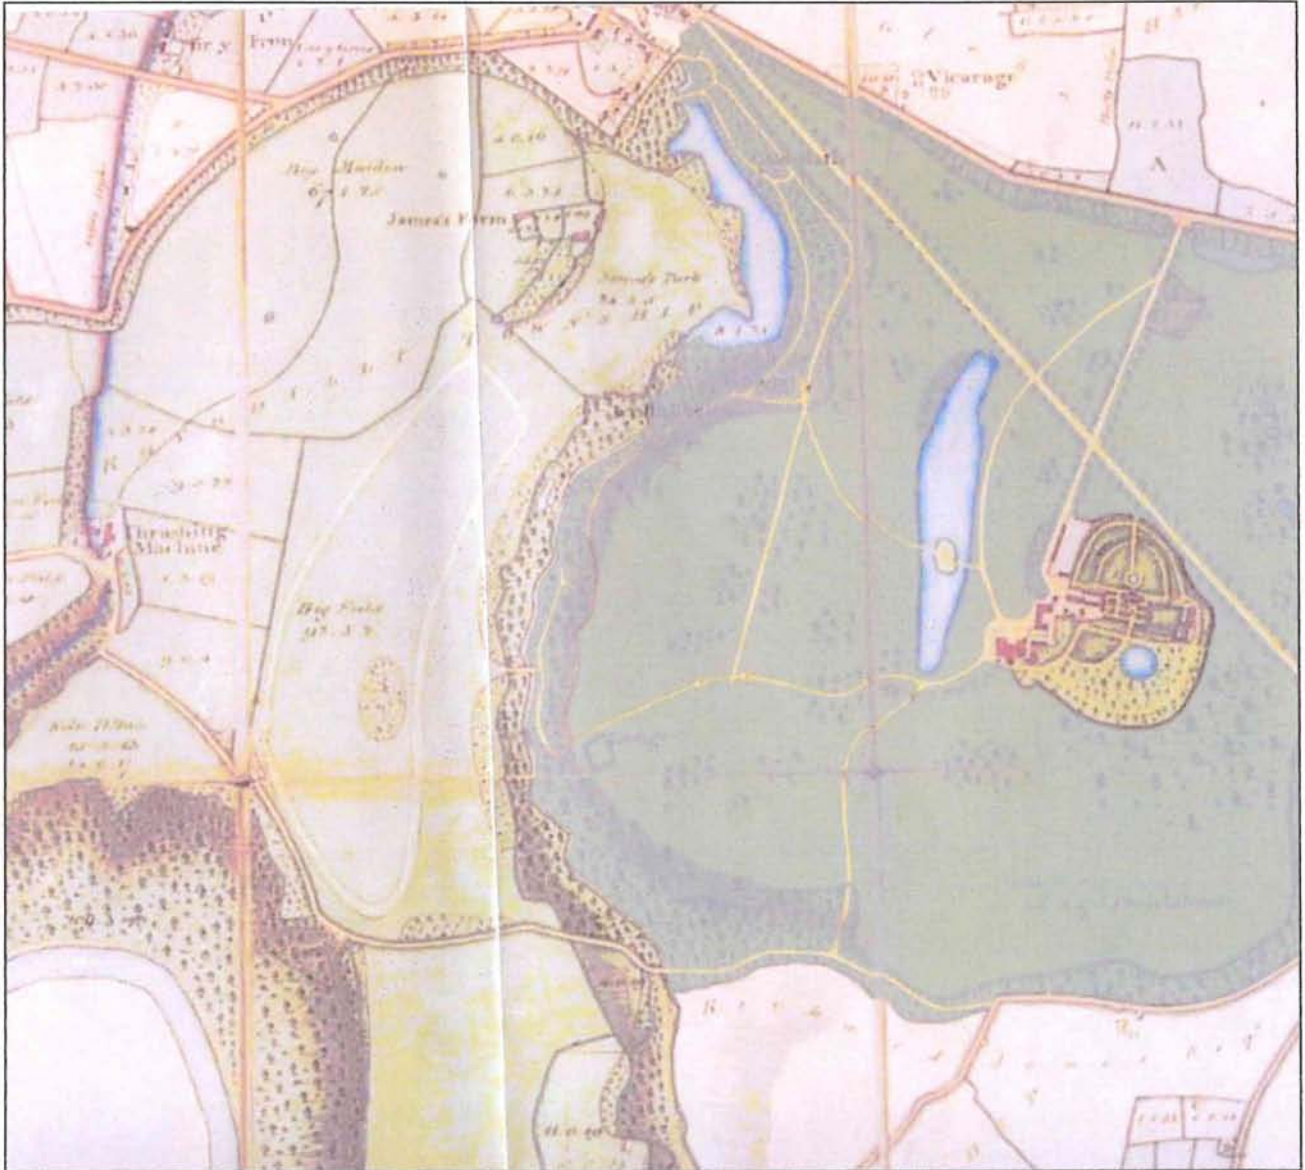
- 2.8 The next plan of the Wynnstay Estate, undated, but attributed to the early 19th century perhaps between 1800 and 1820, reveals a very different picture (Fig 4).⁴ It is evident that by the early 19th century, the landscape to the west of the park had been re-drawn. The field boundaries between the River Dee and the Afon Eitha valley were removed and replaced with new ones that were laid out to a more regular and rectilinear pattern. The old road running south was closed completely and does not appear on any later map though curiously, its line is almost precisely that of the new bypass.

Fig. 4 The Wynnstay Estate in the early 19th century. Reproduced by permission of Sir Watkin Williams Wynn.

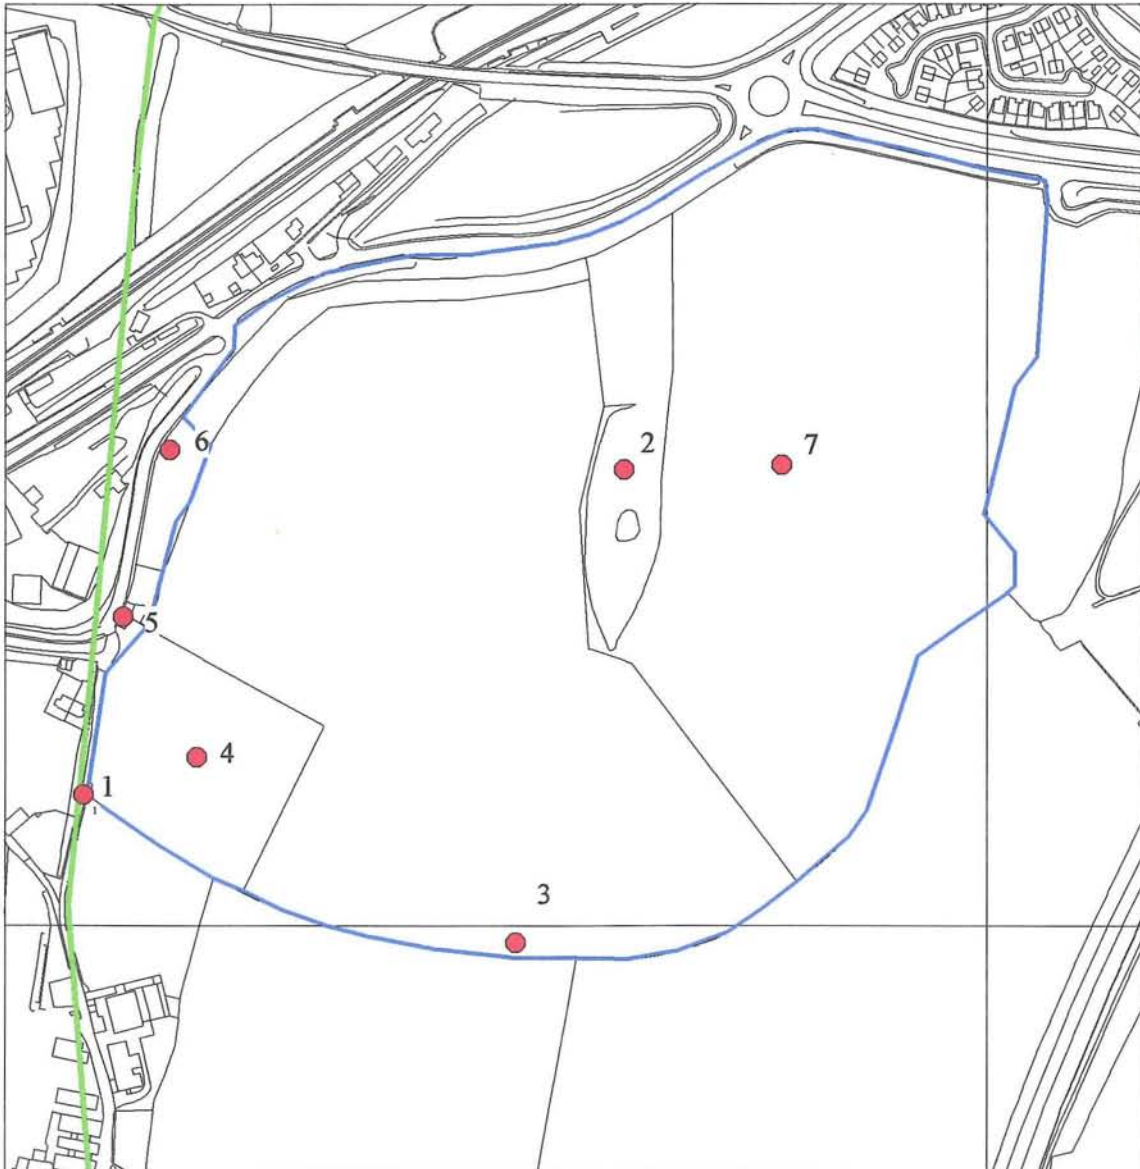
- 3.1 The features described below are those that are or were formerly visible within, or on the edge of, the development area. They are ordered in a simple sequential number system for ease of use, and are indicated on Fig. 6. Some of these may already have been given numbers for other purposes, within the list of Scheduled Ancient Monuments maintained by Cadw, or in the Historic Environment Record maintained by the Clwyd-Powys Archaeological Trust, but these numbers will not be referred to in this text unless it appears useful.

Fig. 6 The features of archaeological and historical interest within the development area. Scale 1:5,000
Ordnance Survey data provided by Wynnstay Estate, licence number 0000000
