Old School, Llanarmon-yn-Ial

ARCHAEOLOGICAL EVALUATION

I Grant
April 2010

Report for Revd Huw Butler

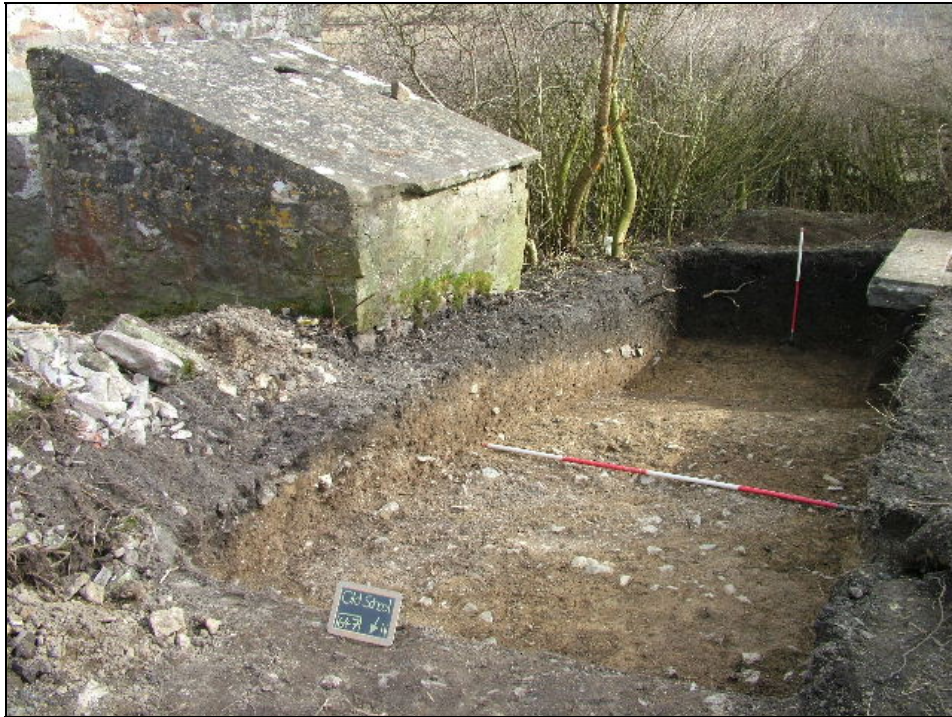
Plate 2. Location of the trench west of the outbuilding.

The trench, sloping north to south, ends 6m short of the earlier churchyard wall.

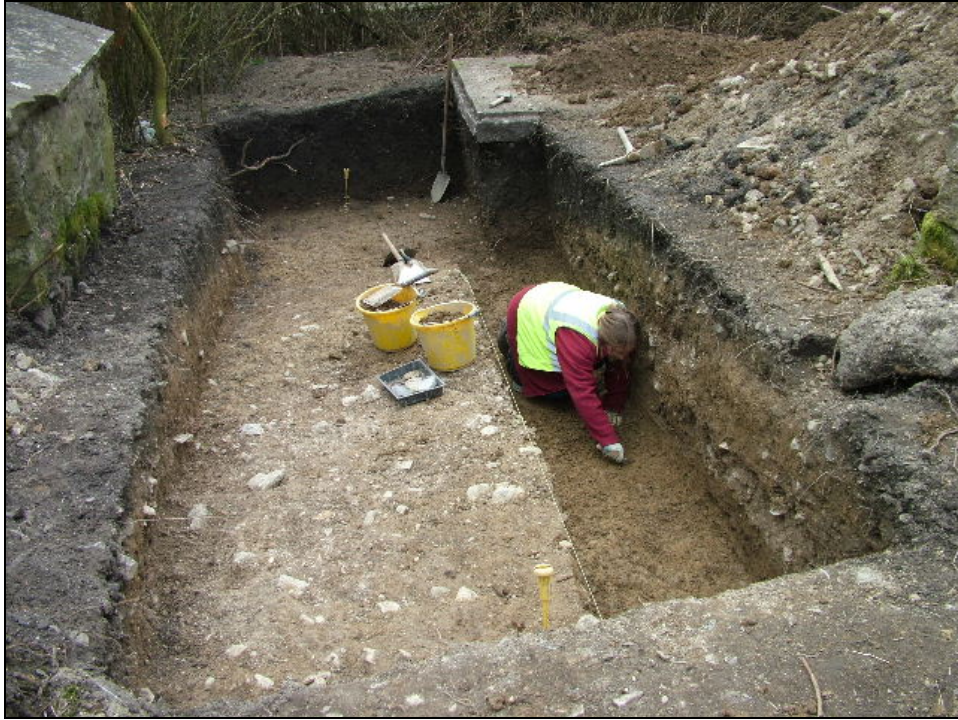
Plate 3. Excavation of the sondage along the western side of the trench.
Photo CPAT 3058-0008

wide along the western edge of the trench. The test trench was excavated down to the undisturbed natural subsoil (12), effectively removing a further 0.8m in depth of material that consisted of numerous layers of re-deposited clay and building debris (2,3,4,5,6 & 7) overlying earlier in-situ cemetery deposits (8 and 9) (see Plates 3 and 4).

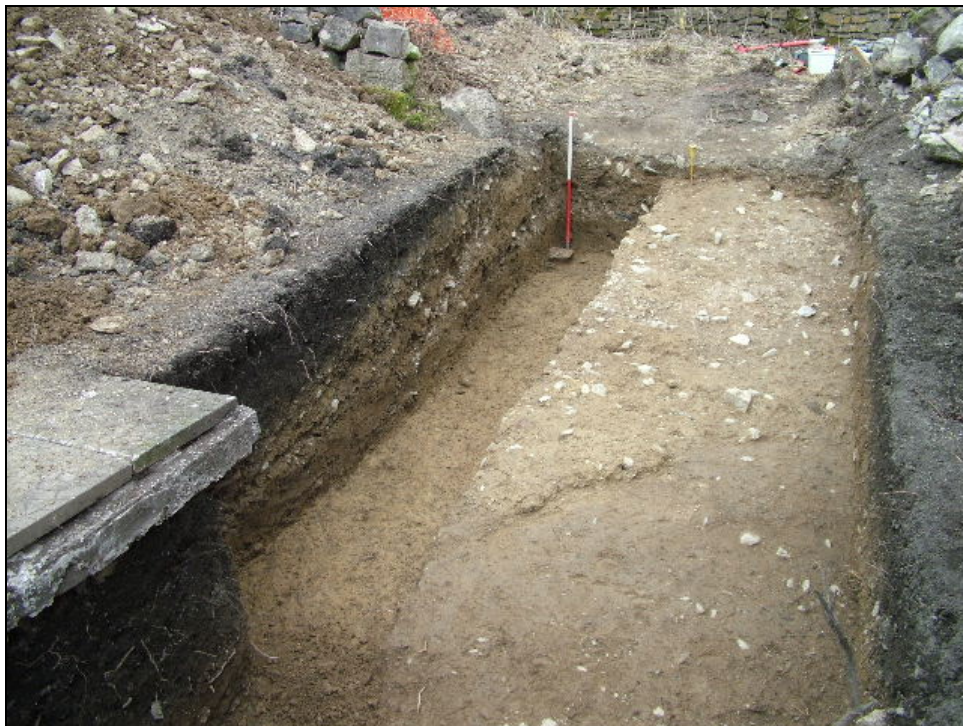
Plate 4. Completed sondage, illustrating original ground surface.
The extensive tip-lines of re-deposited material can be clearly seen in the east facing section.
Photo CPAT 3058-0022

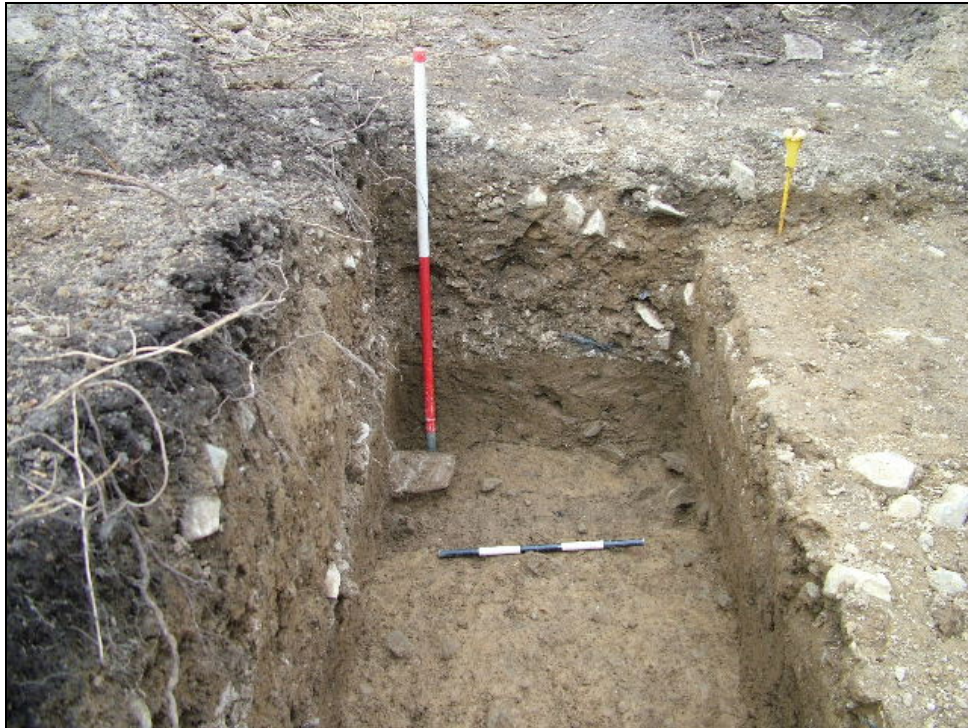
Plate 5. Narrow gully (11), located at the north-west end of the trench.
The overlying undisturbed cultivation/cemetery soil can be seen in section.
Photo CPAT 3058-0019

- 3.6 At the northern end of the trench was a narrow gully (11) orientated east to west and cut into the natural subsoil (12) (see Plate 5). At its western end the gully appeared irregular in shape, the width widening from 0.21m to 0.46m, suggesting possible disturbance from animal burrowing. The gully, containing a single fill (10) of light grey silty clay, was the only cut feature recorded within the limits of excavation. Although it remains undated, it is possible to say that it pre-dated the overlying 18th-century deposit (8). Contemporary with the gully was an adjacent deposit (9) of light grey-brown, silty clay, 0.06m thick. The deposit, which extended southwards and beyond the limit of excavation, appeared as a coarsely metallated surface of small rounded pebbles with occasional flecks of charcoal. This would appear to be the earliest surviving 'artificial' ground-surface and the only possible deposit of medieval origin. Both the gully (11) and the deposit (9), were sealed by a uniform deposit (8) of mid-yellowish brown silty clay, 0.32m thick. The deposit, which contained charcoal throughout, was well graded with little in the way of stone inclusions and was comparable with garden cultivation deposits that might be found in a village or other settlement. No human remains were recovered from the deposit which is unusual considering its location within the churchyard and this suggests that burial practice in this general area had ceased by the time this soil was deposited, or perhaps that this peripheral area had never actually been used for burial. Fragments of clay-pipe stems and sherds of Buckley/Staffordshire-type, brown-glazed pottery, recovered from the material suggest the deposit can be dated to the late 18th and early 19th centuries.
