The Haim, near Llandrinio, Powys

ARCHAEOLOGICAL WATCHING BRIEF

Report for The Environment Agency

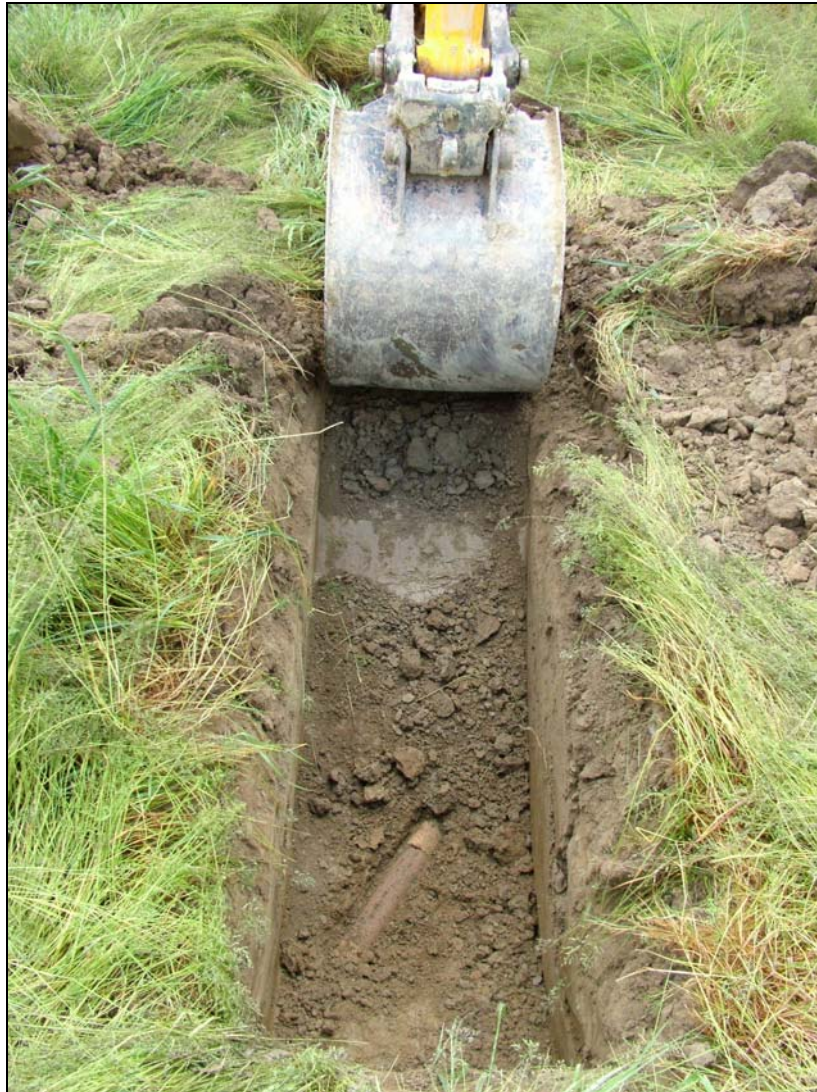
- 4.2 While the pits were being excavated a careful watch was kept on the deposits to determine whether any archaeological material was revealed. The only evidence of activity related to previous drainage works and comprised two lines of land drain. That in the test pit at SJ 32524 16148 was not examined as the excavation was moved to avoid disrupting its function, and only a line of gravel fill was observed at 0.5m below the ground surface. At SJ 32711 16070, however, the drain itself was observed at a depth of 0.9m, having a north-north-east/south-south-west alignment and comprising sectional ceramic pipes measuring 0.3m long and 0.08m in diameter. It is likely to be of 19th or early 20th-century origin.

Plate 1 Sectional ceramic drainage pipes in the test pit at SJ 3271116070
