**CPAT Report No 1044**

# Chirk Castle Home Farm

**ARCHAEOLOGICAL EVALUATION**

Report for National Trust

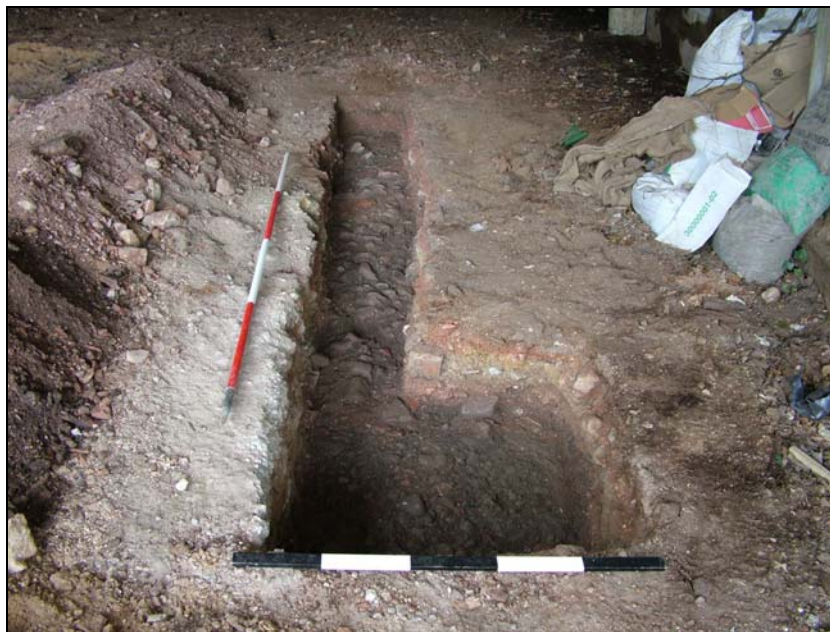
- 3.2 Trench 1 revealed a number of floor layers which predated the existing modern detritus surface (01) in the interior of the barn, the most recent comprising a deposit of concrete rubble (02) up to 0.05m thick, which overlay a layer of orangey-brown silt containing wood fragments (03), up to 0.1m in overall thickness. Earlier floor levels in Trench 1 were represented by two distinct reddish layers of compacted silts, clays and shale (04 and 06), both of which sloped down from the east-south-east to the west-north-west, such that 04 was the uppermost layer at the east-south-east end of the trench, dropping to 0.1m below the surface at the opposite end. Floor 06 had a similar fall, descending from 0.1m below the surface to 0.25m below it at the west-north-west end of the trench. Both floors were of relatively modern date, certainly no earlier than the late 19<sup>th</sup> century. The excavation was halted at the upper surface of an uneven layer of rough cobbling (07), formed from pebble-sized stones and brick fragments, which increased in depth from 0.16m at the east-south-east end of the trench to a maximum of 0.32m at the opposite end.

Plate 1: Trench 1 after excavation, showing the roughly cobbled floor (CPAT 3083-0014)

- 4.1 The west-north-west part of the barn contained at least three former floor levels, all of which had a marked slope down from the east-south-east. The earliest floor (07) comprised a roughly cobbled surface with a similar slope, and was perhaps a former outdoor yard. The floor was revealed in both Trenches 1 and 2, its depth below the modern ground surface increasing from 0.16m at the east-south-east end of Trench 1 to 0.32m at the west-north-west end. The slope of these layers may be a result of the influence of underlying elements of Offa's Dyke, in particular the slope down from the bank into the ditch of this early medieval earthwork.

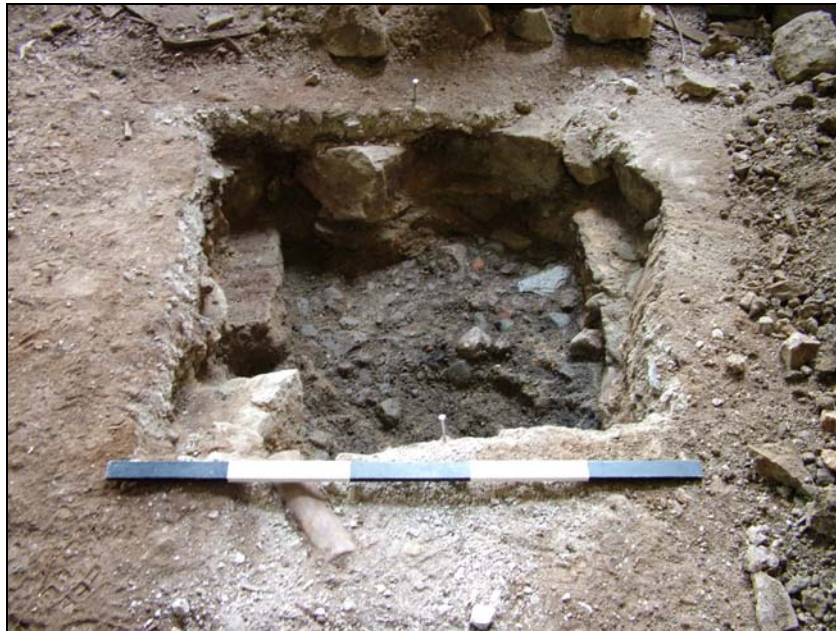
- 3.3 Trench 2 had the same sequence of upper layers (01 to 03) as Trench 1, these sealing a layer of large stones and late 19<sup>th</sup>-century bricks (08), up to 0.15m in overall thickness. A concrete slab (09), 0.08m thick, was found below layer 08 and this sealed the same roughly cobbled floor surface (07) found in Trench 1, at a depth of 0.35m below the existing barn floor.

Plate 2: Trench 2 after excavation, showing the roughly cobbled floor (CPAT 3083-0022)

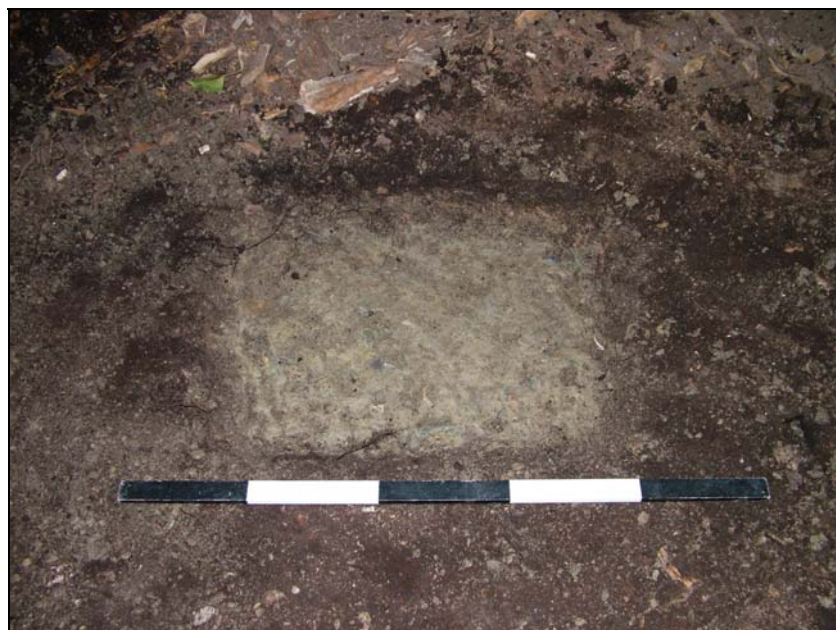
- 3.4 Trench 3 comprised a small sondage, measuring 0.8m by 0.6m, in the east-south-east part of the barn interior. Removal of the modern detritus (10), 0.04m thick, and a layer of stone hardcore (11), 0.1m thick and with a maximum particle size of 0.05m, revealed a layer of yellow-grey clay (12). This was not examined any further as it lay on the line of the bank of Offa's Dyke. It may well represent an undisturbed bank remnant, probably truncated when the barn was built, although this cannot be proved conclusively from the very small amount exposed.

Plate 3: Trench 3 after excavation, showing the clay deposit which may represent the remains of Offa's Dyke (CPAT 3083-0021)

- 4.2 The layers did not continue as far as Trench 3 in the east-south-east part of the barn interior, where it seemed possible that the clay layer (12) found beneath modern rubble and detritus may represent surviving evidence of the bank of Offa's Dyke, at a depth of less than 0.15m below the surface.
