**CPAT Report No 1053**

# **Dyffryd, Maesbrook, Shropshire**

**WATCHING BRIEF**

Report for Environment Agency

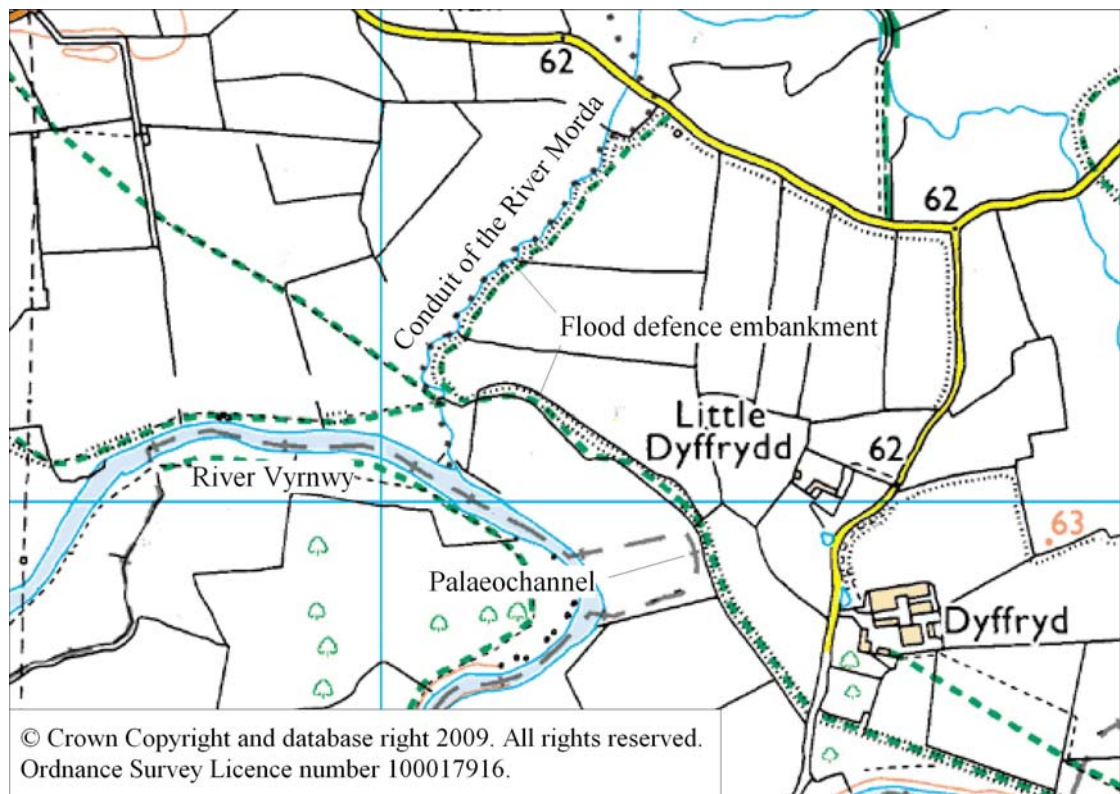
- 3.1 The flood defences at the time of the watching brief comprised a low meandering embankment running along the east side of the River Morda conduit, then turning east (and later south-east) to mirror the overall alignment of the River Vyrnwy. The location of the palaeochannel is readily seen on Fig 1, as it is followed by the line of the boundary between England and Wales, which loops away from the north-east side of the Vyrnwy after following the centre of the existing river course, and then shortly returns to it.

Fig. 1 Overall site location

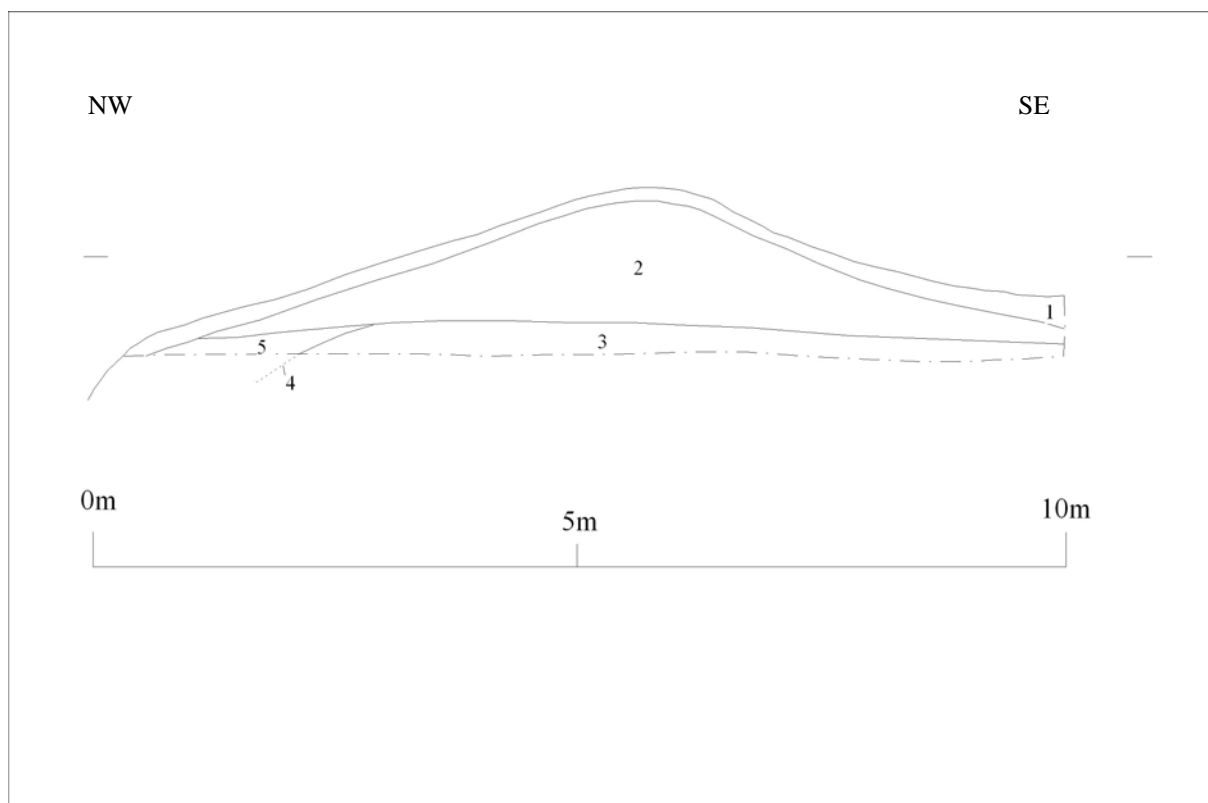
- 4.2 A section was cut across the embankment at NGR SJ 29168 20309 (See Fig. 2 and Plate 1, below) to provide a view of its internal structure, but this proved to be relatively uninformative, the bank makeup beneath the mid grey-brown silty topsoil (1) being a single deposit of brown and grey clayey silt (2) containing no datable material and resting on natural yellowish-brown clayey silt (3). The overall width of the bank was approximately 9.0m, and its crest was 1.4m above the old ground surface on which it was built. On its north-west side, the edge of the bank overlay what appeared to be a small section of an infilled former course (4) of the River Morda, although only about 2m of this was visible before the present course of the river conduit was encountered.

Fig. 2 Section of the former flood defence bank at SJ 29168 20309

- 5.1 The watching brief successfully recorded evidence for the construction of the flood defence bank at Dyffryd, a feature which is likely to have been built soon after the passing of the enclosure act for Llandrinio and Llandysilio parishes, in 1799. A representative section was drawn of the bank, prior to its removal and replacement with a new bank on a straighter alignment.

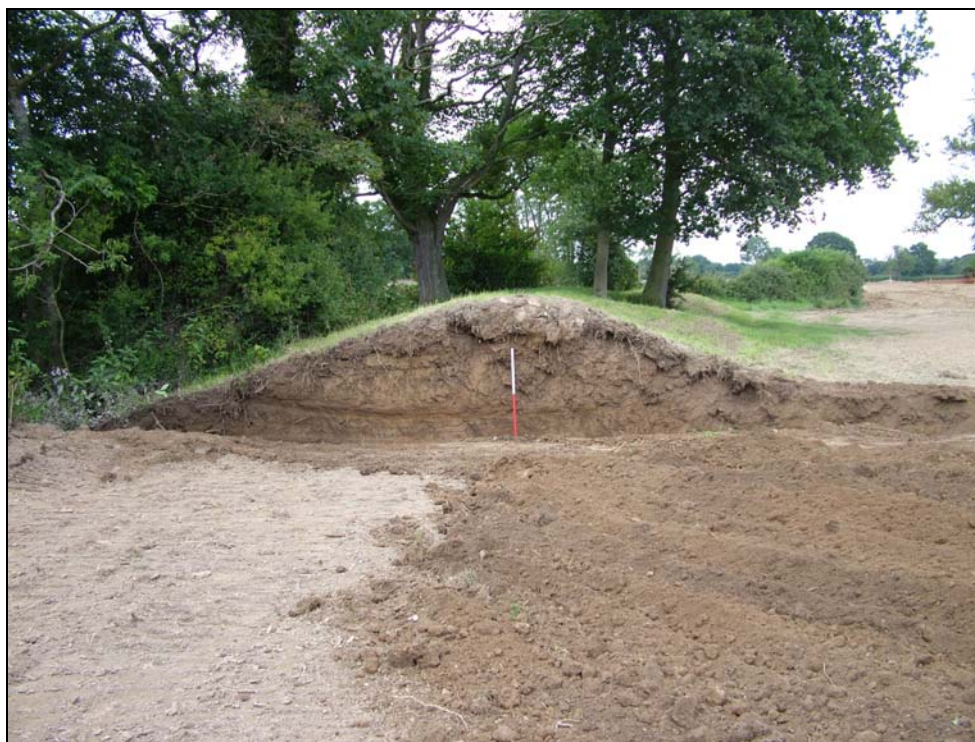
Plate 1 Section across the flood defence bank at SJ 29168 20309, from SW (Photo CPAT 3144-0004)
