**CPAT Report No 1039**

# Meifod Flood Risk Management Appraisal

**ARCHAEOLOGICAL WATCHING BRIEF**

Report for Environment Agency

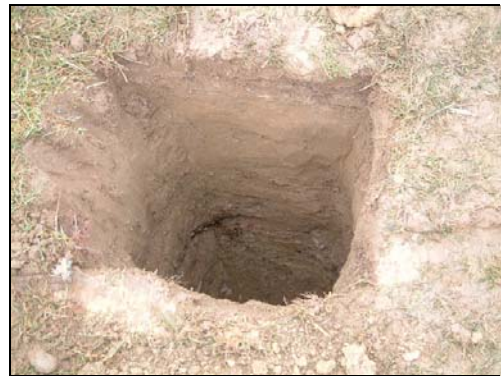
Plate 1 Window Sample 5

- 3.2 This was located along the existing floodbank to the east of Broniarth Bridge and comprised a hand-excavated test pit, measuring 0.35 x 0.3m, which extended to a depth of 1.2m, below which the investigations were conducted by core sampling.

- 3.3 The results revealed two phases of bank construction, the earliest of which consisted of a 0.6m-thick deposit of firm, yellow silty clay with occasional stones and grit, the base of which lay around 1.5m below the surface of the present floodbank. This was sealed beneath a 0.55m-thick deposit of firm, pinkish clay containing fragments of limestone and an upper layer of stoney clay around 0.25m thick, indicating a second phase of construction, raising the level of the embankment. The uppermost layers within the sample consisted of 0.25m of firm, silty clay and a thin layer of turf/topsoil.

- 4.4 The analysis of historic cartography has already demonstrated that the modern flood bank follows the line of an earlier feature for around 360m on the southern side of the village. This was reaffirmed by the watching brief during the excavation of window sample 5, which revealed two phases of construction. Further to the west, window samples 7 and 8 demonstrate a single build for the embankment.

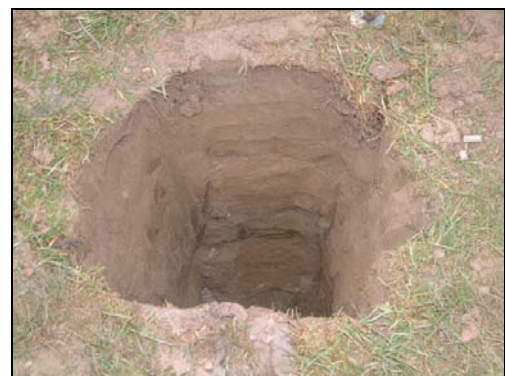
Plate 2 Window Sample 6

- 3.4 This was also located along the existing floodbank to the east of Broniarth Bridge and comprised a hand-excavated test pit, measuring 0.3 x 0.3m, which extended to a depth of 1.2m, below which the investigations were conducted by core sampling.

- 3.5 Unlike WS 5, there was no evidence for an earlier phase of embankment, with the floodbank having been constructed from a single deposit of silty clay and gravel extending beneath the topsoil to a depth of around 1.8m.

- 5.2 Rather unexpectedly the results from WS6, to the east of Broniarth Bridge, indicated a single construction phase, whereas WS7, further to the west, suggested two phases. This is surprising as by comparing the Ordnance Survey mapping of 1886 with modern mapping it is clear that the present floodbank follows the course of the earlier embankment in the area of WS6, but shows no earlier feature at the location of WS7.

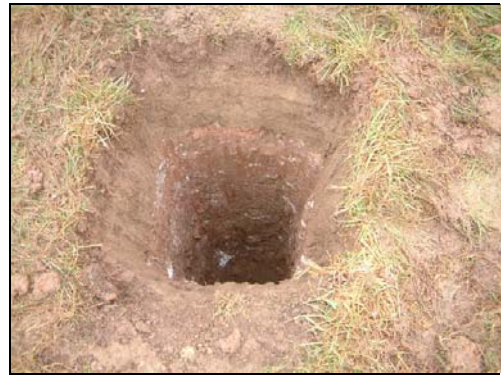
Plate 3 Window sample 7

- 3.6 Located along the existing floodbank to the west of Broniarth Bridge, this comprised a hand-excavated test pit, measuring 0.3 x 0.3m, which extended to a depth of 1.2m, below which the investigations were conducted by core sampling.
- 3.7 Again, two phases of construction appear to be evident, the earlier of which was composed of a deposit of red-brown silty clay around 0.3m thick, sealed beneath a layer of gravelly clay up to 0.2m thick. The second phase comprised a single 1.3m-thick deposit of red brown silty clay containing fragments of limestone.
