CPAT Report No 1019

Underground Cabling adjacent to Brecon Town Wall

ARCHAEOLOGICAL WATCHING BRIEF

Report for Western Power Distribution

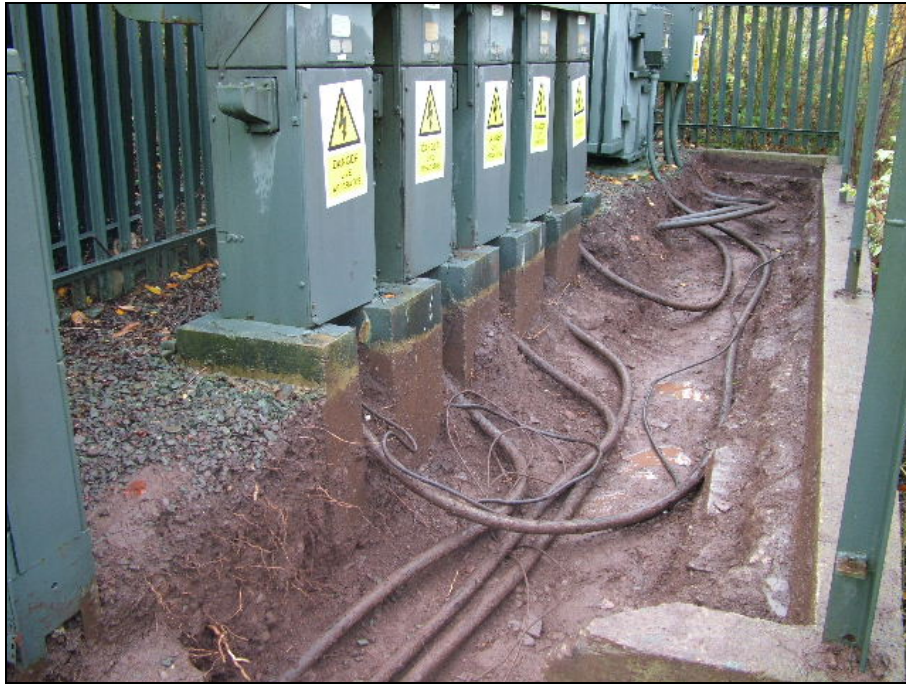
Plate 1. Excavation within sub-station compound. Photo CPAT 2980-004

- 4.1 The watching brief was conducted between the 2nd and 3rd November 2009. A written, drawn and photographic record was maintained, a summary of which is provided in Appendix 1. The archive has subsequently been deposited with the regional Historic Environment Record.
- 4.2 Initial work began within the unscheduled area that comprised the compound of the existing sub-station. A trench 10m x 1.5m (orientated north-west to south-east) was machine excavated using a toothless bucket to a depth of up to 0.8m. This exposed all of the existing electrical cables in situ, and no further excavation was required within this area. The deposits removed were a mixture of dark brown silty clay, up to 0.6m thick, and an underlying reddish brown sandy clay. Both deposits were concluded to be the backfill of previous groundworks (See Plate 1).

- 4.3 A few fragments of pottery of probable late medieval/early post-medieval origin were recovered together with numerous 18th and 19th-century ceramics, none of which were retained for the archive. Throughout the excavation the natural undisturbed subsoil was not observed in the base of the trench.

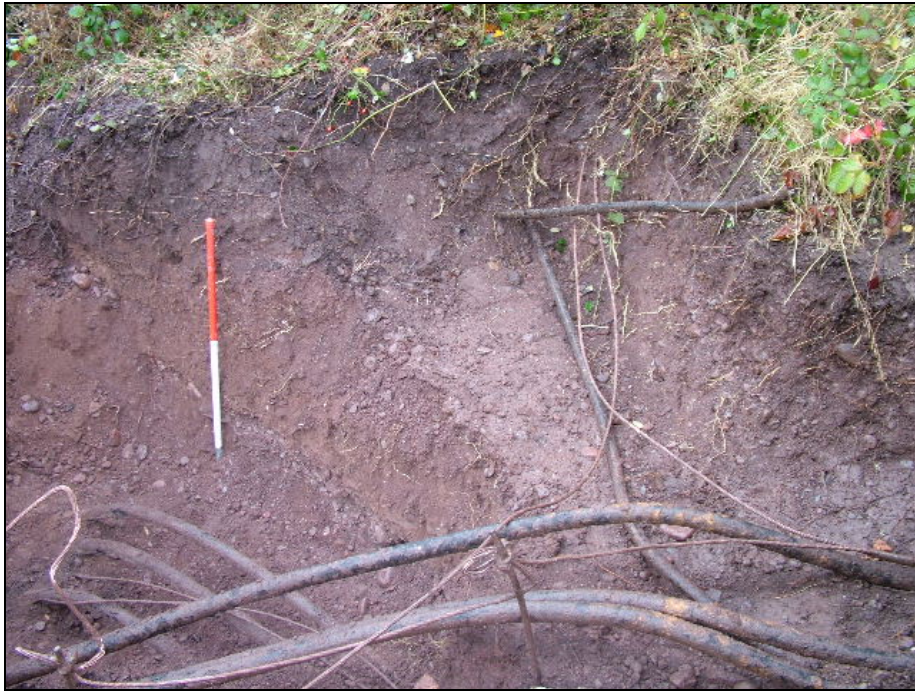
Plate 2. South-west facing section through scheduled area illustrating lower insitu deposits
Photo CPAT 2980-005

- 4.4 The second phase of the watching brief monitored excavations beyond, and to the west of, the sub-station compound. The initial area, approximately 5m x 4m and orientated north-west to south-east, was machine and hand-dug to a depth of up to 1m. Once again this exposed all of the existing electrical cables in situ. All of the excavated material was a mixture of re-deposited embankment gravels and modern backfill from 20th-century groundworks. Underlying the in-situ cables was a deposit of reddish-brown sandy clay overlying river-washed gravels and pebbles. These lower deposits could possibly be the in-situ remains of the material used in the construction of the 13th-century medieval embankment (See Plate 2.)

- 5.1 It is evident that the bank upon which the sub-station is sited has been heavily landscaped in the past fifty years. Therefore it can be assumed that any deposits of archaeological value have been removed from this part of the site.
- 5.2 All groundworks west of the sub-station (including the trench excavated within the scheduled area) were located within earlier (20th-century) groundworks. It has been assumed that the river-washed gravels mixed with sandy clay deposits, observed in section and at the base of the phase II excavation, are part of the construction material associated with the 13th-century medieval embankment. They remain in-situ and undisturbed by the recent groundworks.
