St Michael's Church, Abergele
ARCHAEOLOGICAL EXCAVATIONS 2009

I Grant
February 2010

Report for:
Reverend Shirley Griffiths,
St Michael's Church
Abergele

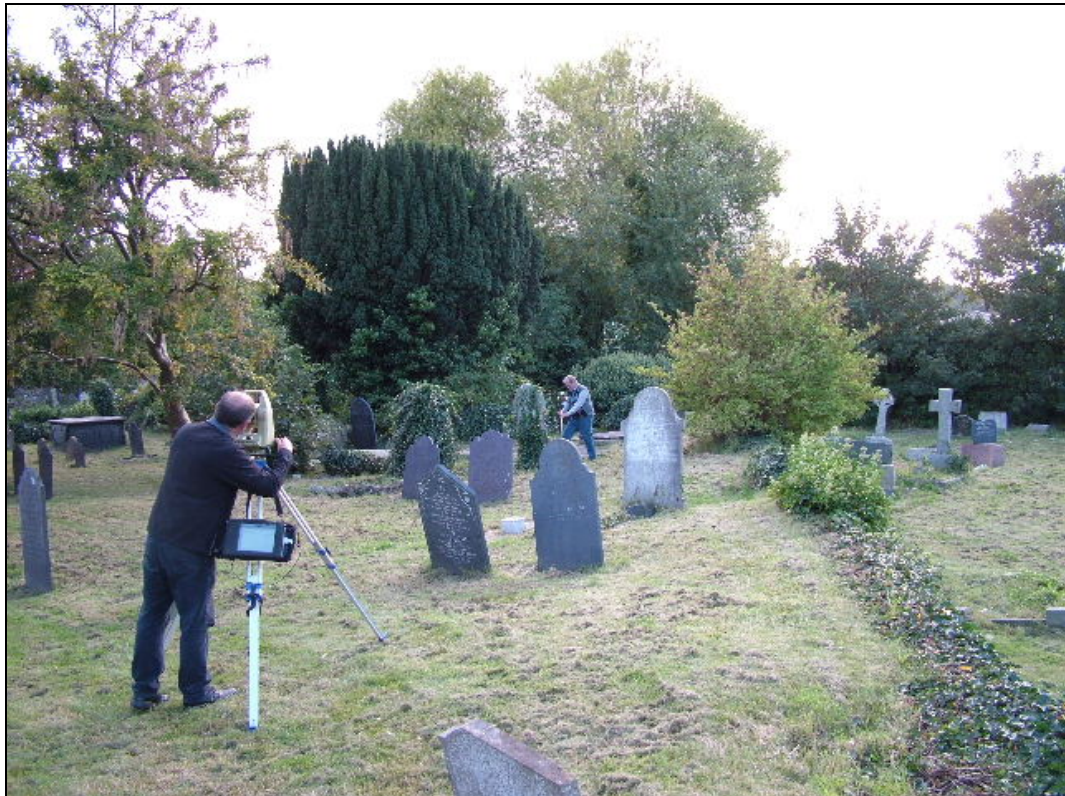
Fig. 1 Surveying the western quadrant of the graveyard. Photo CPAT 2972-002

- 3.1 As part of the Abergele College training programme a survey was carried out on the 23rd Sept 2009 and consisted of the digital recording by EDM and Penmap software of all the in-situ burial monuments in the western part of the churchyard, in relation to the churchyard boundary (see Fig. 1). A polygon (almost exclusively rectangular) was created which defined the extent of each monument and plans at 1:250 and 1:500 scales were then produced showing these polygons in relation to the boundary and the Ordnance Survey grid lines at 10m intervals (see Fig. 2). This would then allow accurate grid references to be calculated for each monument by the volunteers for subsequent data entry into a database. Typical information to be held on the database could include details of the monument inscriptions. Originally it had been hoped that this information would be gathered and subsequently entered onto the database during the course of the vault excavation. However, the level of volunteer attendance during the project dictated that all their efforts were directed towards the completion of the excavation goals. It is hoped, therefore that the graveyard survey as part of an ongoing project can be completed by the students at a more appropriate time in the future.

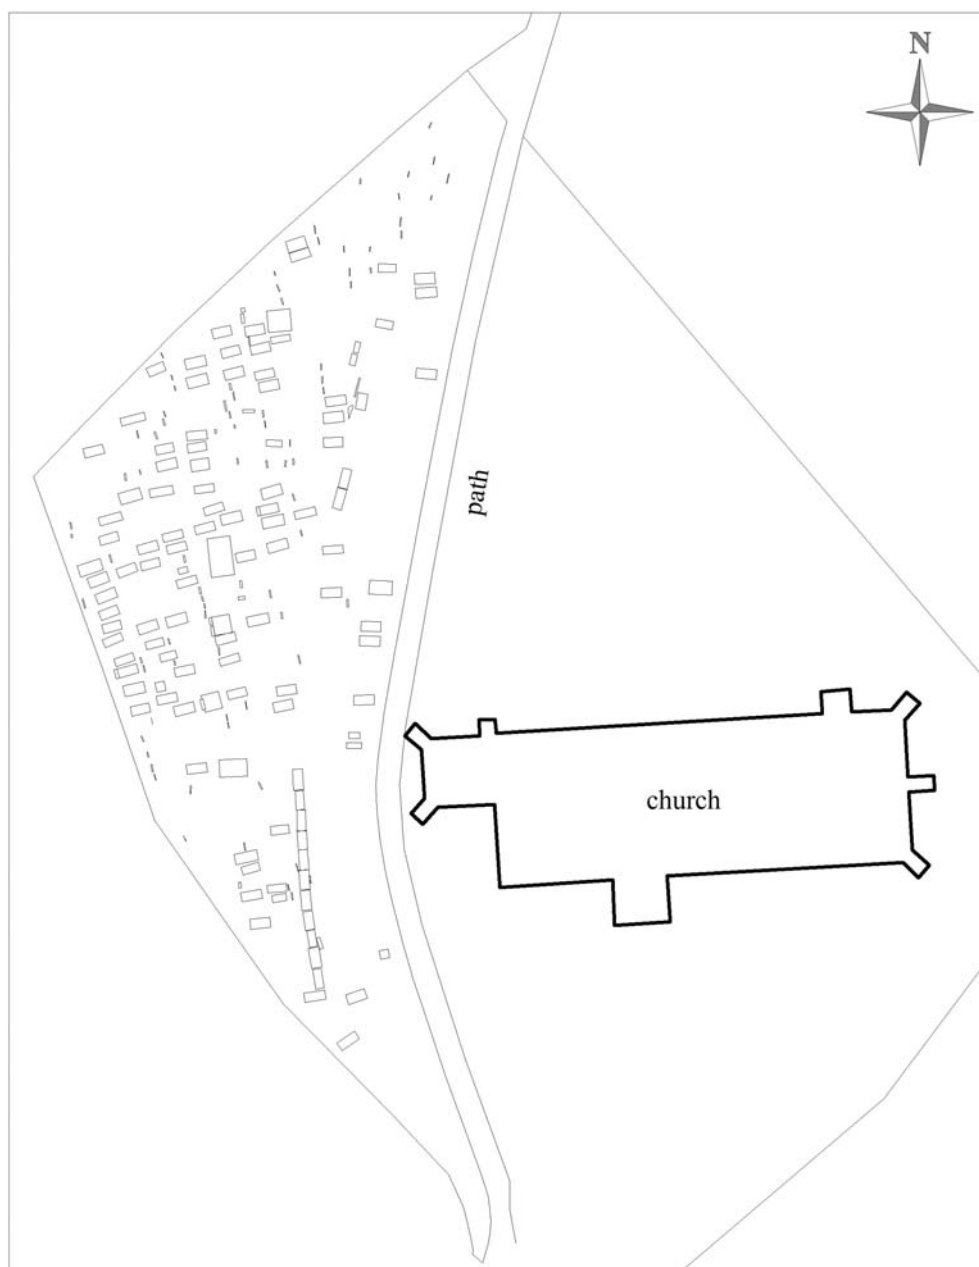
Fig. 2. Plan illustrating the extent of the graveyard survey.

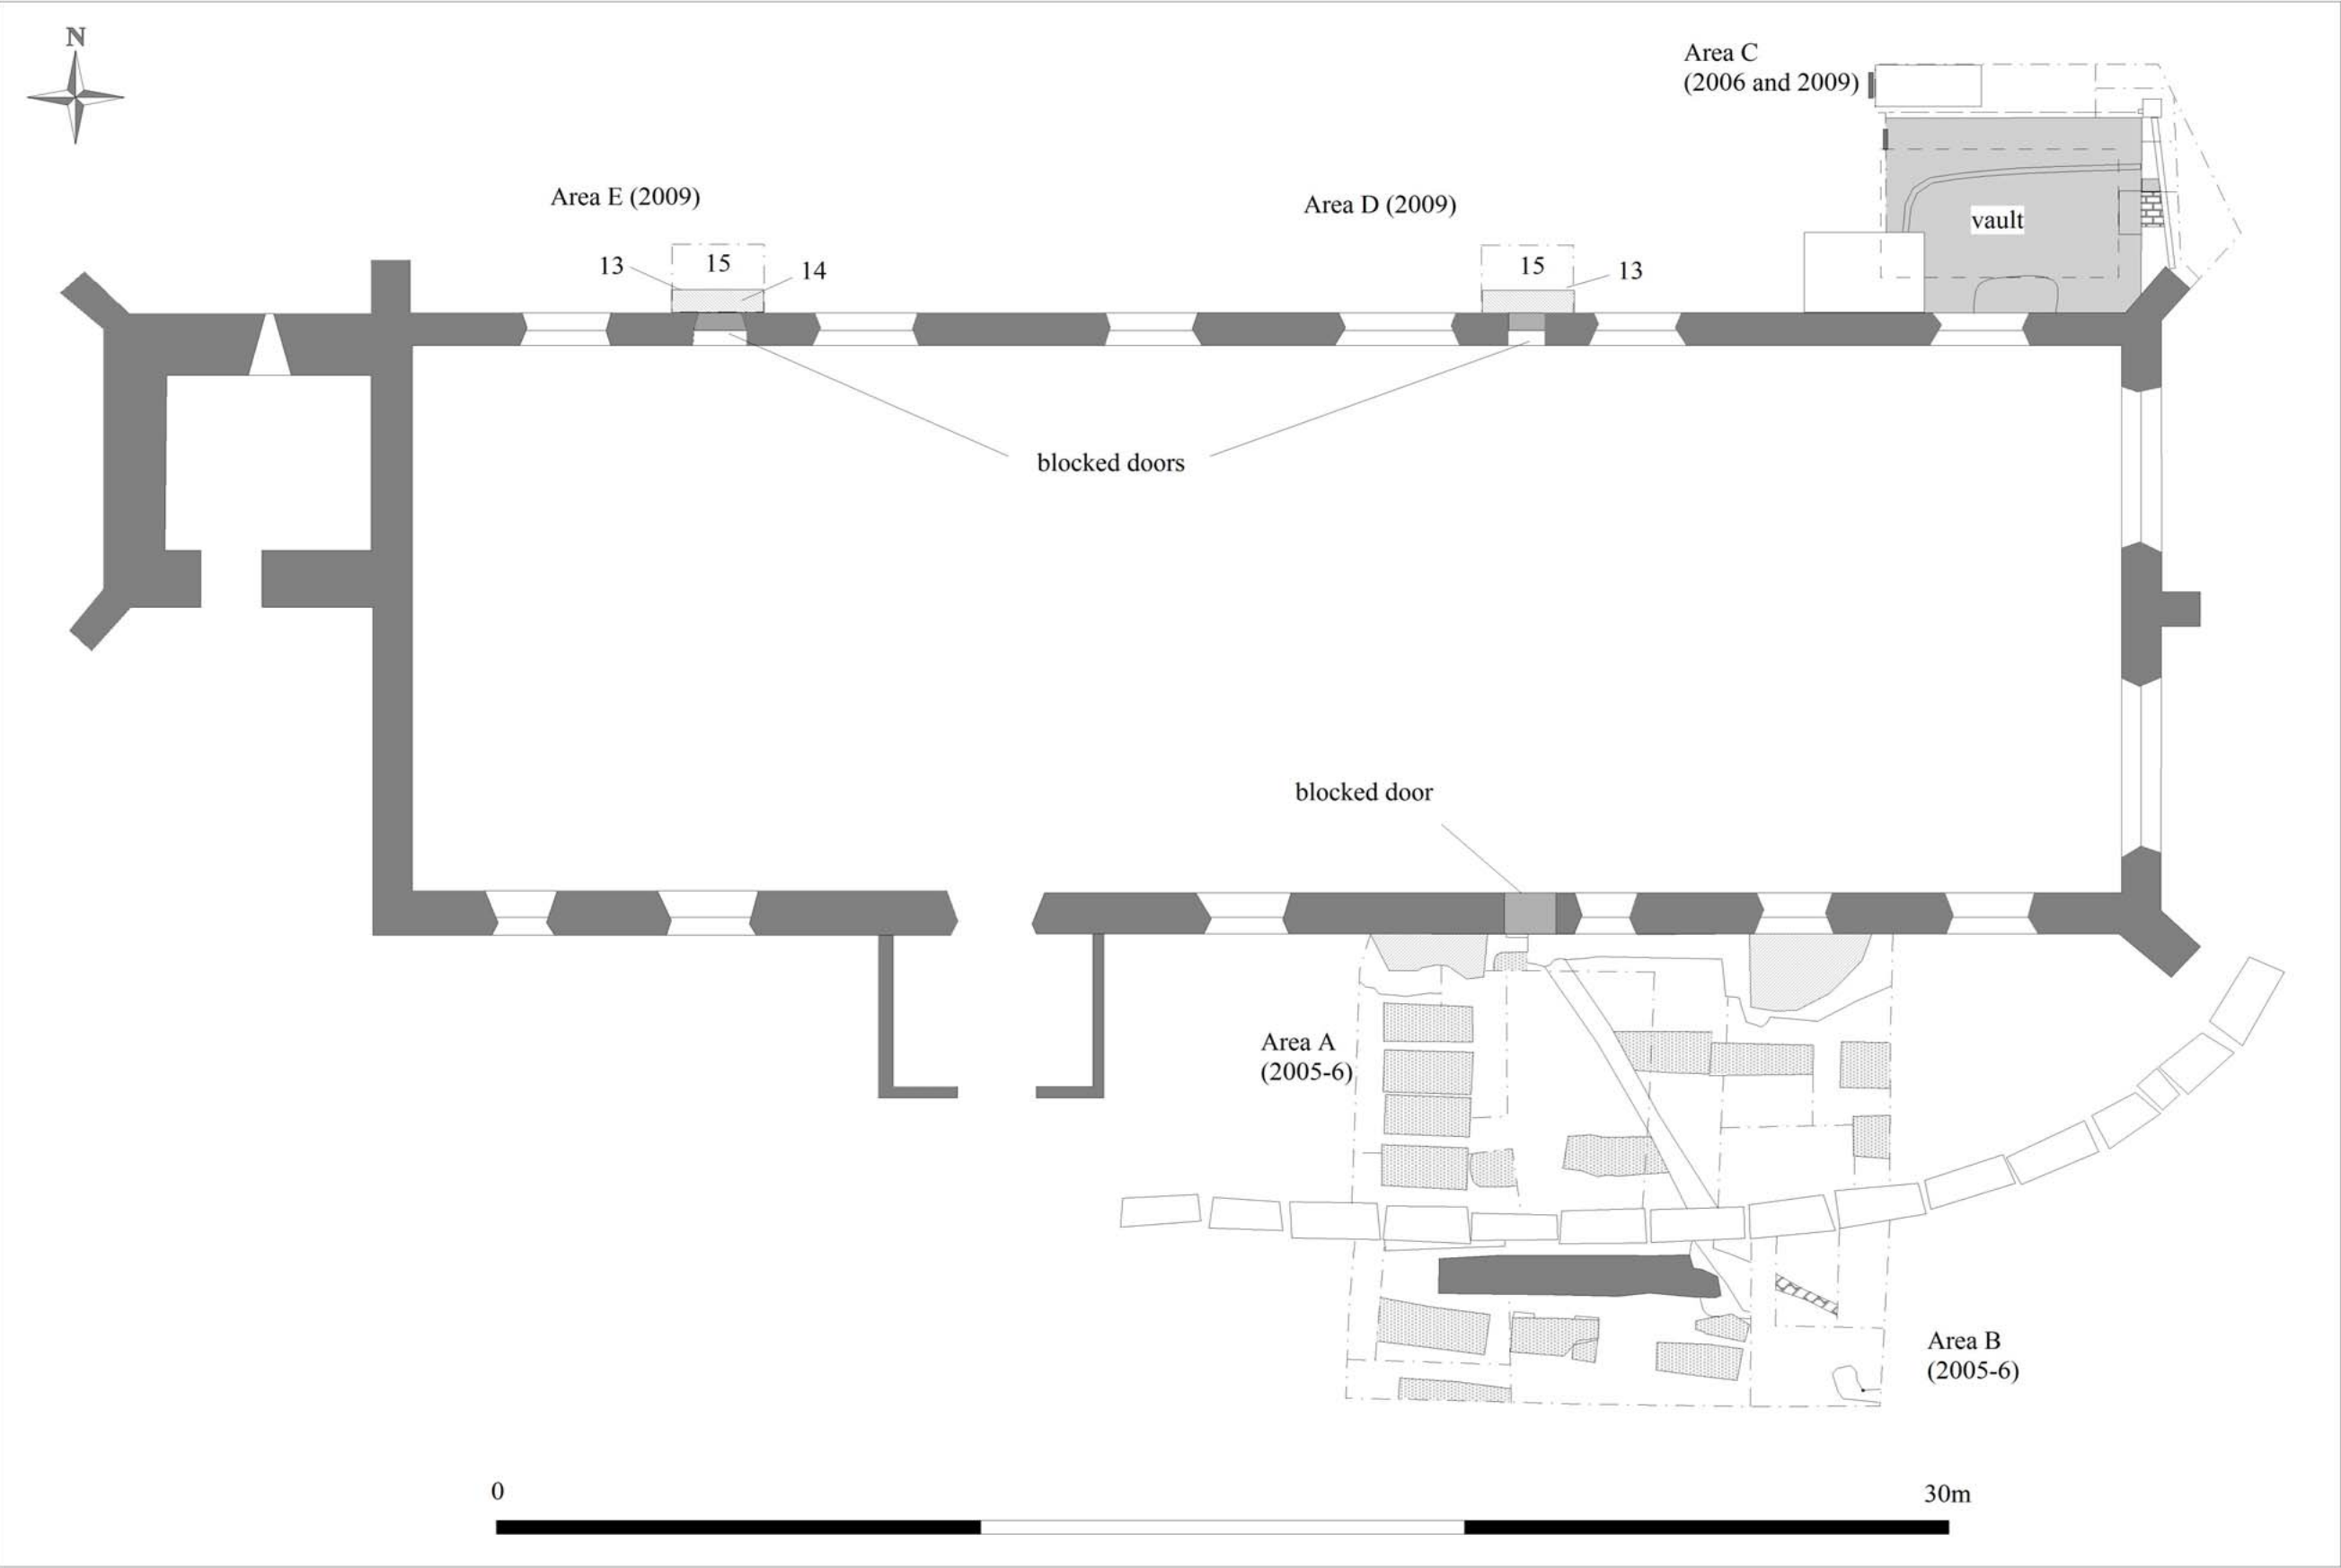
Fig. 3. Overall plan of St. Michael's Church locating the areas of excavation 2005-2009.

- 1.2 The 2006 programme of work included some explorative excavation of an area of vaulted masonry, previously unrecorded until uncovered by workmen in 2005 when a stone was removed from the masonry surface to reveal an empty stone vault (Fig. 3 Area C). An outline plan of the 'barrel-vaulted' structure was revealed, the blocked entrance to which lay below ground along the eastern side of the vault. The restrictions in the work programme meant that at the end of the excavation basic archaeological questions remained unanswered. Although the vault remained undated it was thought that it could be contemporary with, if not earlier than, the adjacent portion of the post-13th century but medieval north chancel. It was evident that further work would be required in and around the immediate environs of the vault in order to establish its true nature. In late September 2009 CPAT, together with a small contingent of students from Abergele College, returned to St Michael's in order to continue their investigations of the vault.

- 4.6 The main area of excavation focussed on the east end of the north side of the church along the north chancel wall. This was the area of vaulted masonry previously uncovered during the excavations of 2006 (see Fig. 3 Area C). It was always our intention to try to confirm the location of the vault entrance with a view to gaining access to the inner chamber. This would involve the removal of at least three repositioned graveslabs (part of a perimeter footpath through the graveyard) in order to gain access to the underlying deposits. At the same time the bounds of the previous 2006 excavations were

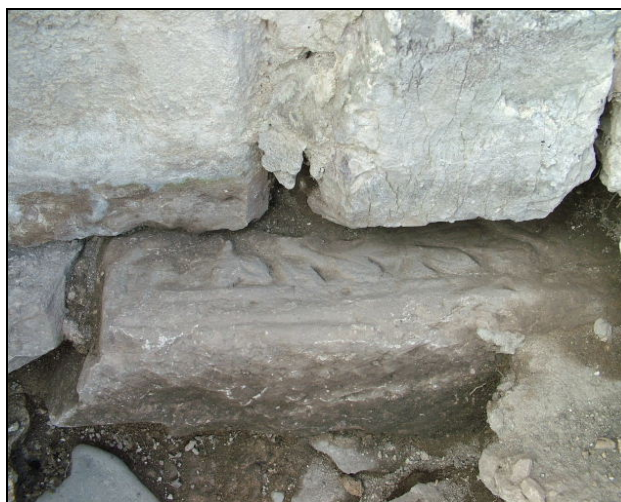
Photo CPAT 2007-064

Fig. 4. Detail of the inscribed medieval artwork (probably late 13th century in origin) on the memorial stone in the 'priest's doorway'.

- 4.5 The small-scale test trenches located adjacent to the blocked doorways along the north wall (Areas D and E) were a response to the remarkable chance discovery of a late 13th-century inscribed medieval gravestone, found underpinning the blocked-up 'priest's doorway' in the south wall in 2006 (see Fig. 4). By exposing the footings of both doorways it was hoped that we would reveal at least the make-up of the earlier church footings whilst establishing the original ground level that existed during the 14th century along the north side of the church.

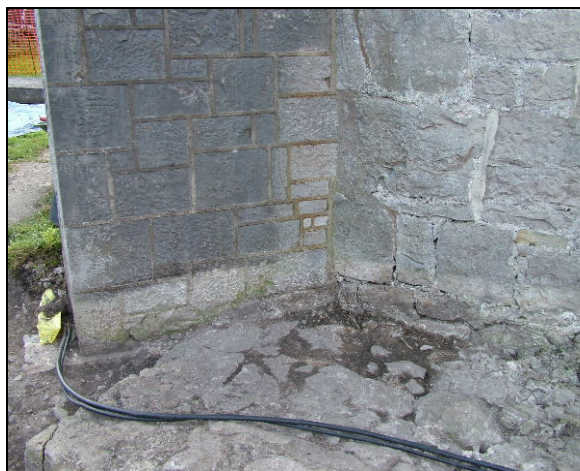
Fig. 5 South-east corner of the vault underlying the church buttress. Photo CPAT 2972-018

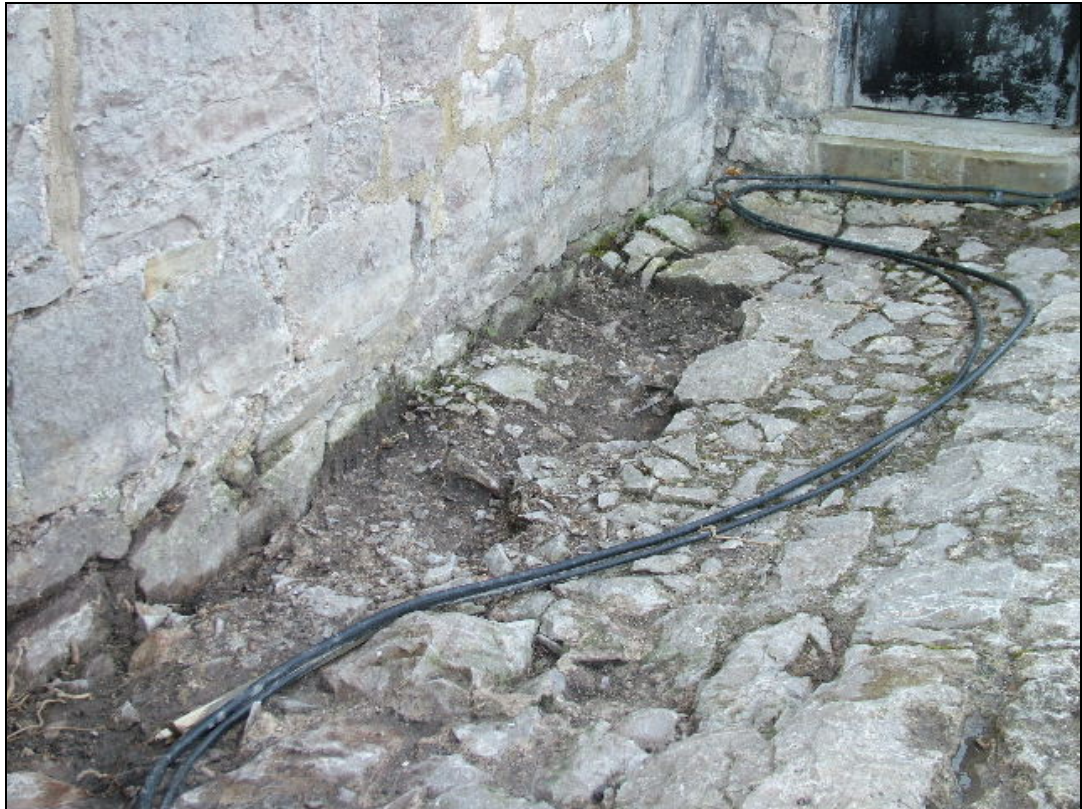
Fig. 7. Disturbance (31) in the vault roof alongside the nave wall.
Photo CPAT 2972-043

- 4.7 Adjacent to the chancel wall, the excavations of 2006 had highlighted an area of disturbance within the vault roof. The pit-like feature (30) backfilled with fragmented limestone appeared to be either a repair in the roof or possibly the result of earlier exploratory works. Upon removing part of the backfill (31) of the pit it became obvious that the vault roof was not tied into the chancel wall and in fact the structure abutted the earlier 14th century church wall (see Fig. 7). In order to maintain the integrity of the vault roof no further material was removed from the feature.

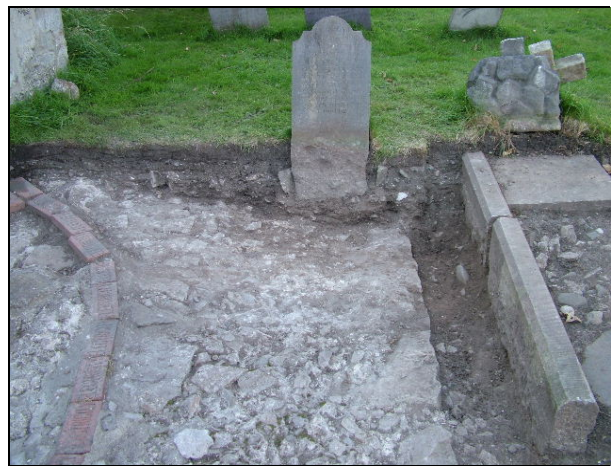
Fig. 8. Grave marker (10), dated 1868, overlying the vault roof. Photo CPAT 2972-029.

roof. No grave cut was identified and so we are unable to use this memorial to post-date the construction of the vault (see Fig. 8). The other memorial (09), orientated west to east and dated 1837 – 1870, came complete with a well-defined grave outline. The grave, which was located beyond the northern extent of the vault, had been enhanced with fairly modern stone work and paving slabs.

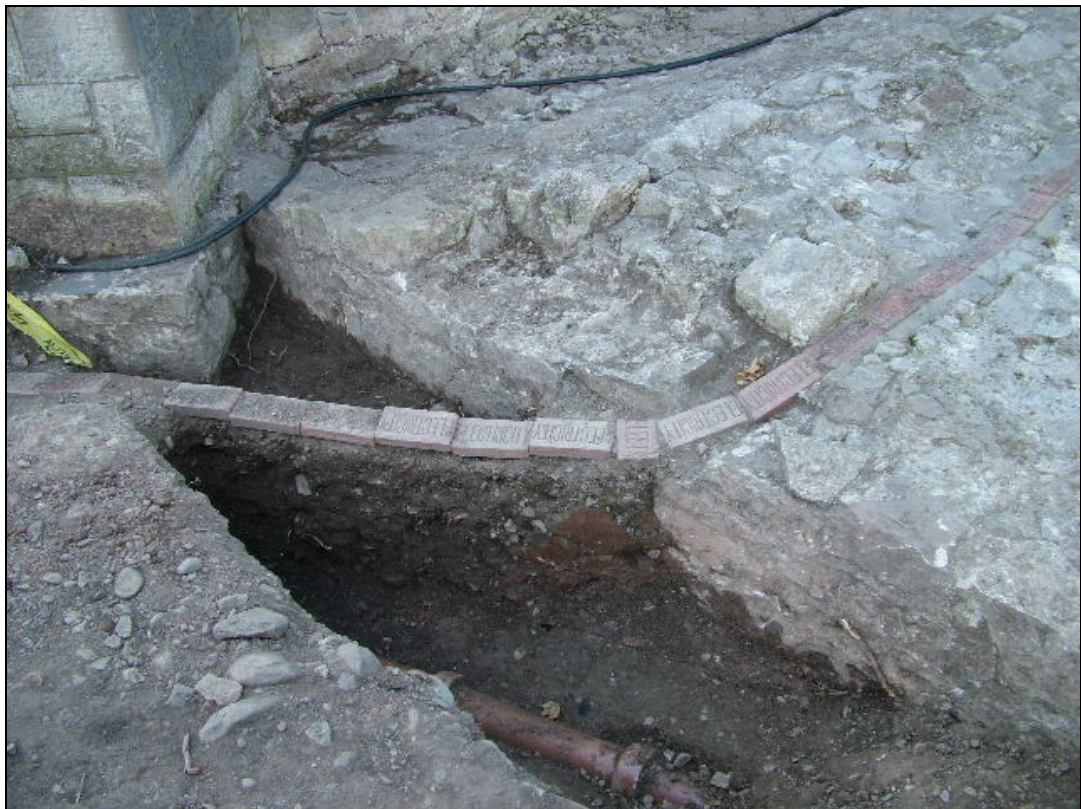
Fig. 9. Cable services and water drain (19) at east end of the vault. Photo CPAT 2972-035

- 4.9 At this point during the excavation it became clear that if we were to achieve our principal project aim (locate the entrance and possibly access and date the vault) we needed to reduce the area of excavation to a manageable size. To this end a test trench, 1m in width, was located at the north-east and eastern end of the vault. Elsewhere the lower remains of the graveyard deposit 07 remained in situ (see Fig. 10). The electricity cable (11), installed in the 1950s and encountered during the 2006 excavation, continued to restrict our progress along the eastern edge of the vault. Whilst negotiating this hazard a number of deposits (16,17 and 20) were removed from around the vault. In general, this material was fairly loose and mortar-flecked and was characteristic of building debris. Eventually we were to discover that this was the backfill of an early 20th century service trench (21) that contained a 0.12m diameter salt-glazed ceramic water pipe (19) and brick-built junction box (18). The drain had been carefully directed along the northern edge of the vault, turning southwards to pass in front of the postulated vault entrance and around the Victorian church buttress (22) (see Fig. 9). Unfortunately, the modern pipe drain had to be left in situ, once again limiting the width of our test trench along the eastern face of the vault.

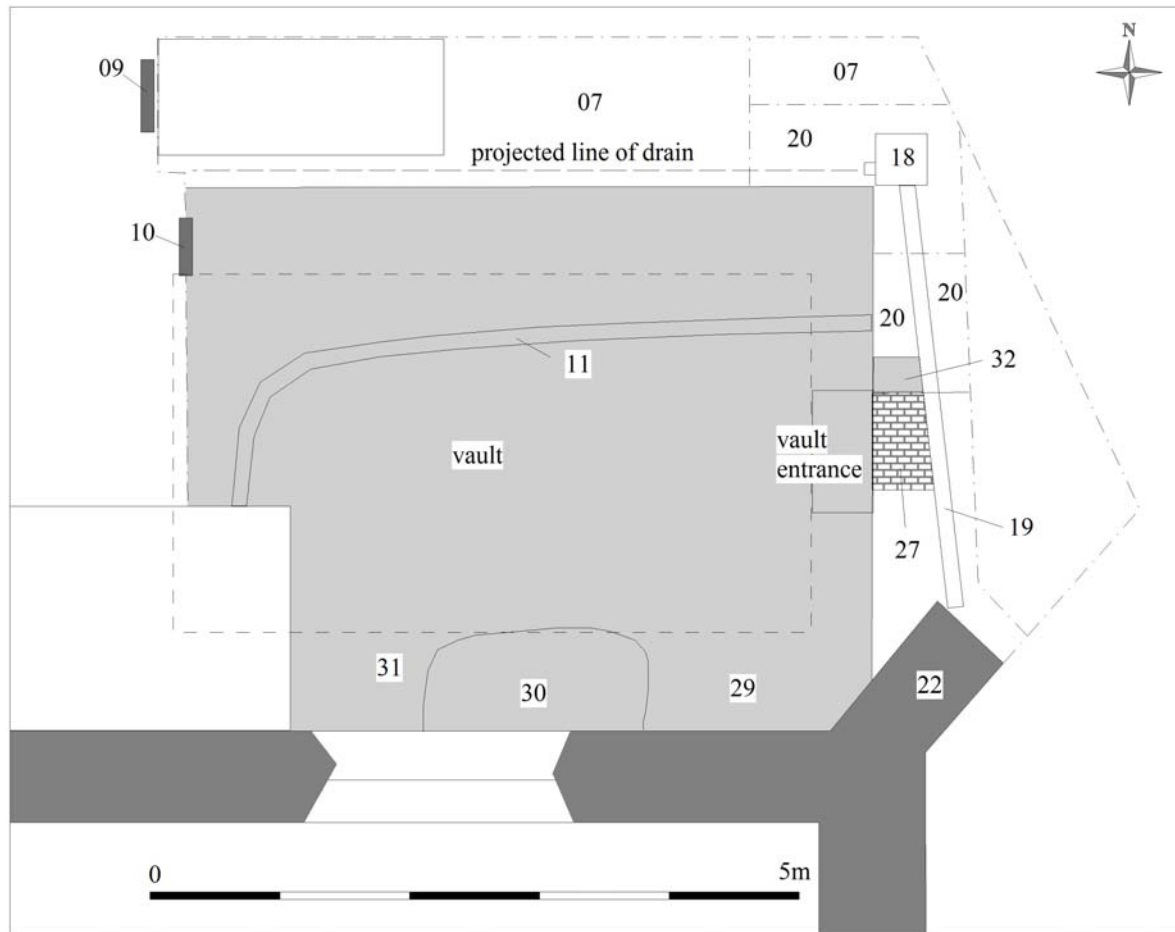
Fig. 10. Plan of the vault excavation, (Area C) 2009.

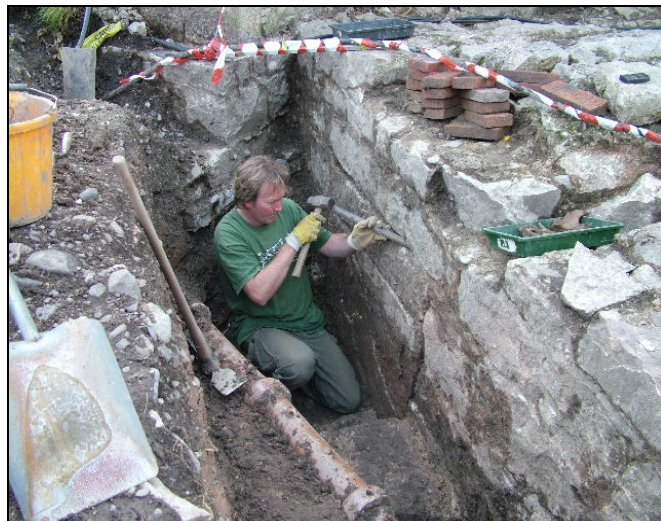
Fig. 11. Removing the clay seal used to secure the vault door. Photo CPAT 2972-048

4.10 Whilst removing the remnants of the drainage backfill the location of the vault entrance was confirmed in the east-facing wall. In order to define the access point a deposit of thick pink clay and brick rubble (08) had to be removed from around the stone coursework. It was evident that this material had been used to maintain a watertight seal to the vault. Of note was a cemetery deposit (06), a firm greyish brown silt soil that in turn sealed the clay. The narrow dateline extracted from the recovered finds demonstrated that the deposit 06 was the first cemetery soil encountered that appeared to be undisturbed. The collection of ceramics such as green pearl-ware (dated *c.* 1815), Buckley-ware, white stone-ware and clay pipe suggests a deposition date of the early 19th century (see Fig. 11).

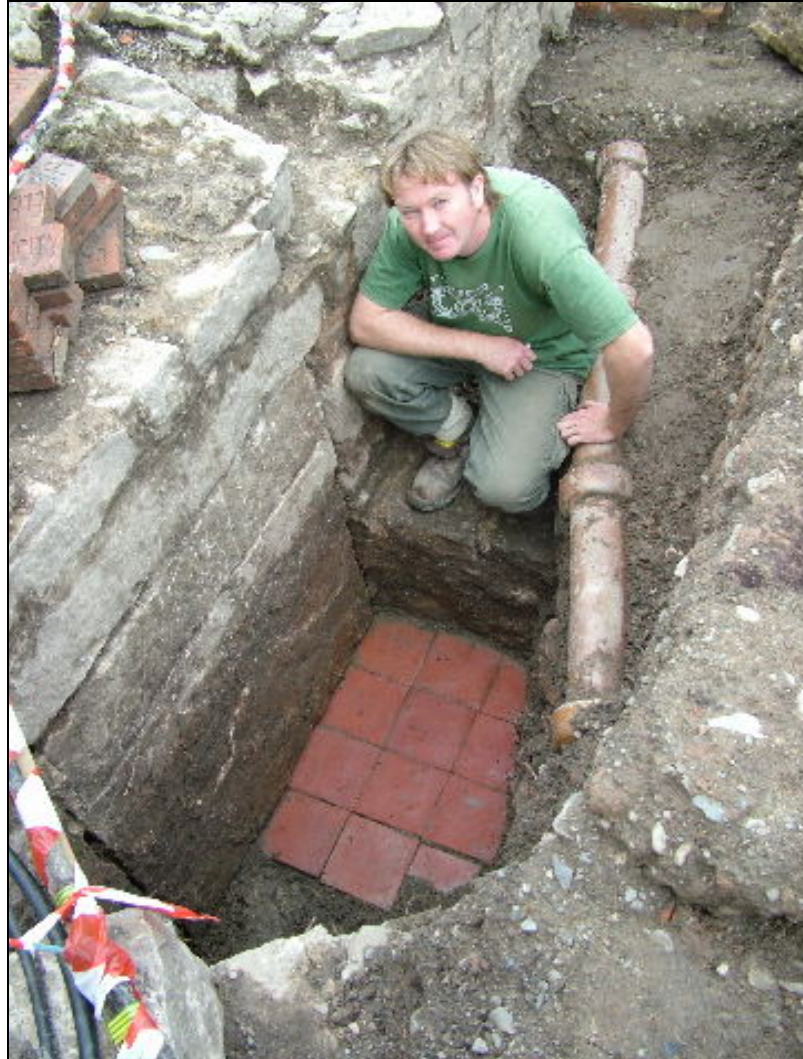
Fig. 12. The author kneeling on the flanking wall (32) at the entrance to the vault. The polished red quarry tiled floor (27) runs eastwards away from the vault. Note the tiles that are missing as a result of the insertion of the later church buttress c. 1861. Photo CPAT 2972-062.

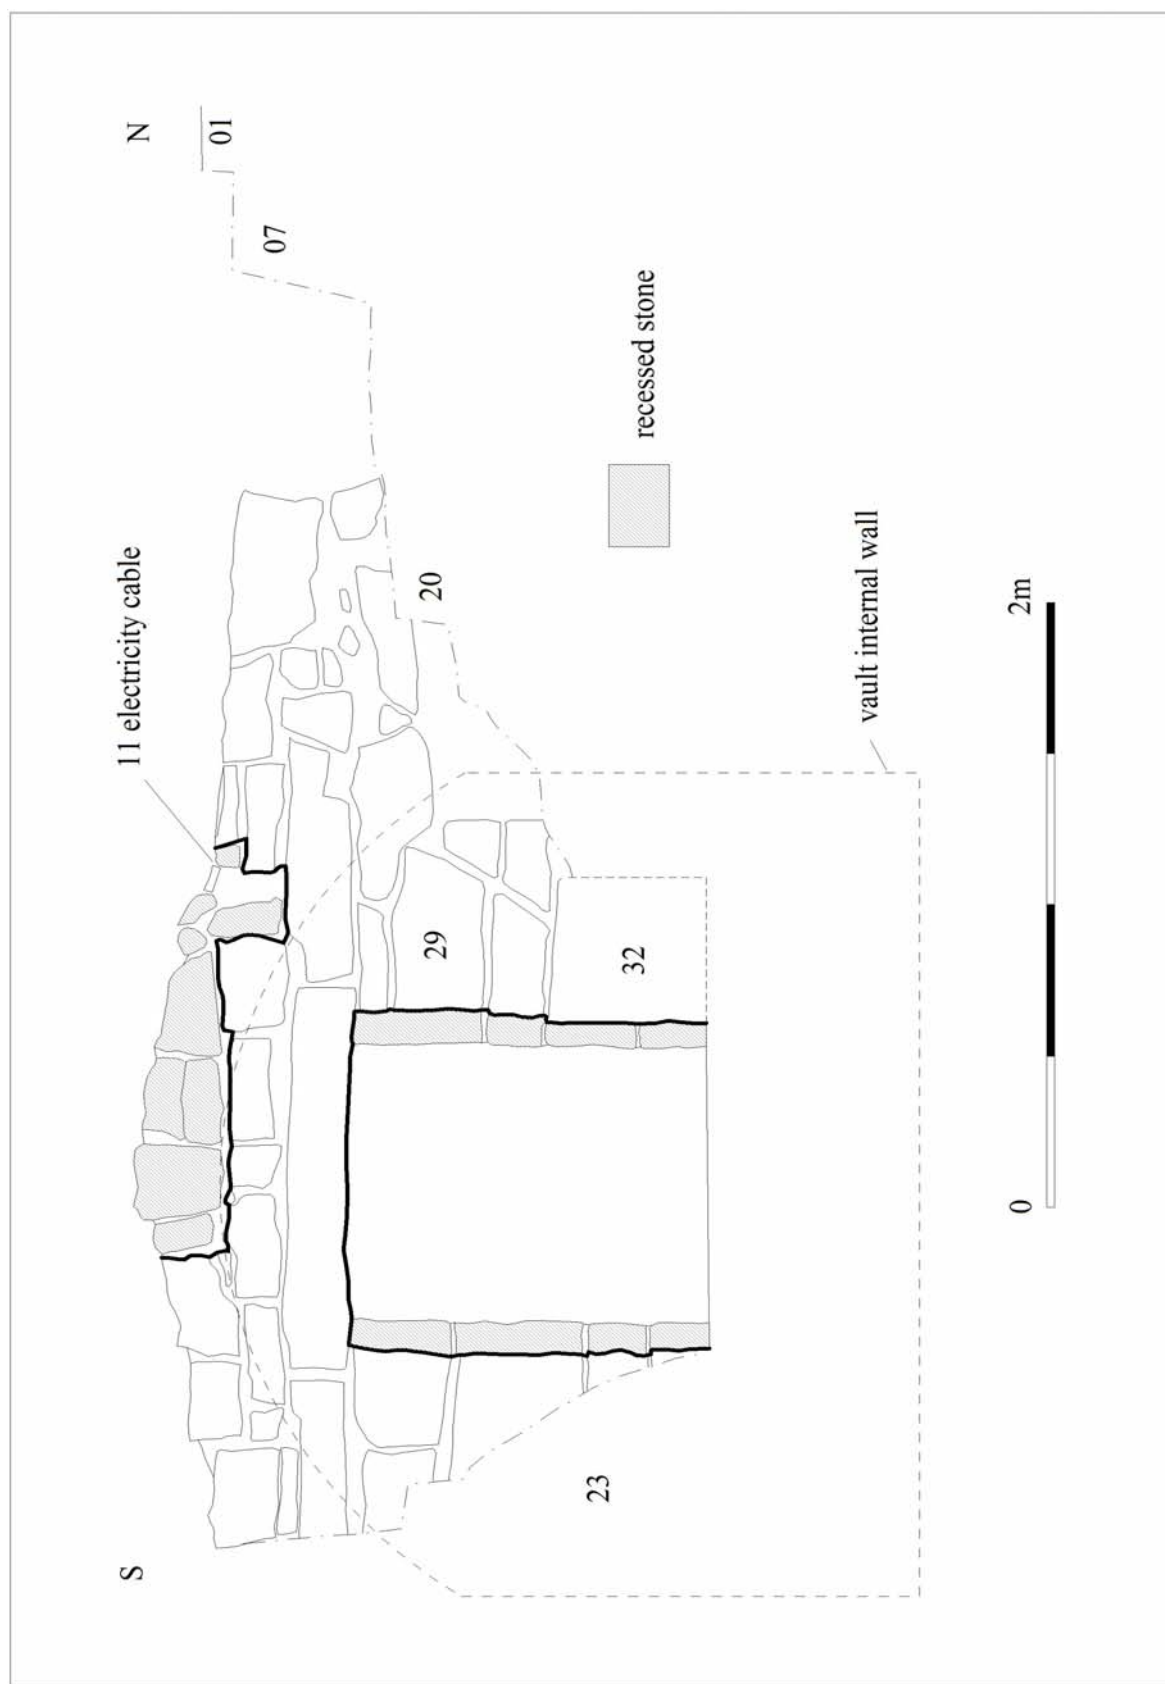
Fig. 13. East-facing elevation of the vault illustrating the entrance and internal chamber dimensions.

- 4.11 The entrance to the vault measured just over 1m², crowned by a large limestone lintel 1.26m in length and 0.2m wide. The access had been sealed tightly with a combination of two limestone blocks, 1m x 0.2m and 1m x 0.8m, and pink reddish clay (25) that had been rammed into the recesses between the coursework. At the foot of the doorway, external to the vault, a floor of red polished quarry tiles (27) defined the intended access point. To the north they were flanked by a low-lying limestone wall (32), 0.4m high and orientated east to west (see Fig. 12). Both the wall and the tiled flooring extended eastwards below the modern drain (19) and beyond the bounds of the excavation. To the south both the flanking wall and the floor had been removed by the foundation cut (24) of the Victorian ashlar and limestone buttress (22) (dated 1861). To maintain the integrity of the buttress, the foundation backfill (23) surrounding the south-east corner of the vault was left in-situ. The overall external height of the vault, from the tiled floor to the top of the barrel roof was 1.75m (see Fig. 13).

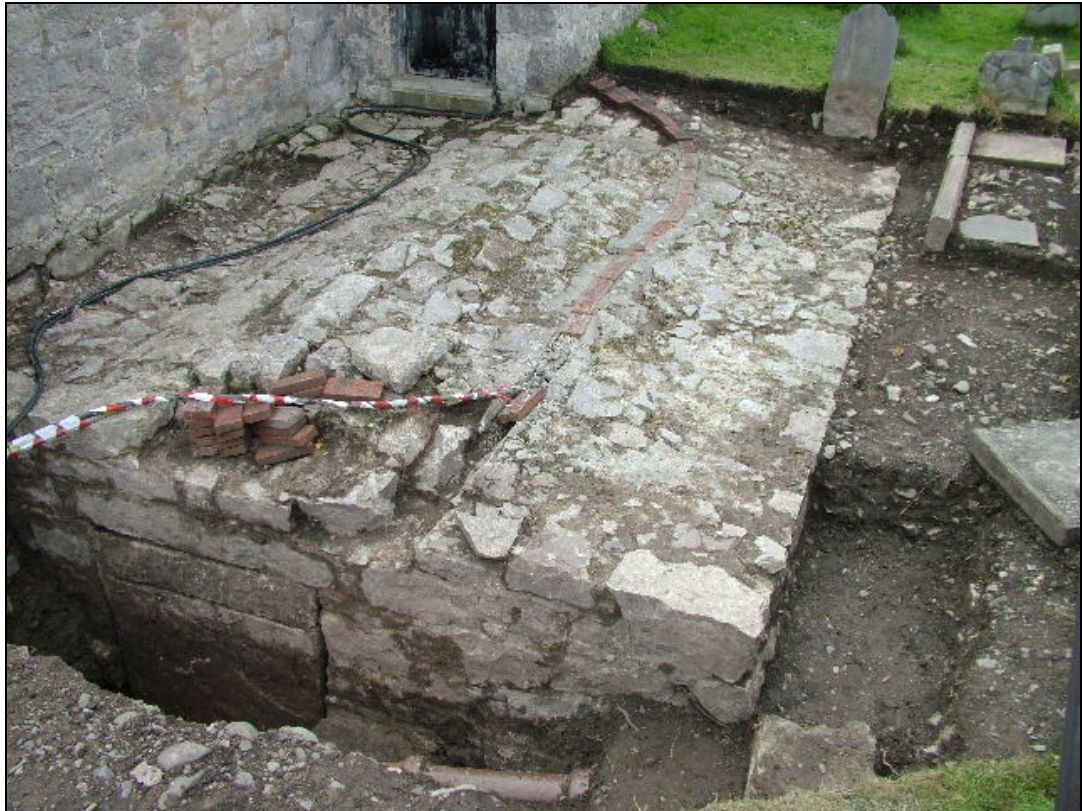
Fig. 14. Overall view of the vault, showing the blocked access in the east-facing wall. The graves 9 and 10 can be seen in the background. Photo CPAT 2972-061.

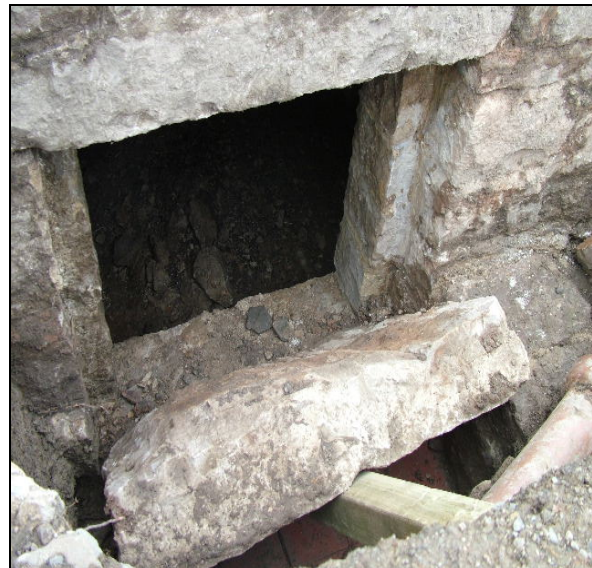
Fig. 15. East facing access with limestone block door in the foreground. Photo CPAT 2972-074.

- 4.12 Removing the limestone doorway proved to be quite a task, especially as we needed to keep the weighty stonework nearby in order to reconsolidate and re-seal the vault doorway at the end of the excavation. Upon removal of the door, it became apparent that an elaborate recess/door jamb had been built into the entrance to prevent the door falling back into the inner chamber (see Fig. 15). The interior floor was approximately 0.65m below the base of the doorway (see Fig. 13). The interior of the vault was empty of any form of funerary fixtures and all that remained in-situ was the red-polished quarry tiled floor (28), identical to the exterior floor. The general impression was that the chamber had remained water-tight and the only residue

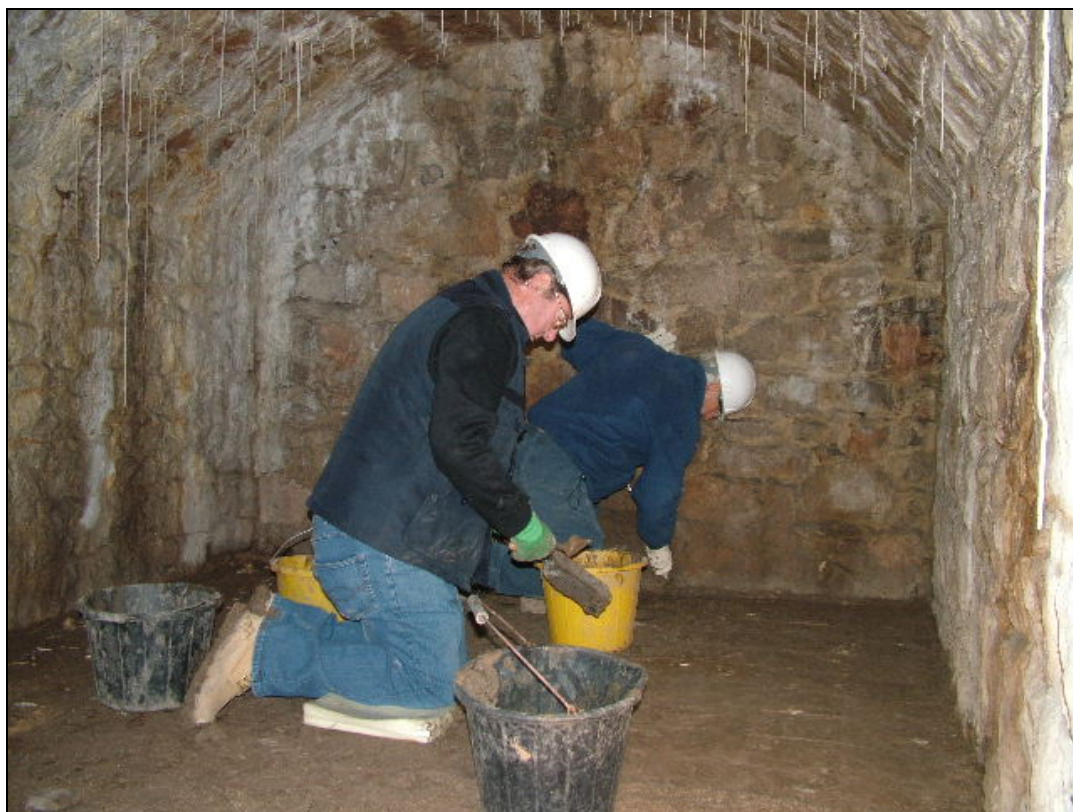
Fig. 16. Students Gerry Cuthbert and Pete Pickering, cleaning a section of the interior tiled floor. Photo CPAT 2972-084.

was the calcified lime mortar that seeped from the barrel-vaulted roof and a thin deposit of silt that coated the tiled floor. In order to study the tiles in detail, 50% of the floor was hand cleaned, brushed and washed (see Fig. 16). The result was quite impressive with a good section of the floor restored to bright polished red tiling. A detailed photographic and measured survey of the interior walls was then undertaken.

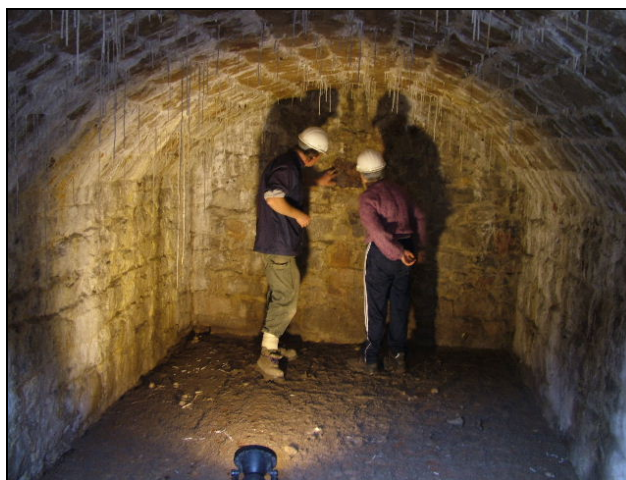
Fig. 17. The author and Rev. Shirley Griffiths inspecting the coursework of the west wall of the vault. Photo CPAT 2972-075.

indicate different phases of build possibly relating to earlier construction associated with the adjacent north chancel wall of the church. It was concluded that all of the coursework was contemporary with a single post-medieval construction date. The east-facing wall, including the roof coursework, had eleven courses of stonework. Unlike the sides of the vault, which appeared to be approximately 0.95m thick, the eastern wall had been constructed two blocks wide with a thickness of 0.47m. Externally, the vault was 4.2m wide (north to south) and at least 5.2m long (east to west). The western extent of the vault was not seen but if we take the internal dimensions and add the thickness of the east wall then the overall length of the vault is approximately 6m (see Figs. 18, 19 and 20).

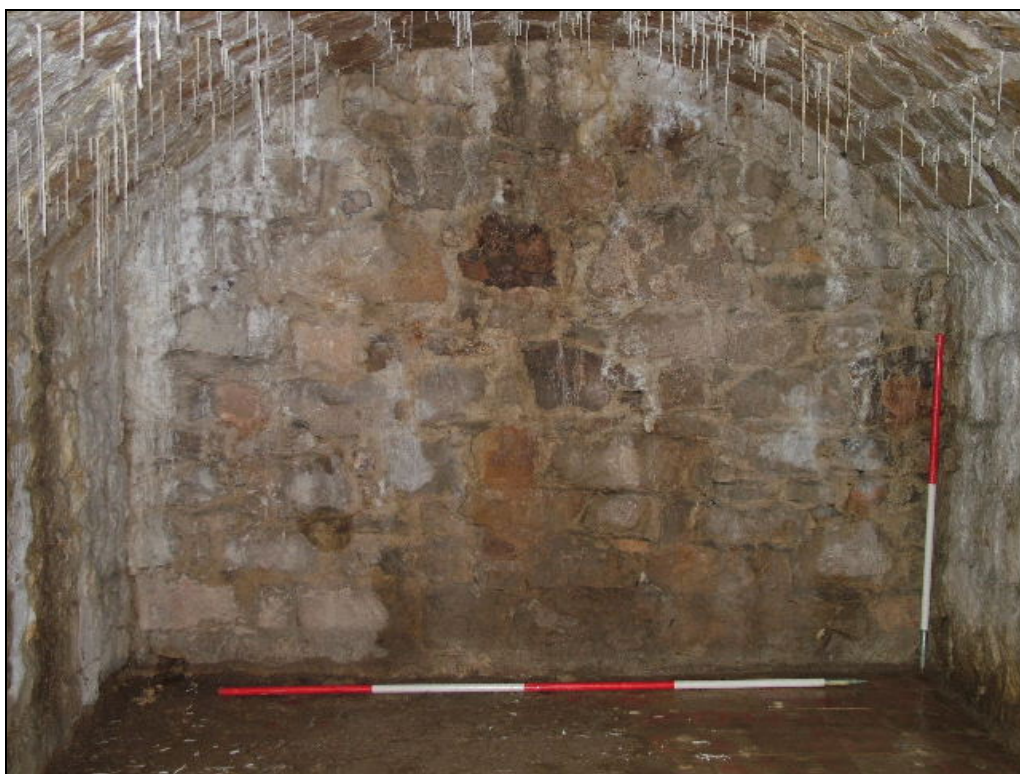
Fig. 18. The interior west wall of the vault, viewed from the east. Photo CPAT 2972-018.

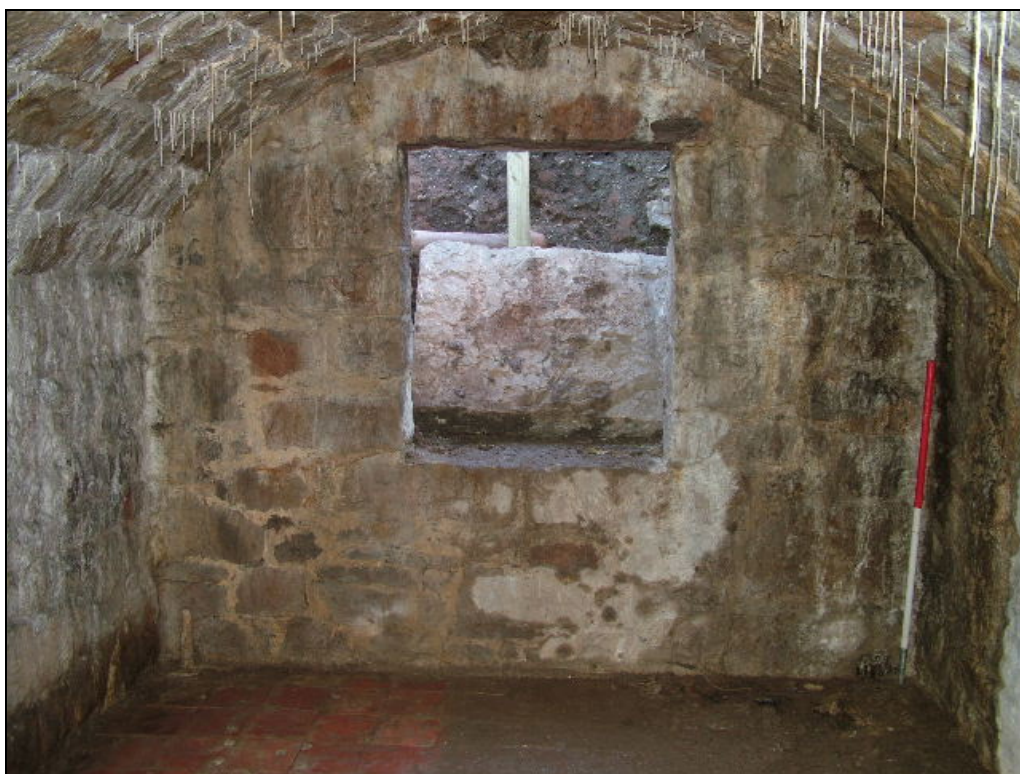
Fig. 19. The vault entrance and east wall, viewed from the west. Photo CPAT 2972-097.

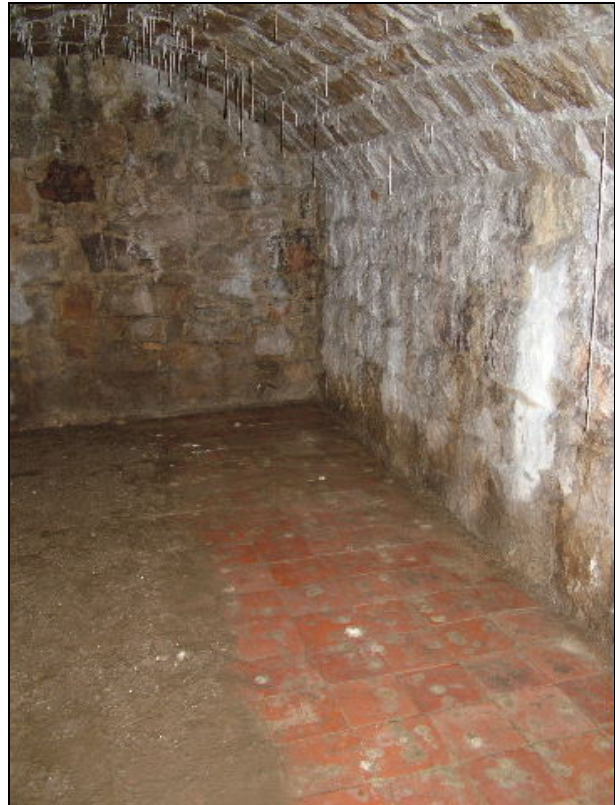
Fig. 20. The north and west walls of the vault, illustrating the section of quarry tiled floor that was cleaned. Viewed from the east. Photo CPAT 2972-105.

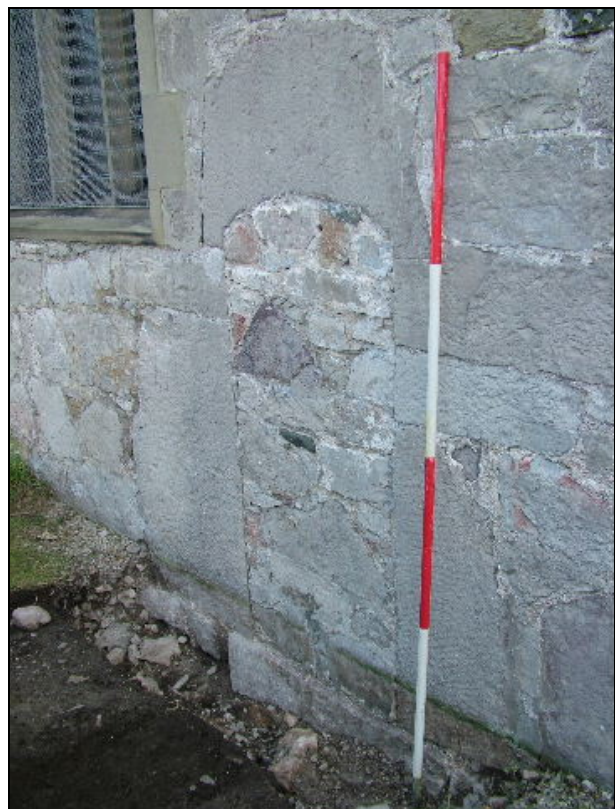
Fig. 21. The east doorway (Area D) with the modern drain removed from the base. Photo CPAT 2972-114.

- 4.16 At a point 4.7m west of the modern outbuilding attached to the north chancel wall, a test pit was excavated below a blocked-up doorway (see Fig. 3). The 'east' doorway, 1.66m high and 0.76m wide, is believed to be of 14th or 15th-century origin. It was hoped that by exposing the footings it might be possible to record evidence of the earlier church foundations and ground levels from the medieval period. The test pit measured 1.92m east to west by 1.43m. A 'french' drain of lime chippings (13), 0.5m wide and 0.35m deep (12), was first removed from alongside the nave wall at the base of the doorway (see Fig. 21). After isolating the modern drain cut, the modern churchyard topsoil was removed (0.14m thick) down onto a uniform layer of dark grey-brown silt and rubble (15). This deposit contained numerous fragments of disarticulated human

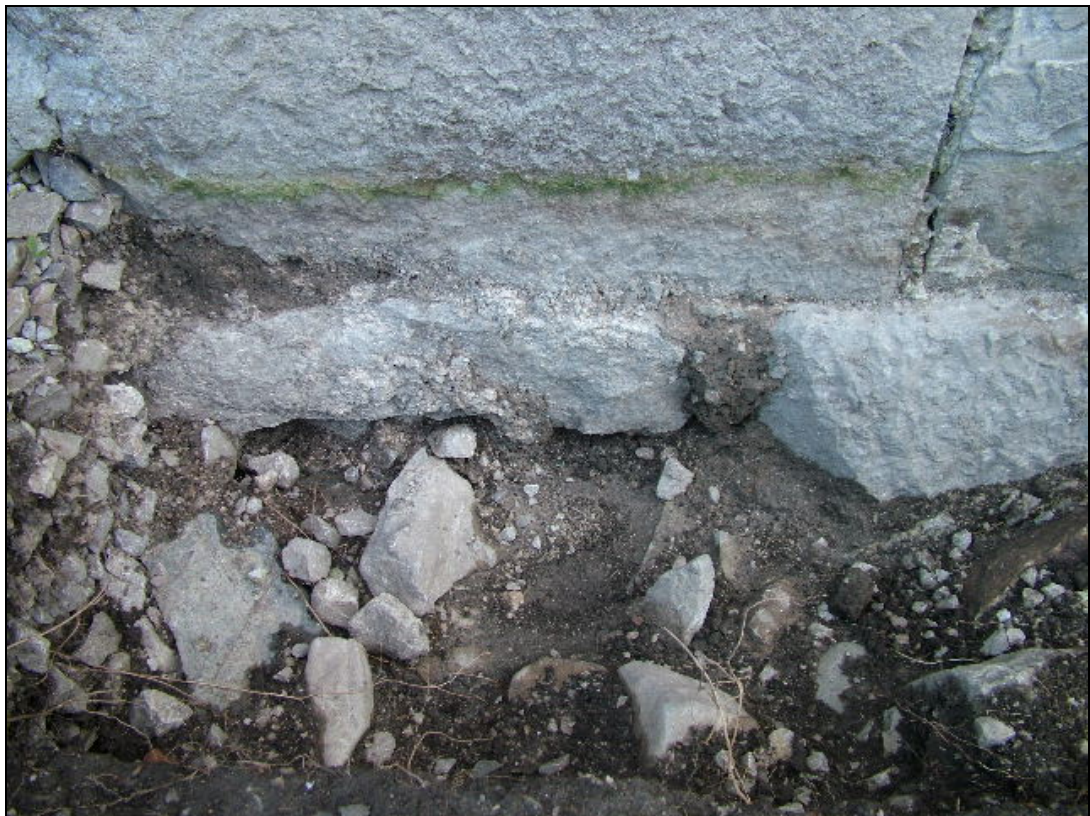
Fig. 22. Deposit of medieval rubble (34) underpinning the east door. Viewed from the north.
Photo CPAT 2972-118.

- 4.17 Underlying the threshold of the blocked doorway was a layer of fragmented limestone and sandstone rubble (34). This deposit, similar to the material underlying the doorway in the south wall recorded in 2006, could possibly be demolition material associated with an earlier phase of St. Michael's (see Fig. 22). The principal aim of the excavation was to follow this deposit northwards across the test pit. This would have allowed us to locate the cut for a medieval foundation trench and possibly recover some dateable artefactual evidence. Due to time constraints all of our labour resource was diverted to the vault excavation in Area C and no further progress was made with the excavation in this area. The trench was backfilled, the drain reconsolidated and the turf was replaced.
