St Michael's Church, Abergele
ARCHAEOLOGICAL EXCAVATIONS 2009

I Grant
February 2010

Report for:
Reverend Shirley Griffiths,
St Michael's Church
Abergele

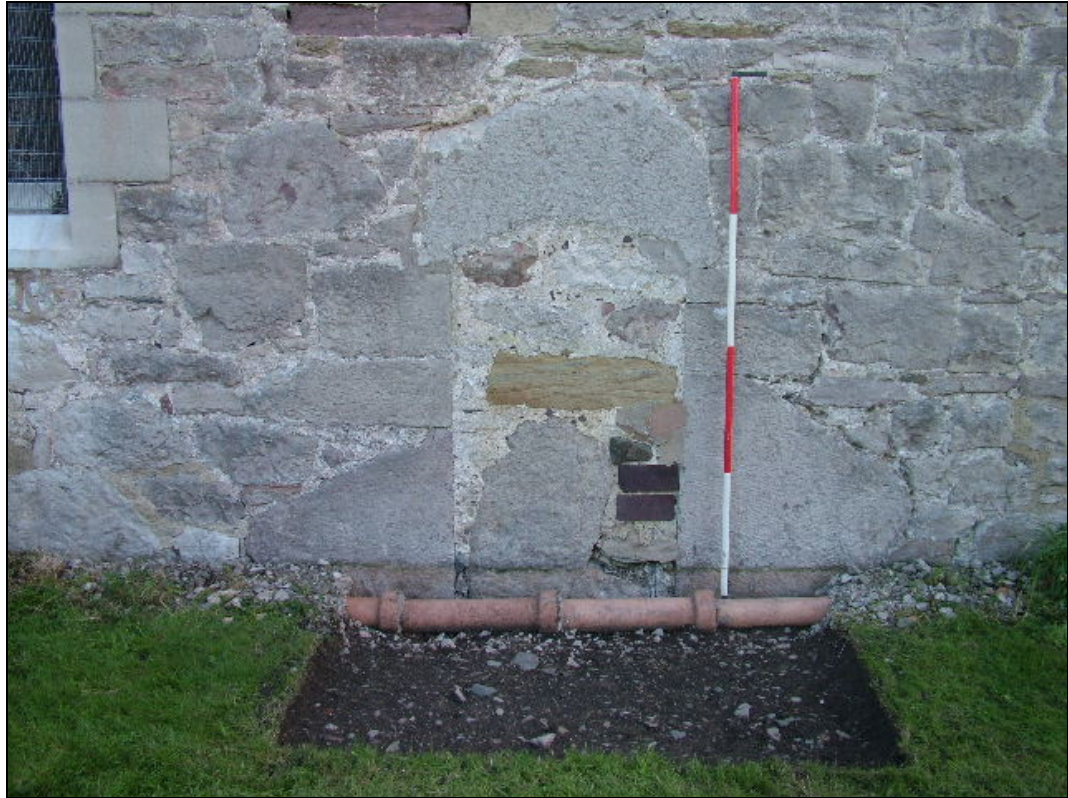
Fig. 23. The west doorway (Area E) viewed from the north. Photo CPAT 2972-106.

- 4.8.1 At a point 15.5m west of the test pit in Area D another test pit was excavated below a similar blocked-up doorway (see Fig. 3). The 'west' doorway, 1.72m high and 0.91m wide, is also believed to be of 14th or 15th-century origin. The aims of the excavation were identical to those in Area D. The test pit measured 1.85m east to west by 1.47m. The process of excavation was repeated; the 'french' drain (13) was first removed from alongside the nave wall and the modern churchyard topsoil was removed (0.1m thick) down onto the same uniform layer of dark grey brown silt and rubble (15). Unfortunately, a modern salt-glazed ceramic pipe (14), was encountered traversing the base of the wall. The pipe was part of the water drainage system for the church tower and roof and so it was

imperative that it remained in-situ. This effectively prevented any further excavation alongside the blocked doorway (see Fig. 23). Further excavation throughout the trench would probably have located the medieval layers but once again time constraints and limited resources signalled the end of excavation in this area.
