CPAT Report No 984

Walton Roman Marching Camps

ARCHAEOLOGICAL WATCHING BRIEF

I Grant
April 2009

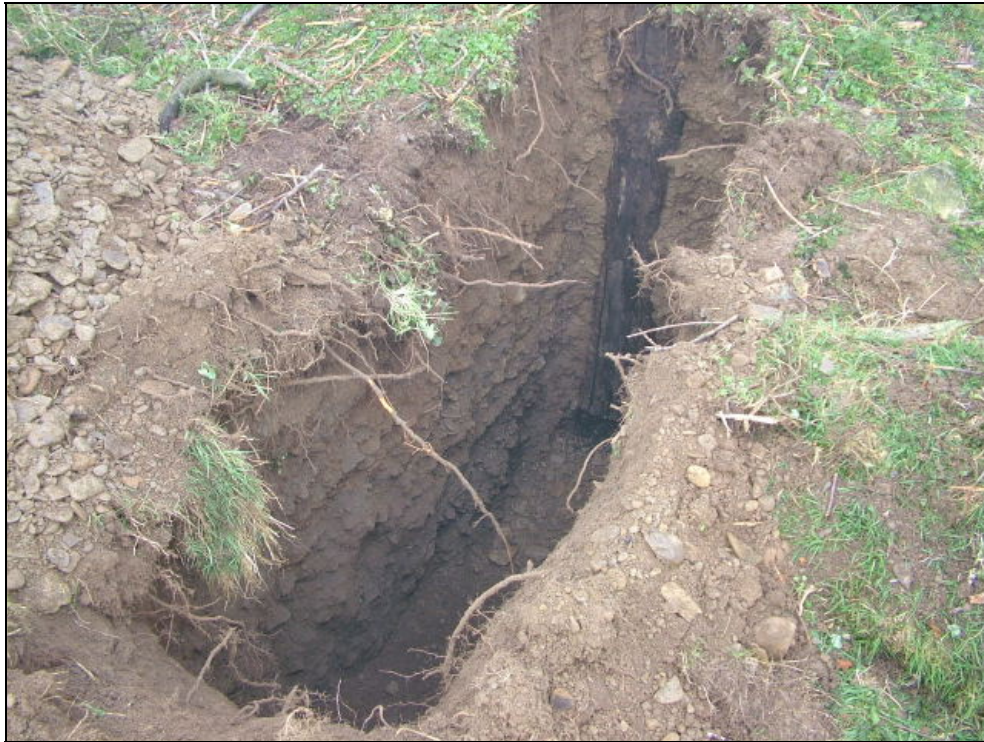
Fig. 3 Pit excavated for replacement electricity pole. Photo CPAT 2817.002

- 3.1 The watching brief was conducted on 19 March 2009 and comprised the close archaeological monitoring of all groundworks associated with the installation of the underground cable. Although not originally part of the scheduled works, the watching brief also included monitoring during the replacement of an existing wooden electricity pole. This was deemed to be unsafe by Western Power, who conducted the cable installation, and the work was carried out as an emergency repair, presumably under Class Consent. The new pole was erected within a pit measuring 1m by 2m and 2m in depth, with an additional pit, 1m by 1m and 1.5m deep, to accommodate a stanchion on its western side (see Figs 3-4).

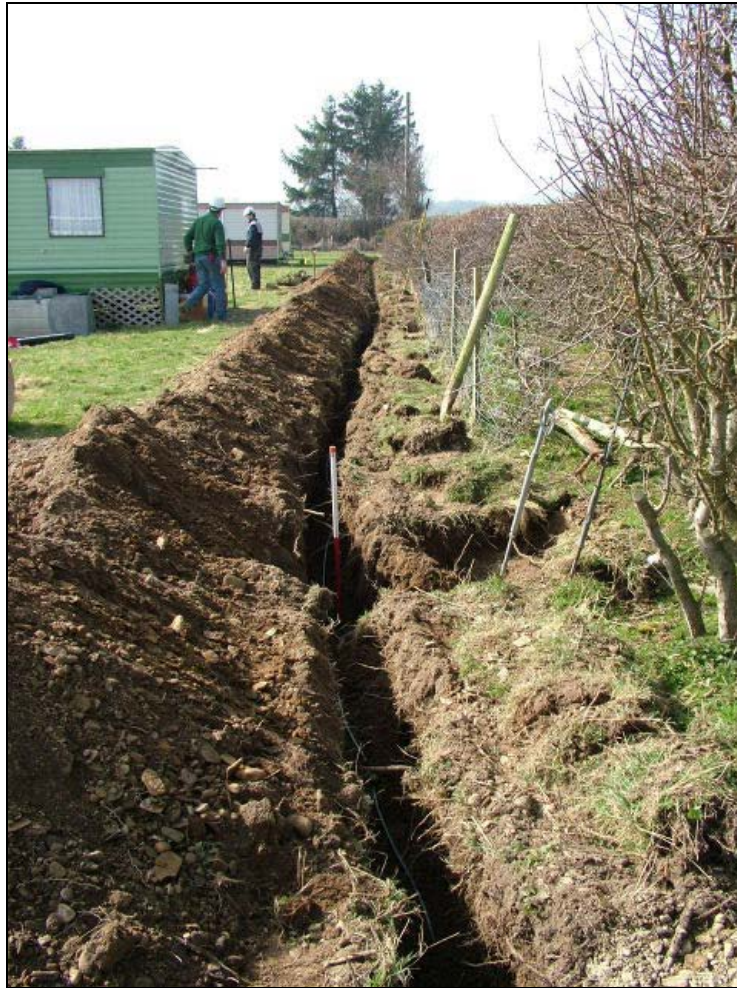
Fig. 4 View westwards along the cable trench, showing the position of the stanchion pit.
Photo CPAT 2817.005

- 3.2 The underground cable required the mechanical excavation of a trench 67m in length, 0.3m to 0.4m wide, and between 0.7m and 0.8m deep. The trench commenced at a point 18m east of the north-western corner of the field and ran parallel to, and around 1m south of, the northern boundary of the field. Three electricity connection points were installed along the route, each requiring the excavation of a pit measuring 0.5m by 0.5m and up to 0.5m deep.
- 3.3 The topsoil was generally observed to be up to 0.3m thick, overlying either a layer of orange-brown silty clay 0.2-0.25m thick, or an orange-brown silty gravel 0.2m thick, beneath which were undisturbed natural gravels. The watching brief failed to reveal any archaeological features or deposits, and recovered no artefacts of any period.
