Shrawardine Castle, Shropshire

ARCHAEOLOGICAL SURVEY

CPAT Report No 436

N W Jones
January 2002

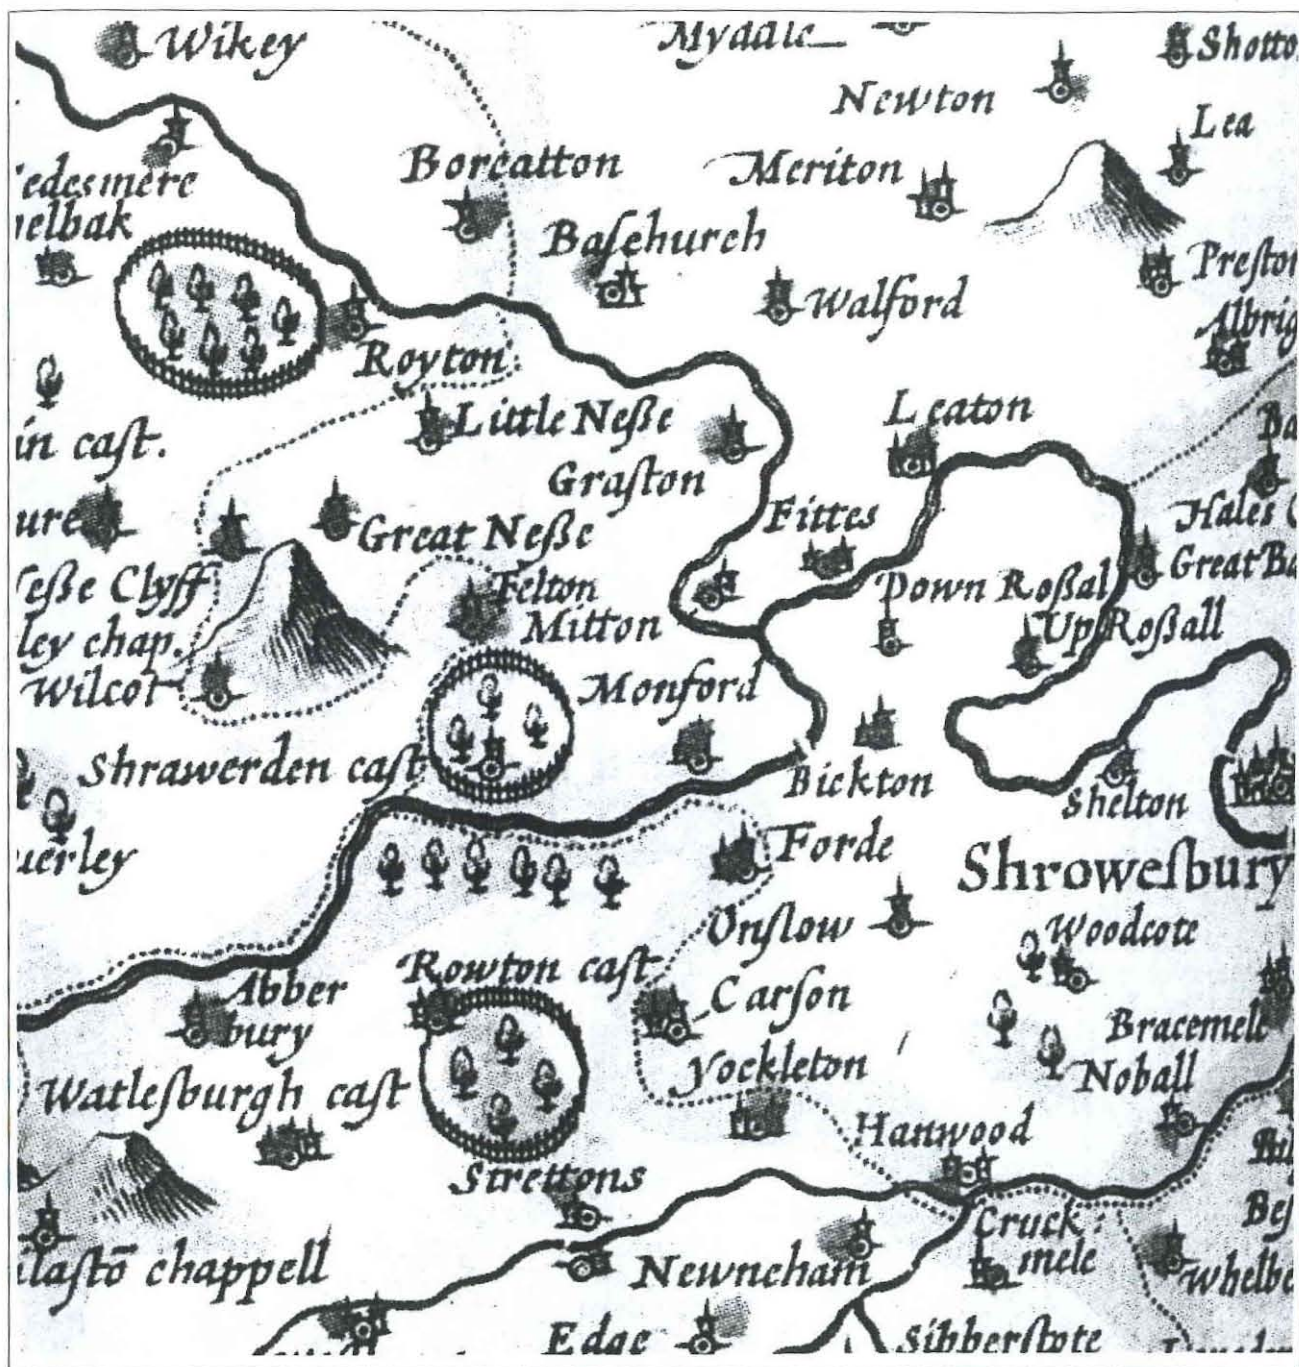
Fig. 1 Extract from John Speed's map of Shropshire 1611

- 3.3 The rebuilding of the castle was ordered by Henry III in 1220, but in 1229 the castle-guard duties were transferred to Montgomery, suggesting that the Crown was no longer interested in refortifying the castle. At some point after this, the castle appears to have come into the possession of the Fitzalans who renamed it Castle Isabel. Although the Fitzalan estates were forfeited and later reinstated at various times over the following three centuries they were still held by Philip Howard, grandson of Henry Fitzalan, Earl of Arundel in 1583, at which point Shrawardine was sold to Sir Thomas Bromley, Lord High Chancellor to Elizabeth I. Shrawardine is depicted by Christopher Saxton in 1577 surrounded by a park pale, suggesting that the Fitzalans may have developed the castle into a country estate before it was sold. This depiction was later copied by John Speed in 1611 (fig. 1)

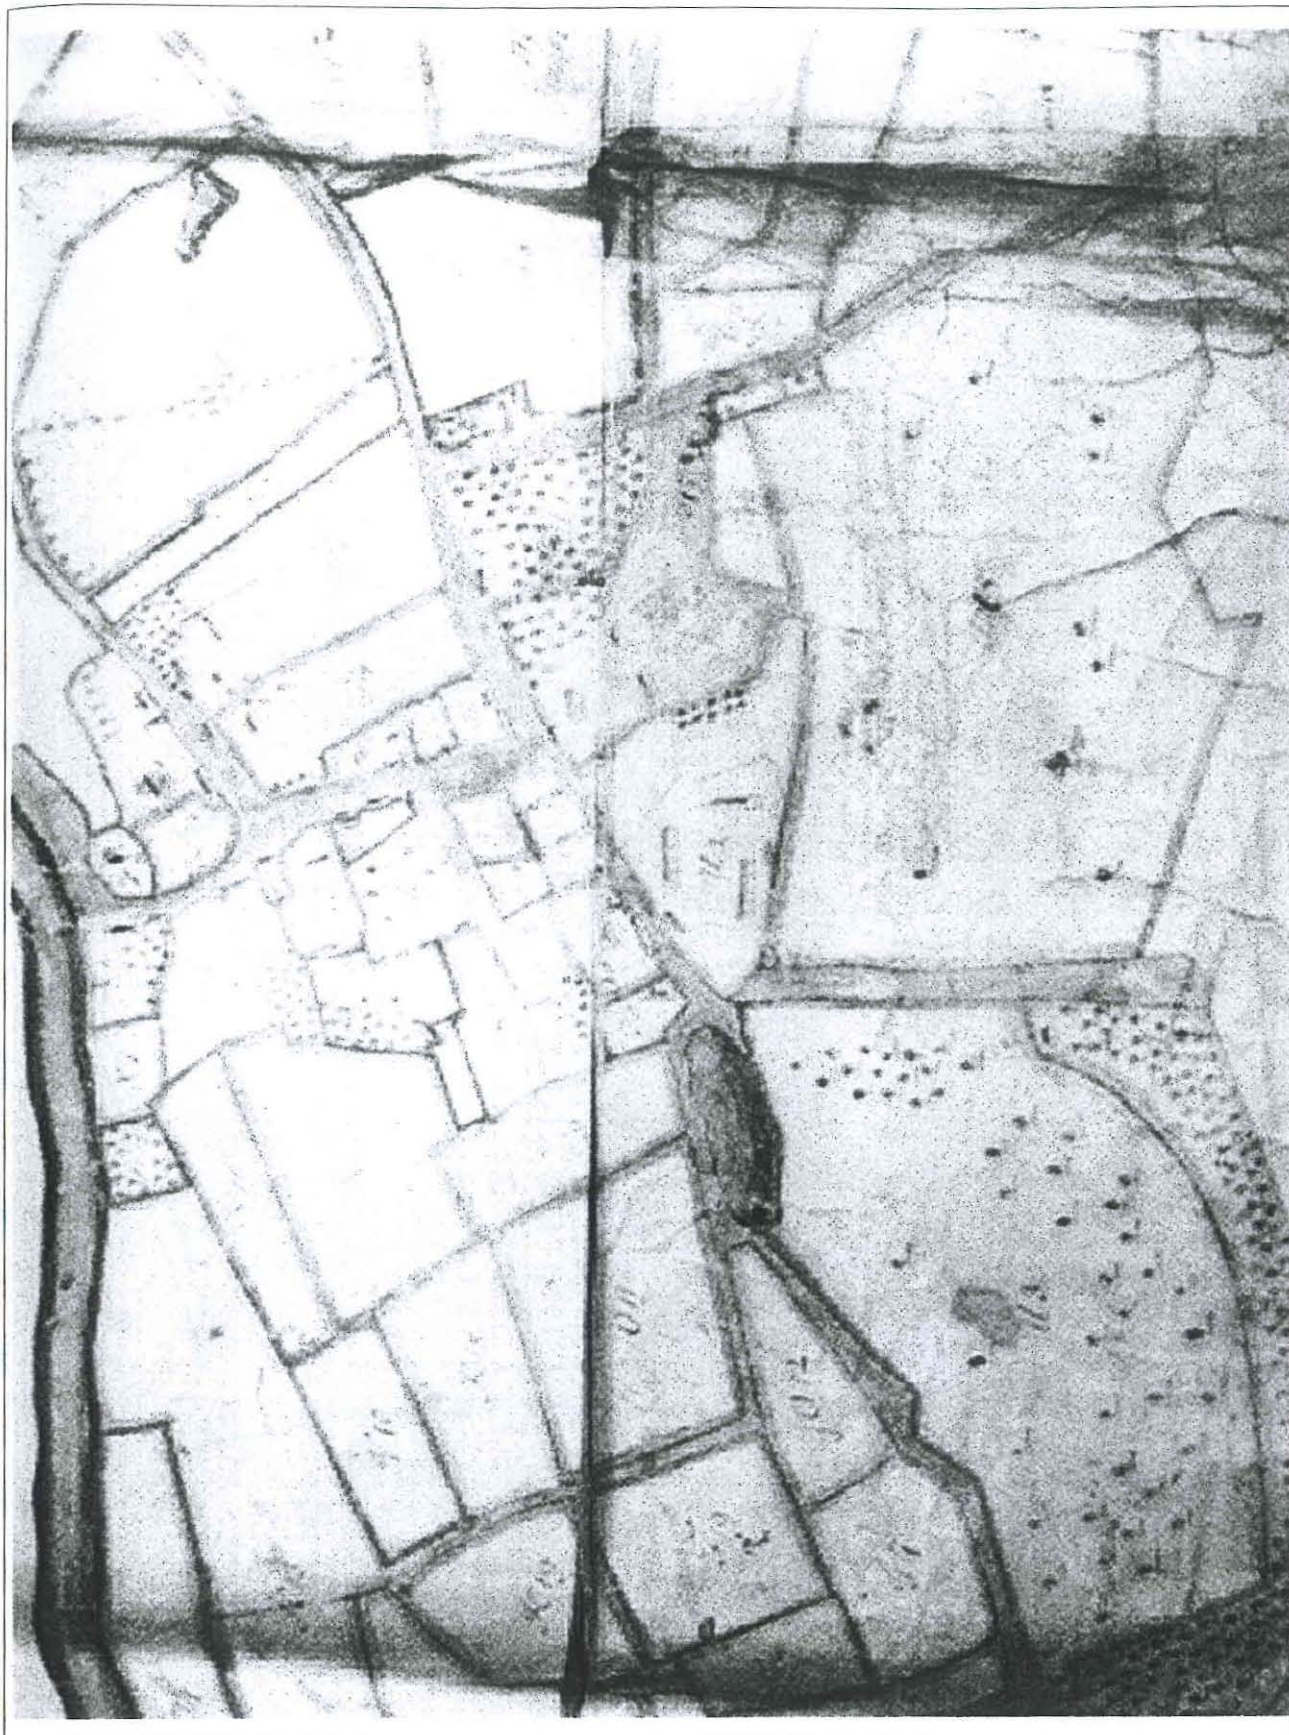
Fig. 2 Extract from 1728 map of Bromley Estate, Shrawardine

- 3.5 The earliest detailed cartographic evidence is provided by a map of the Bromley Estate in Shrawardine, dated 1728 (SRRC 552/8/306; fig. 2). The area of the castle is recorded as being Castle Court, let to Edward Parton. The map depicts the castle mound with three surviving masonry fragments and it suggests that the castle was roughly rectangular in plan. There is also interesting detail regarding parts of the castle defences and bailey, as well as details of houses to the west of the castle. A plan of 1824 (SRRC 552/8/352; fig. 3) shows the castle mound with three sections of masonry but in no real detail.

- 5.10 To the south and east of the motte there are faint signs of multi-angular revetment to the broad ditch which survives as an earthwork. The ditch is now crossed by an irregular causeway and the survey does show possible structural masonry here, although it is uncertain whether this is an original feature or perhaps just spoil and rubble dumped from antiquarian excavations. A structure identified within the bailey opposite the south-west corner of the castle mound may be the base of a tower (fig. 16), possibly associated with a drawbridge. To the west of the motte there is no surviving earthwork ditch, although the geophysical survey has tentatively identified its outer extent which broadly coincides with the depiction on the 1728 estate map (fig. 2).

- 6.16 Although there appear to be no contemporary depictions of the castle at this time, the map of the Bromley Estates in 1728 (SRRRC 552/8/306; fig. 2) provides some indication of what might have existed. Unfortunately, there is little detail of the castle itself, which had presumably already been substantially robbed by this time, although three sections of masonry are depicted. What is shown, however, is the eastern side of the inner bailey, together with the straight north-eastern side which joins a boundary leading to the pond. This boundary may be the earthwork which survives to the north of the castle, along the eastern side of the track. To the west of the castle two buildings (fig. 16) are depicted with gardens in between, apparently set within the enclosure of the castle defences. The southernmost building has been identified by the geophysical survey, which also identified a possible pond in this area. A third, two-storey building (fig. 16) is shown further to the west and this is depicted again on the Tithe Survey of 1844. By 1882, however, the building appears to have been demolished, surviving now as a series of low earthworks. The 1728 map also shows a row of buildings along the street front at the western edge of the survey area (fig. 16), the eastern side of which is now marked by a pronounced scarp within the field, running parallel to the road.

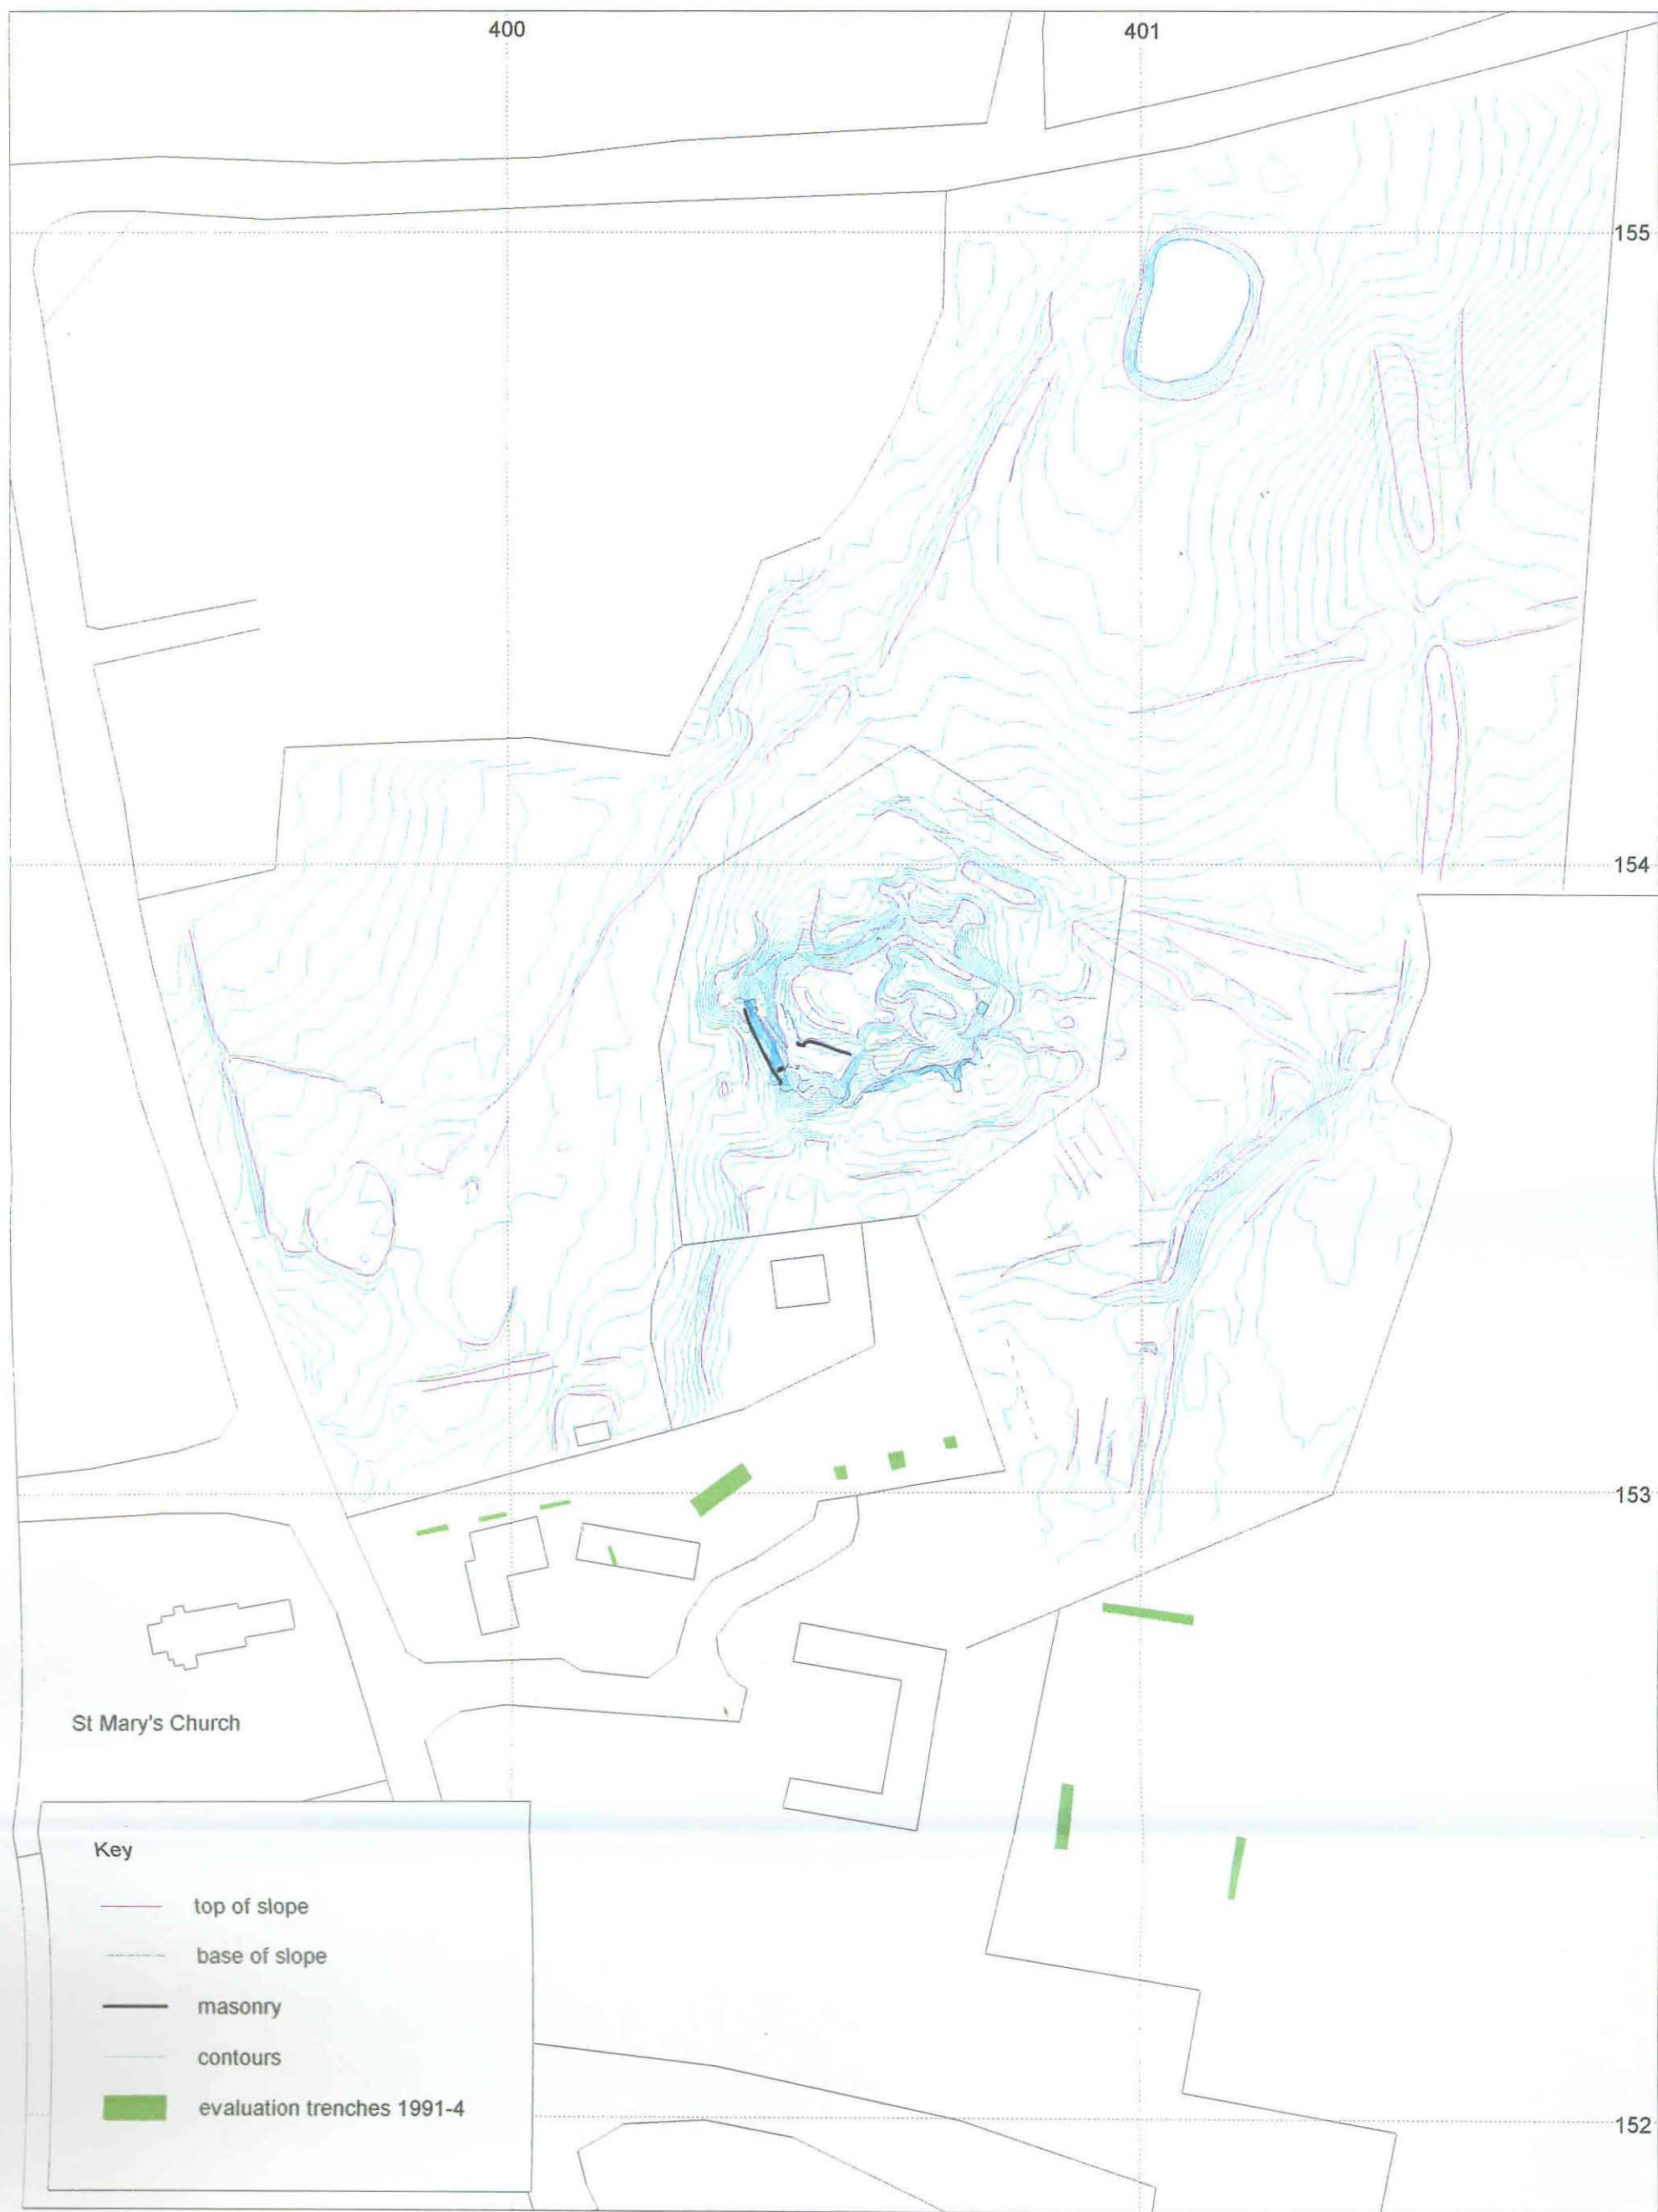
Fig. 7 Topographical survey, scale 1:1,000. Contours at 0.2m intervals

- 4.3 A contour model (fig. 7) has been produced with contours at 0.2m intervals, clearly showing the surviving earthworks. This has been used as a basis for producing a hachured plan of the surveyed earthworks (fig. 8). Further processing of the data has also enabled the production of a relief shade model (fig. 9), which gives an impression similar to that of a vertical aerial photograph. The results from the survey have shed further light on the earthwork remains of the castle and surrounding landscape, details of which are presented in section 6.

- 3.8 The expansion of the village during recent years has led to a series of archaeological evaluations being undertaken to the south of the castle mound (see fig. 7), the results of which have confirmed the presence of the bailey ditch as well as revealing a 12th-century pottery kiln (Hannaford 1991; Hannaford 1992; Hannaford and Phillpotts 1994).

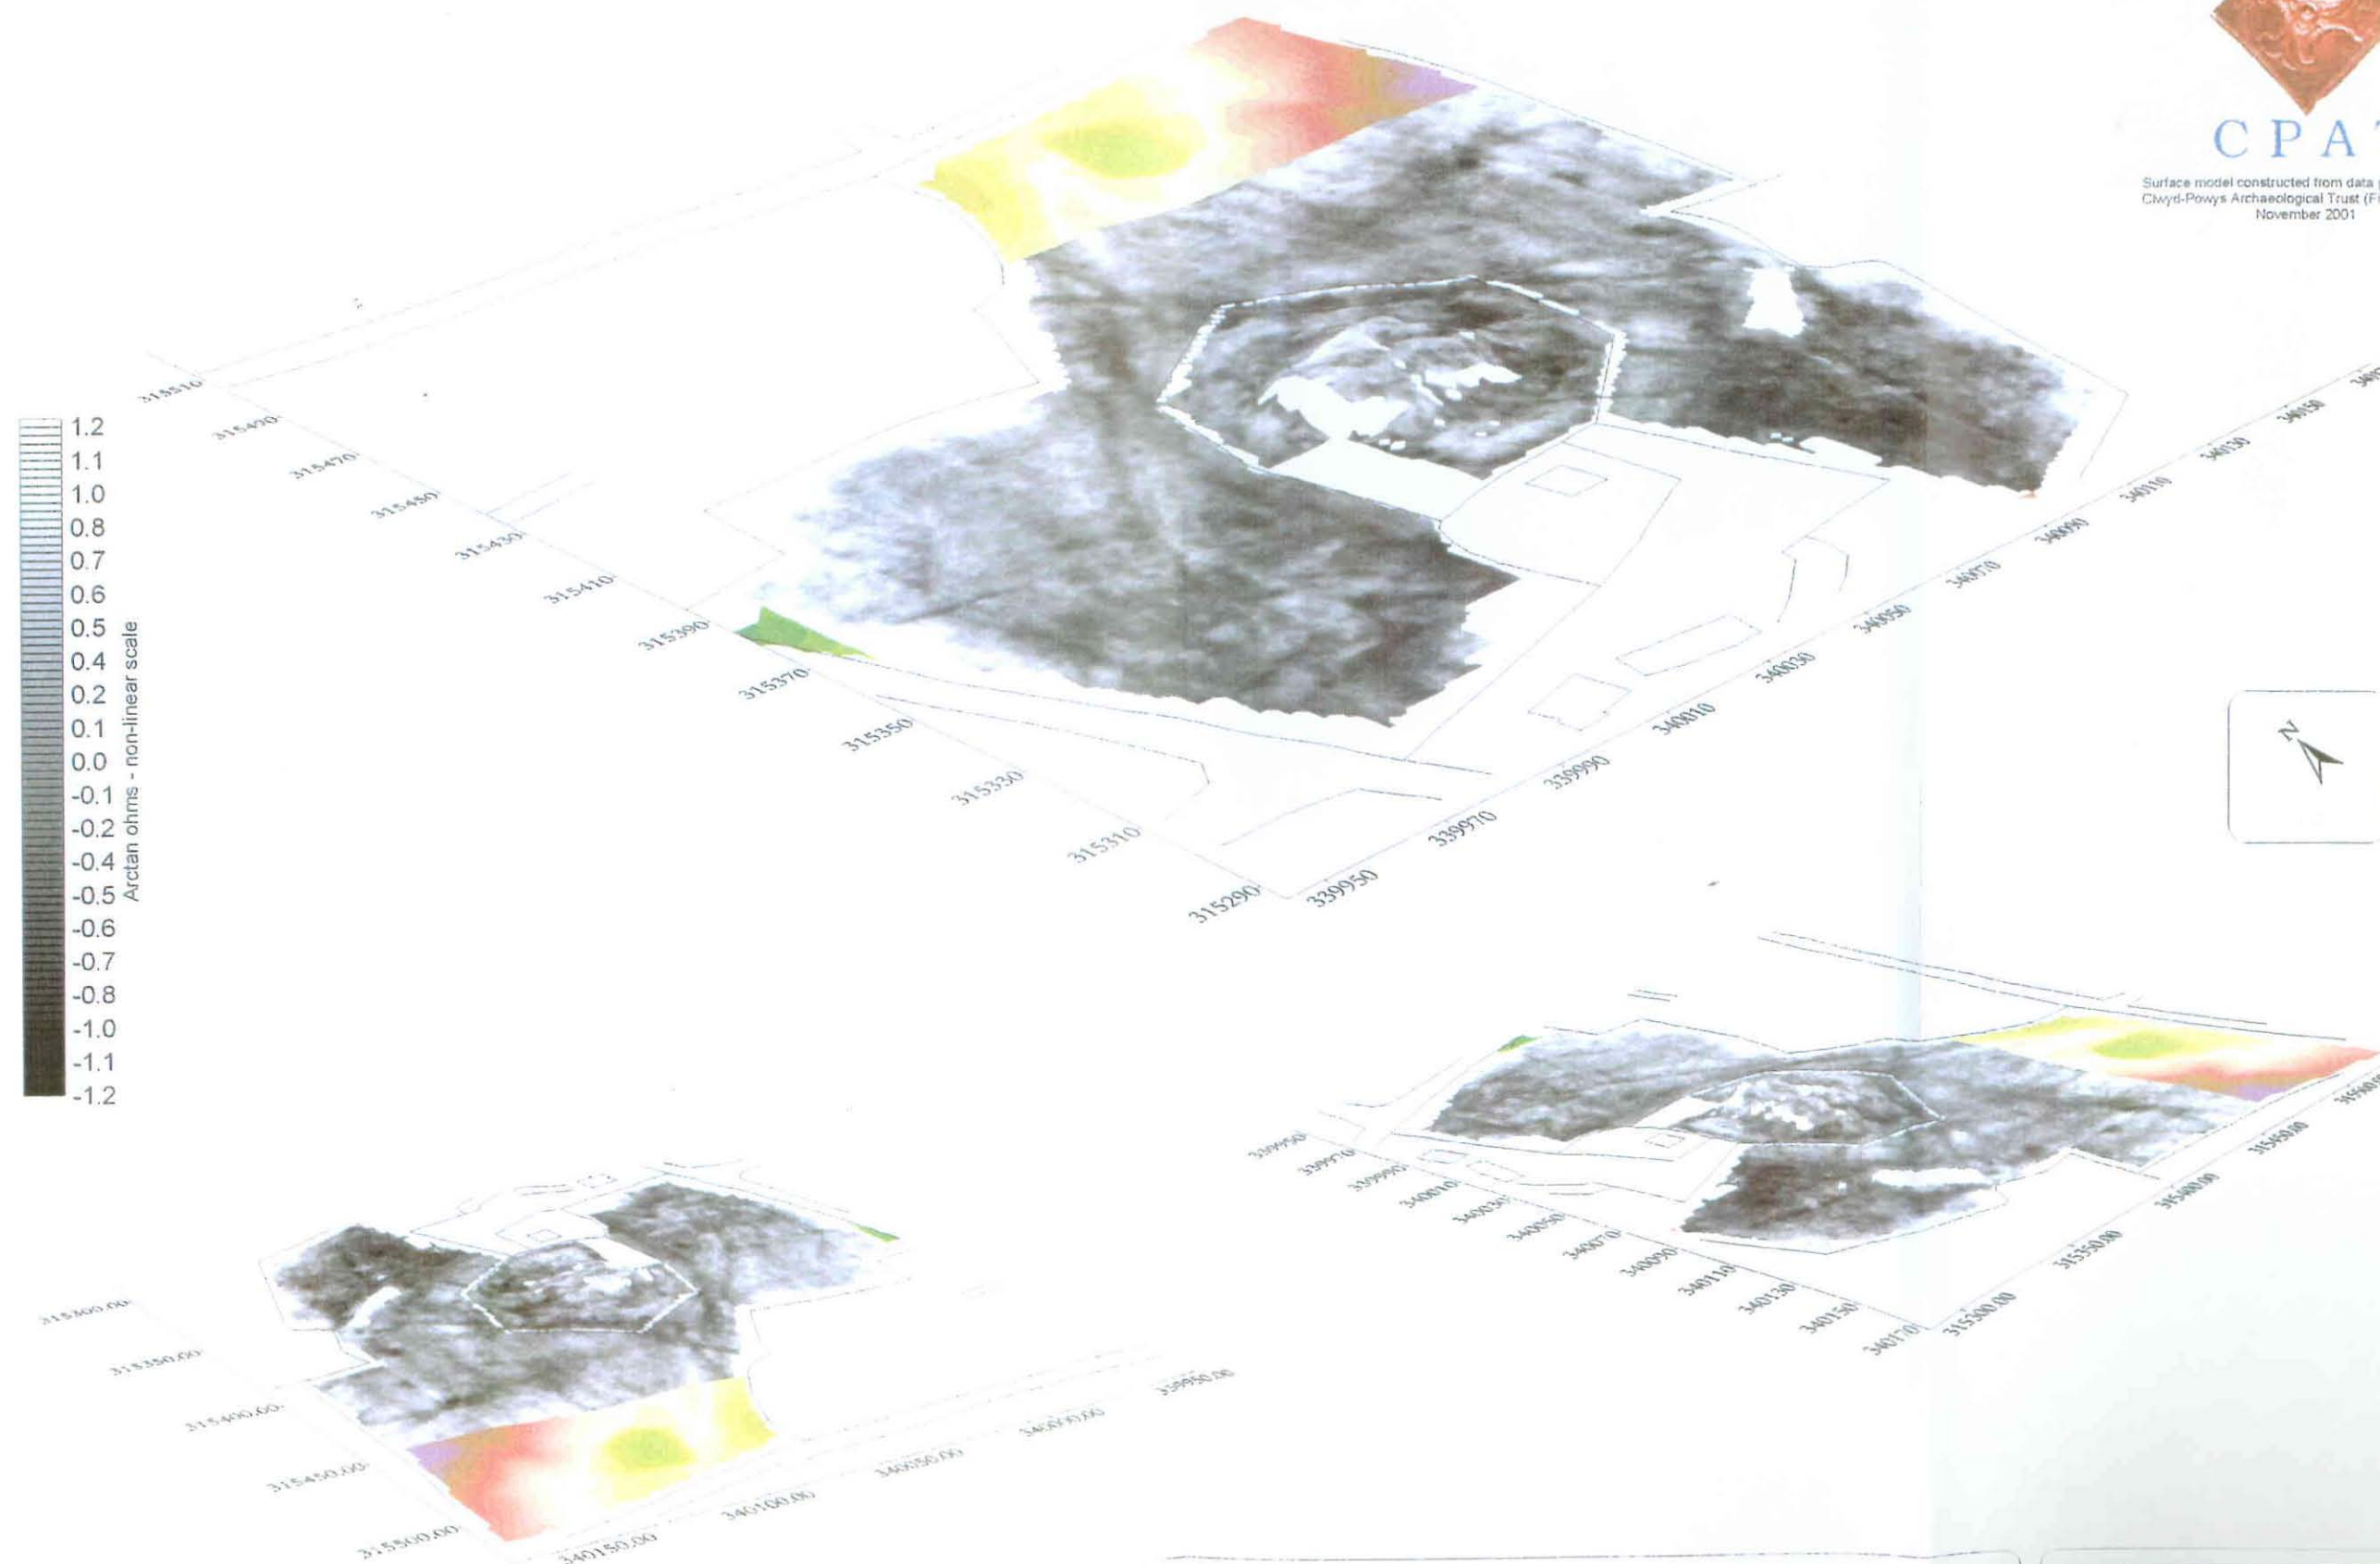
Fig. 14 Geophysical survey: Pseudo-aerial Perspective view of Electrical Resistance data

Project Code: SHW20011
Project Name: Shrawardine Castle
Drawing No.: DWG 08
Drawing Title: Pseudo-Aerial Perspective View of Layer 'A' Electrical Resistance Data
