Old Mill, Harley, Shropshire

ARCHAEOLOGICAL SURVEY

CPAT Report No 593

November 2003

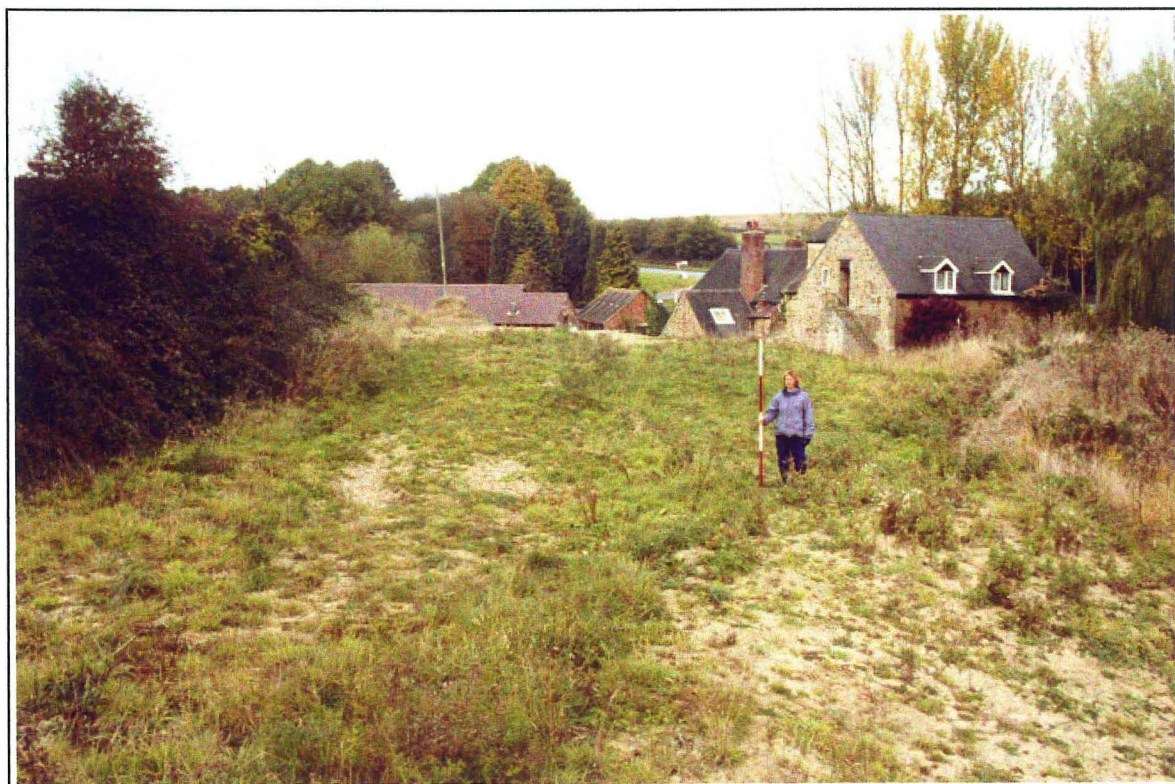
Plate 1 Harley Mill pond from SW showing area of groundworks. Photo CPAT CS03/53/33

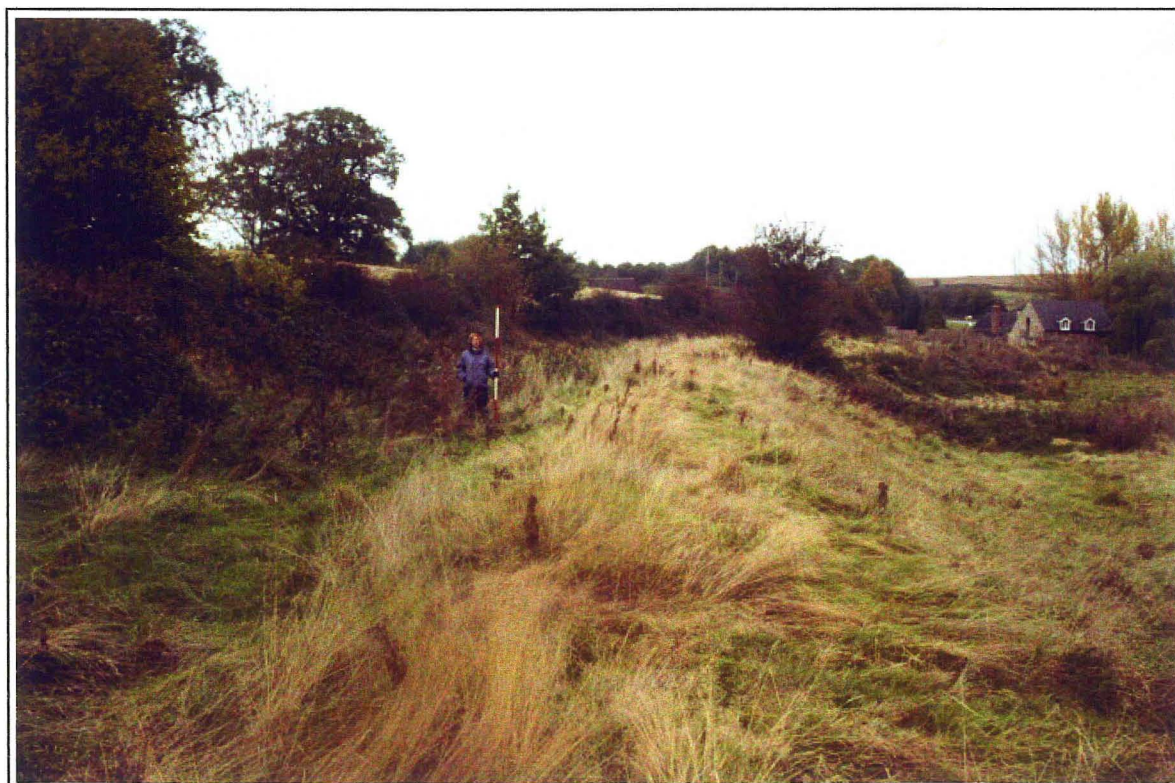
Plate 2 Harley Mill leat and mill pond from S. Photo CPAT CS03/53/34
