**CPAT Report No 1097**

# Pentre Mill, Dyserth Hydro Scheme

## CULTURAL HERITAGE ASSESSMENT

**N W Jones and R J Silvester** May 2011

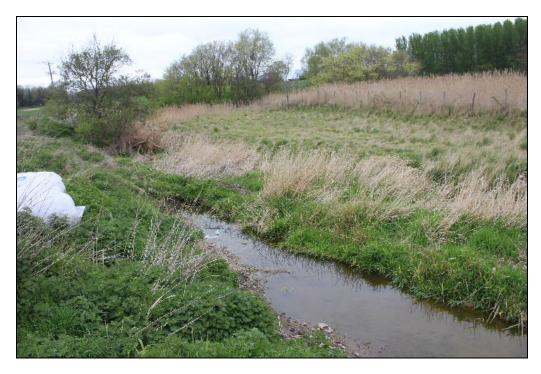
*The mill pond.* On early Ordnance Survey maps from the end of the 19<sup>th</sup> century, the mill pond is depicted as an elongated, almost elliptical feature aligned south-east to north-west with two outlets at northern end and an i nlet leat at the southern. It was at that time about 50m long and a little under 20m wide. The entire outline of the pond can still be seen but it is now largely silted up and grassed over, with a drop of less than one metre on the northern side. Fed by the leat entering from the east a channel around 4m wide has been created along the southern side of the pond for almost its whole length. This contains sluggish water for only the first 15m or so, but after that ex hibits only a damp and marshy base. The fact that the ch annel is deeper than the pond surface indicates that in the past it continued to funnel water to wards the overspill channel after the pond had silted up.

The silted millpond from the south. CPAT 3272-0025

The mill pond is completely silted up, but there is no indication in the development plan th at this will be affected by the hydro works.

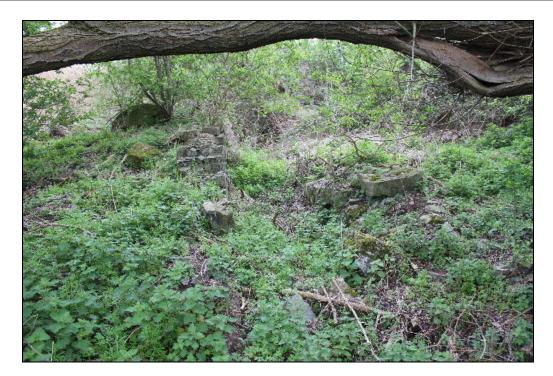
*The head race.* At the northern end of the mill pond the water was channelled into a short head race to the mill wheel via converging stone-built walls, that on the west side bein g rather longer than that on the east. Although the vegetation makes assessment difficult, it appears that the head race was fairly level or had a slight slope at most, and was designed to feed an overshot w heel. A portion of the mill race wall (on the east) still stands to a height of about 2.2m.

The mill remains looking up from the tail race. CPAT 3272-0018

*The mill buildings.* These are positioned around about 2m or more below the mill pond, as a result of the careful adaptation of a valley slope here. Two buildings are shown on the 19<sup>th</sup>-century Ordnance Survey maps; both have now been reduced to low stony foundations and in places these are barely discernible. The larger of the two was presumably the mill itself, and fragments of mill machinery and at least one mills tone are scattered across its surface. The purpose of the smaller building immediately to the south is not clear.

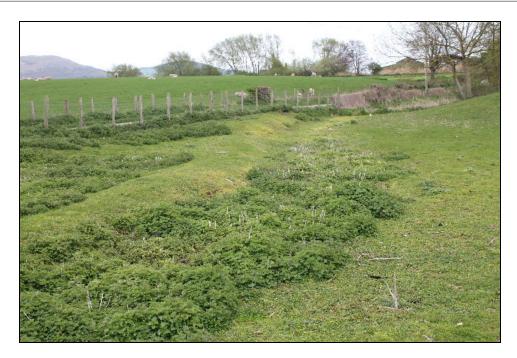
*The tail race*. In the fenced off scrub, the tail race still shows as a pronounced gully as it descends the slope, though there is no convincing visible evidence of a stone-built element to its structure. In the pasture ground to the north it takes the form of a hollow around 1.8m wide with a bank of spoil on its eastern edge. The mill race has, then, been allowed to silt up. It might be mentioned here that the local topography implies quite strongly that this channel followed the original course of Afon Ffyddion.

The tail race from the north-west. CPAT 3272-0015

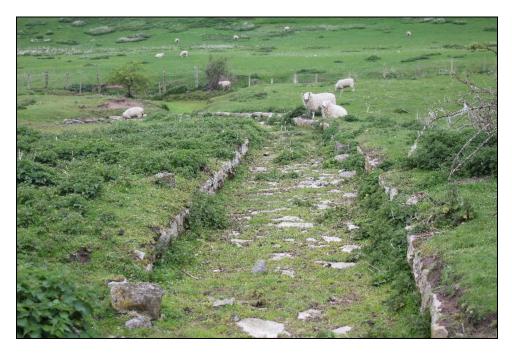
*The overspill channel.* Immediately to the west of where the mill race runs off the mill pond, there is another egress for water in the form of an overspill channel. This is a formalised construction. A short length of stone-built channel with so me concrete facing is about 1 .9m wide and 0.6m deep. Along its short length of around 8m, there are two stone 'steps', presumably designed as a fish ladder. Beyond this short stretch, the channel adopts a curving course downhill, its stone base and low side walls still very clear, making it the best-preserved part of the mill infrastructure. There are no obvious steps in this section. At the bottom of the slope, the stonework stops and the channel becomes a flat-bottomed grassy hollow leading to the stream.

The overspill channel looking northwards. CPAT 3276-0006

The overspill channel and weir is a fine piece of archaeology. It is to be retai ned and fitted with cross strakes and it is recommended that damage for any structural modifications be kept to a minimum.

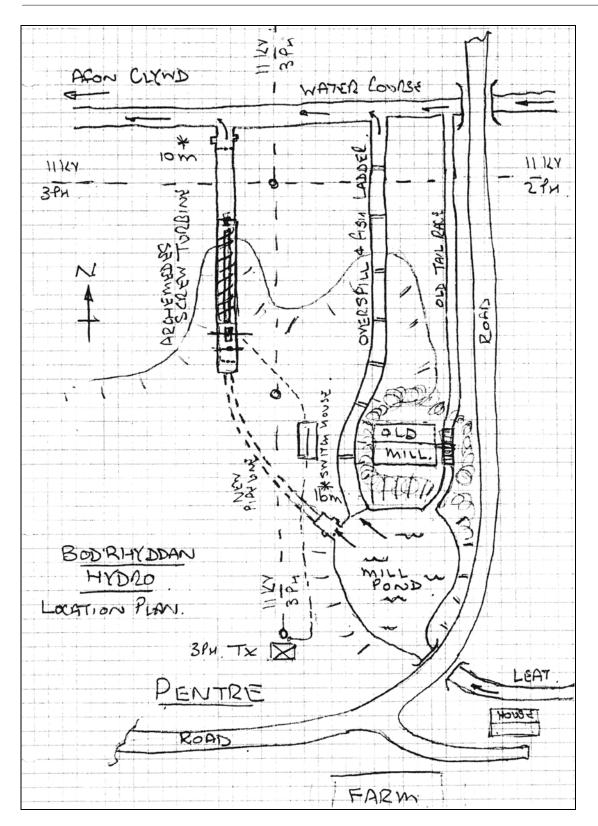
Carter Jonas' sketch plan of the proposed works

Alternative locations have been suggested for the turbine planned for the development. The sketch map attached to the development plan reveals that one location would be in the field which sh ould be away from the mill complex and have few if an y archaeological implications. The alternative is to use the mill wheel pit. This would require the clearance of vegetation and presu mably some of the collapsed material from the mill itself, while the introduction of the turbine as well as the clearance work would require the use of heavy equipment which could cause further damage to the mill site. A watching brief coupled with detailed recording is recommended.
