CPAT Report No 1036

Medieval Crosses and Crossheads

SCHEDULING ENHANCEMENT

March 2010

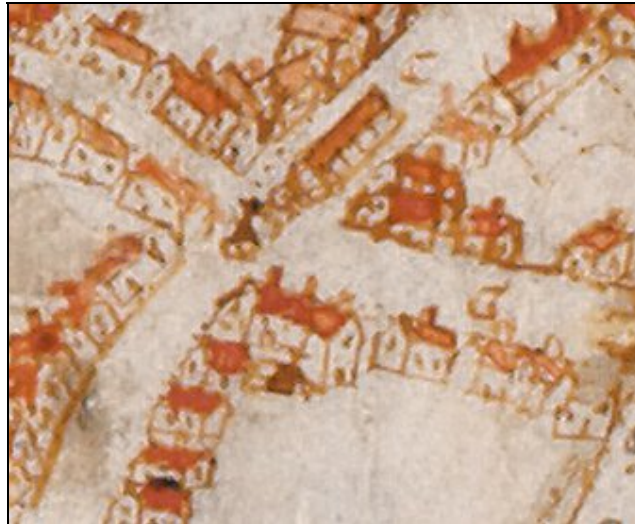
Welshpool town cross as depicted by Humfrey Bleaze in 1629

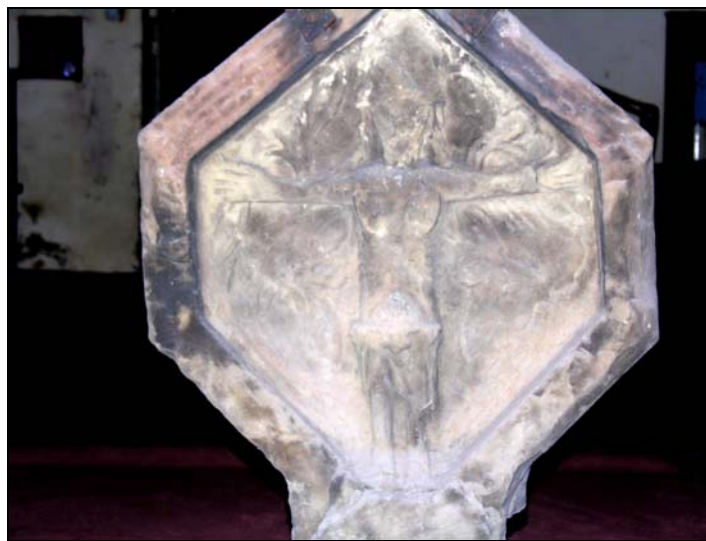
Llanynys crosshead with crucifixion

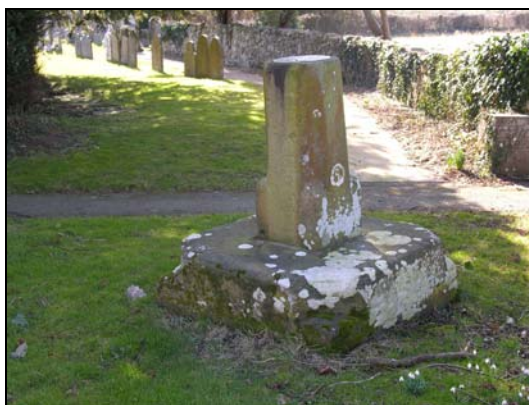
Llanefydd cross base

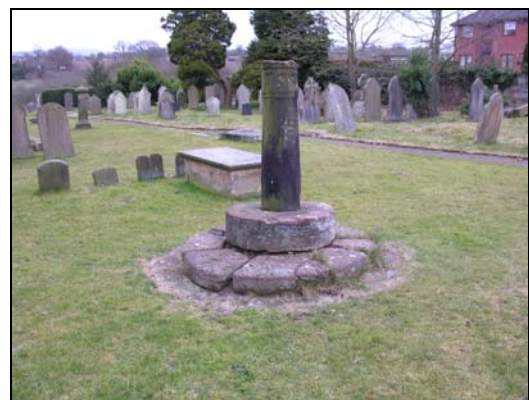
Holt cross base

century upheavals than shafts and heads, because they could be re-used, particularly for sun-dials, and because they were uncontroversial in the religious climate of the day. Thus the socket stone of Llanefydd with the stump of the shaft has been reinstated in the churchyard after more than century in the vicarage garden, while the steps and socket stone at Holt have remained as the support for a sundial.

The existing description should be abandoned. Whatever it is describing it is not Holt. The churchyard cross is represented by three circular steps to the south of the church. The lowest step is just above ground level with a basal diameter of about 2.2m and the three steps combined are about 0.5m high. The third step also acts as a socket stone fashioned from a single block of stone and showing some repair. Above this is a cylindrical pillar of local pink sandstone, without chamfers or stops and about 1.25m high. This is topped by a slightly expanded 'capital' carrying a date of 1766. This does not appear to be a re-worked cross shaft but a new pillar for the church sundial (RS 03/2010).

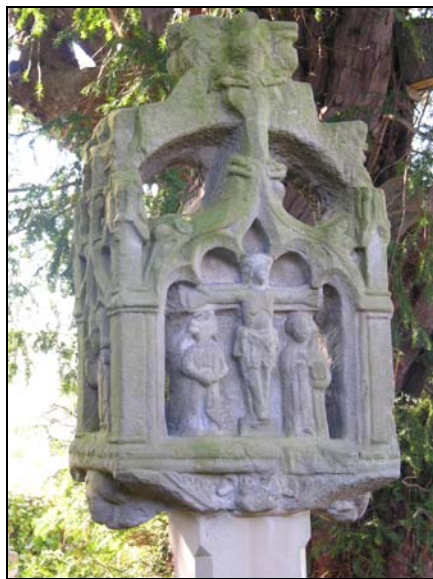
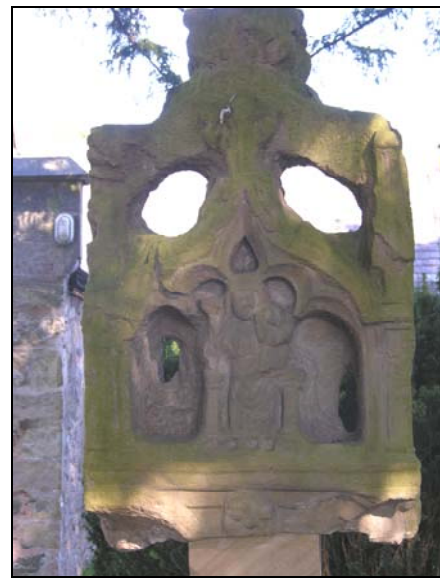
Tremeirchion crosshead from the east

Tremeirchion crosshead from the west

The cross shaft and base have long gone, but the cross head was sold to a Catholic gentleman and it ended up at St Beuno's College in Tremeirchion. However in 2004 under a faculty it was returned to Tremeirchion churchyard where it was re-erected on a new shaft and pedestal with three short steps. The cross head is 1006mm high x 64mm wide x 26mm deep. The bottom has been broken off and this is most obvious on the east and west faces, but otherwise a fine example of a medieval crosshead.

The cross shaft and base have long gone, but the cross head from Tremeirchion churchyard was sold to a Catholic gentleman in the 19th century and ended up at St Beuno's College elsewhere in the parish. In 2004 under a faculty it was returned to Tremeirchion churchyard where it was re-erected on a new, though rather short shaft with three small steps. The cross head is 1006mm high, 64mm wide and 26mm deep, and is elaborately decorated. The bottom has been broken off and this is most obvious on the east and west faces, but it is otherwise a very fine example of a medieval crosshead.

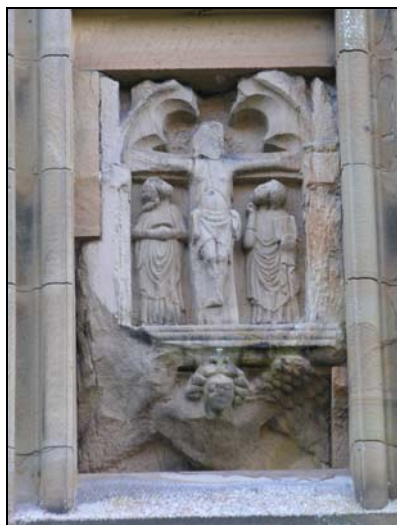
The Halkyn crucifixion

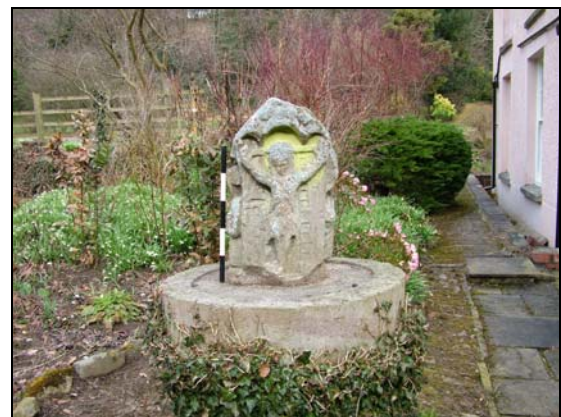
Crosshead from Denbigh Friary

The cross head from Denbigh Friary was found in the grounds there in the 19th century and removed to Dolhyfryd (the full story is given by Owen in 1886). It allegedly measured 0.62m by 0.6m by 0.2m and has a crucifixion on one side, the Virgin and St John on others. The modern OS map records the stone to the north-east of the house (RS 03/2010).

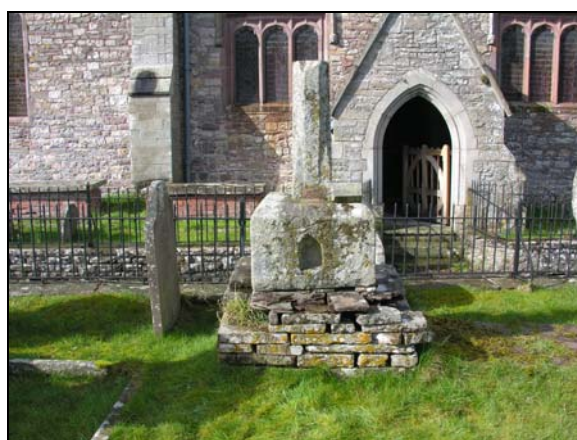
Llangattock cross base

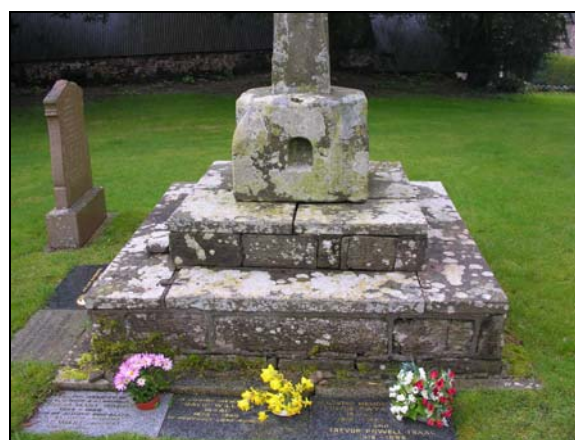
Cwmdy cross base

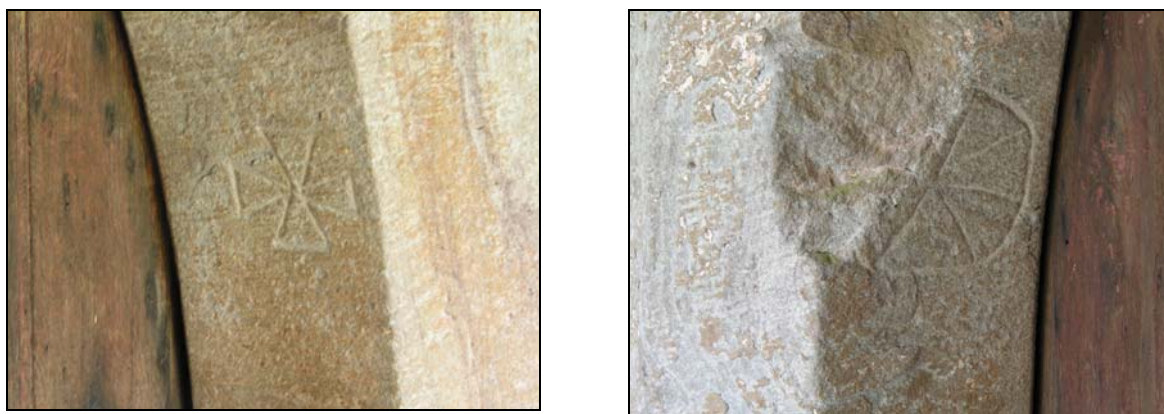
Consecration crosses on the springers of the south door of Llanfilo Church (Brecs)

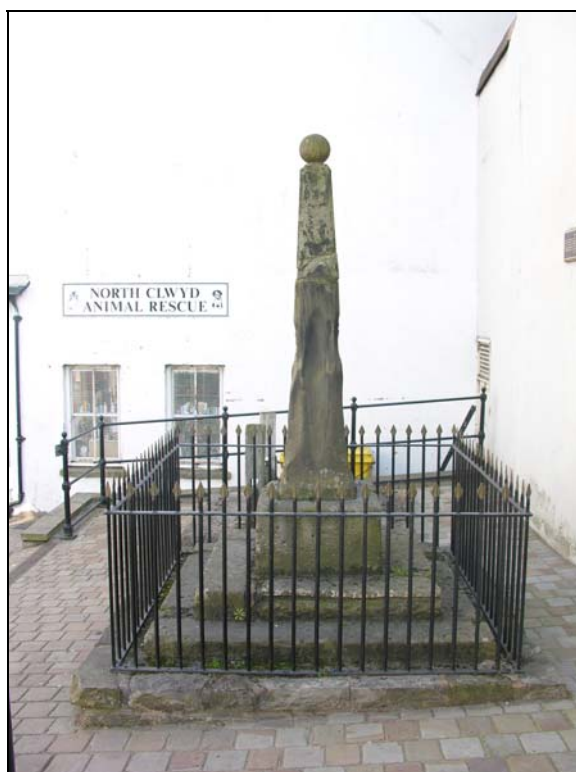
The market cross at Denbigh

Denbigh is exceptional, indeed perhaps unique in our region, for the survival of its cross. It has travelled around the town, yet in this there is an implication too that its past significance and

importance has been appreciated by the town council. Until the 1840s it stood by the market place, but then was replaced by a new Victorian cross and was transferred to the bowling green area by the castle. The Victorian cross itself was moved to a roundabout in the Lenten Pool area of the town in 1923 when a war memorial was erected in its place in the town centre, while the medieval cross moved again in 1982 and was re-sited behind the market hall in the town centre, a matter of a few metres from where it had been for many centuries.

The medieval Market Cross formerly stood by Crown Square but was removed in the 1840s when replaced by a Victorian cross (PRN 99779). It was re-erected by the bowling green adjoining the castle walls according to Owen (1886), and was transferred to its present position - at the top of Vale Street behind the Market Hall, and with the town stocks for company - in 1982. Three steps lead up to a square socket stone supporting a tapering shaft with concave chamfers on the lower portion, the present height of the cross a little under 3m. It is capped by a ball finial of 1760. The adjacent information board states that from 1821, butchers' stalls were attached to it, and this accounts for the knife-sharpening grooves in the stones (RS 03/2010).

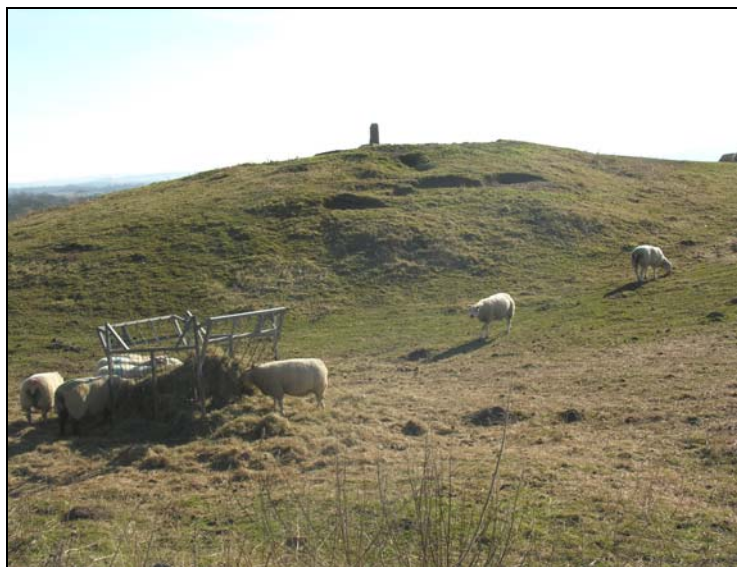
Can we identify many (or any) boundary crosses in east Wales? Criccin Cross to the east of Rhuddlan is one probable example, regardless of whether it corresponds with the cross of Dissard noted above. Its positioning on an isolated natural tump suggests that it was prominently placed to signal a boundary, but the argument holds precisely because of this location, not because of the appearance of the cross itself. A glance at the early Ordnance Survey maps shows that it is on the parish boundary between Rhuddlan and Cwm, and that the boundary in the late 19th century even detoured around it following the road that looped in order to avoid going over the mound. A boundary cross might thus seem likely for this scheduled ancient monument, but this is in fact the civil parish boundary, and the much longer standing ecclesiastical boundary followed an extremely irregular course through fields to

Criccin cross

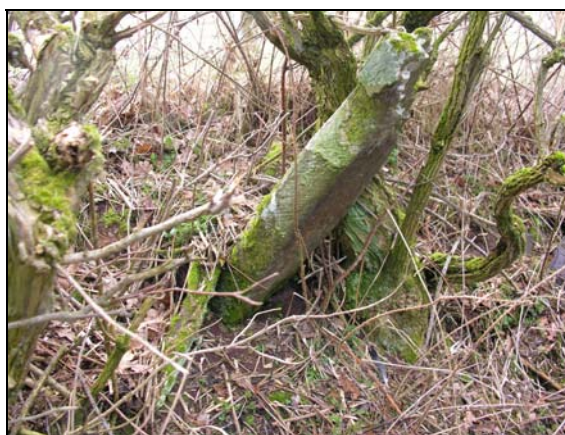
The Pedlar's Cross near Llanigon (Brecs)

However, the Pedlar's Cross near Llanigon (scheduled) is probably beside an ancient track running southwards towards Llanthony Abbey, and it has been suggested that the 13th-century cross not too far away in St Martin's church at Cwmyoy (also in Monmouthshire) was a wayside cross on the pilgrim's way to St Davids, though Peter Lord favours an interpretation as a churchyard cross (Proctor 2007, v; Lord 2003, 174).

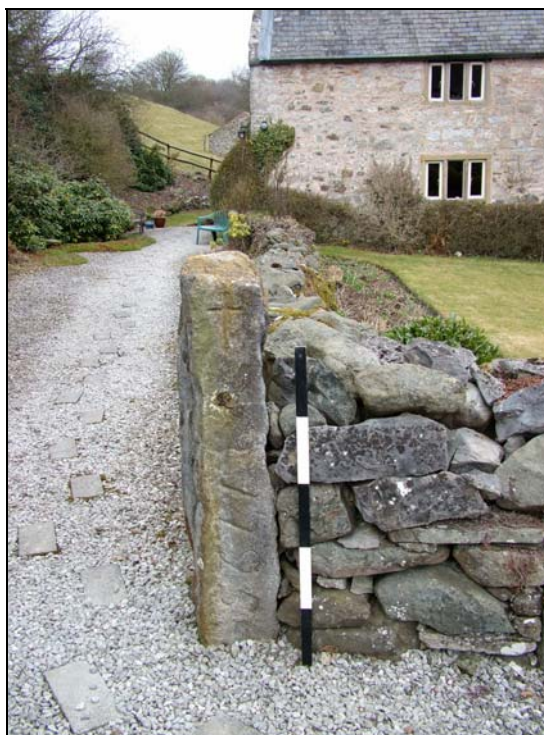
Initially it was felt that the Maes-y-groes cross in Cilcain could fall in this category. It lies within a short distance of a lane which runs north to south passing Cilcain but potentially traceable for a considerably longer distance, below the Clwydian Hills and in this area west of the Alyn Valley. Projecting it northwards it could reach Holywell and Basingwerk Abbey and southwards to Valle Crucis Abbey in the Dee Valley, but this is all a speculative notion without any research to back it up. However, our field assessment indicates that the stone on which the cross is incised is of rather more recent origin, probably contemporary with the inscribed date and that a monastic link is unlikely. Notwithstanding this, why isn't this stone listed? The nearby house is Grade II* and the barn Grade II.

The Maes-y-groes cross in Cilcain
