CPAT Report No 1102

Caergwrle Weir, Wrexham

SURVEY AND RECORDING

Report for Hyder Consulting and the Environment Agency

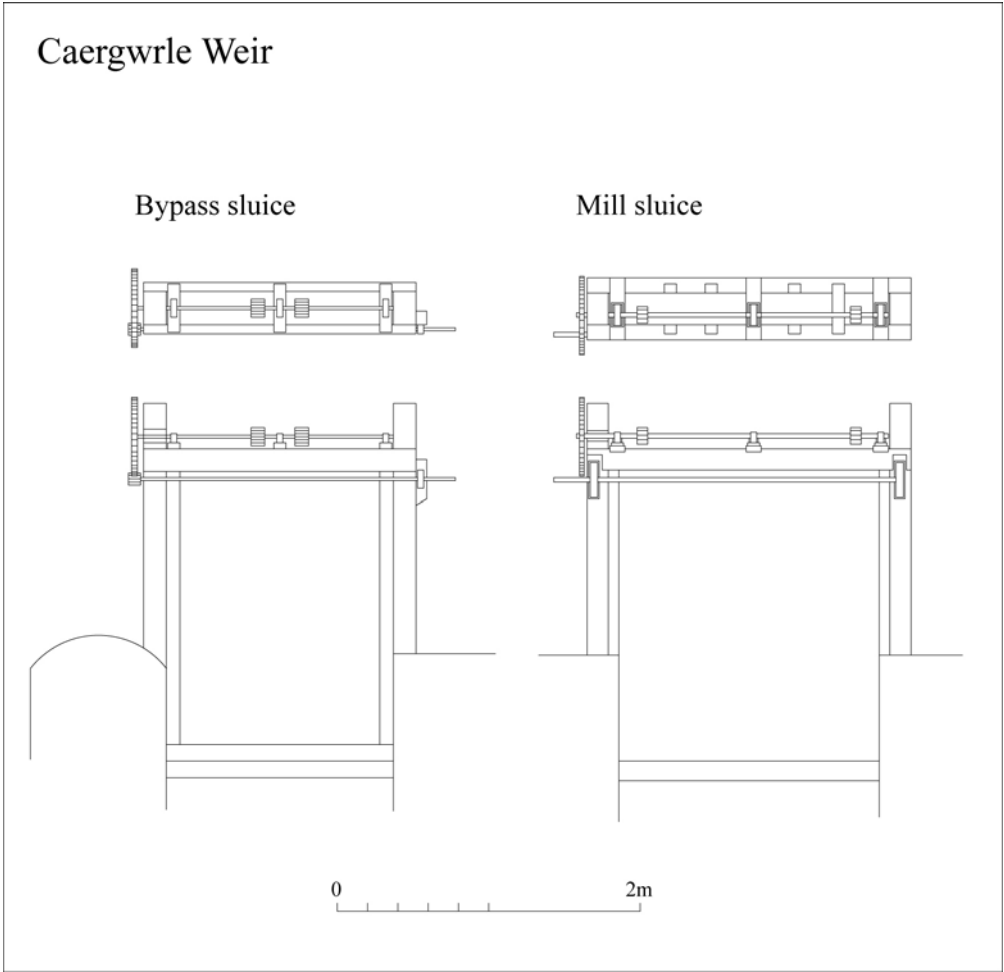
Fig. 3 Plans and elevations of the sluices viewed from downstream

- 3.1 The weir is located immediately to the south of the bridge which carries the A550 over the River Alyn and extends for around 30m across the river at an angle, diverting water towards the eastern bank. At the eastern end of the weir the water is controlled by two sluices, the westernmost at the head of a spillway and the eastern at the head of the mill race.

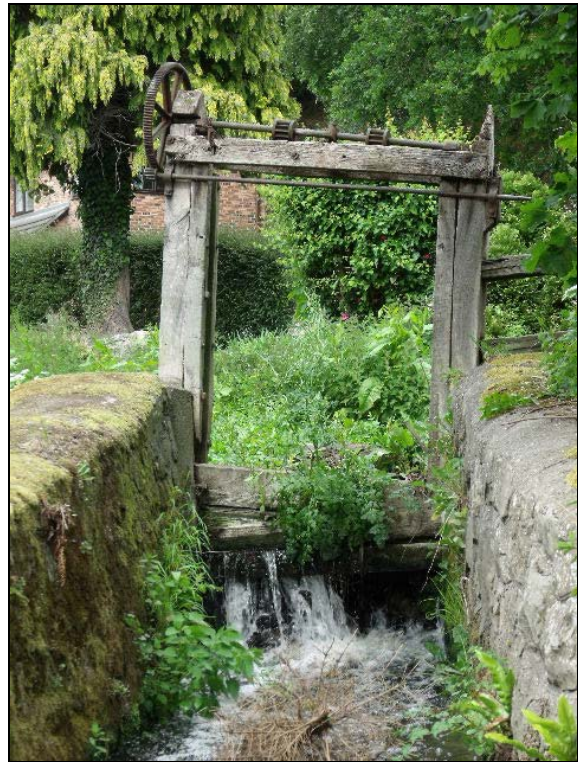
- 3.2 The sluice gate is in relatively good condition, comprising vertical posts on either side, supporting cross members which in turn support an axle mounted on three bearings, with a gear wheel on the western end. Geared sprockets on either side of the central bearing would have engaged with two racks mounted on the lifting board, which is now missing. The mechanism was operated from the eastern side by a crank handle which would have engaged onto the end of a spindle mounted on the southern face of the sluice, with a geared sprocket on the opposite end which engaged the gear wheel on the axle.

Fig. 4 The spillway and sluice. Photo CPAT 3288-0008

- 3.3 The spillway consists of a sloping channel which runs down the eastern side of the weir, separated from it by a stone wall and it is within this channel that the new fish pass is to be constructed.

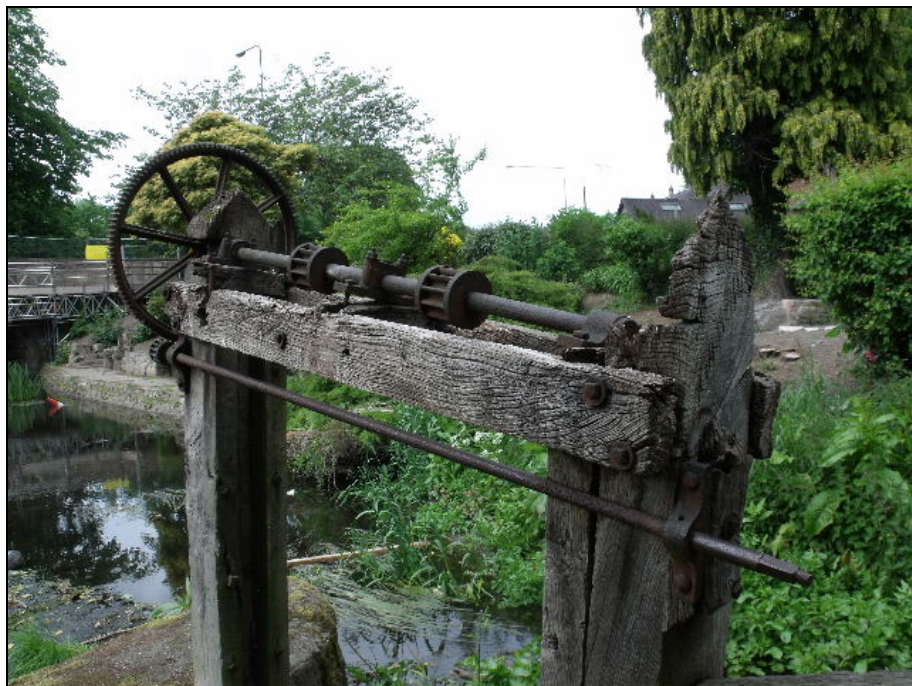
Fig. 5 The spillway sluice mechanism. Photo CPAT 3288-0014

- 4.1 The surviving features consist of a weir and two sluices associated with an adjacent mill building which has been converted to a dwelling. The flour mill dates from the first half of the 19th century and was part of the Rhyddyn Estate.
- 4.2 These features are good surviving examples of 19th-century mill infrastructure and although not exceptional they have significant value as a group, which can be regarded as of local rather than regional importance. The proposed alterations involve the removal of the bypass sluice, with the existing spillway being used for the new fish pass. It would be appropriate for the sluice to be repaired and replaced as part of this scheme if at all possible.

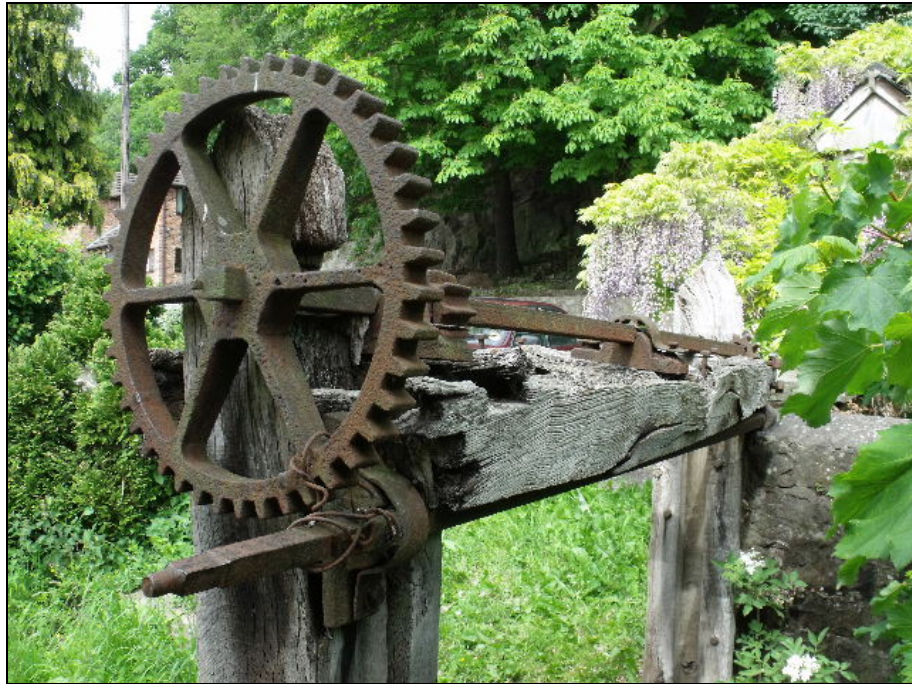
- 3.4 Some 2.4m to the east there is a second sluice controlling water into the mill race which appears to have driven an undershot wheel. The mechanism is similar to that of the spillway sluice, although it was operated from a crank handle on the western end, next to the gear wheel. The fact that the two mechanisms are not identical suggests that they are not contemporary and reinforces the belief that the spillway was a later addition.

Fig. 6 The mill sluice mechanism. Photo CPAT 3288-0013
