CPAT REPORT No. 1124

Tesco, Cefn Mawr, Wrexham

**ARCHAEOLOGICAL WATCHING BRIEF
AND BUILDING SURVEY**

December 2011

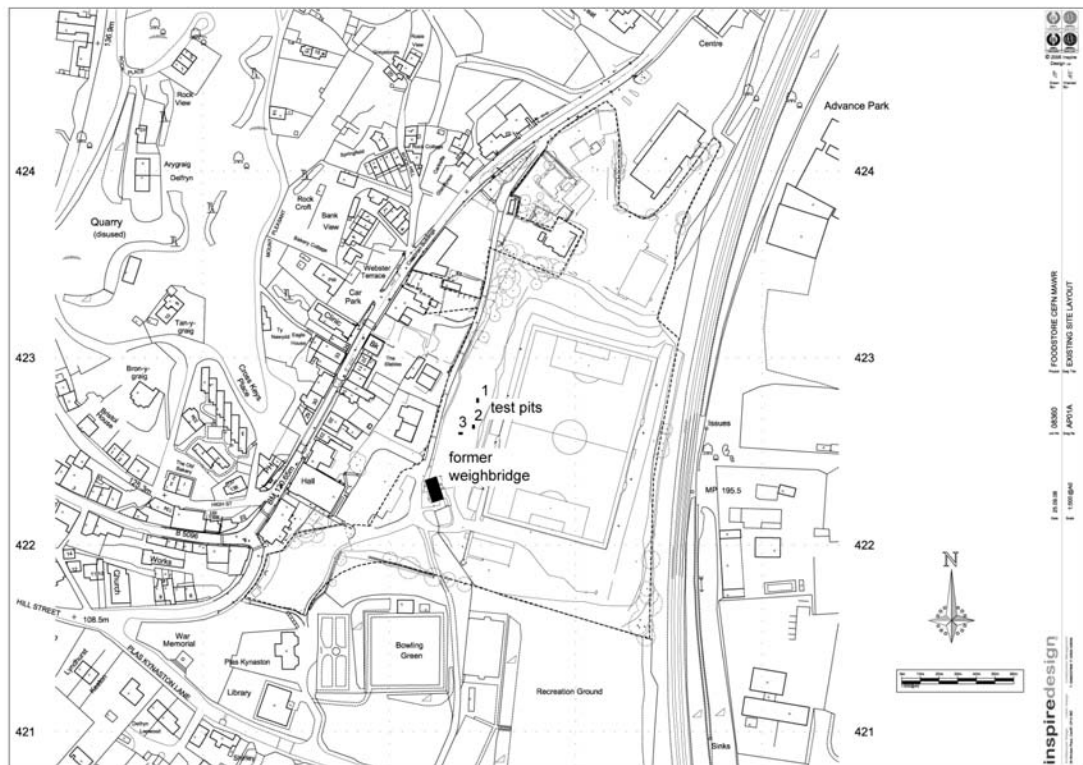
Fig. 1 Site and test pit location plan.

- 5.3 Three test pits (Figs 1 1-3) were excavated along the postulated alignment of the 19th-century tramline. The pits, varying between 3m and 6m in length and 2m in width and up to 1.8m deep, were excavated by machine down to the natural subsoil, which sloped from north-west to south-east. All the deposits recorded within the trenches consisted of re-deposited 20th-century dumped material.

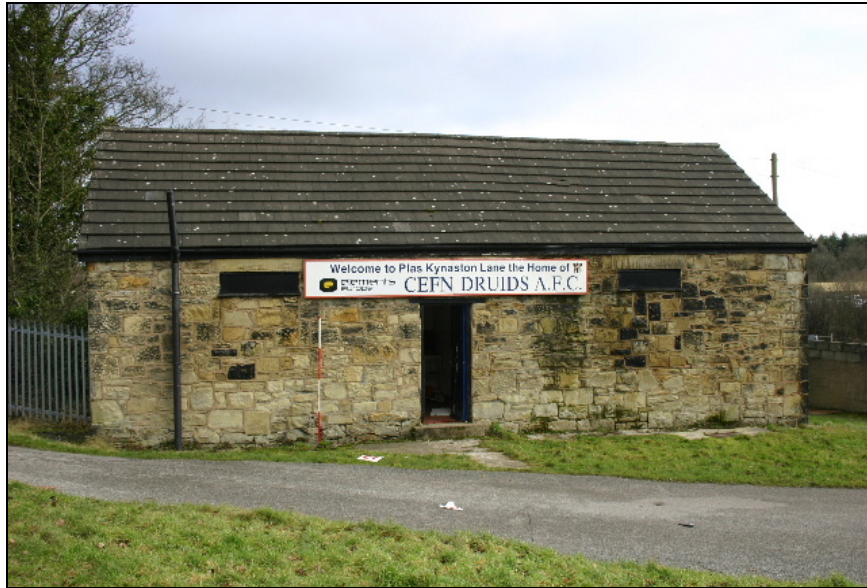
- 4.1 At the south-western corner of the development, adjacent to the main entrance and turnstiles to the former Cefn Druids ground, was a single-story, pitched-roof building of Cefn stone construction that had been used as changing facilities by the football club (Fig. 3). The building represented an isolated survivor from the 19th-century industrial complex and is traceable on the earliest Ordnance Survey editions, marked ‘W.M’ on the 1899 edition, indicating that it probably functioned as an office related to a weighbridge.

Fig. 3 'Cefn Druids' 19th century building viewed from the west.
Photo CPAT 3231-0002

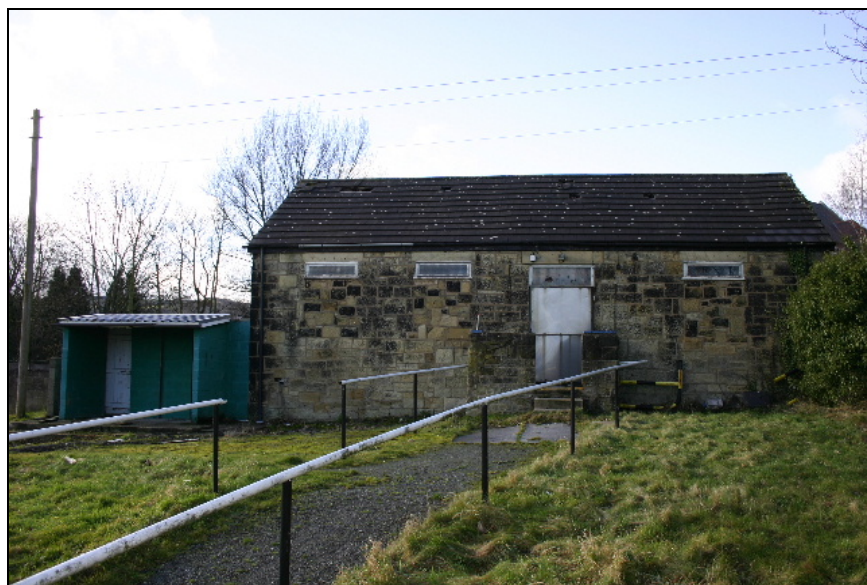
- 4.3 The single storey building, still standing to its original height of 5.5m, was constructed from locally quarried 'Cefn' sandstone with a pitched roof of modern concrete tiles. The roof, which presumably would have originally been slate tiled, was a 20th-century timber replacement that, internally, was supported on two central brick plinths and the original sandstone gable ends. The brick plinths could be a later addition, possibly chimney breasts that had been subsequently blocked up. Originally the 19th-century building appears to have been one large open room, measuring internally 11.5m x 5.5m. The main central access, still maintained, was through the western elevation with an additional broader access, the original purpose of which is unknown, through the eastern elevation opposite. The external porch-way, abutting the eastern wall, is also built from 'Cefn' sandstone but is of later date (Fig. 4).

Fig. 4 'Cefn Druids' 19th-century building viewed from the east.
Photo CPAT 3231-0023

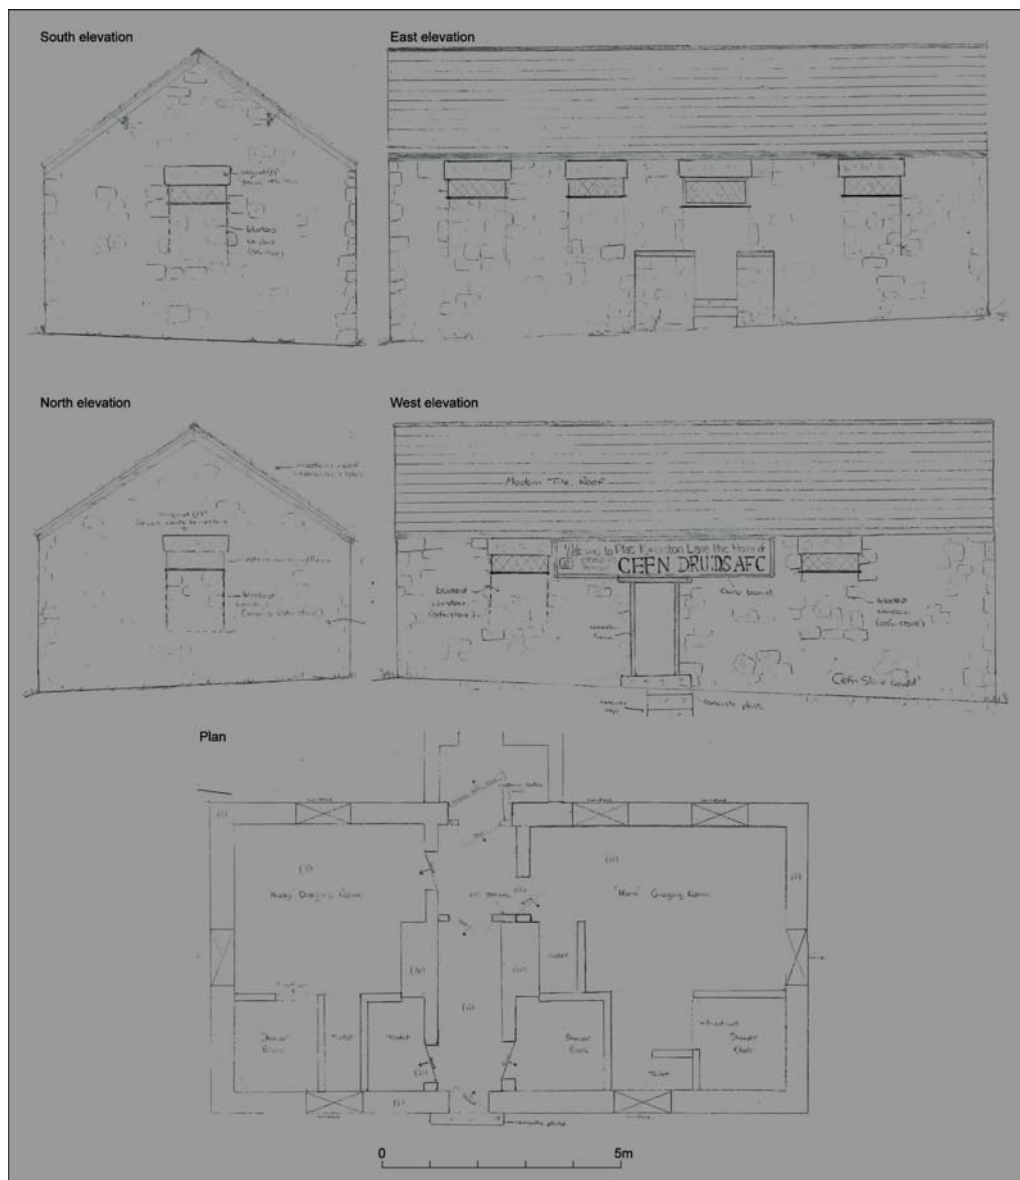
- 4.4 Along the western elevation, matching windows flanked the doorway, with a single window in each gable end. The eastern wall was somewhat different with two windows on the south side of the entrance and a single one on the north. The windows, originally of contemporary build and of 19th-century origin, had been greatly reduced in size and partially blocked up 'sympathetically' using similar 'Cefn' sandstone.

- 4.5 Internally the building had been modified into two separate 'changing' rooms partitioned by a central hallway. Through the western entrance there was access to a toilet booth and shower block off the hallway. Additional shower blocks and toilet booths had been constructed within each of the changing rooms. All of the internal floors had been re-levelled with concrete. A combination of plasterboard, stud-walling, modern breezeblock and brick had been used to construct, or alter, all of the internal rooms and partitions (Fig. 5). Any evidence of original 19th-century fixtures and fittings was concealed behind liberal layers of modern lime/wash mortar.

Fig. 5 'Cefn Druids' 19th-century building.
Elevations and ground plan produced as part of the Building Survey.

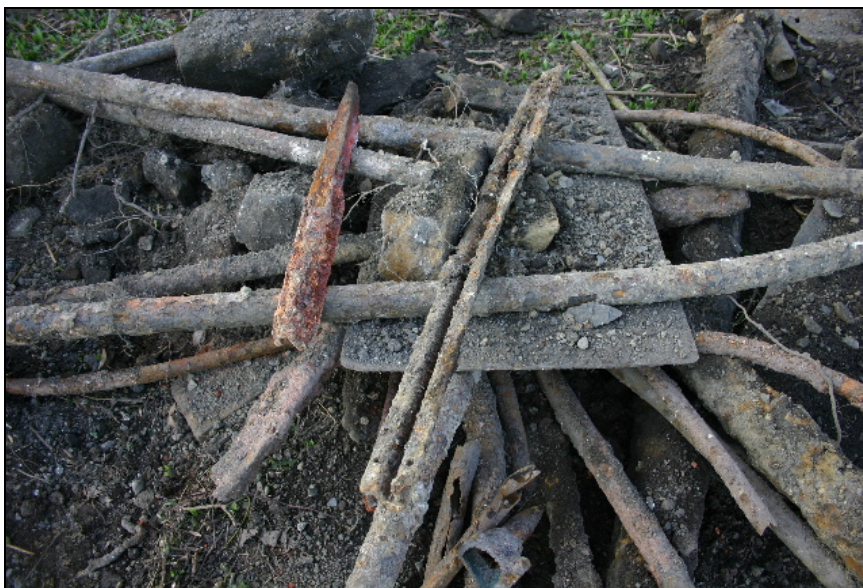
- 5.2 During the process of monitoring ground-works, all forms of scrap metal were collected from the tons of rubbish that had been used for landfill on the site. Occasionally, vestiges of the original 19th-century tram/rail network would appear in the form of fragments of tramline (Fig.6). However, none of the rails was ever recorded in situ and we must assume that all evidence of the network had been removed during the 20th century.

Fig. 6 Two surviving sections of tramline, together with assorted scrap metal.
Photo CPAT 3252-0008

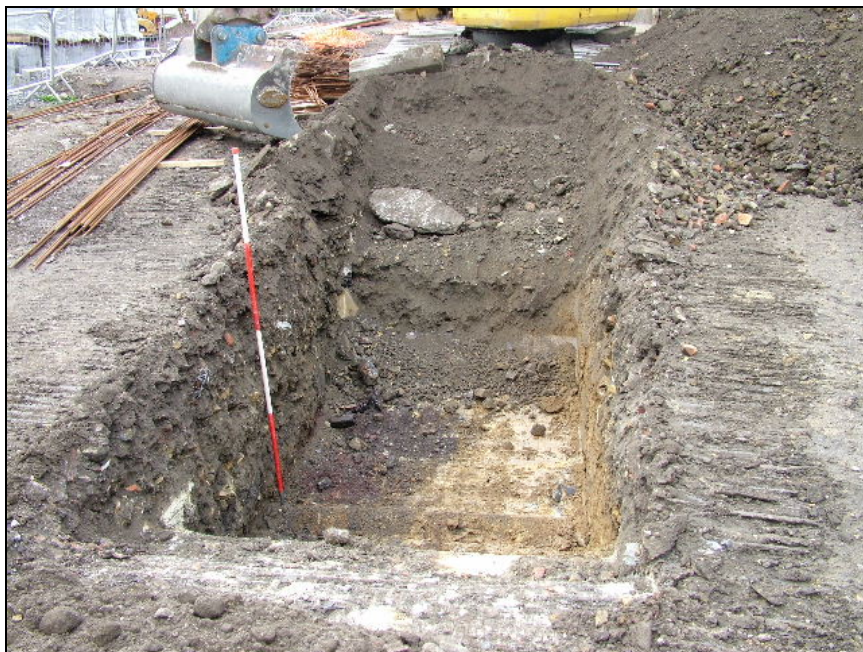
Fig. 7 Test pit 2, viewed from the north-north-east.
Photo CPAT 3252-0013
