Former Cattle Market Welshpool, Highway Improvement

ARCHAEOLOGICAL WATCHING BRIEF

R Hankinson
March 2011

Report for McBurney Civils Ltd and Tesco plc

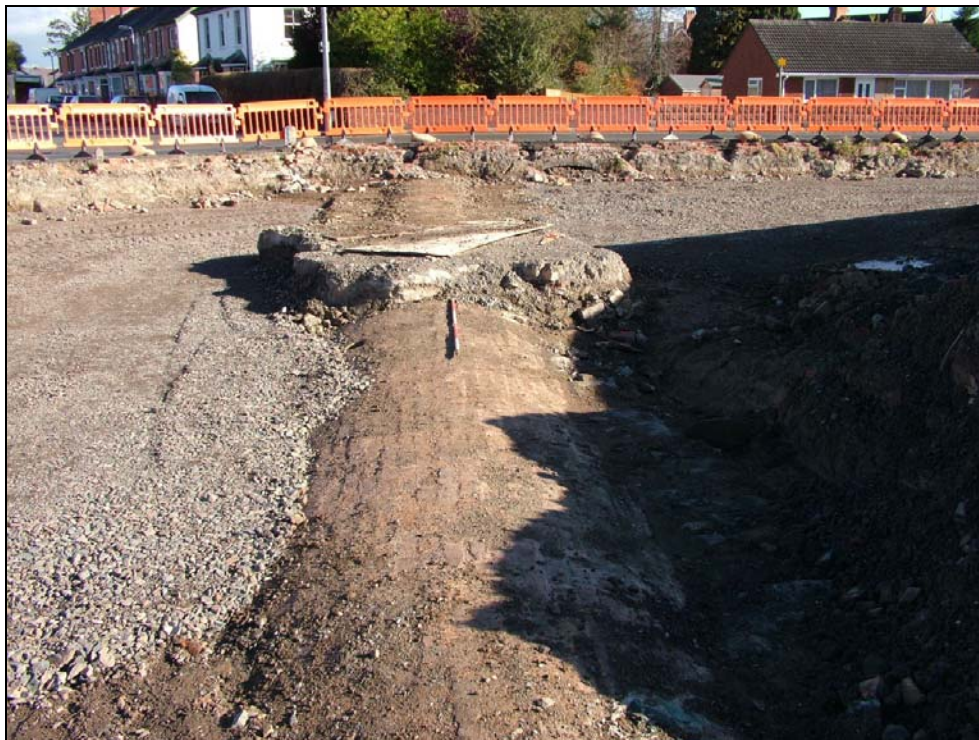
- 4.3 On the inside of the bend mentioned above, the base of the wall that bounded the livestock market was still in evidence, although this was evidently of relatively late date, perhaps not before the mid-19th century at the earliest. The top of the culvert carrying the Lledan Brook was also exposed but this feature was preserved in-situ so recording was limited to photography of the point where it passed beneath the public road.

Plate 1: The top of the culvert carrying the Lledan Brook beneath Mill Lane
(Photo CPAT 3199.0008)

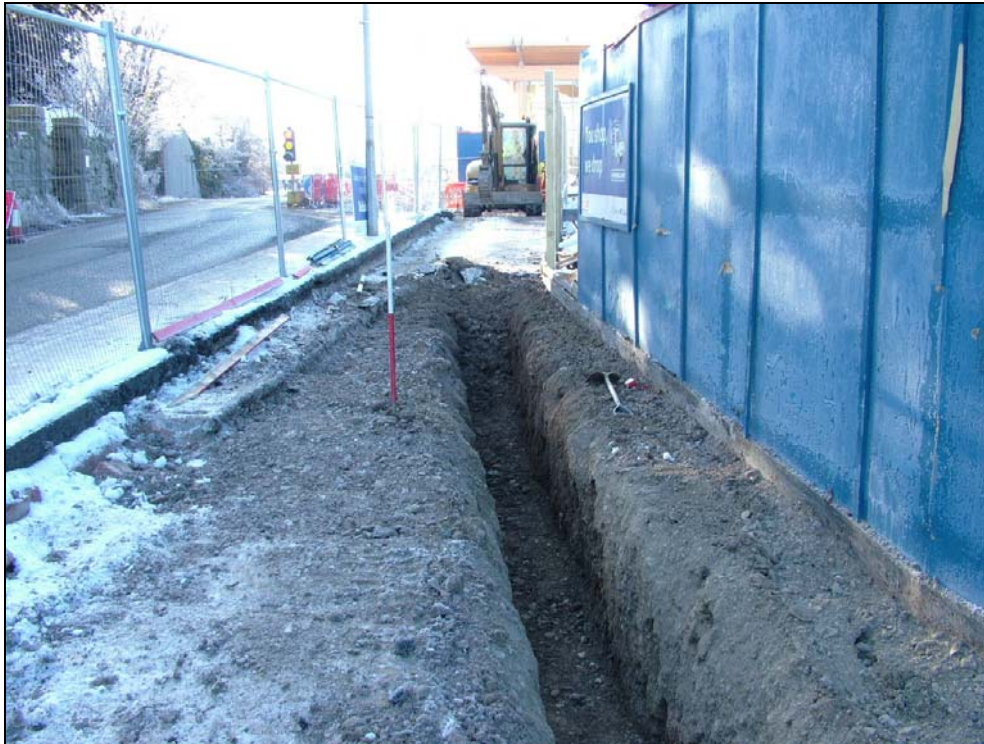
- 4.4 No evidence of features associated with the motte and bailey castle, on the opposite side of Smithfield Road from the supermarket, was seen in the trenches observed. However, there were two instances where the excavation of launch holes for direct-drilled underground services was carried out without the contractors informing CPAT, meaning that the work was conducted without archaeological supervision.

Plate 2: Excavation of the roadside drain opposite Domen Gastell motte and bailey castle
(Photo CPAT 3199.0017)

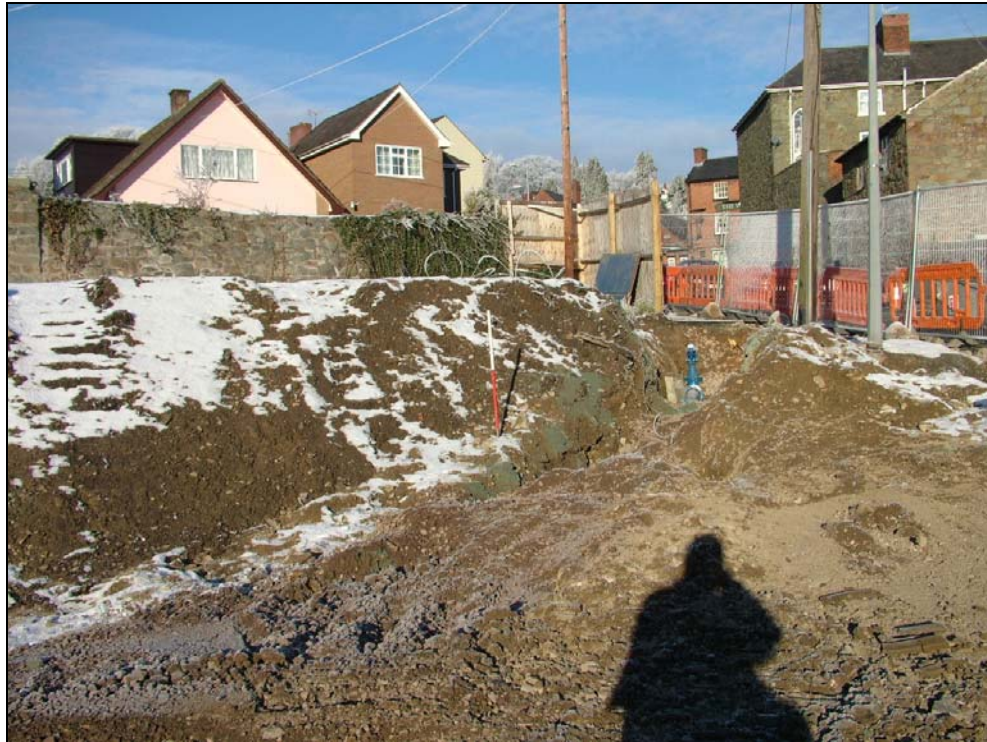
- 4.6 The house itself was built of brick and was of relatively late date, the plot having previously formed part of the grounds attached to the vicarage. However, an archaeological evaluation carried out in the gardens between the house and Mill Lane in 2002 (Grant and Jones 2002) revealed evidence of occupation belonging to the 13th or 14th centuries at a depth of between 0.5m and 0.7m below ground level, and this seemed to be an area which merited close examination. Unfortunately, work on widening the access into the car park section was carried out without CPAT being informed and it was therefore not supervised and any archaeology present was destroyed without a record. Examination of the ground after the work had been done revealed no evidence of medieval occupation, but very little of the ground remained undisturbed, most having been reduced in level by more than 1m, which is below the level of the top of the natural subsoil as identified in the 2002 evaluation.

Plate 3: The former garden plot attached to the Moorings showing the reduction in ground level
(Photo CPAT 3199-0015)

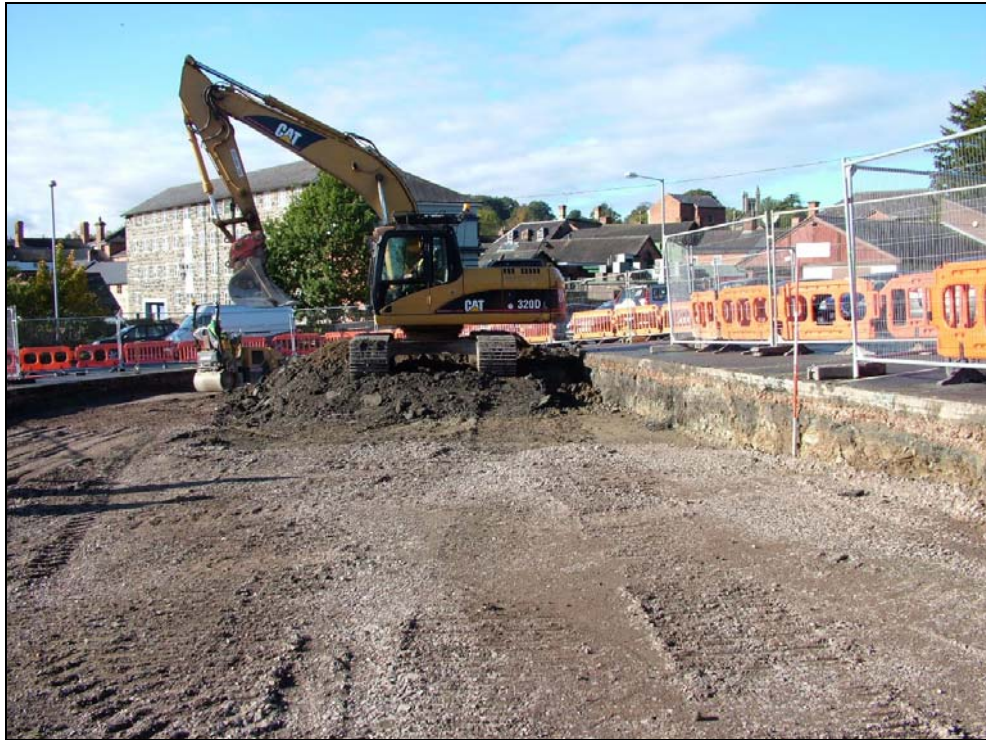
Plate 4: Machining of the new section of road across the car park (Photo CPAT 3199-0002)

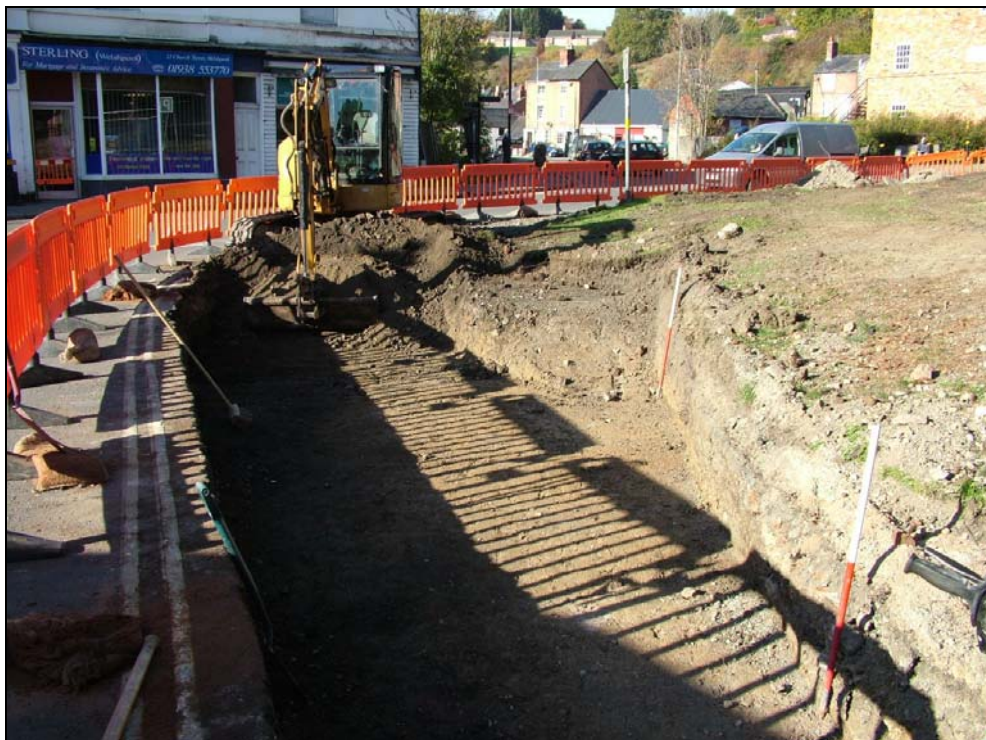
- 4.9 The remainder of the route involved alterations to the existing car park access road from Church Street, specifically the widening of the splayed section opening onto the road. This section appears to have been used as an access route in the 19th century but it seems unlikely that it is earlier than that as it partly lies on the (subterranean) route of the Lledan Brook and the watercourse remained uncovered at that time when the Tithe map was created in 1840.

Plate 5: Machining at the Church Street junction (Photo CPAT 3199-0010)

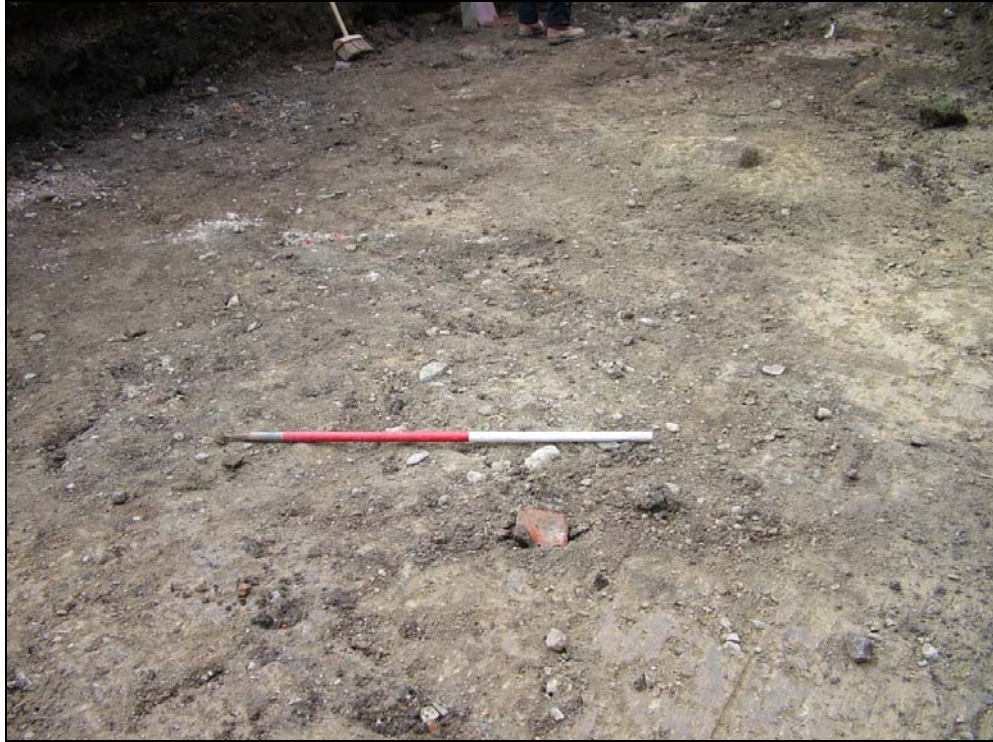
- 4.10 A small number of archaeological features were revealed in the course of machining, including a single undated post-hole, 0.4m in diameter and 0.2m deep at NGR SJ 22541 07580 and a 2m-square pit at NGR SJ 22542 07579. The latter was not examined in detail as material in its fill was no earlier than the 18th century. Both features had most probably been truncated by later activity as there was about 0.65m of 19th-century and later overburden.

Plate 6: The 2m-square pit, with the post-hole just visible at top right (Photo CPAT 3199-0013)
