# **Aberhafesp pumping station and rising main, Powys**

**ARCHAEOLOGICAL ASSESSMENT**

**CPAT Report No 726**

Report for Severn Trent Water

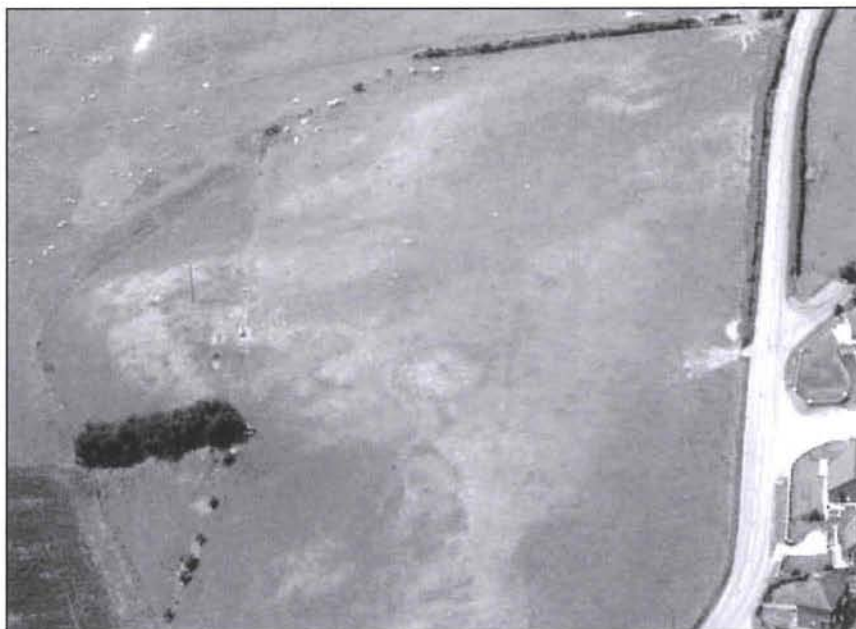
- 4.1 The information from the regional Historic Environment Record yielded only two recorded sites within the assessment area: the remains of a Bronze Age round barrow (PRN 4022) and a possible prehistoric enclosure (PRN 7031) sited on the crest of a spur. Oblique aerial photography (plate 1) was used to plot the cropmark of the round barrow, and this was revealed as a ring ditch up to 20m in diameter, with a large central pit. No evidence has been encountered during the assessment that confirms the presence of the possible enclosure, and its authenticity remains unproven. The ring ditch, however does demonstrate the presence of Bronze Age activity in the area and there is the possibility for further buried remains on top of the spur.

Plate 1 Pentre Round Barrow (PRN 4022) showing as a cropmark in 1989. Photo CPAT 89-MB-0619

The site has been identified from cropmarks visible on an aerial photograph taken in 1977. The results of further photography in 1989 (Plate 1) were used to plot the cropmark, revealing a single ring ditch 18 to 20m in diameter, in the centre of which is a large pit, probably representing a burial. Cropmark features of this type normally represent the plough-levelled remains of a Bronze Age burial mound, or round barrow. The field survey has demonstrated that there are no longer any upstanding earthwork remains of this feature, although significant buried archaeological deposits are likely to survive.

- 7.3.3 The only known site which is considered to have significant archaeological potential is Pentre Round Barrow (PRN 4022). This should be preserved in situ. In order to facilitate this, an exclusion zone of at least 50m in diameter should be clearly marked around the perimeter of the site prior to any groundworks commencing, and the fencing of any wayleave should also be excluded from the defined area. Because of the difficulty in identifying the position of the feature, the fencing should be supervised by an archaeologist with access to the plan contained in this report.

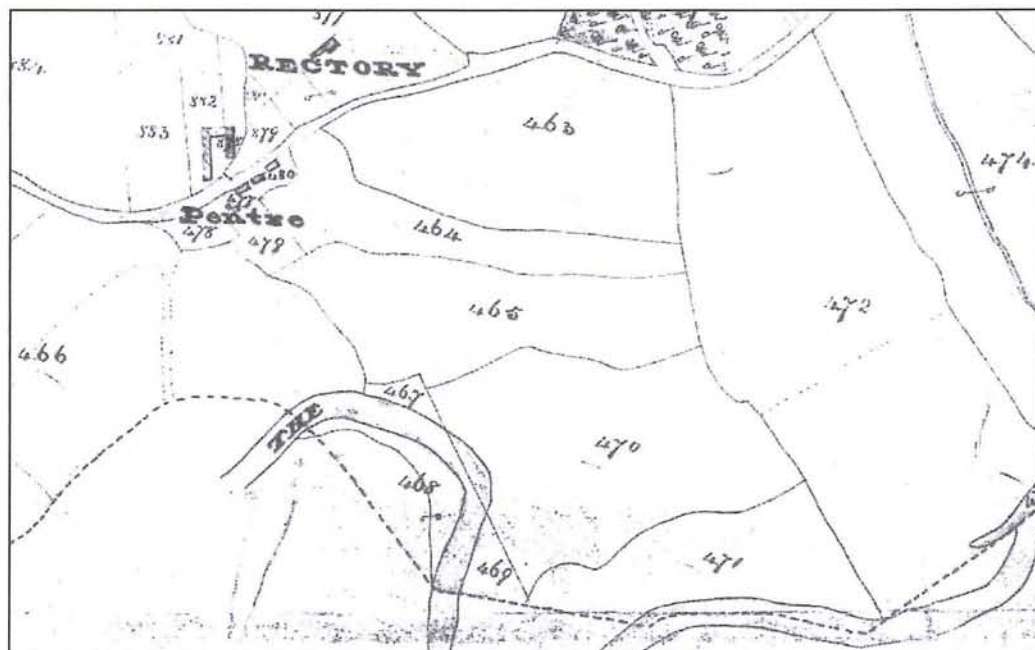
- 4.4 Earlier maps and aerial photographs taken in 1975 show a barn (PRN 89430) which had been demolished or removed by the time that a further series of aerial photographs were taken in 1981. These did reveal, however, two broadly parallel lines about 70m apart, running south-westwards from the garden of Pentre Cottage across two fields. As they approach the second boundary they adopt a slightly more easterly alignment. The Tithe map of 1839 (fig. 2) confirms that these were field boundaries and that in the accompanying survey the field itself was called 'long meadow' (PRN 89433). The field to the north of this was called Maes Pendre, the element *maes* suggesting that it may have been an open field in the medieval period (TA 463) which would have been sub-divided into numerous strips cultivated by different farmers. Other field names recorded at the time of the tithe survey include 'ox pasture' (TA 466), 'piece below pentre' (TA 465) and 'cow pasture' (TA 472).

Fig. 2 Tithe Survey for Aberhafesp parish 1839

Two broadly parallel linear cropmarks about 70m apart, running south-westwards from the garden of Pentre Cottage across two fields. As they approach the second boundary they adopt a slightly more easterly alignment. The Tithe map reveals that they were field boundaries and that in the accompanying survey it was called 'long meadow'.

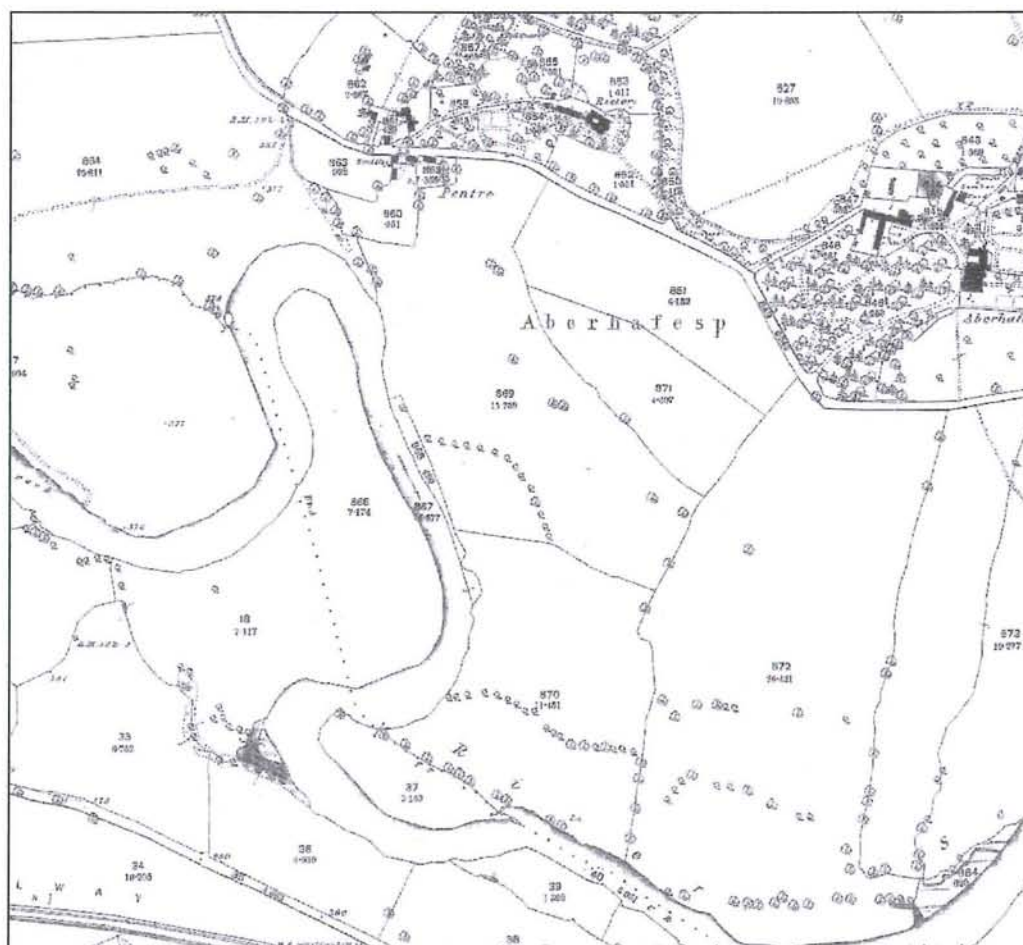
- 4.5 The Ordnance Survey 1<sup>st</sup> edition 1:2,500 map of 1886 (fig. 3) shows little change from the present day field pattern, the only notable difference being significant changes in the course of the River Severn. The map also shows a track (PRN 89434), still in existence, which ran south from the B4568 and then west to a ford across the River Severn.

Fig. 3 Ordnance Survey 1<sup>st</sup> edition 1:2,500 map, 1886

The Ordnance Survey 1<sup>st</sup> edition 1:2,500 map of 1886 shows a track, still in existence, which ran south from the B4568 and then west to a ford across the River Severn.

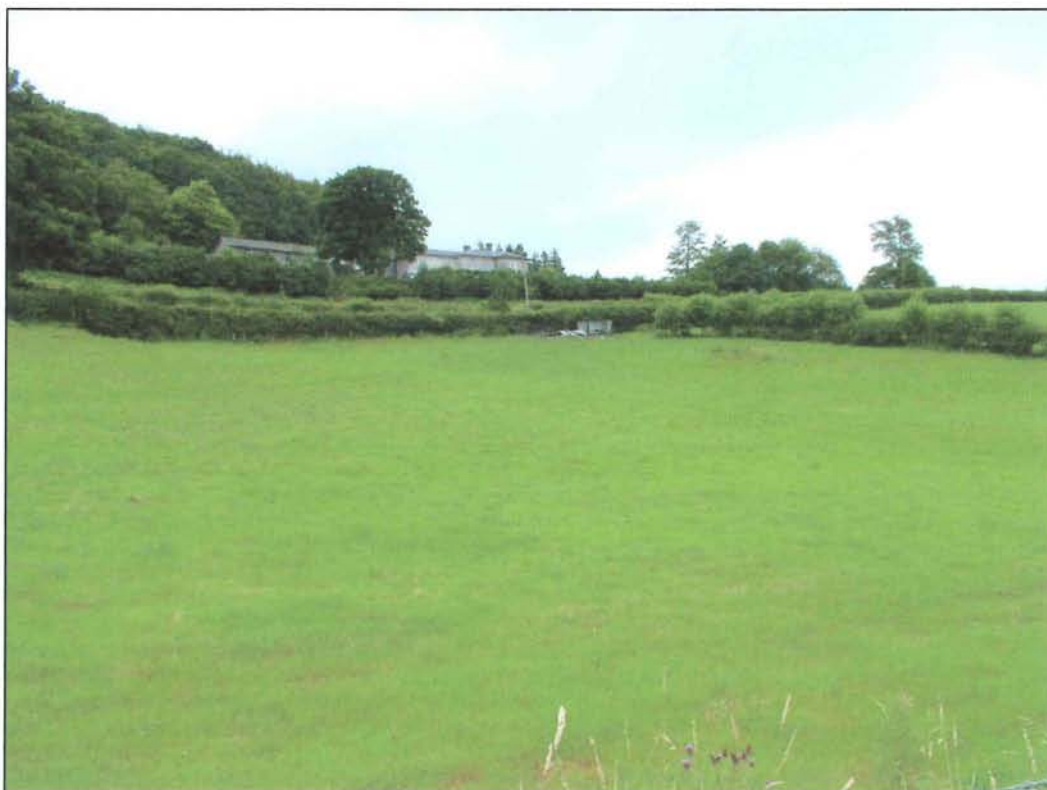
- 5.1 The basic methodology of the field survey is briefly described in paragraph 3.2, above. One new site was revealed during the field survey, which was also able to verify and enhance the records for a number of sites which had been recognised from desk-based sources, in each case allowing an assessment of their nature, function and potential importance.
- 5.2 A brief assessment of the field boundaries in the study area reveals that the predominant form is of hedges on low banks of earth or stone, sometimes with an adjacent drain.
- 5.3 The field survey identified the earthwork remains of a former field boundary (PRN 89431), forming a lynchet up to 0.6m high (plate 2).

Plate 2 Aberhafesp field boundary IV (PRN 89431). Photo CPAT 1969-08

A curvilinear earthwork forming a lynchet up to 0.6m high was identified during the field survey which appears to be the remains of a former field boundary.

- 7.3.4 The remaining sites have no additional mitigation recommended over and above the general watching brief described in para 7.3.2.
