CPAT Report No 765

**Bank Buildings, Rectory Lane,
New Radnor, Powys**

ARCHAEOLOGICAL EVALUATION AND BUILDING SURVEY

F Grant and N W Jones
January 2006

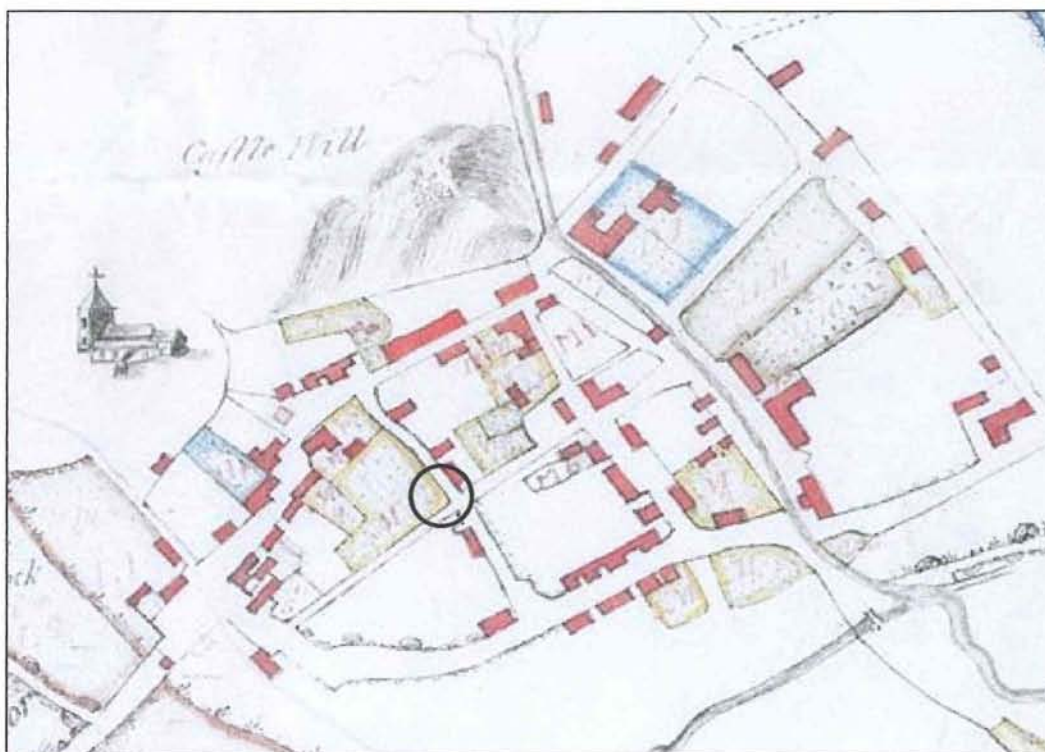
Fig. 3 Later 18th-century map of New Radnor (reproduced by permission of Powys County Archives).
The evaluation area is indicated by the circle.

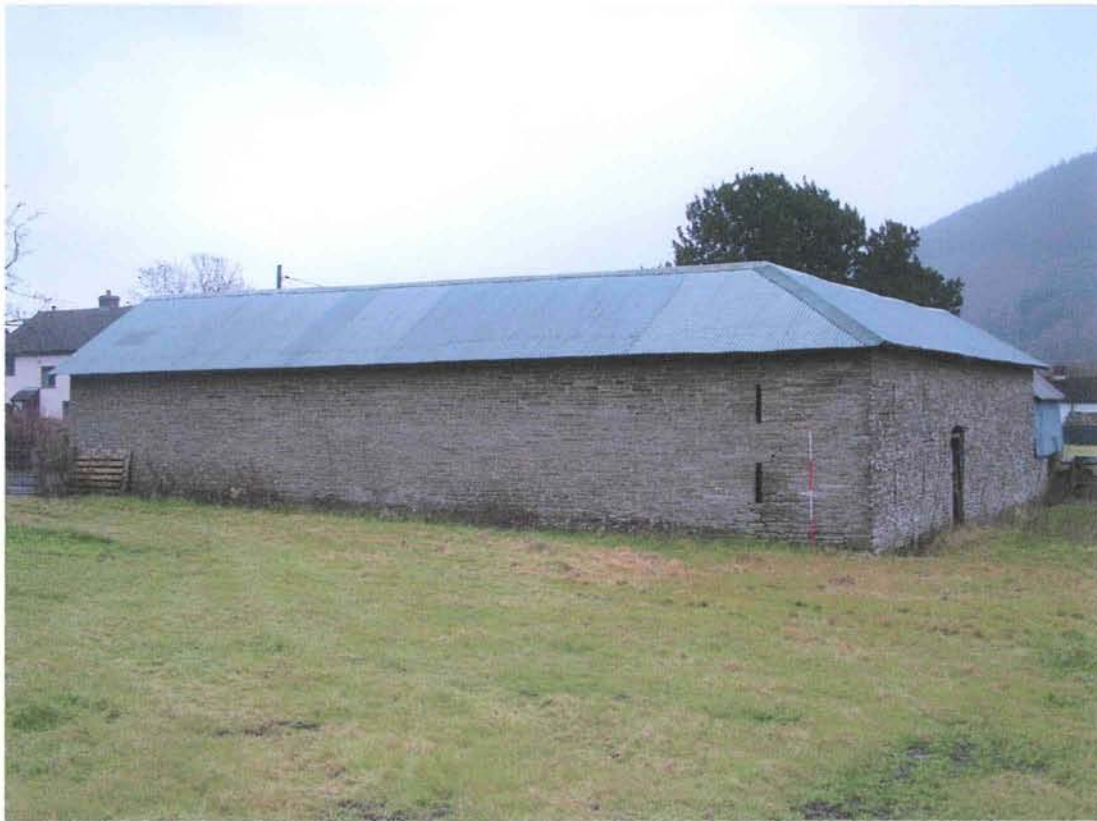
Plate 1 External view of barns from the north-west. Photo CPAT 2070-03

- 3.2 The building consists of two ranges forming an L-shaped stone and timber-built barn, partially enclosing a yard area to the east. The building is internally sub-divided with timber partitioning to form individual bays used as stores and animal housing. The main ranges are 19m long and 5.5m wide, with a smaller southern extension to the southern range measuring 6m long and 4.5m wide. The north and west-facing walls, and the east and west-facing gables of the main complex are stone-built, constructed from coursed blocks of rubble stone, bonded with lime mortar forming walls 0.5m thick. The west and south walls of the extension have a high plinth of similar stone construction, above which there is timber framing with weather-boarding on the south-facing elevation and corrugated metal sheeting on the west. The stone gable wall is topped by a single line of edge-set red bricks. The east- and south-facing walls of the complex are constructed from timber framing, clad in weather-boarding, apart from a single, short (2.73m) stretch of stone wall at the western end of the south-facing wall. The entire barn is now roofed with corrugated metal sheeting.

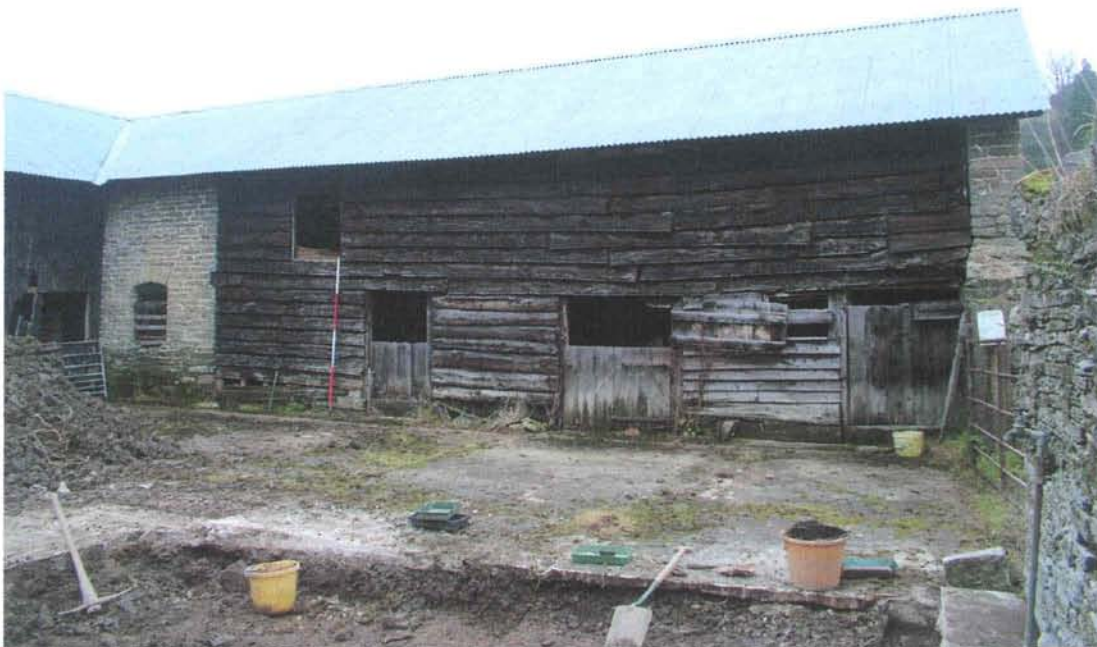
Plate 2 External view of the northern range of barns from the south. Photo CPAT 2070-10

- 3.7 The ground floor of the northern range is sub-divided into four animal housing bays (G8-G11), with an L-shaped corridor (G7) running internally along the main part of the northern wall, accessed from an external door in the east-facing gable and from the southern range in the west. The corridor provides access to the feeding mangers and hay-racks present to the rear of each of the four easterly bays. The mangers are all set upon a low stone-built plinth at least 0.25m high (the full height and any detail regarding the floors of the bays could not be ascertained owing to the quantity of decayed bedding material). The easternmost bays (G9-G11) are accessed via stable doors opening on to the yard in the south, whilst G8, separated from the yard by the only yard-facing stretch of stone-built wall, is accessed internally from the corridor, with a stone arch topped window opening in the stone wall.

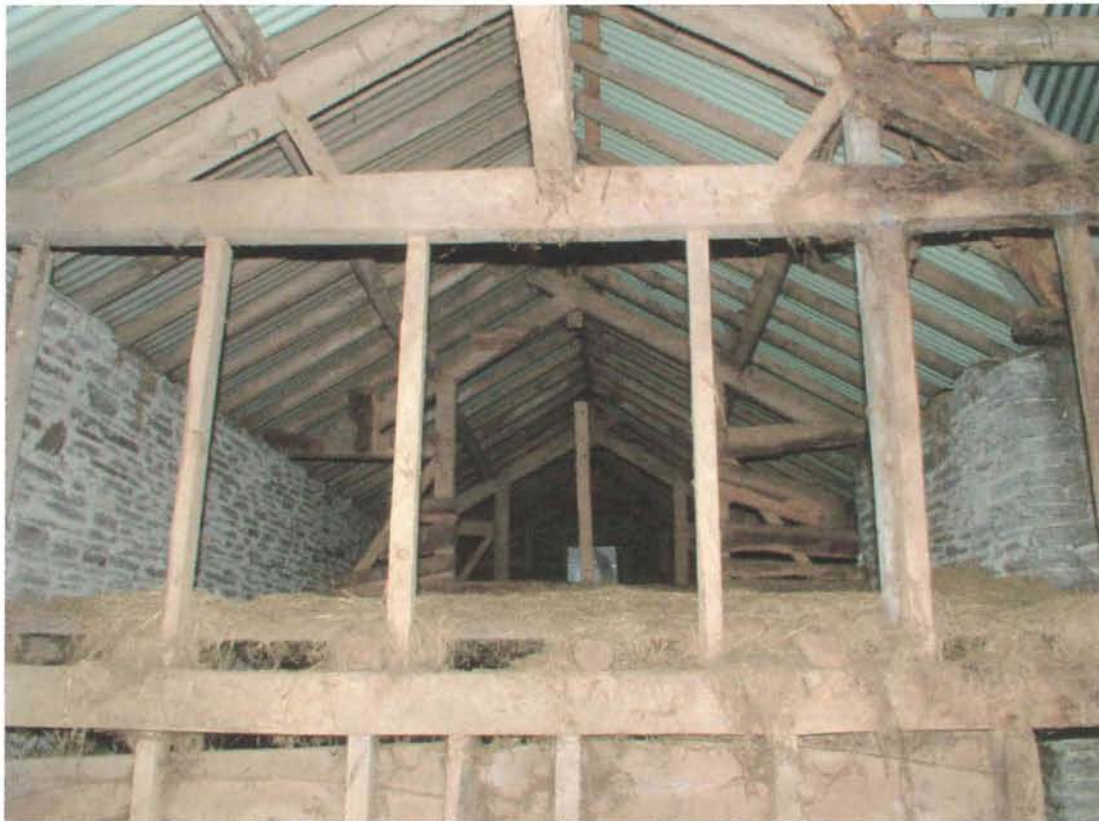
Plate 4 Internal view of the northern range of barns, showing trusses and partitions. Photo CPAT 2070-41

- 3.8 The first floor area above G8-G11 is occupied by a hay loft rising to roof height; access was not possible to allow a full inspection. However, the construction of the trusses was noted, all of which were of simple design with principal rafters and a collar, some of which had additional slanted struts. At least two of the trusses in the northern range had been cut to allow through access at first-floor level, and vertical supporting timbers inserted. The floor of the hayloft (and ceiling of the bays beneath) is constructed from timber planks set on horizontal beams. Access to the hay-loft was possible internally from the western end and from a loft hatch centrally placed in G7, and via a wall-set, stone arch-lintelled hatch in the east-facing gable wall.

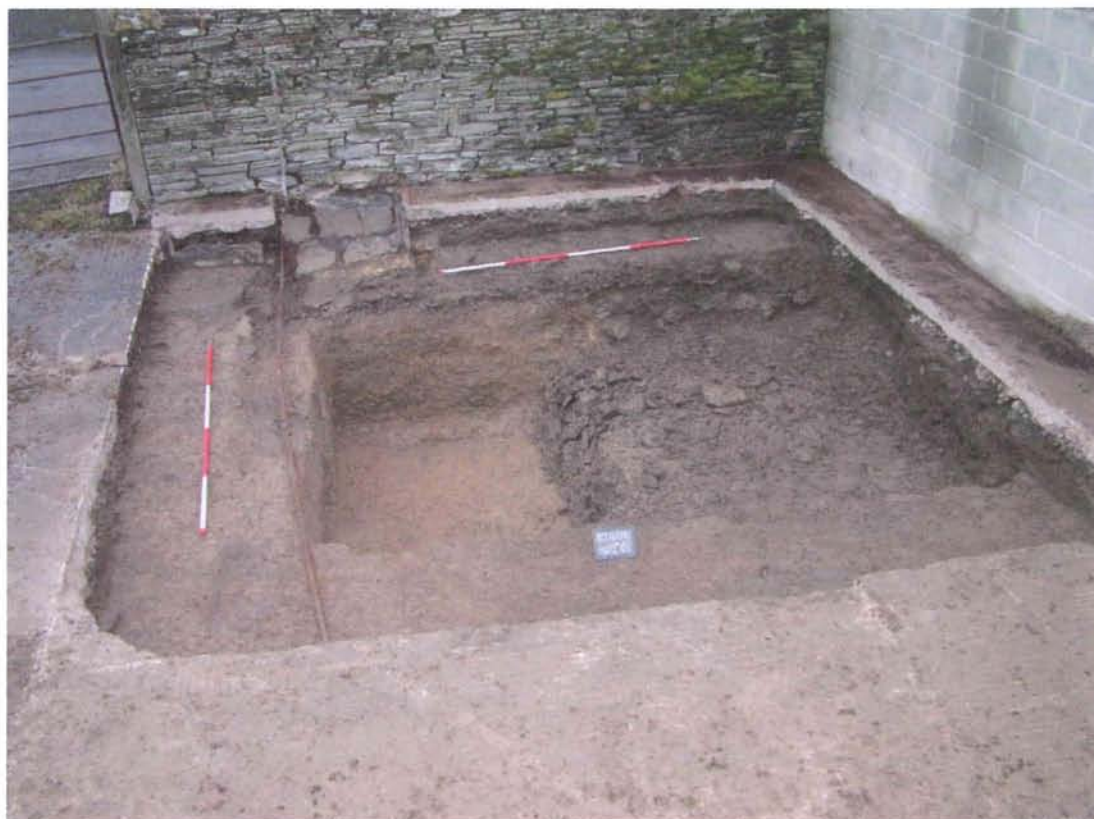
Plate 5 Excavated area from the west. Photo CPAT 2070-20

- 4.1 The evaluation comprised a single trench within the farmyard, measuring 5 x 5m, and set along the street frontage (Fig. 6). The aim of the evaluation was to identify the nature and possibly the dating of any archaeological features within the development area. Particular emphasis was placed on identifying evidence that might relate to medieval activity on the Rectory Lane street frontage.

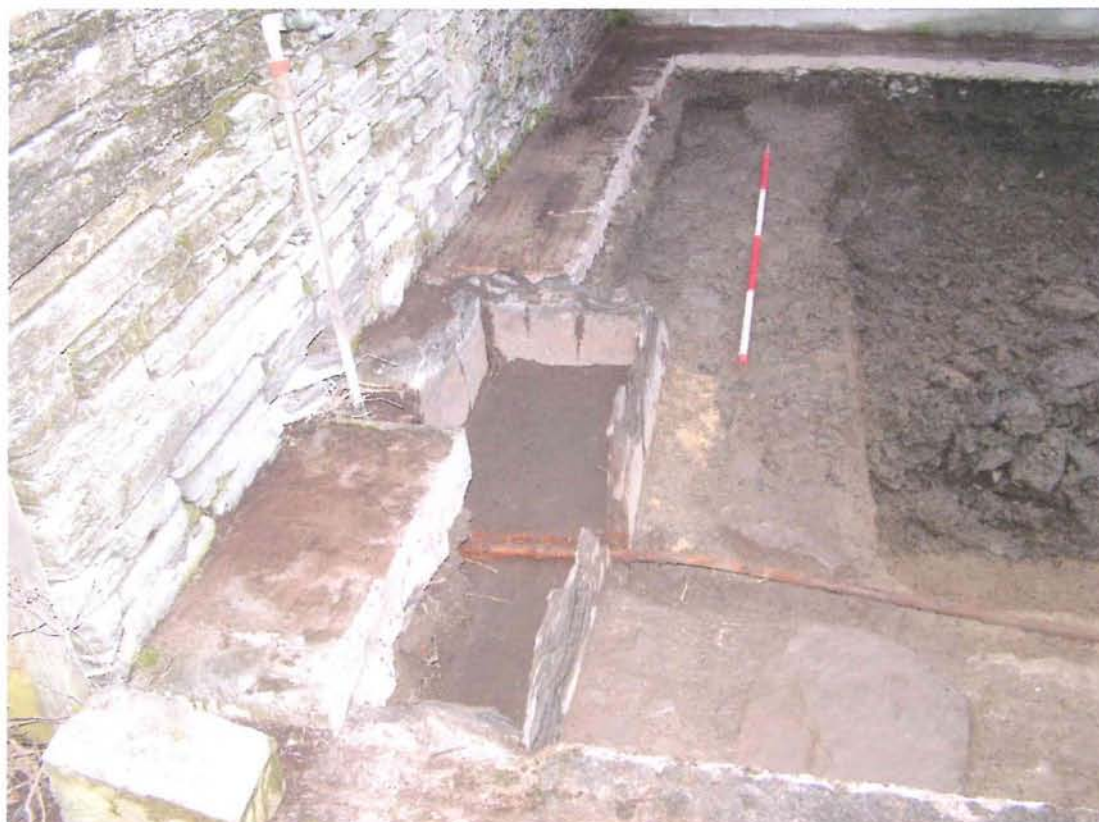
Plate 6 View of the slate tank (05) and pit (09). Photo CPAT 2070-24

- 4.3 It became apparent during the machine clearance that a large, rectangular pit (09) occupied much of the evaluation trench, thus truncating any of the earlier potential archaeology. This feature measured at least 2.9m east-west and 4m north-south, and continued southwards beyond the limit of the excavation. In order to ascertain its character the northern half was excavated by

machine, removing a stony fill (08). The pit was around 1.3m deep, with vertical sides and a flat base, cutting into the natural orange-yellow clay (34) and yellow clay-gravel (33) subsoils. Material in the deposits suggested that it had been infilled during the late 19th century. Although the feature had destroyed any earlier archaeology in this area, certain features and deposits were revealed in section in its sides and in the remaining area of the trench.

- 4.11 The earliest of these events involved the insertion of a slate-slab constructed water trough (05) at the north-east corner of the trench. This structure was placed into a rectangular pit (07), then packed externally with a firm, plastic, bright yellow clay (06). A cobbled surface was then laid over the top of the clay, incorporating a single larger slab and extending up to 1.6m out to the west. A stone-lined culvert (11) was constructed, running approximately east-west towards the trough, possibly at around the same time as the trough was built, although any evidence confirming the relationship has been destroyed by later activity. The large rectangular pit (09) truncated both the cobbling associated with the trough and the culvert. Although no evidence was identified to reveal the function of this pit, worm channels visible from base to top along the sides of pit imply that it was lined, and possibly contained a metal tank. At some point both this large pit and the trough were back-filled with material containing similar ceramic sherds of a late 19th to early 20th century date. A cut feature (38), probably a pit, was identified in the south-west corner of the trench, visible in the east-facing section. The fill of this feature (37) contained ceramic dating to the later 19th to early 20th-century. The latest phase of water management in this area involved the laying of an iron pipe (35), approximately east-west across the northern part of the trench, to serve a stand-pipe still present in the north-east corner. The pipe was placed in an apparently spade-dug trench (03), then back-filled (36), and appears to respect the northern edge of the large pit (09). Inserting the pipe involved breaking a gap into the west side of the slate slab trough, and cutting into the material (04) which had back-filled the trough.

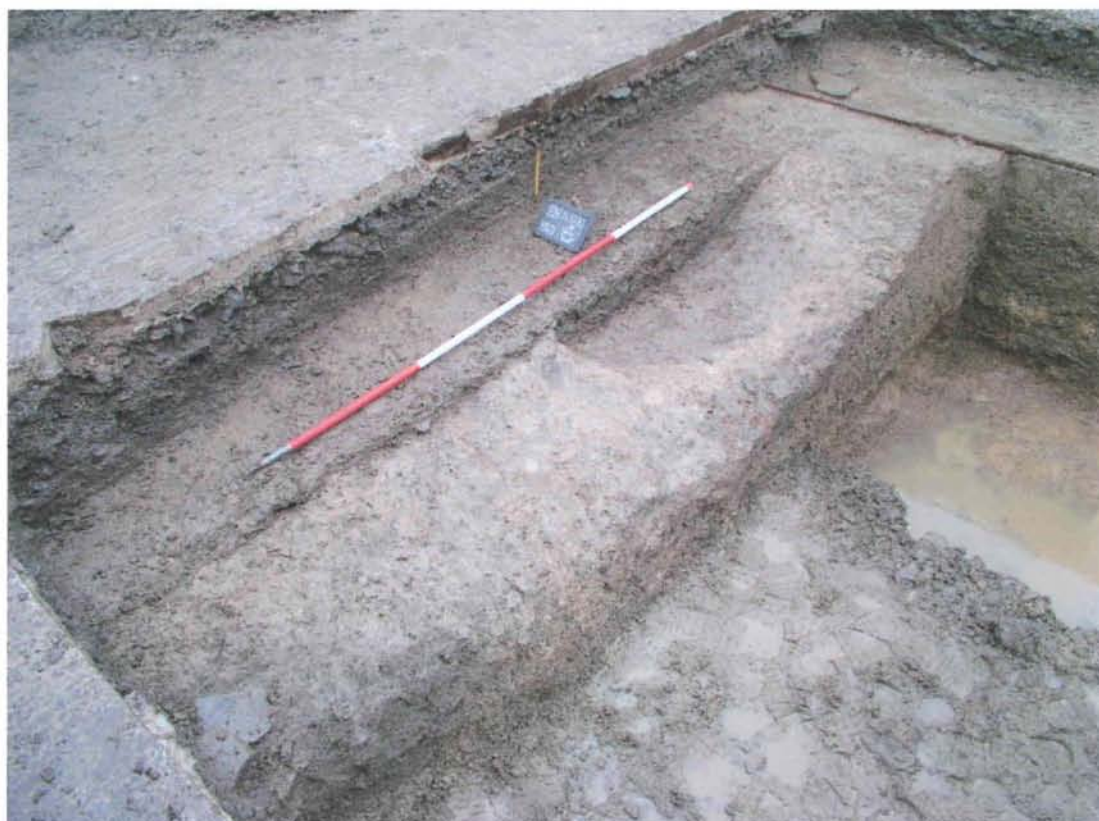
Plate 7 View of medieval pits 24, 26 and 28 from the south-east. Photo CPAT 2070-51

- 4.6 In the south-western edge of the trench three pits were revealed, cutting in to the underlying deposit (31). The southernmost pit (24) had been truncated by the insertion of (09), revealing in section a depth of 0.23m with a concave northern side and a relatively level base. The pit continued southward beyond the limit of the excavation, but appears to have originally been circular in plan. It was not excavated further, but a spout from a medieval (13th-14th century) jug was retrieved from the upper part of its dark greyish-brown, silty-clay fill (25). The central pit (26) had similarly been truncated by the insertion of (09), and only the very eastern edge survived. This pit again appeared to have been circular in plan, with a diameter of over 1.46m and a depth of 0.15m, and contained a grey clay fill (27) with a distinct component of reddish-brown burnt daub. The northernmost pit (28) was partially revealed in plan, continuing beyond the edge of the trench to the west. It had a diameter of *c.* 1.5m and contained at least two fills, (29) and (30). Investigation of the uppermost fill (29) revealed a stony, mid brown silty-clay with a depth of at least 0.10m and which contained medieval (13th-14th century) ceramics. The underlying fill (30) was a mid brown, fine textured clay loam.
