Trehelig argae reconstruction, Welshpool, Powys

ARCHAEOLOGICAL WATCHING BRIEF

CPAT Report No 897

Report for Environment Agency

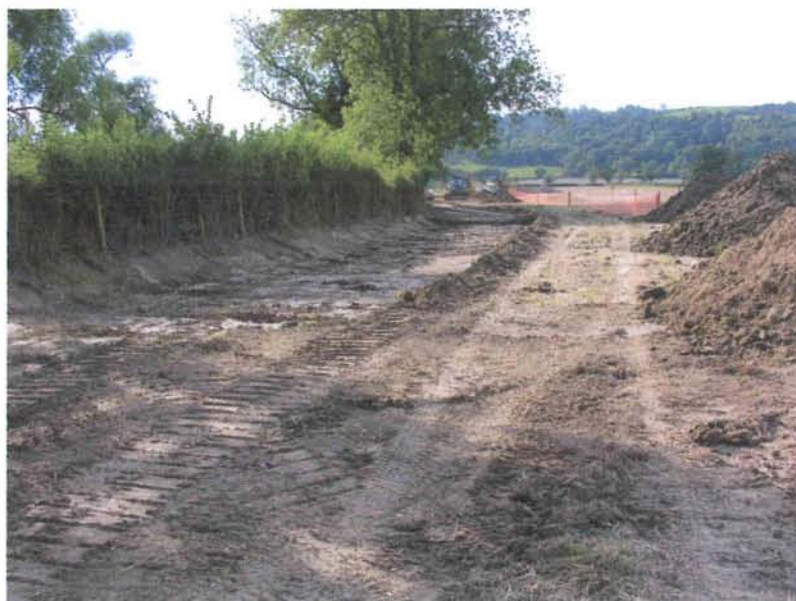
- 4.3 Site visits commenced on 17 August, when lengths of the rear face (that facing away from the river) of the bank at the western end were in the process of being machined away. No finds or features related to the flood defences or earlier activity were identified.

Plate 1 Machining at the west end of the argae (Photo CPAT 2480-001)

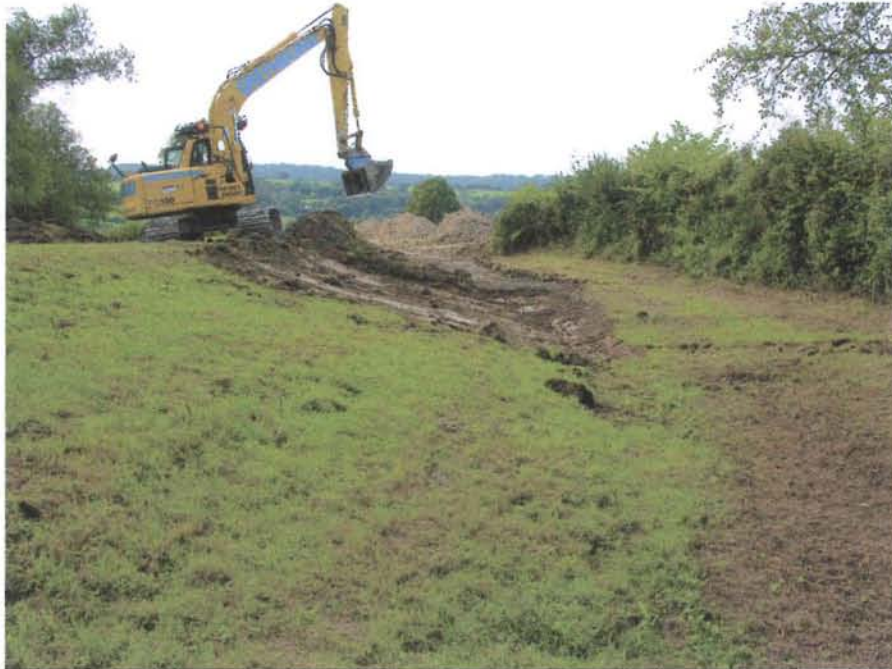
- 4.4 Subsequent works to the west of 'The Gro' revealed a probable holloway, in the order of 4m wide, which appeared to have a metallated surface of grey gravel. The feature curved around between the flood defence bank and the boundary of land belonging to 'The Gro'. It seems not to have been picked up at the desk-top stage of the assessment, although part is depicted on the accompanying maps.

Plate 2 Location of former holloway (Photo CPAT 2480-006)

- 5.3 The site of a dwelling dating to the 19th century, which had been evaluated by Dodd *et al* (2006), was marked out prior to the commencement of excavations in its immediate locality and was successfully avoided. Evidence of a minor trackway, probably belonging to the same period, was noted to the west of 'The Gro' during the watching brief.

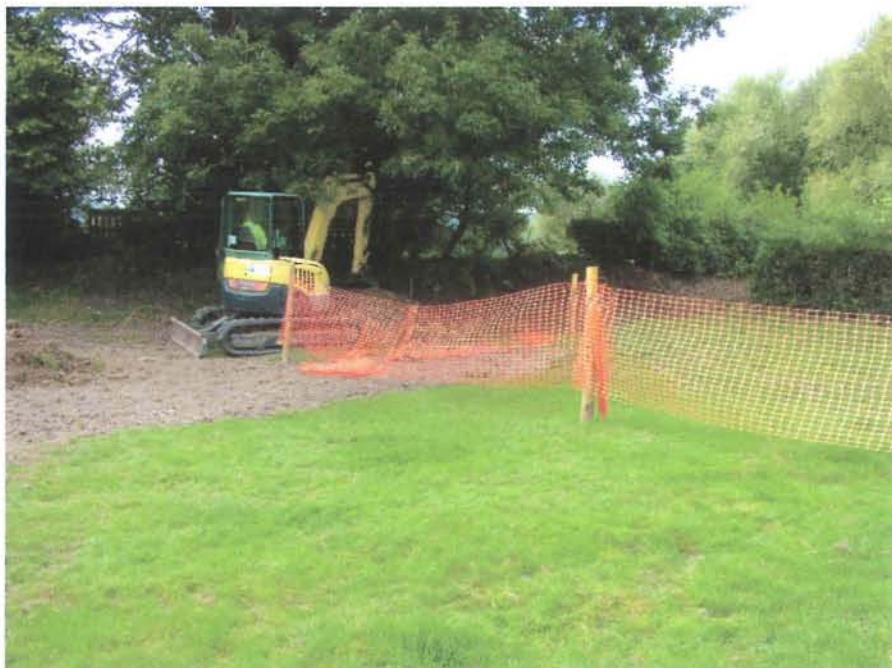
Plate 3 Protective fencing around the site of the former dwelling (Photo CPAT 2480-012)

- 4.6 In Dodd's evaluation, Trench 2 had revealed evidence of the dwelling, but Trench 1, to the south-west, was reported to be devoid of archaeological features. Trench 1 was therefore taken as a suitable line on which to place a temporary fence designed to act as a barrier and prevent disturbance of the site during machining. This was put in place prior to the commencement of work on the rear face of the bank.

- 4.7 The machining of the rear face of this section was carried out on 13 September, and this included the field to the north, which was also occupied by buildings belonging to the Trehelig-gro settlement. A few sherds of 18th- to 19th-century slip-decorated earthenware were noted in the adjoining field, to the north-west of the dwelling; otherwise all finds were 19th century or later in date. No significant features were observed and the remains of the dwelling evaluated by Dodd (*et al*) were successfully avoided.

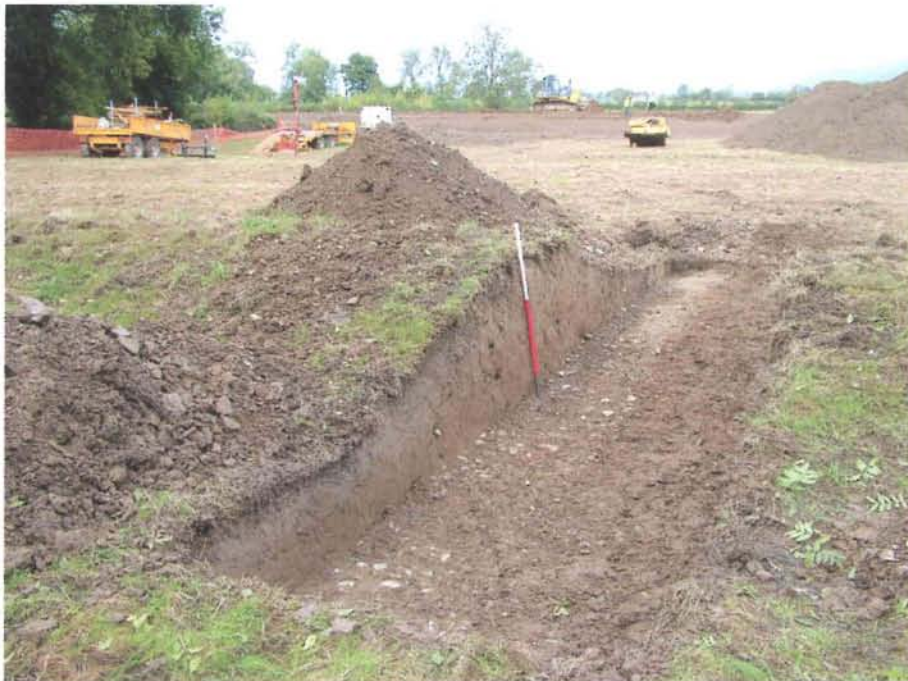
- 4.8 On 24 September, a section was cut under archaeological supervision, through the part of the argae which had become redundant. This provided an opportunity to record its construction and to evaluate the possibility of underlying features being present. The trench was 7.3m long and 1.6m wide, with the argae being 6.4m wide and 0.94m high at this point. The resulting section revealed that the argae was composed of a single layer of brown river silt, with some slag/clinker facing having been subsequently added to the front face, presumably to minimise the effects of erosion in flood conditions. The side facing the river was only 0.4m high in relation to ground level, demonstrating the amount of material (*c.*0.5m thick) which has been deposited between the river and the argae since it was constructed. The redundant section of argae was subsequently reduced to ground level; preliminary observations confirmed that the deposits preceding the argae would not be exposed by this work, at which point the watching brief was terminated.

Plate 4 Trench cut through the redundant section of argae (Photo CPAT 2480-020)

- 5.2 At the south-eastern end of the argae, the alignment was changed and the original earthwork was levelled. The opportunity was taken to record a section through the original argae, in a trench excavated under archaeological supervision at SJ 21460225, prior to its levelling. This proved that the earthwork had been constructed of redeposited river silt with the subsequent addition of material on the river side of the bank to give added protection in times of flood. The excavation also demonstrated that silting on the river side of the argae had raised the ground surface by approximately 0.5m, in comparison to that on the opposite side.
