CPAT Report No 906

Yr Hen Danerdy, Machynlleth, Powys

ARCHAEOLOGICAL SURVEY

N W Jones
February 2008

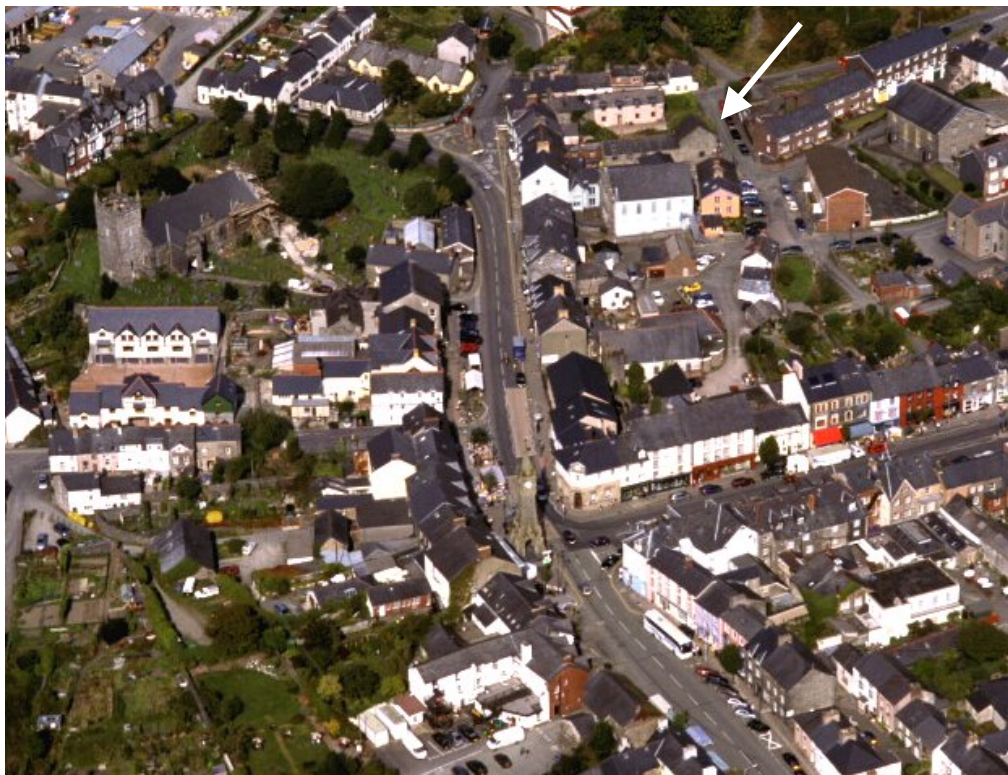
Plate 1 Aerial view of Machynlleth with the old tannery building visible towards the top, behind the Tabernacle. Photo CPAT 03-c-0759

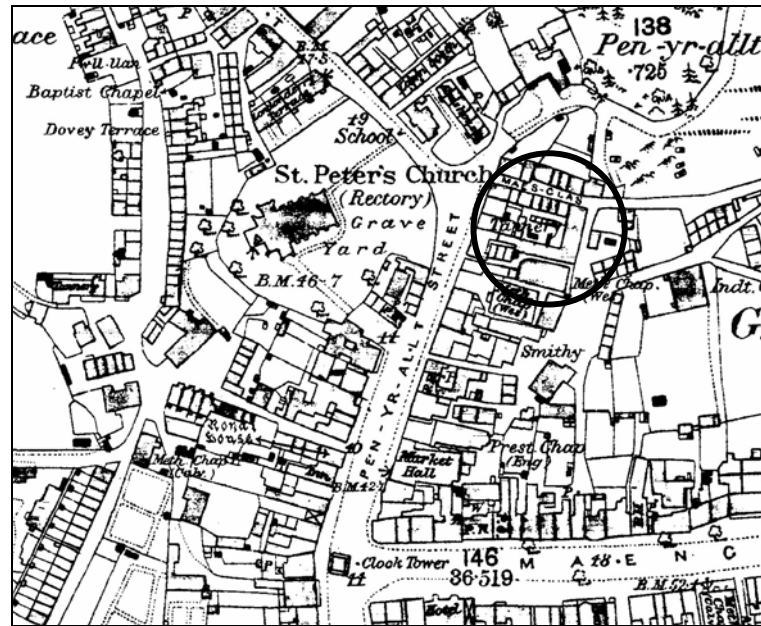
Fig. 1 Ordnance Survey 1st edition 25'' map of 1889

- 3.6 The earliest cartographic depiction of the tannery in Maes Glas is the Ordnance Survey 1st edition 1:2,500 map of 1889 (Fig. 1), surveyed in 1887, which is broadly contemporary with the tenure of David Evans. This shows an L-shaped building partly enclosing a yard area within which five pits are depicted. Another tannery is recorded further to the east, off Brickfield Street. The 2nd edition mapping of 1901 (Fig. 2) again shows the building, but does not identify it as a tannery, suggesting that the business had ceased, although the Brickfield Street tannery remained.

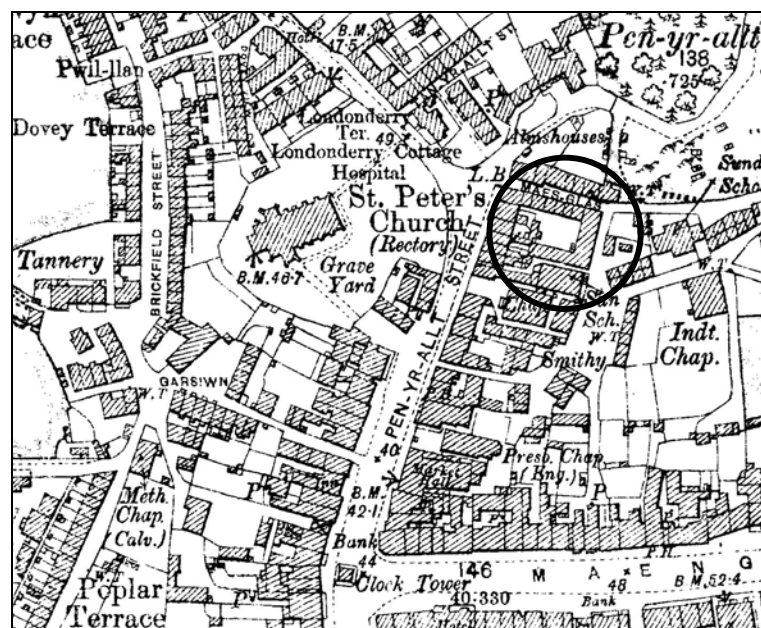
Fig. 2 Ordnance Survey 2nd edition 25'' map of 1901

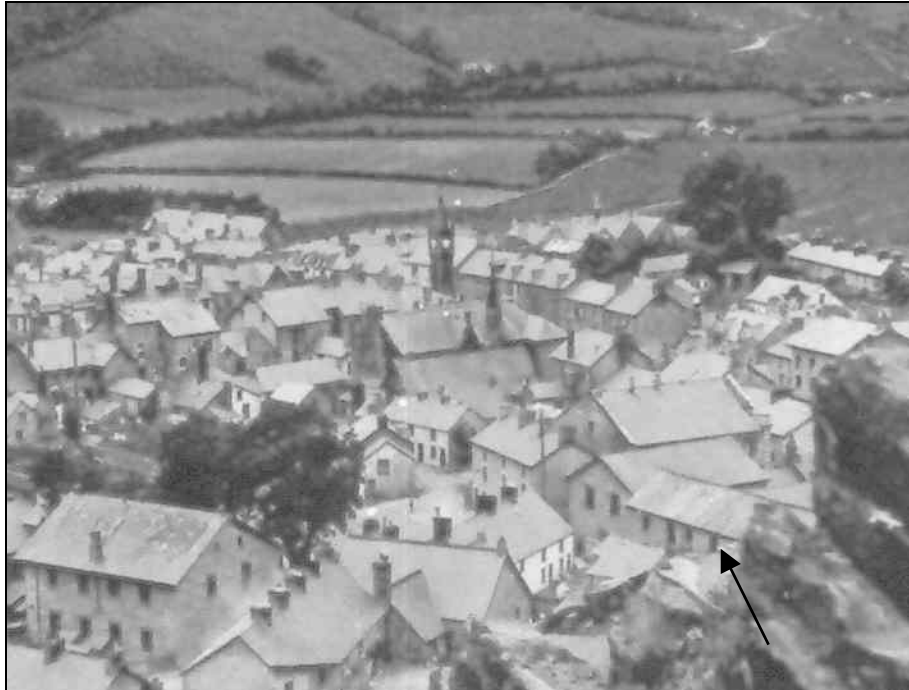
Plate 2 Extract from a late 19th-century postcard of Machynlleth. The eastern wing of the tannery is in the bottom right, partly obscured by the outcrop.

- 3.9 A contemporary postcard of Machynlleth (Plate 2) shows part of the eastern range of the tannery, although sadly most of the building is obscured.

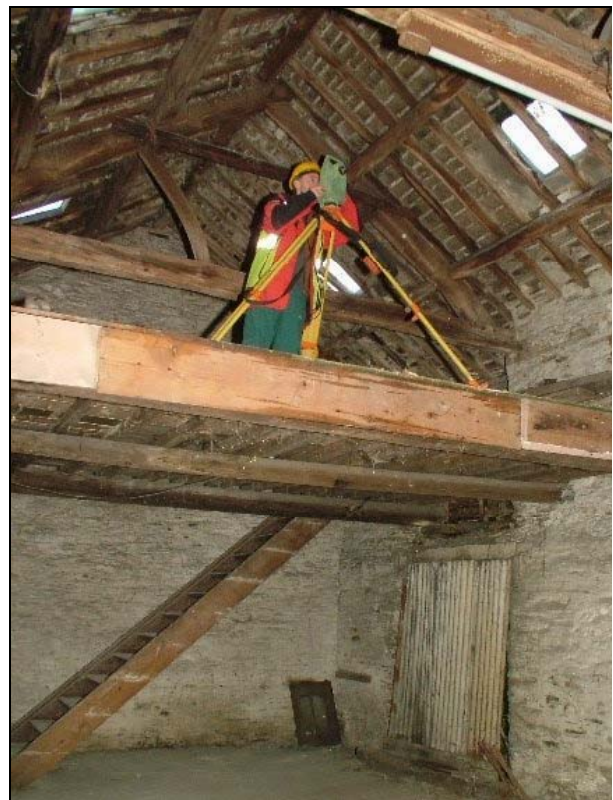
Plate 3 Digital survey of tannery interior. Photo
CPAT 2506.082

4.2 The drawn record was based on a detailed total station survey which employed a Reflectorless Electronic Distance Meter (REDM), used in conjunction with Penmap survey software. Additional detail was added using a hand-held laser tape (Disto) and conventional measured survey. The resulting survey data was used to produce a series of digital plans, elevations and sections.

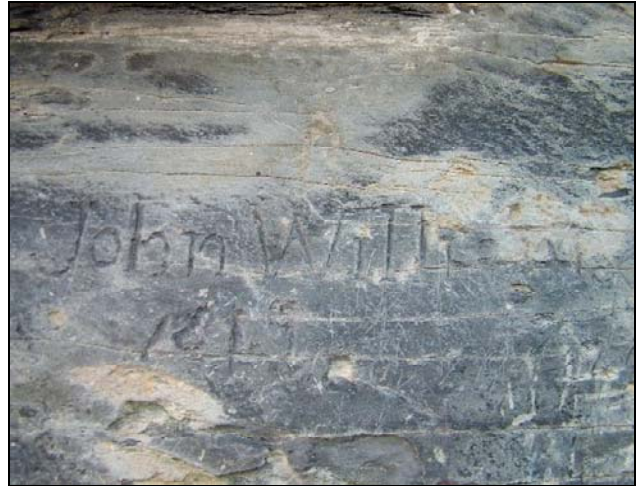
Plate 4 Date inscription 'John Williams 1819'. Photo CPAT 2506.064

- 4.5 The building has two storeys and is stone-built, largely utilising the friable fine-grained sedimentary rock typical of the town, although the southern elevation displays a plinth of boulders, most notably at the eastern end. The ground-floor openings all have brick arches, while those on the first floor have timber lintels, with the exception of a window in the west gable. There is a small and unobtrusive date inscription on a quoin at the southern end of the east elevation, which reads 'John Williams 1819' (Plate 4), and it seems reasonable to assume that this represents the date of construction.

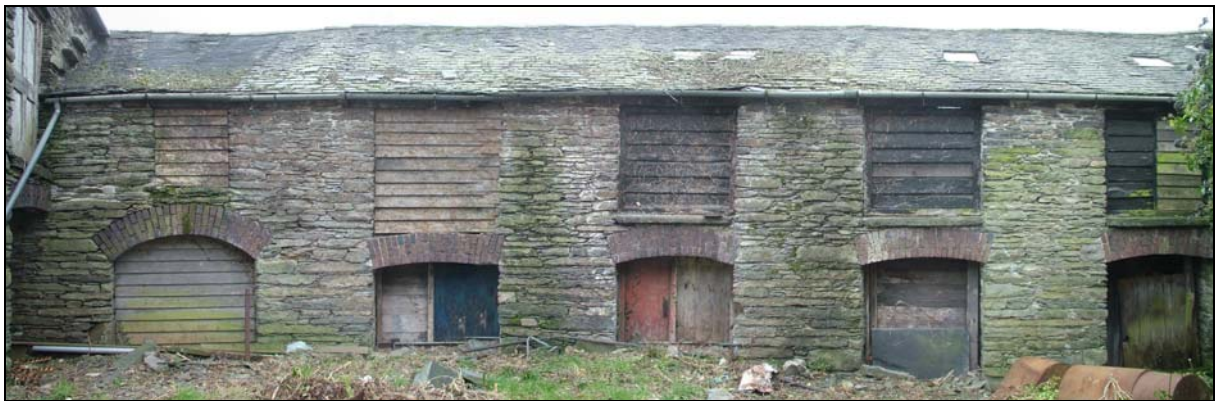
Plate 5 North elevation of the Southern Range

- 4.6 The southern range is divided into five bays by three trusses and a partition wall which separates the eastern bay from the rest. The western three bays were originally open at ground- and first-floor level, although the floor has since been removed and replaced in part by a rough platform at the western end. On the ground floor there was a single doorway in the southern wall, which is now blocked, and four matching doorways in the northern wall, opening onto the yard. The stone partition wall originally had a central doorway which was later blocked; presumably at the same time new openings were inserted against the southern wall, through both the partition wall and the west wall of the eastern range.

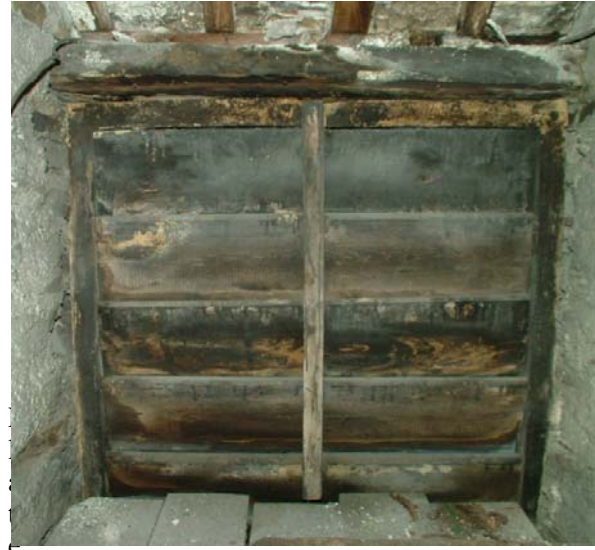
6 Louvred window in southern elevation of southern range. Photo CPAT 2506.101

- 4.7 The first floor was undoubtedly the drying room, or airing loft, with opposing louvered windows. Of the four windows in the south elevation, three retain their original frames and louvers, one of which is complete with the pole bar that was used to adjust the ventilation. This window, the second from the west end, has five louvers attached to the central pole bar by means of iron staples. The louvers were fitted into the frame by means of a wooden peg in either end which allowed them to pivot (see Fig. 3 and Plate 6). The remaining windows, including those on the north side, have six rather than five louvers. In addition, the window at the western end of the north elevation is divided into two sections, the eastern half retaining its original louvers and pole bar, while the western half has been replaced; it was not possible to determine whether this

side was also louvred. The opposing window on the south may have been similar, although the frame has been lost. The large window at the eastern end of the drying room, on the north side, does not appear to have been louvred, but has a modified casement, suggesting that this end of the room served a different function. Comparison with the Rhaeadr Tannery suggests that this was also where currying took place (Leigh 2007, 108).

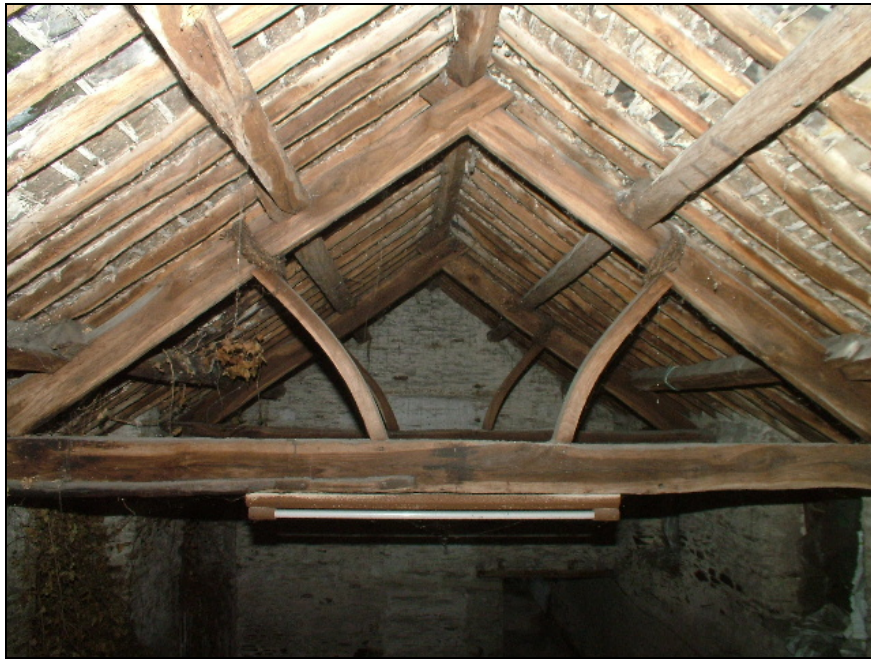
Plate 7 Southern Range Truss 2 viewed from the west. Photo CPAT 2506.002

- 4.8 The three pegged trusses are of simple form but with unusual curved struts between the tie-beam and principal rafters, which support the ridge pole and two purlins on either side (Plate 7). Each truss has two mortices in the underside of the tie-beam which would have held posts. By comparison with the Rhaeadr Tannery, it may be assumed that these supported the tenter rails on which the tanned hides were hung to dry. It is also interesting to note the thick ropes tied around the ends of the trusses which may have supported further rails.

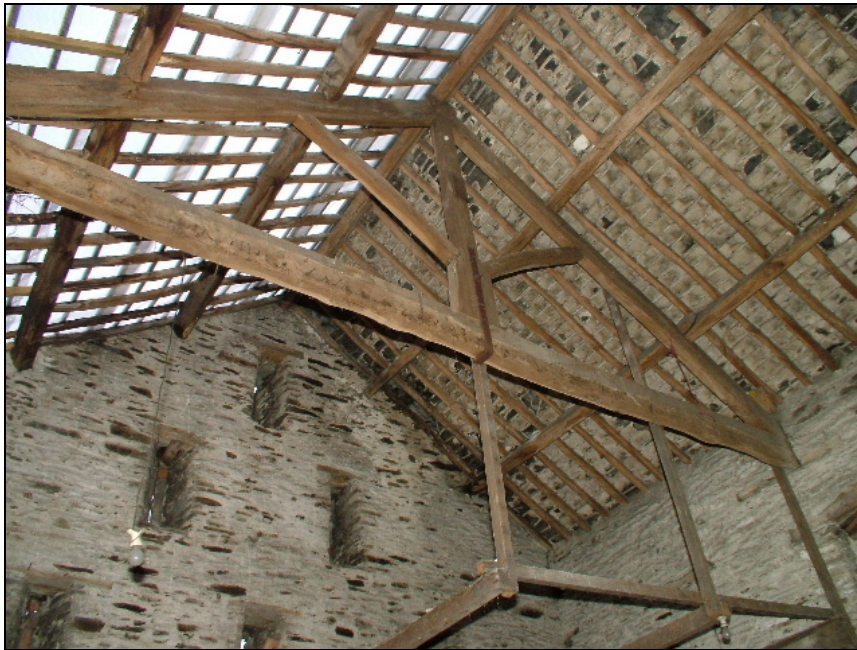
Plate 8 Eastern Range king-post truss and ventilation slots

- 4.11 There is a single, pegged king-post roof truss with iron straps, which supports the ridge pole and two purlins on either side. The southern gable has six ventilation slots and there is a further single slot in the west wall, which unusually opens into the adjoining southern range rather than the exterior. Their presence indicates that this room was used for storing the oak bark which may have been brought in ready milled, or as bark strips to be dried and milled on site. There is, however, no evidence for any milling machinery or power source. A doorway in the east wall would have been used for loading the bark from the lane below, while other doorways led to the

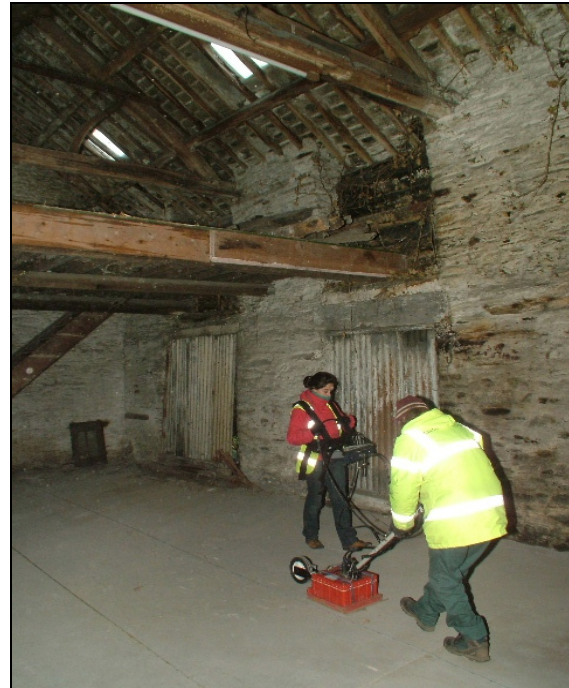
Plate 10 Ground Penetrating Radar Survey inside the southern range. CPAT 2506.068

5.2 A recently-excavated test pit inside the southern range, adjacent to the blocked southern door, demonstrated the nature of the upper deposits, comprising a 0.15m-thick concrete slab, on top of a considerable depth of building rubble. The GPR survey demonstrated that the rubble layer is around 0.8m thick, and probably lies directly on the original floor of the tannery at around 0.95m beneath the surface of the concrete. However, in the eastern room of the southern range the original floor appears to have been much higher, possibly just below the concrete.
