CPAT Report No 920

Nantclwyd House Gazebo and Garden, Ruthin

BUILDING RECORDING AND WATCHING BRIEF

March 2007

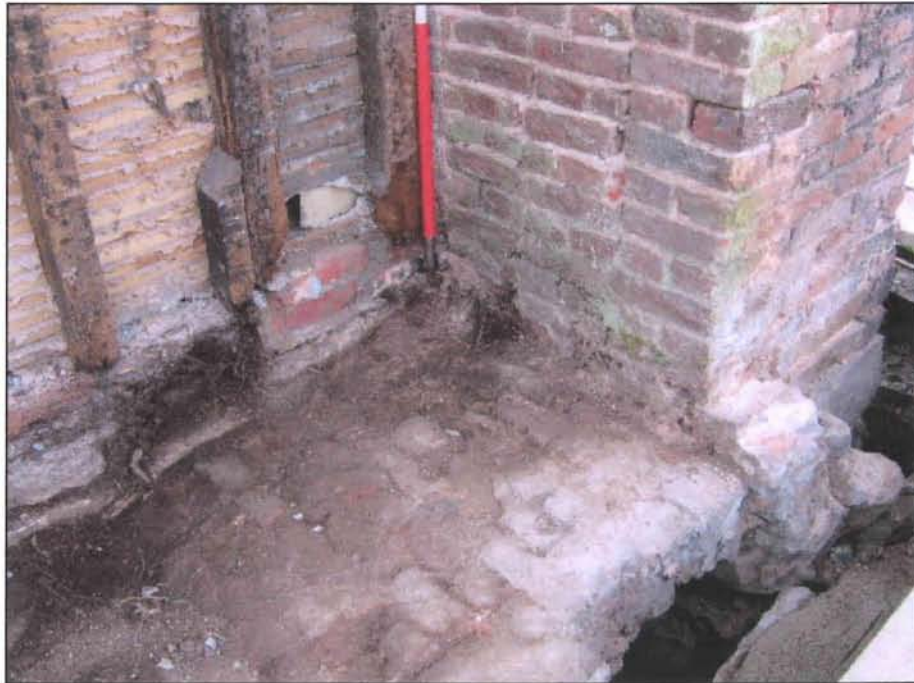
Plate 2 Brick vaulting and chimney base. Photo CPAT 2520-002

- 3.5 The undercroft also incorporates a void between the north wall of the gazebo and the boundary wall, within which the supporting structure for the chimney is visible. The void is roofed by brick vaulting (Plate 2), springing from an extension of the east wall of the gazebo. The brick flue from the first-floor fireplace is angled across to the main chimney and is supported by a series of timbers, some of which are set into the north boundary wall.

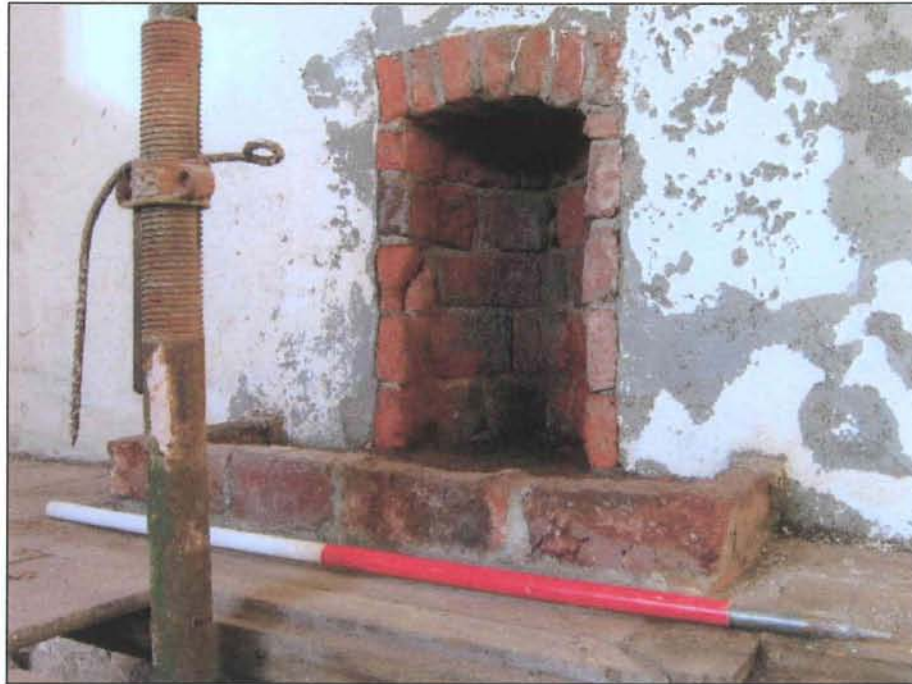
Plate 3 Ground-floor fireplace. Photo CPAT 2520-086

- 3.8 There is a small brick fireplace set midway along the north wall, which appears to be contemporary with the external chimney (constructed of similar sized bricks), and original to the building (Plate 3). The hearth and surround would seem to have been reset on a cement base, with slightly thicker bricks, set on edge, for the hearth surround. The whole has been repointed with grey mortar.

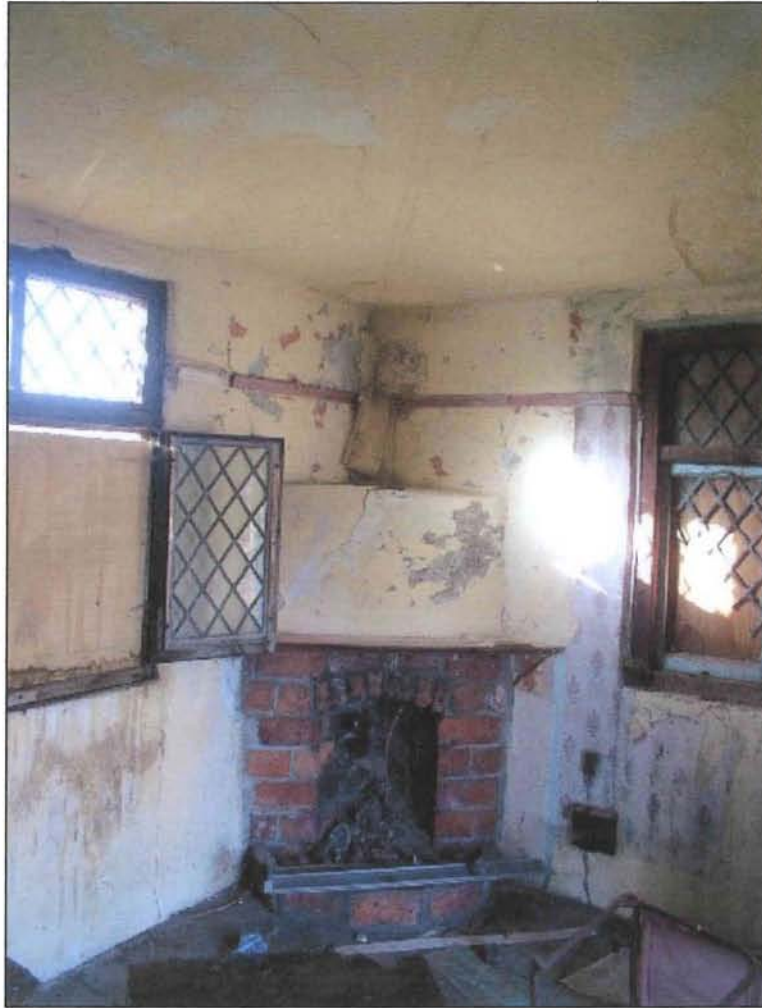
Plate 4 First floor interior. Photo CPAT 2501-011

- 3.11 The upper room is of timber-frame construction and measures 2.9m east to west by 3.3m north to south internally, and 3.2m by 3.50m externally. The doorway is centrally located on the east side and windows are set centrally into the north, west and south walls. A brick fireplace is set in the north-east corner of the room (Plate 4), of similar style to the lower fireplace, although it is larger and has a more substantial brick surround. The hearth and its surround may have been reset.

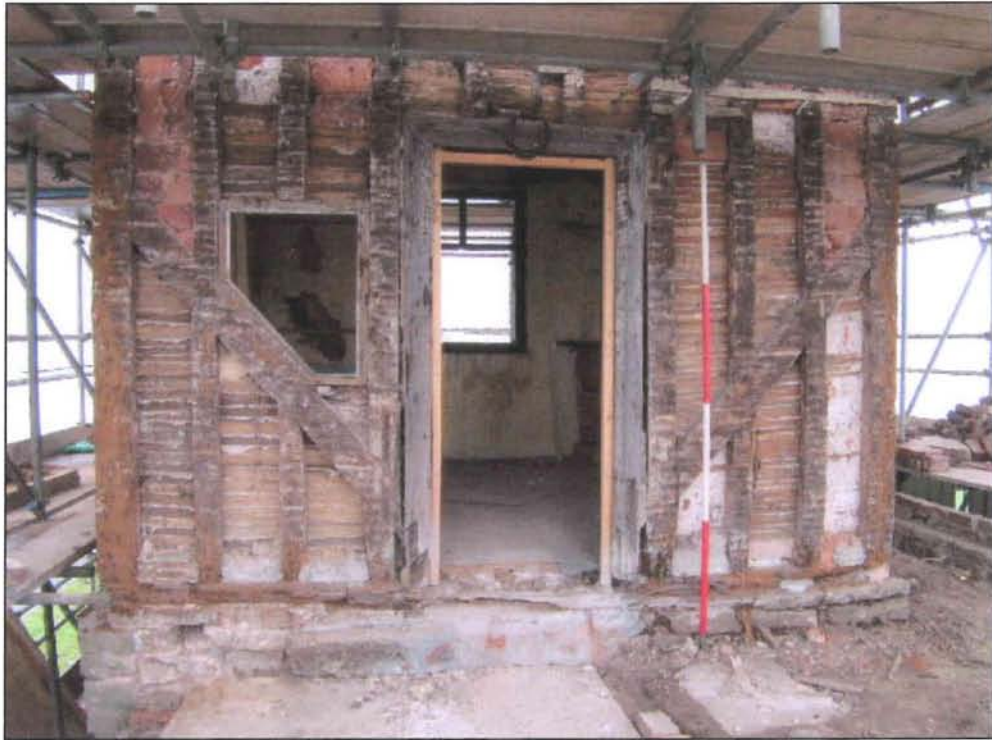
Plate 5 Eastern elevation of the first floor showing timber framing. Photo CPAT 2520-072

- 3.13 The timbers in the east elevation (Plate 5) are largely original, except for the doorframe and the window to the south of the door which is a later insertion. On the south elevation the studs below and either side of the window sill, together with the associated sill beam have been renewed and the diagonal braces truncated. A length of the western sill beam below the window, together with associated studding has been renewed, truncating the southern diagonal brace. The studs below the window in the northern elevation have also been renewed. The chimney structure is attached to the west side of the elevation.

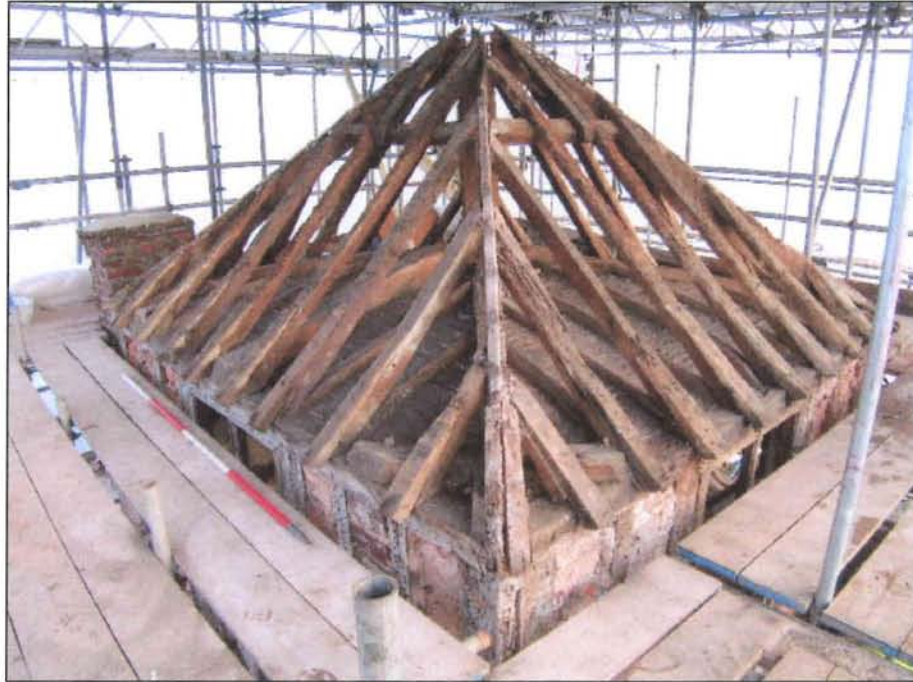
Plate 6 Gazebo roof structure. Photo CPAT 2520-028

- 3.14 The pyramidal roof (Plate 6) is supported on a wall plate and comprises four principal rafters which rise from the corners to a central post at the apex, some 1.6m above the wall plate level. A cambered beam runs east to west across the centre, and is pegged into the wall plate at either end. The central king strut is tenoned and pegged into the beam, supporting the four principal rafters. At the time of the survey the rafters were separated from the top of the king strut and it is uncertain whether or not they were nailed in place. At the corners of the roof angle ties and dragon beams are pegged to the wall plates with the principal rafters tenoned and pegged into the dragon beams. The purlins are close to the apex and are nailed to the rafters. Common rafters rise from the wall plates, some of which are supported by the purlins, and are nailed to the principal rafters. Two rafters have been replaced on the north side and one each on the west and south sides. A number of later supports have been nailed to strengthen the structure where the original rafters have weakened. All of the rafters have sprockets, tapering upwards, nailed to their ends.

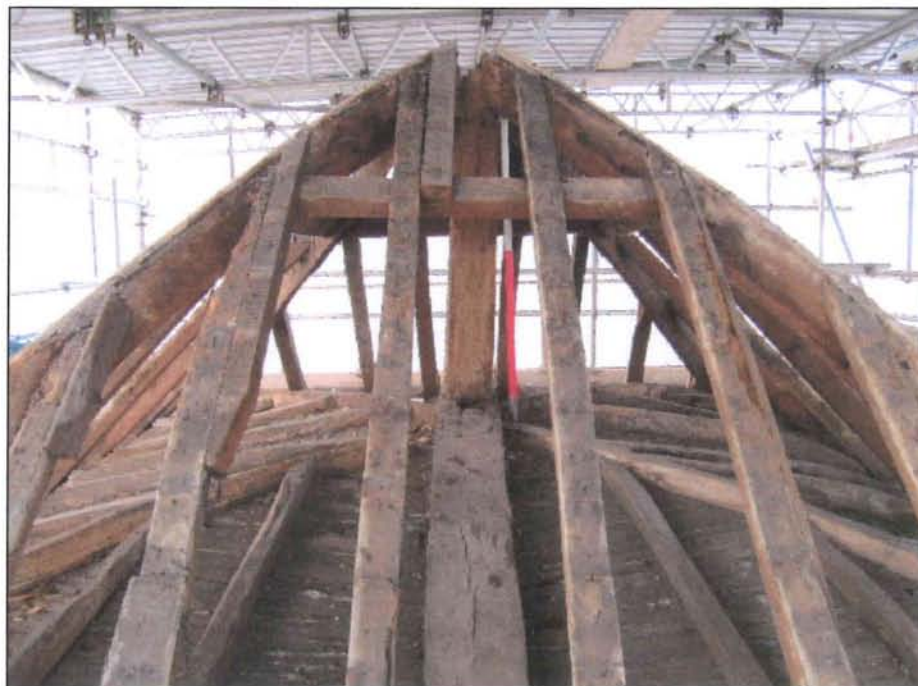
Plate 7 Roof timbers and supporting structure for ceiling below. Photo CPAT 2520-041

- 3.15 At ceiling level four curving beams, notched at one end to the angle ties and nailed centrally to the main cambered beam, have nailed to them numbers of smaller beams extending from the wall plates. This provides the framework (Plate 7) to which the underlying laths are attached, running in quarters parallel to the wall plates, forming the quadripartite coved ceiling in the room below.

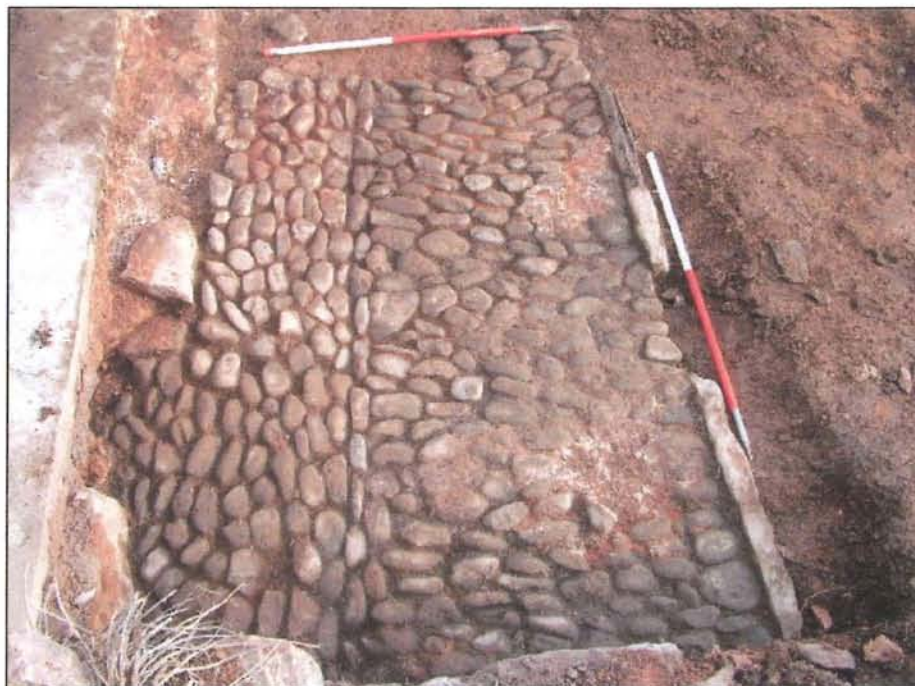
Plate 8 cobble flooring in the possible carriage house to the east of the former brewery.

- 4.8 The monitoring of further groundworks adjacent to the former brewery revealed more detail of the foundations and cobbled surface uncovered during earlier works (see Fig. 5). The earliest walling (Phase A), which measured 0.5m wide and survived up to 0.9m in height at the east end, was constructed from a mixture of limestone and sandstone, bonded with a pink

lime mortar. The wall clearly predated the standing building of the former brewery and extended from it to the east for 4.1m before turning northwards at 90°. The surviving upper course of the wall was a slightly different build (Phase B), although possibly contemporary. Following the construction of the brewery the earlier walling was largely demolished and used in part to form a foundation for a slightly narrower wall (Phase C), possibly for an outbuilding. Within the building the remains of a cobbled floor were revealed, constructed of river cobbles, including at least one drain. The cobbled surface is contemporary with that revealed in the adjacent alley to the north and is assumed to be a relatively late addition, possibly dating from the early 19th century. It is possible that this may have been a carriage house, and was certainly later used as a garage, which was demolished as recently as the 1990s (Morris 2002, 57). It is interesting to note that the existing window in the west wall of the old brewery was originally a doorway.
