Offa's Dyke, Craig Forda, Oswestry

ARCHAEOLOGICAL WATCHING BRIEF

CPAT Report No 652

I Grant
October 2004

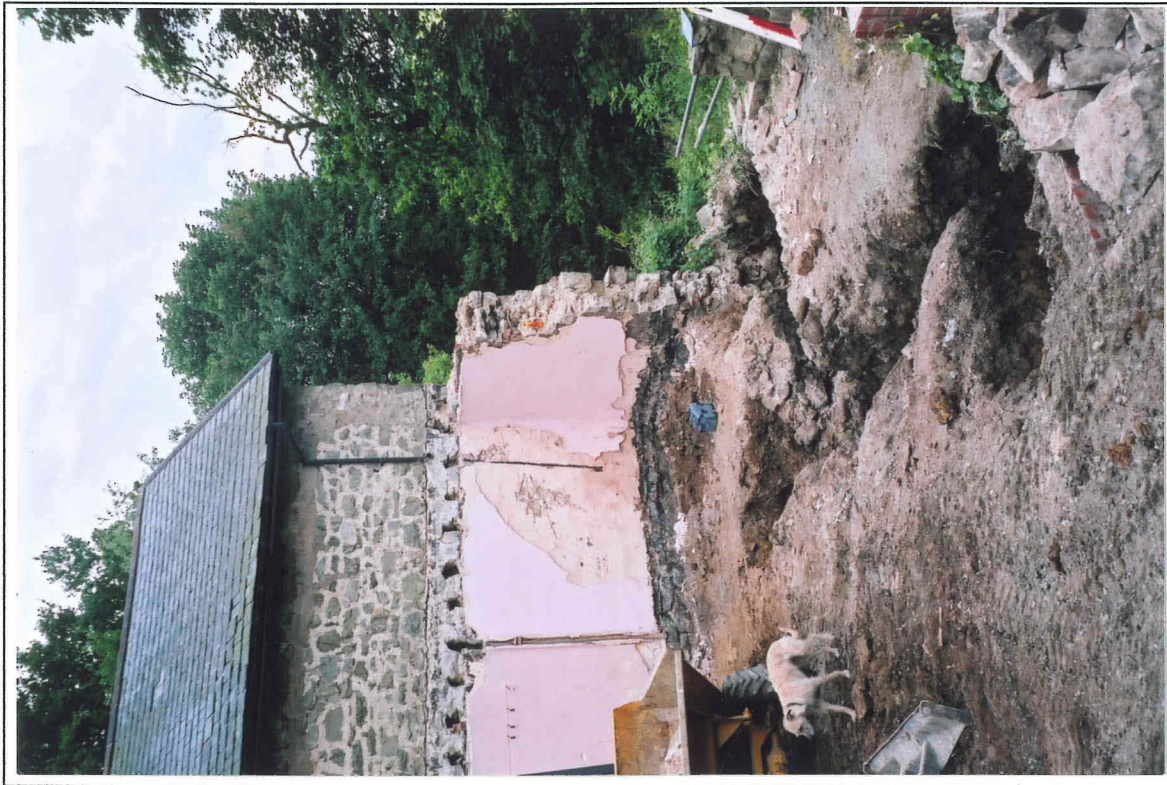
- 3.1 All of the proposed excavations that were to fall within the designated area were carried out using a machine excavator and were monitored over a period of two days, 12th and 13th July 2004. The groundworks included the partial demolition of an existing lime-mortared, stone retaining wall and the removal of any associated foundation material. The wall, possibly of early 19th-century origin, was an integral part of the north-west wing of the cottage and lay abreast the projected alignment of Offa's Dyke (Fig. 3, Plate 1).

Plate 1. Craig Forda from the east, showing location of excavations. The line of Offa's Dyke is projected north to south underlying the part-demolished retaining wall. Photo CPAT 1715.23

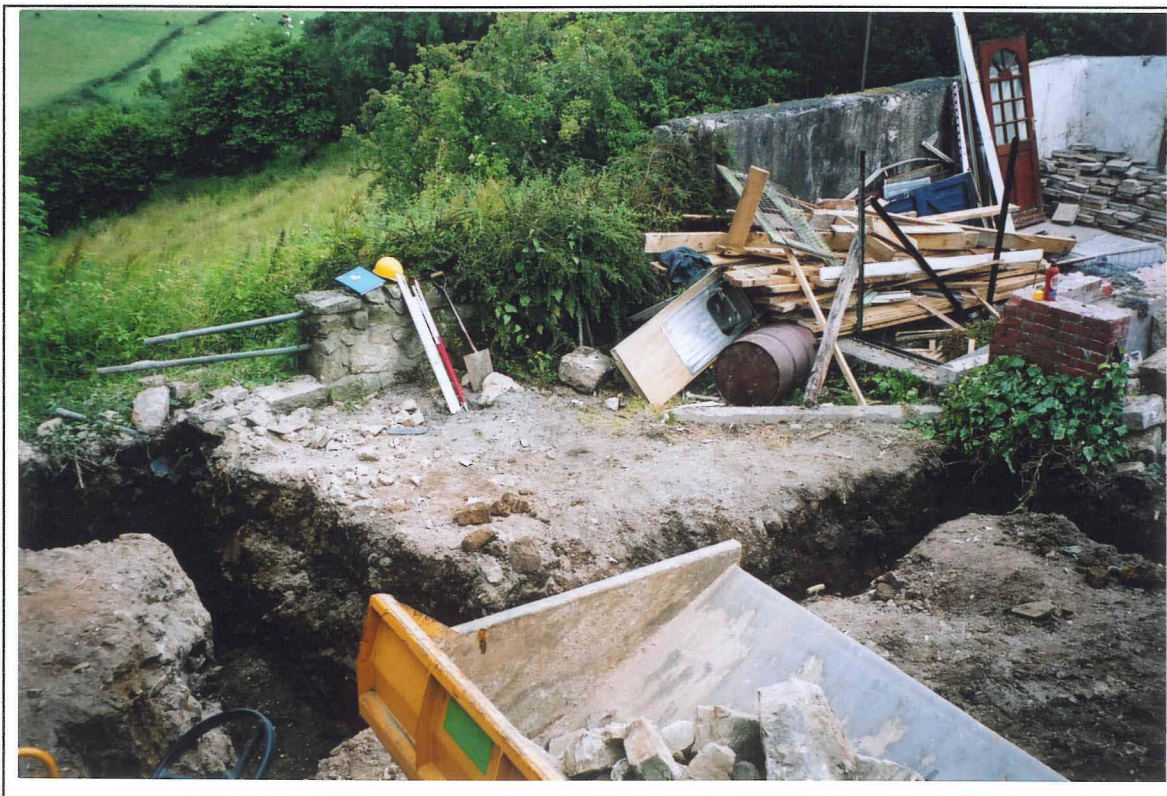
- 3.3 The south-west facing section of this trench revealed that the area north of the development consisted entirely of made-up ground (Plate 2), redeposited during the 19th century. At the base were the remains of footings for a wall, the average size of the blocks being 0.10m x 0.17m x 0.20m and of drystone construction (Plate 4). In addition, fragments of 18th-century slipware were recovered from within the associated deposits. The feature was sealed by a rubble deposit of fragmented pinkish sandstone and a dark brown organic rich silty clay. Although the true nature of the feature cannot be ascertained it is quite possible that the footings are the remains of an outbuilding that predate the existing cottage. The remaining overlying deposits (1.0m in depth) consisted of green shale, gravel, mortar fragments, charcoal and brown sandy clay, all of which was capped by a layer of yellow clay which in turn was sealed by a mixed overburden of loose dark brown silts and general building debris.

Plate 2. View from the south-east, showing footings excavated through 19th Century levelling deposits. The upstanding wall is along the projected line of Offa's Dyke. Photo CPAT 1714.04

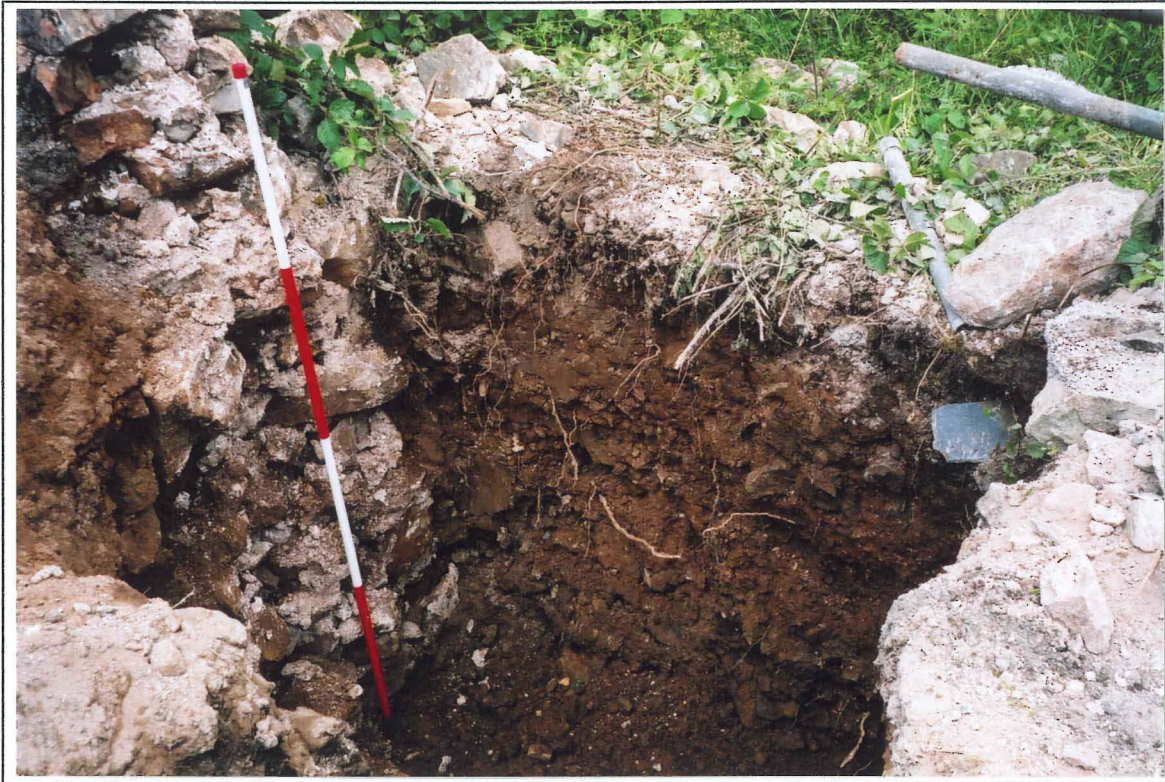
- 3.2 The removal of the northern end of the wall and its associated buttress (0.7m in width) revealed extensive stone footings that extended to a depth of 1.6m. Once this material was removed, the post-medieval deposits visible in the south-east facing section (Plate 3) clearly illustrated that the width of the original foundation cut extended westwards across the projected line of the dyke. The recorded section revealed a dark brown sandy topsoil (0.3m in depth) with an underlying uniform

deposit of light brown sandy clay (1.3m in depth), containing fragments of roofing slate, sandstone, mortar and other 19th-century building debris, all of which had been used to backfill the original construction trench. Shattered limestone bedrock was recorded in situ at the base of the trench. The excavation of this trench (0.7m in width) continued north-east for a further 1.9m before returning along the outer face of the original wall, south-east, for 4.1m and to a depth of 1.5m. The exposed face of the lime mortared wall survived to a depth of 1.4m, with an underlying drystone construction up to 0.1m in depth built onto bedrock. In addition, the bedrock had a tendency to shatter into blocks creating a quarried-out effect across the base of the trench, sometimes also resembling crude drystone building construction in situ.

Plate 3. View from the east, showing 19th century retaining wall and backfill deposits.
Photo CPAT 1715.18
