# **Braich Ddu Wind Farm, near Maerdy, Gwynedd**

**ARCHAEOLOGICAL WATCHING BRIEF**

**CPAT Report No 847**

**R. Hankinson**  
February 2007

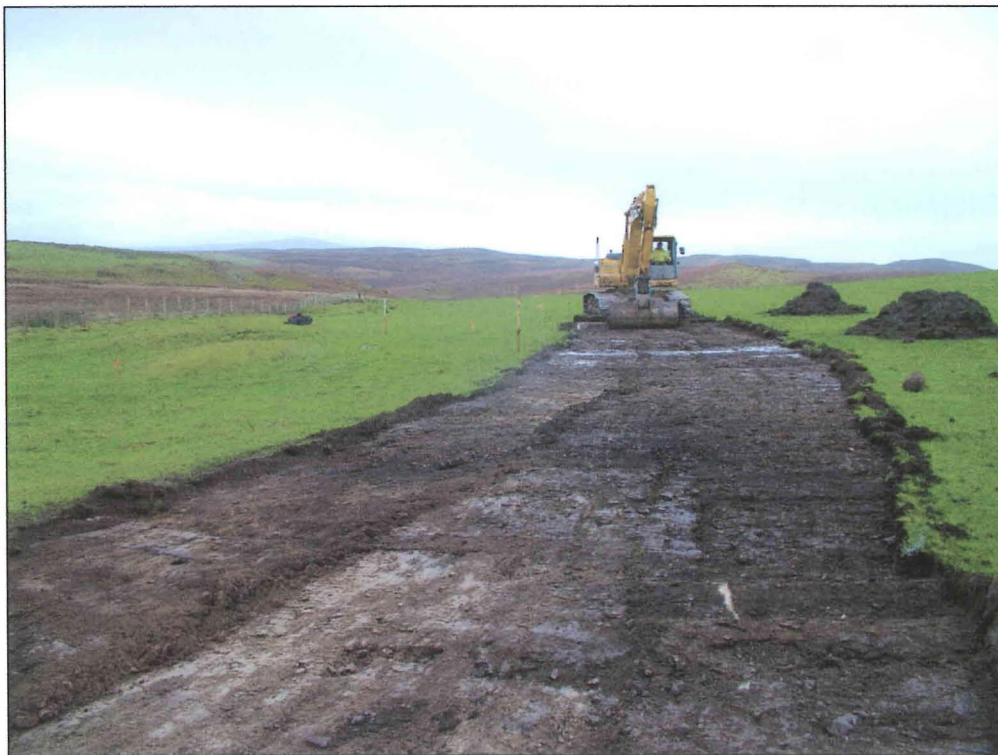
Plate 2 Topsoil stripping in the vicinity of the mounds (PRN 16971), (CPAT photo 2288-002)

- 3.6 Topsoil was removed from the road line passing the mounds (PRN 16971) on 13<sup>th</sup> December. Despite close examination of the area during the machining, no finds or features which might have elucidated the period or function of the mounds were observed. Careful control of the route was maintained during the machining to ensure that there was no encroachment into the zone which had been marked out prior to the commencement of construction work. Both mounds were avoided without damage.
