# **St Mary's Church, Kinnerley, Shropshire**

**ARCHAEOLOGICAL WATCHING BRIEF**

**CPAT Report No 889**

**N W Jones**  
September 2007

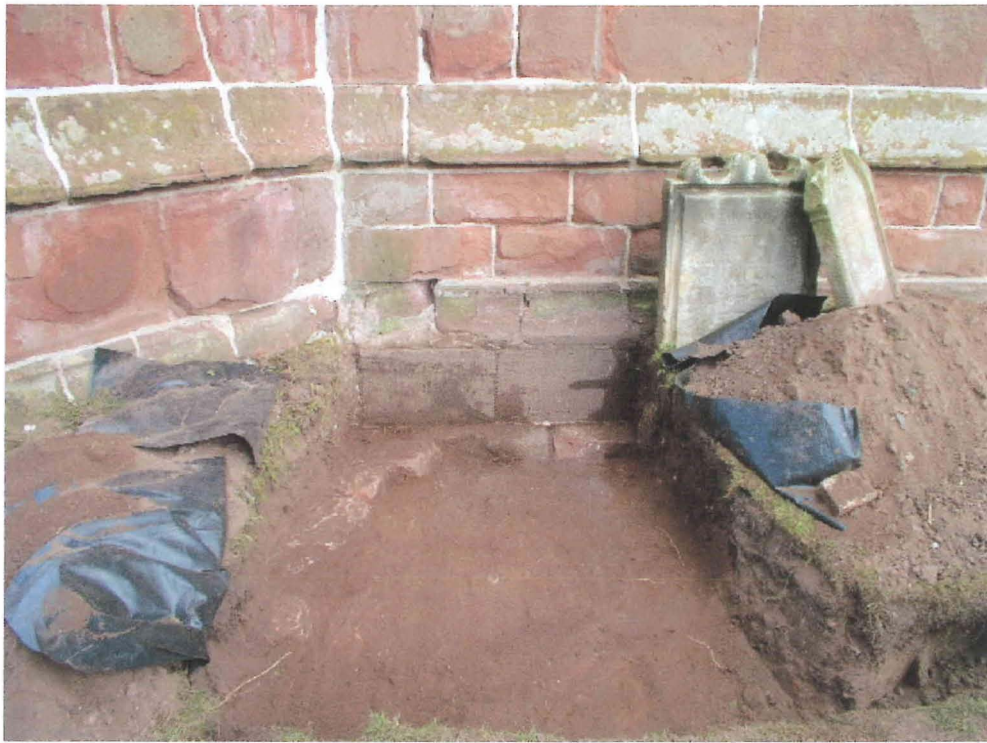
- 4.5 At the base of the west wall of the tower stepped footings (4) were identified, composed of dressed sandstone blocks projecting up to 0.2m from the base of the wall. Adjacent to these blocks, and at the same level, were several rough blocks of sandstone (5) which are assumed to be part of the foundations for the buttress on the north-west corner of the tower.

Plate 1 Excavated area against the west wall of the tower showing the stepped footings (4) and foundation (5) for the north-west buttress.

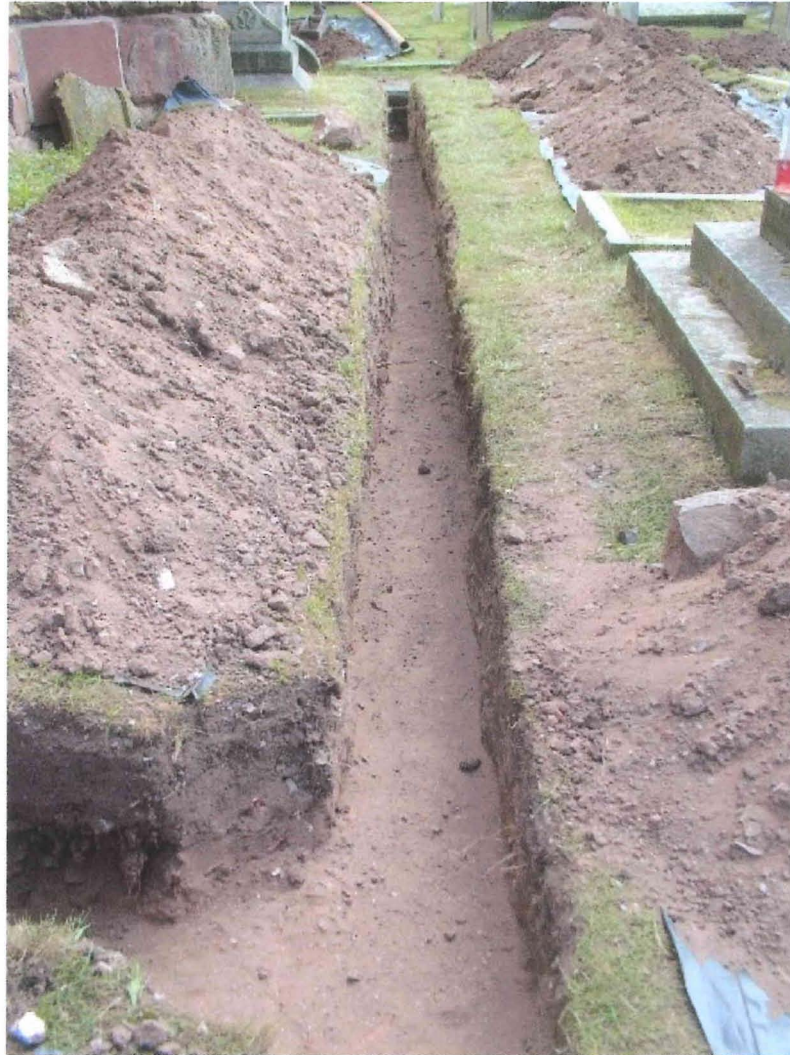
- 4.7 The upper deposit (1) contained fragments of sandstone, lime mortar, slate and disarticulated bone and extended throughout the area to the west and south-west of the tower. Beneath this was a deposit of disturbed soil (2) which also contained fragments of building material and disarticulated bone. No grave cuts were identified between the north-west corner of the tower and the path, although the trench was not deep enough to disturb any in-situ burials and it is possible that graves were present in this area.

Plate 2 Pipe trench alongside the tower, viewed from the north.

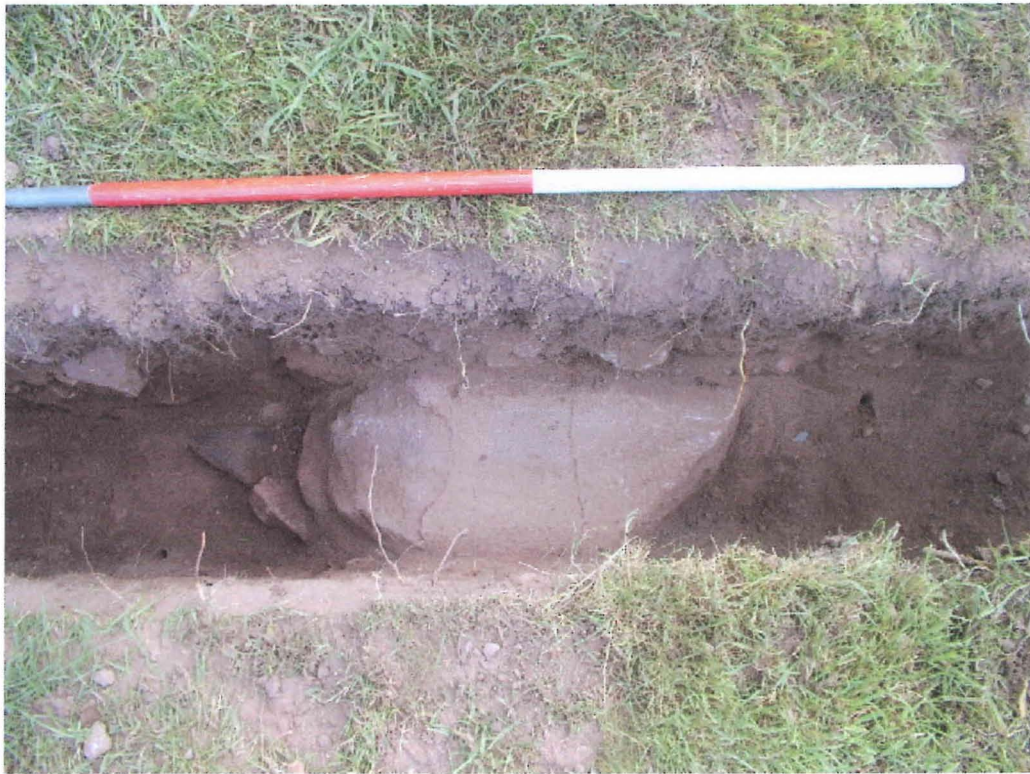
- 4.8 A large block of sandstone was identified close to the buttress on the south-west corner of the tower, along with several smaller fragments of stone which were assumed to be part of the buttress foundations (3). Although no cut was visible it was notable that the west-facing section appeared disturbed and contained a significant quantity of sandstone fragments, while the opposing section did not.

Plate 3 Sandstone block, possibly part of the foundations for the buttress on the south-west corner of the tower.
