**CPAT Report No 1073**

# Ty'r Eglwys, Capel Bangor, Ceredigion

**ARCHAEOLOGICAL WATCHING BRIEF**

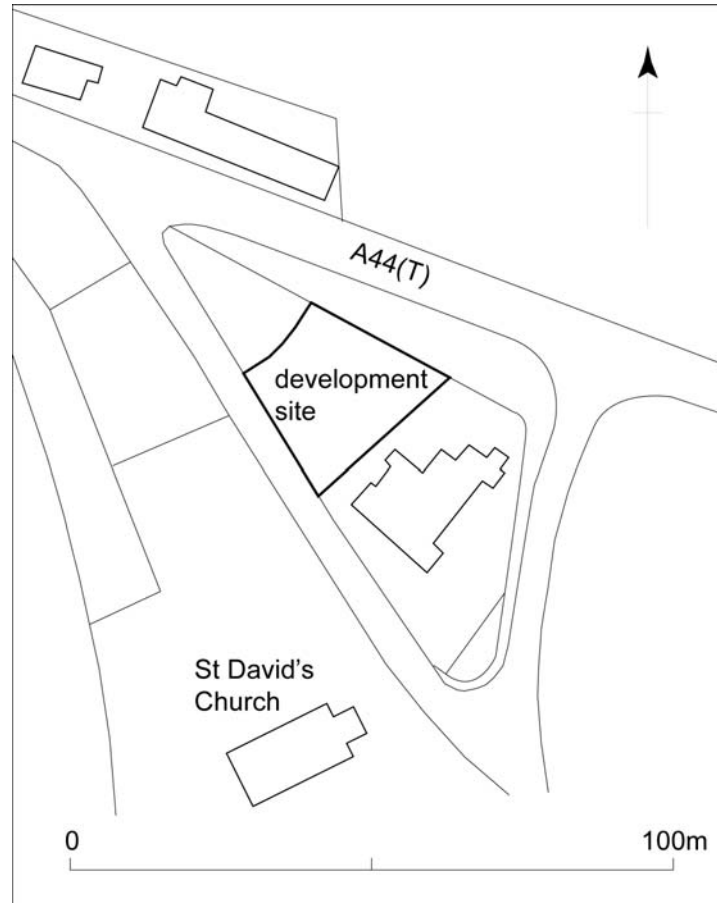
Fig. 2 Location of the development site and St David's Church

- 1.4 The development site was located in the centre of Capel Bangor, on the south side of the A44(T) (SN 6562 8019). The site is in close proximity to the Church of St David's (PRN 6167), the origin of which is thought to predate the Norman Conquest. The name 'Bangor' is of significance as it is generally associated with early medieval ecclesiastical activity. It was therefore anticipated that the development site could contain important archaeological evidence which might be adversely affected by the construction of the new dwellings.

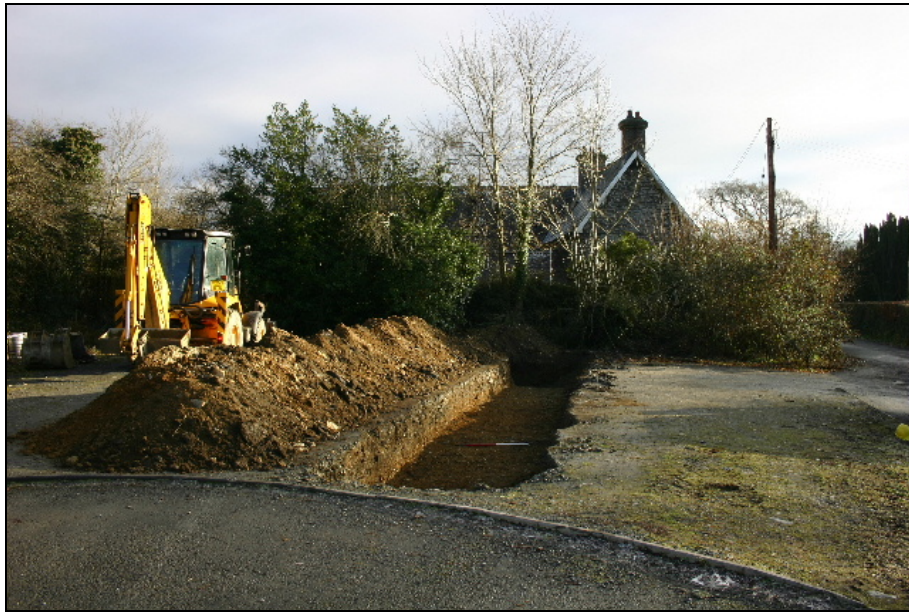
Fig. 4 Location of ground investigation works

- 2.1 The watching brief was carried out on 14 December 2010 and consisted of archaeological monitoring during the mechanical excavation of two test pits and a short connecting trench. The ground investigations were located outside the proposed building footprint in order to avoid unnecessary disturbance that could impact on the stability of the foundations (see Fig. 3). The trench was located parallel with the south-west facing frontage of the plot and was orientated west-north-west by east-south-east. Owing to preservation orders on boundary trees to the east the excavation fell short of the eastern boundary by 6.3m. In all, the trench measured 16m in length (the maximum achievable in the allocated space). Two test pits were excavated within the trench, one at either end. The pits were excavated to a depth of 1.2m below the present ground surface.

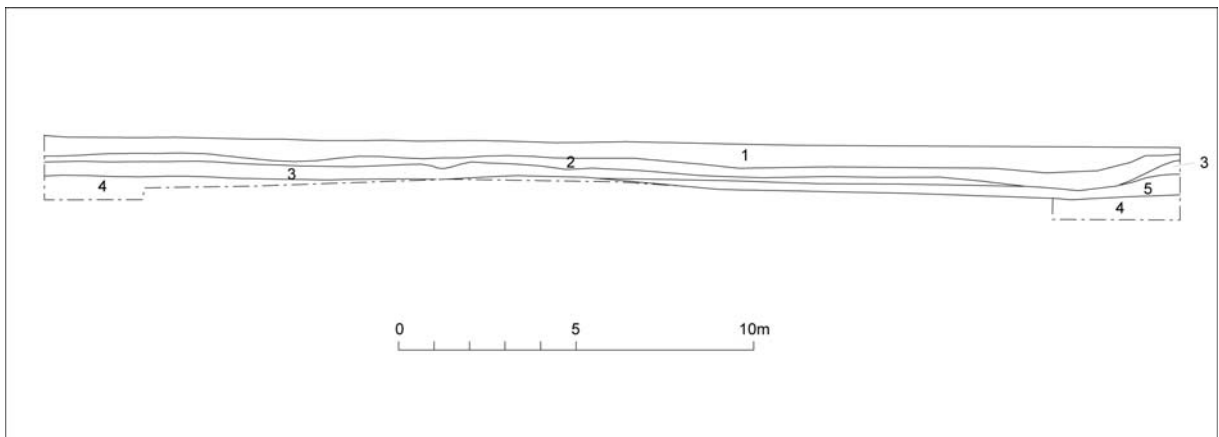
Fig. 5 South-west facing section of the ground investigation works

- 2.3 The natural subsoil (4), a combination of variable river gravels and rounded cobbles mixed with a mottled greenish grey silty clay, was sealed at the eastern end of the trench by a deposit of friable orange silty clay (5), up to 0.28m thick, which in turn was sealed by a yellowish-brown silty clay up to 0.24m thick (3). The latter extended along the entire length of the trench. Overlying this deposit was a firm dark grey clay (2), up to 0.12m thick, which contained coal fragments and house bricks together with organic material. The nature of this deposit suggests that the site may in the past have been subject to a period of water/logging. The overburden forming the uppermost deposit (1) consisted of hardcore chippings mixed with shale and general building debris up to 0.3m thick which appeared to be of relatively recent date. Some 19<sup>th</sup>/20<sup>th</sup>-century ceramics were recovered from the deposits up to 0.45m below the present ground horizon, although none of the artefacts were retained. No other artefacts or features of archaeological significance were observed.

- 3.2 The recorded trench section (see Fig. 5) illustrates the fairly uniform nature of the build up of post medieval/modern deposits across the site. One might assume that these are representative of the deposits in the adjacent area that encompasses the footprint of the development site. Although the ground investigations revealed no evidence for significant archaeological features or deposits this does not discount the possibility that such may be present elsewhere on the site.

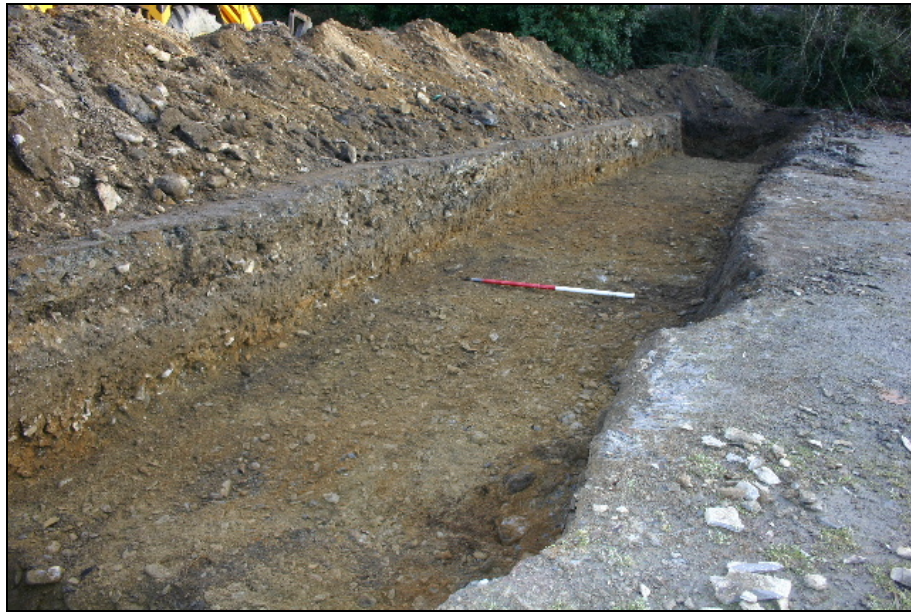
Fig. 6 The surface of the undisturbed natural subsoil revealed by the ground investigation works

- 2.2 The trench was excavated to a total depth of up to 0.9m, removing all modern overburden and ploughsoils onto the surface of the undisturbed natural subsoil. No archaeologically significant deposits were identified during this process and rapid cleaning and the investigation of the surface of the subsoil revealed that no archaeological features were present within the trench.
