**CPAT Report No 1164**

# Hen Caerwys Community Excavation, Caerwys, Flintshire

by  
Bob Silvester and Will Davies

December 2012

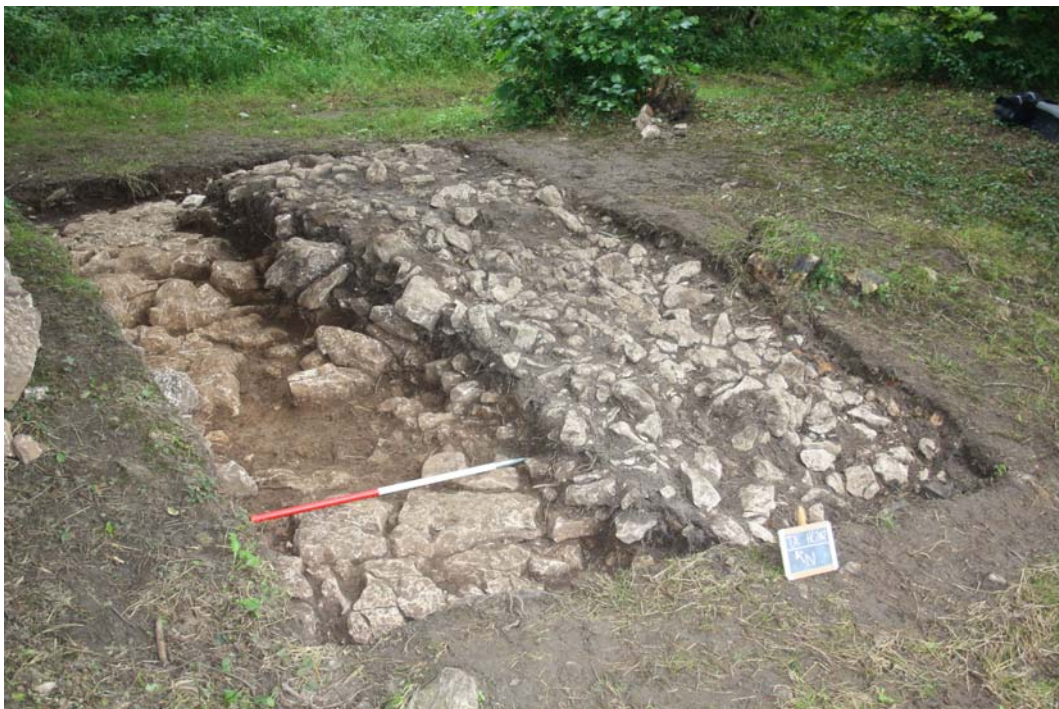
Fig 2 Trench 1 after excavation (CPAT 3492-0154)

Trench 1 was originally about 15m long, the western part of it lying across the interior of the enclosure and exposing only a thin layer of soil above the bedrock. Only that part of the trench that cut through the enclosure bank was re-opened to enable the completion of the section through it. At this point the bank was 3.9m wide and had a height of around 0.6m above the bedrock. It was impossible to determine clear faces, either internally or externally, but the presence of large limestone blocks gave some form to the structure, implying that it was a broad but low feature, with larger lumps of limestone edging smaller rubble in the core.

Above this structure was a band of smaller limestone rubble, little more than 200mm thick which spread more widely than the basal bank. This could reveal a later phase designed to heighten the bank or simply have been a means of heightening the bank during its original construction. Either way degradation of the bank led to this material being spread.

One curious result of excavating the section was that the natural limestone was slightly domed beneath the bank, to a height of between 0.2-0.3m. A visiting geologist disabused the writers of the notion that this could be a result of natural processes, and so it appears that at this point on the circuit of the enclosure the bank was deliberately built on a natural rise.

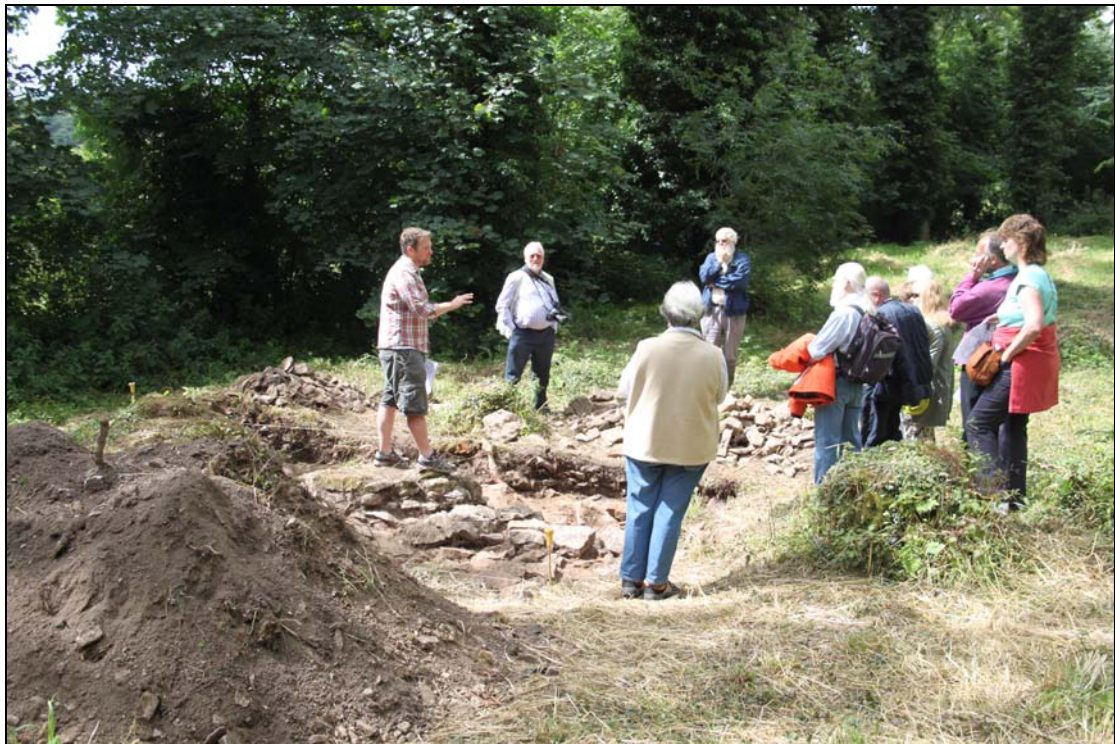
Fig 3 Trench 2 during the open day at the end of the excavations (CPAT 3492-0080)

The location of some of the missing occupation debris neatly completes the sequence of events in this trench. The interior of the ruined medieval building was very thoroughly excavated and almost all of its internal deposits removed down to the rubble platform on which it was founded, leaving only the partial remains of the walls. It would appear from the shallow overburden covering the rubble layer that the 1960's trench was subsequently left open to the elements, accounting for the absence of darker occupation soil, which with most of the rest of the excavated material is likely to be found in the other irregular mounds surrounding the platform, indicating limited further potential for surviving deposits. The only

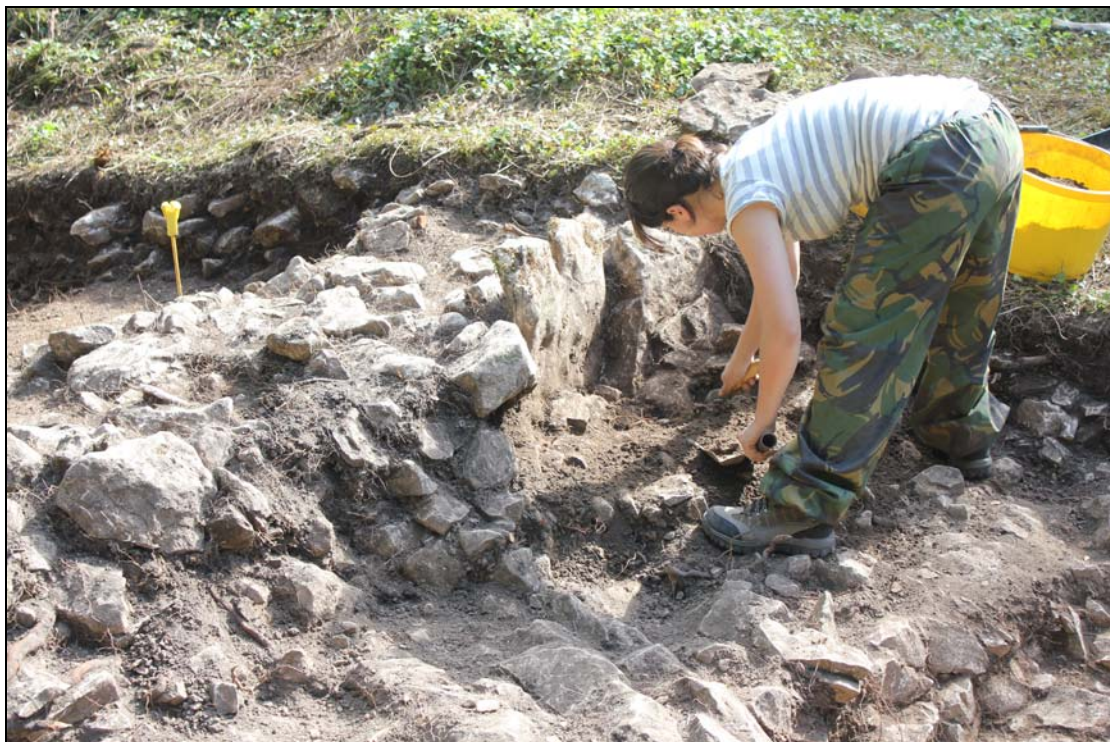
Fig 4 Trench 3 showing the remaining external facing stones of the buildings' north wall (CPAT 3492-0064)

The walls of the building were well-defined, at least on the inner faces which were exposed to view across the whole width of the trench. Of rough limestone blocks they were in general only one course high. The outer wall faces presented a very different appearance. Only on the north side where there were three upright revetment slabs in a line and well-embedded could the line of the outer wall face be confidently established. Elsewhere on the north and along the entire wall face on the south, it was impossible to pinpoint a wall face, and it was the undifferentiated rubble infill of the walls that was encountered. It seems likely that the pressure of the roof bearing down on the walls had a much more drastic effect on the outside than on the inside faces.
