Twyni Byw - Sands of LIFE (SoLIFE) Gwaith Cadwraeth ym / Conservation Works at Morfa Harlech, Gwynedd

Desk-based Assessment and Archaeological Mitigation

Rhif Prosiect / Project No. G2790

Rhif Adroddiad / Report No. 1751

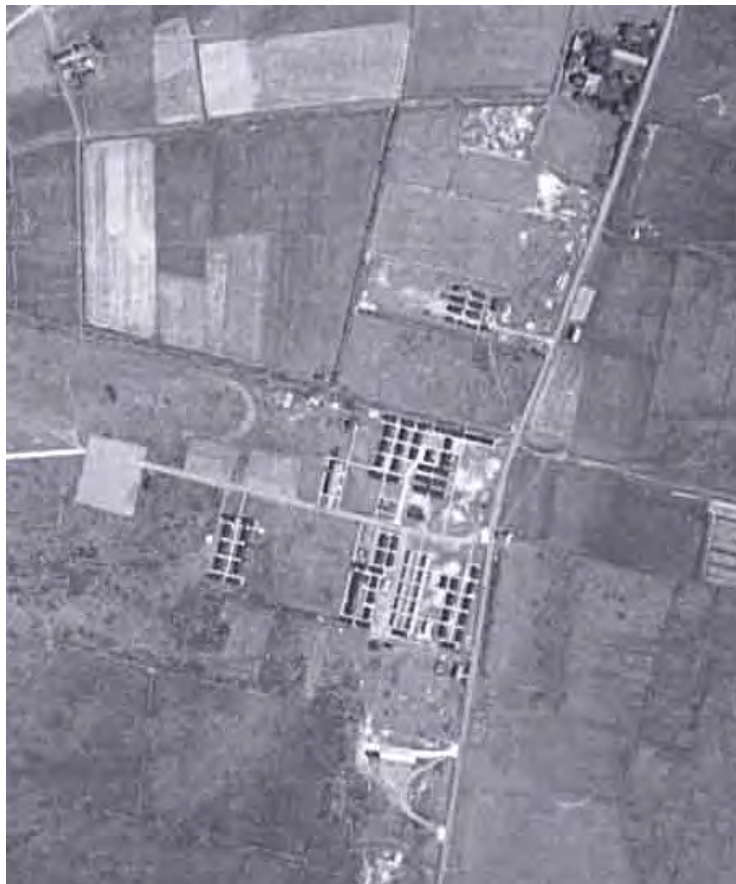
Figure 3. Map and aerial photograph of training camp (PRN 83127 and 83134)

Detail of 1948 aerial photograph showing layout of artillery training camp (library no 4841, sortie 540 RAF 39, frame 5071, date 19/05/1948)

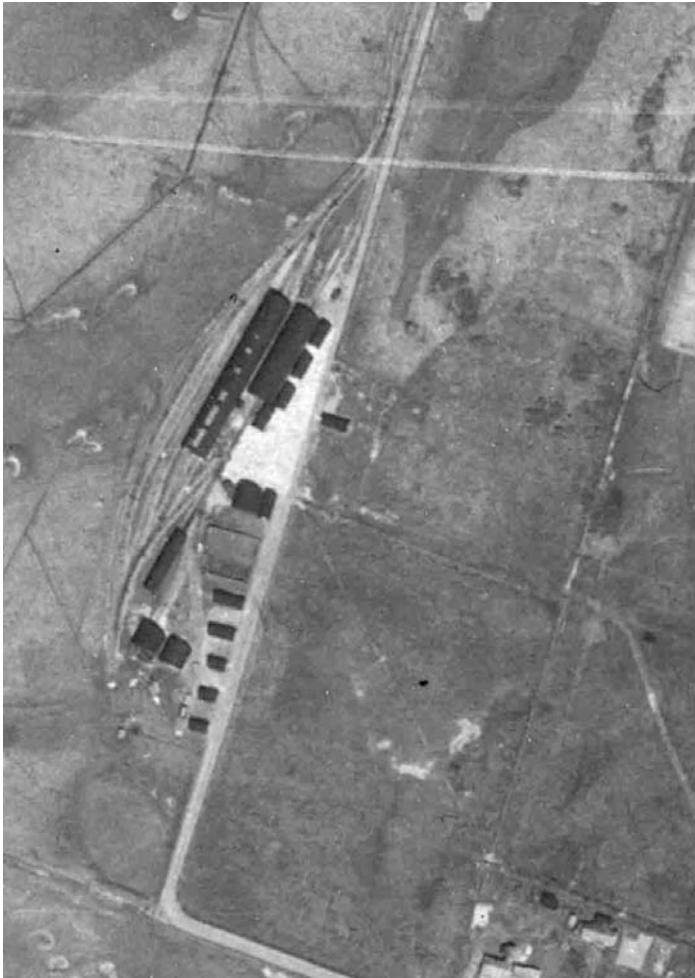
Figure 4. Photographs of the engine sheds (PRN 103561)

Engine sheds still in good condition and tracks still in place in 1946 (library no 4631, sortie RAF 106GUK 1468, frame 2414, date 04/05/1946)

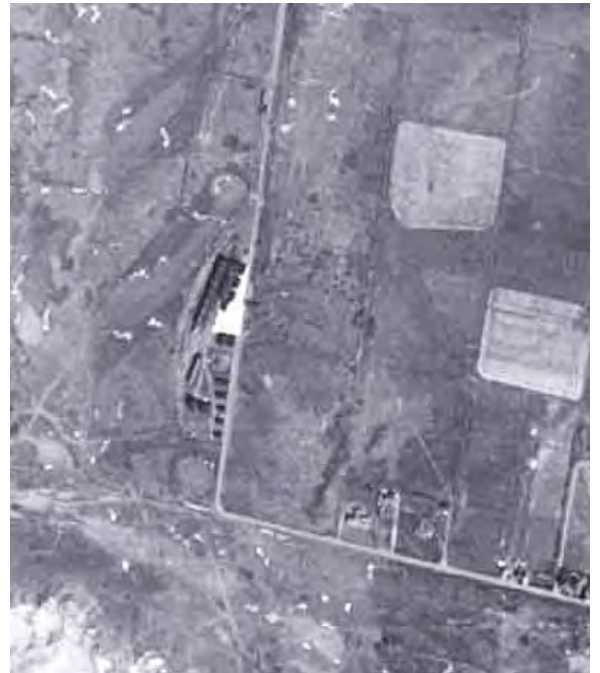
Engine sheds still in good condition but tracks removed in 1948 (library no 4841, sortie 540 RAF 39, frame 5071, date 19/05/1948)

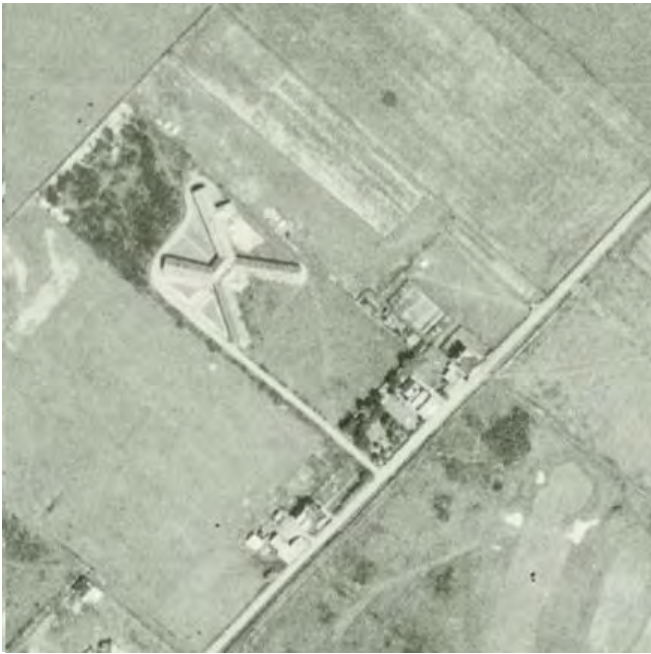
Figure 5. Photographs of the X-plan ranges of buildings (PRN 103563)

Buildings constructed by August 1941 (library no 4107/ M2962, sortie S/438, frame 35, date 24/08/1941)

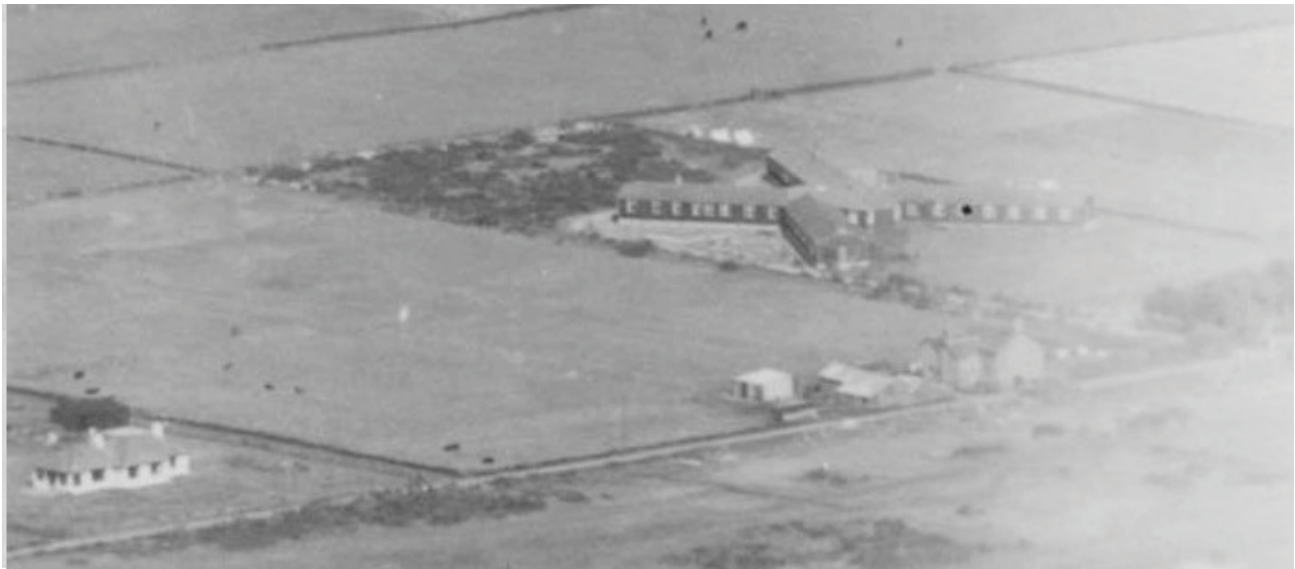
Oblique view of the buildings August 1941 (library no 4107/ M2962, sortie S/438, frame 110, date 24/08/1941)

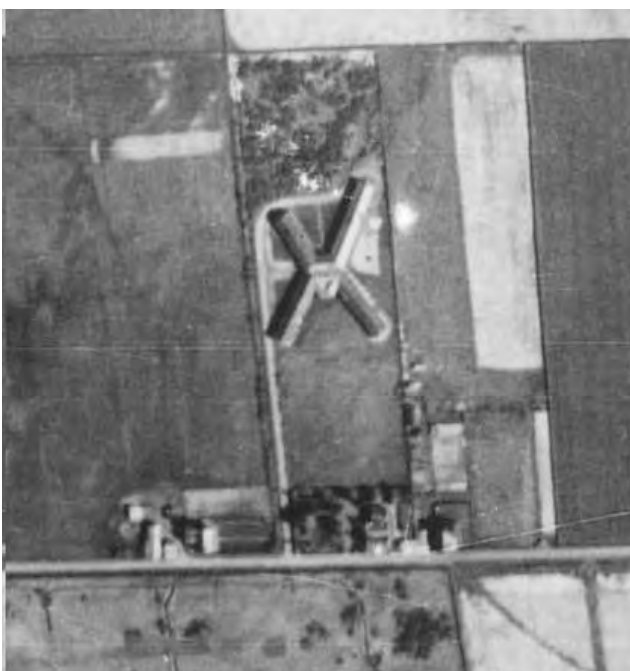
The buildings in April 1942 (library no 4206/ M2324, sortie HLA/489, frame 2 75, date 15/04/1942)

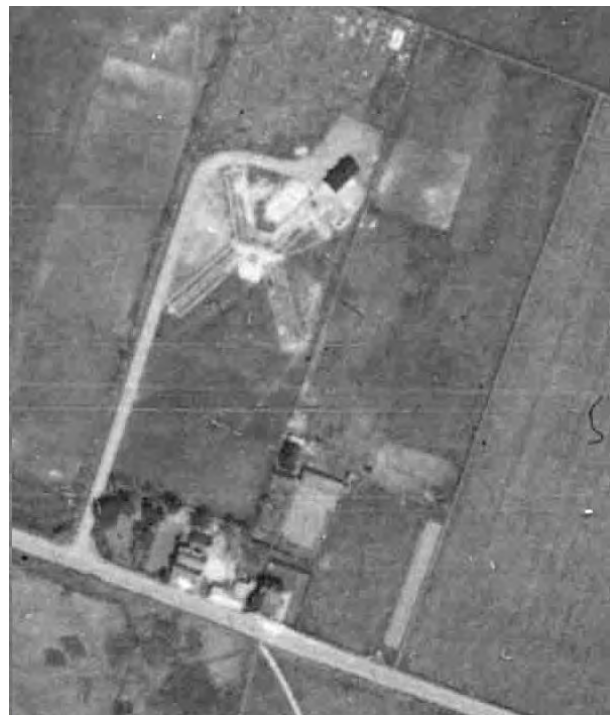
The buildings mostly demolished by May 1946 (library no 4631, sortie RAF 106GUK 1468, frame 2414, date 04/05/1946)

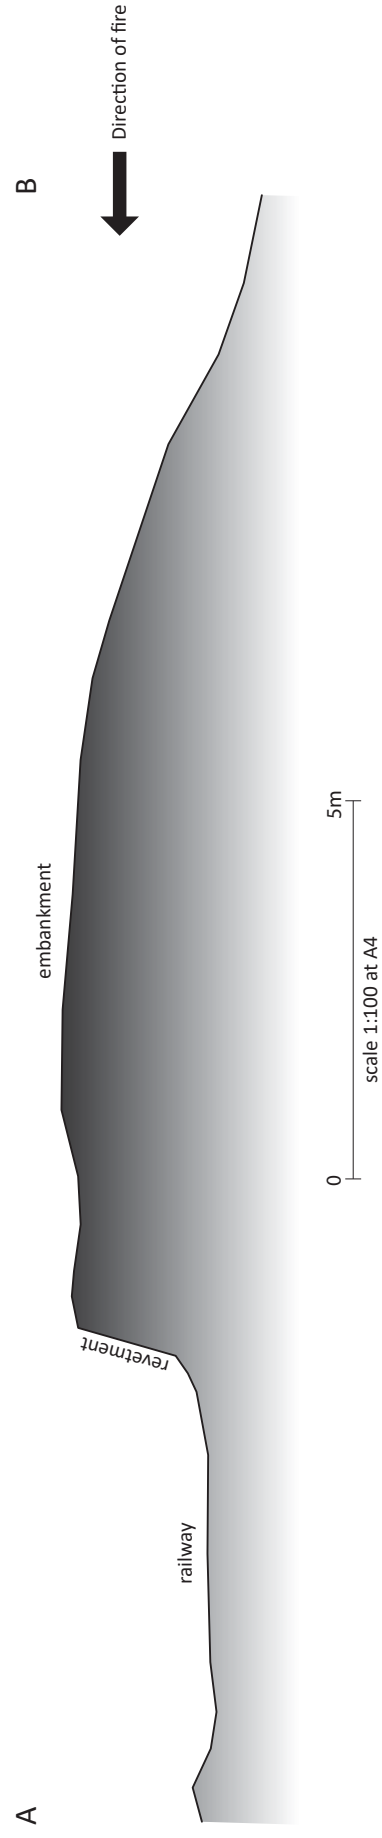
Figure 9. Profile across target railway and embankment (see Figure 8 for location of profile)

The survey of the area within the grazing compartment has provided a detailed view of a part of the target railway and its protective embankment. This shows the sloping eastern face of the embankment to trap incoming shells and the revetment built of concrete in sandbags alongside the railway. The survey also included the southern end of the embankment in this area and showed where the railway continued unprotected into the semi-circular end of the loop, where targets were probably changed or repaired. The LiDAR suggests that there are remains of the railway trackbed all around this semi-circular end and future clearance of vegetation in this area may reveal more information on how the target railway worked.

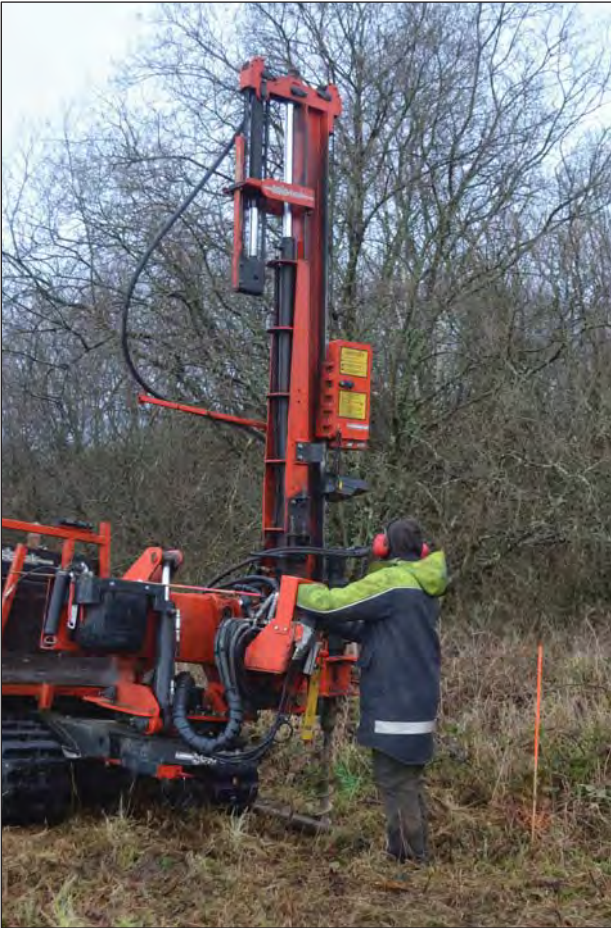
Plate 1. Hole being drilled for fence post
(photo ref: G2790_100)

The archaeological watching brief was to be carried out on groundworks relating to the erection of stock fencing and field gates. Fence posts were inserted using a machine to drill a hole then the posts were driven in (Plates 1, 2, 3 and 4). The process of inserting posts was assessed, and it was considered that no archaeological evidence could be recovered during this process. Most of the fence posts were inserted through the embankment or through sand overlying this and would cause minimal damage to the archaeology. A few of the posts inserted in the southern area risked cutting into the track bed of the railway, but the insertion process meant that no significant information could be obtained by watching the posts being inserted. Even the larger posts for gateways were being inserted in the same way, meaning that there would be no large hole in which layers or features might be recognised. It was concluded that watching the insertion of the posts was of no archaeological value.

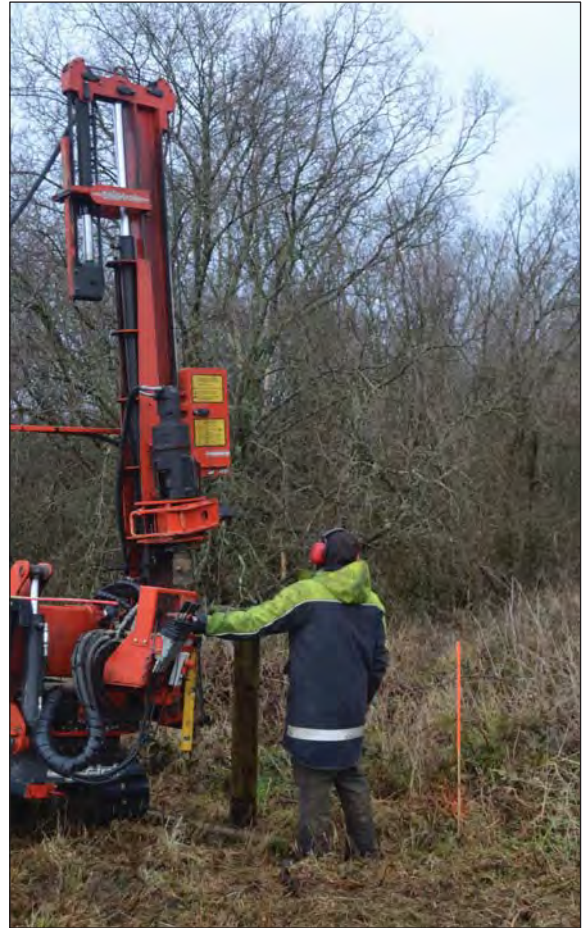
Plate 2. Fence post being driven into hole
(photo ref: G2790_102)

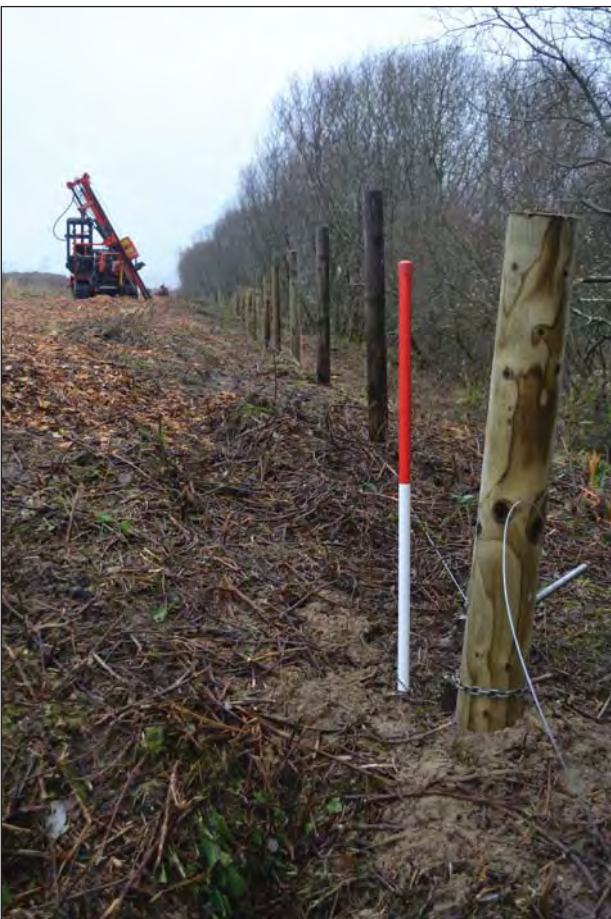
Plate 3. Example of fencing on embankment
(photo ref: G2790_091)

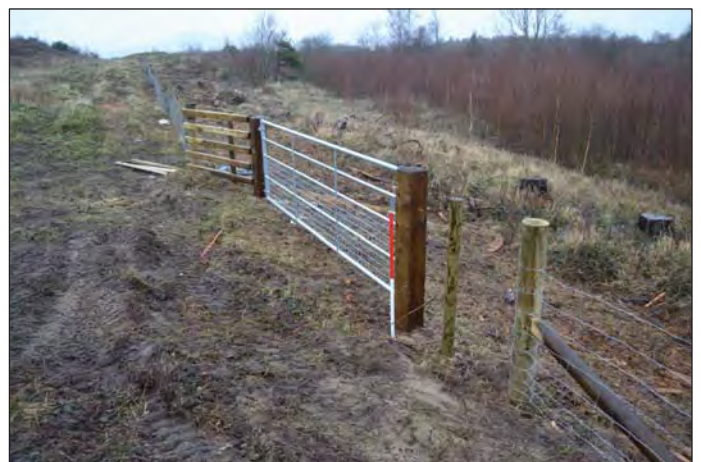
Plate 4. Example of gate in fencing
(photo ref: G2790_092)

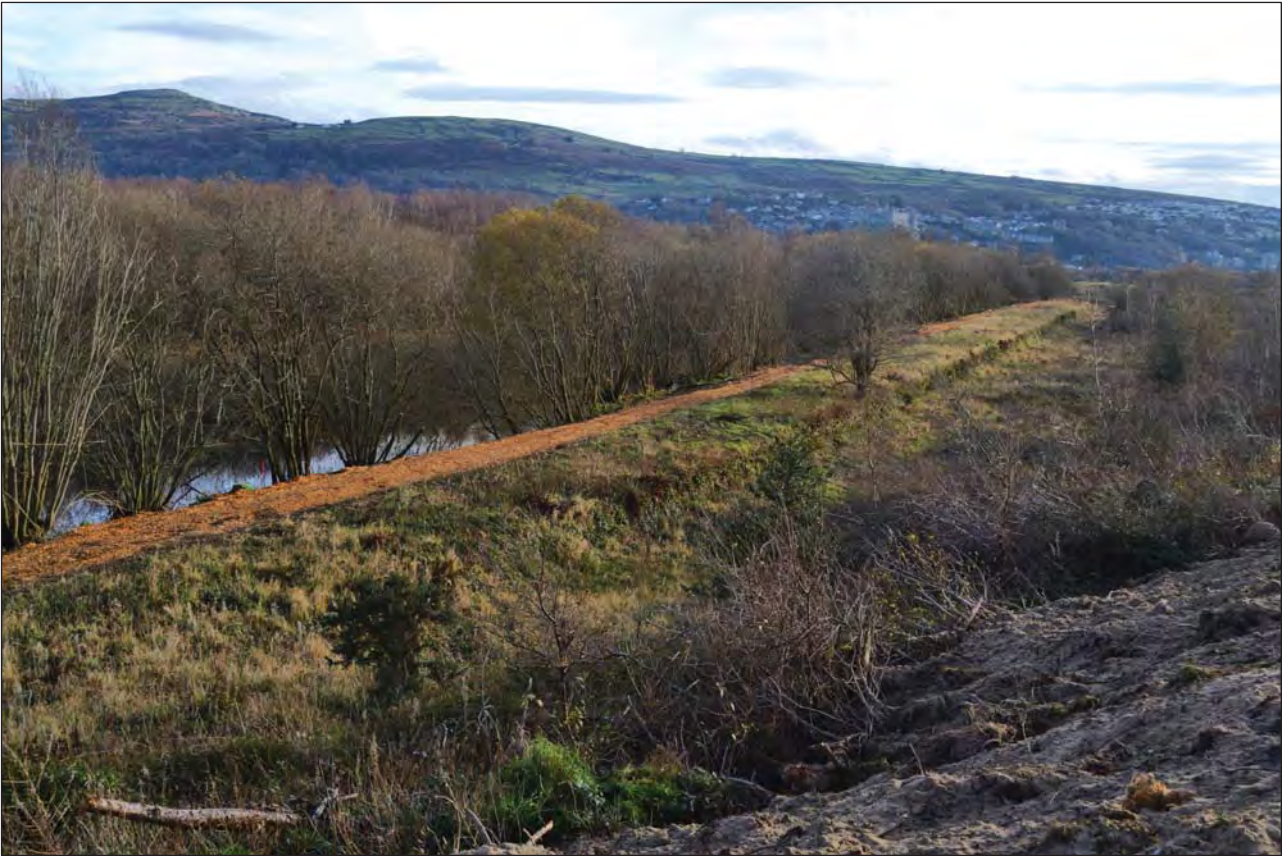
Plate 5. Southern end of the target railway embankment with Harlech Castle in the distance; view from NW (photo ref: G2790_082)

The southern part of the embankment has been used as a trackway by forestry vehicles. The start of this track at the southern end is shown on modern maps and can be seen on the ground as a deposit of dark grey, broken stone. The same stone has been used to create a ramp on to the embankment (Plate 18). Where the track across the area of sand encroachment the sand has been levelled and in one place stone and sand have been used to create a ramp taking the track down off the sand onto the route of the railway, which was used as the forestry track along the northern part of the surveyed section. Other trackways cut from the east onto the embankment in places (Plate 19), but these are where there has been sand encroachment and although there has been considerable disturbance caused by vehicles the sand has largely protected the embankment from erosion.

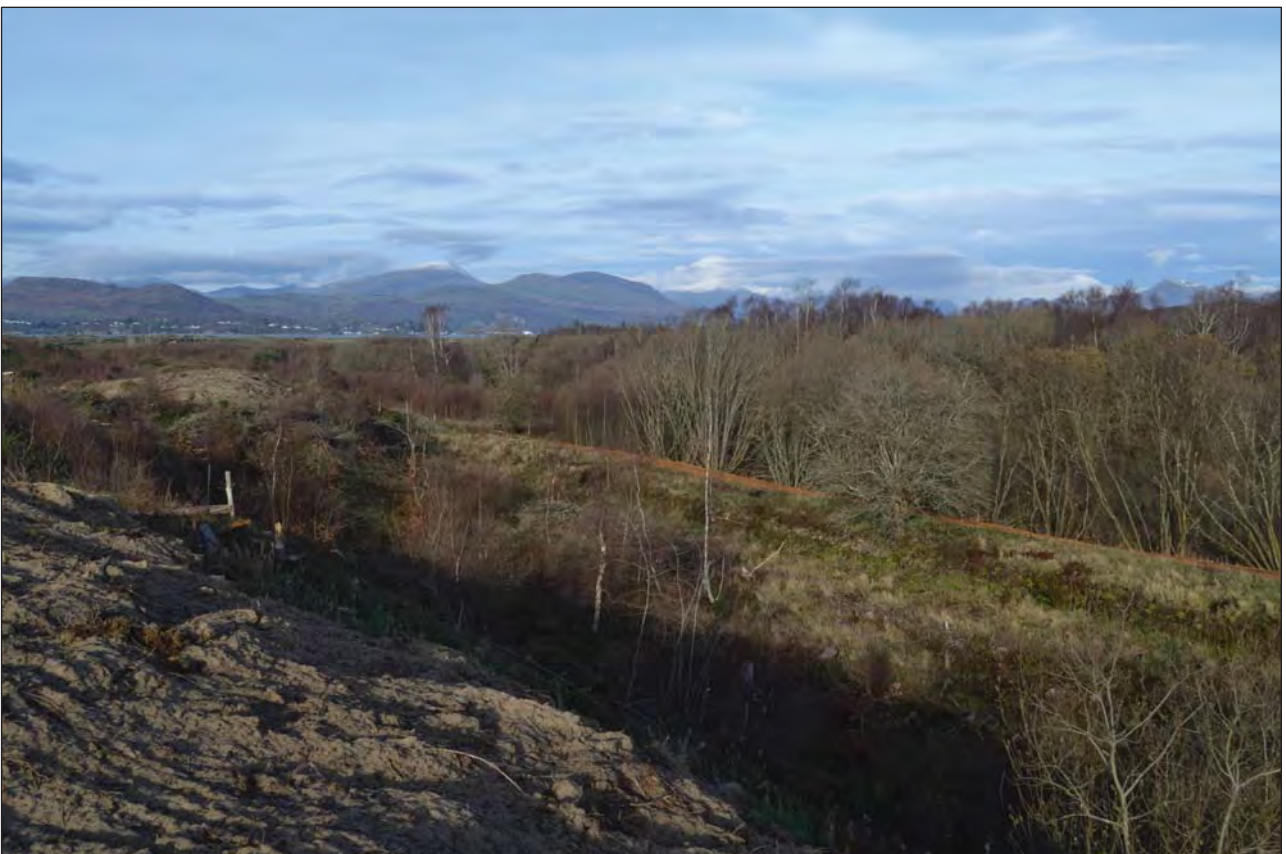
Plate 6. Target railway embankment within regenerating deciduous woodland with high sand dune on left and distant views to the hills beyond the Dwyryd estuary; view from SW (photo ref: G2790_081)

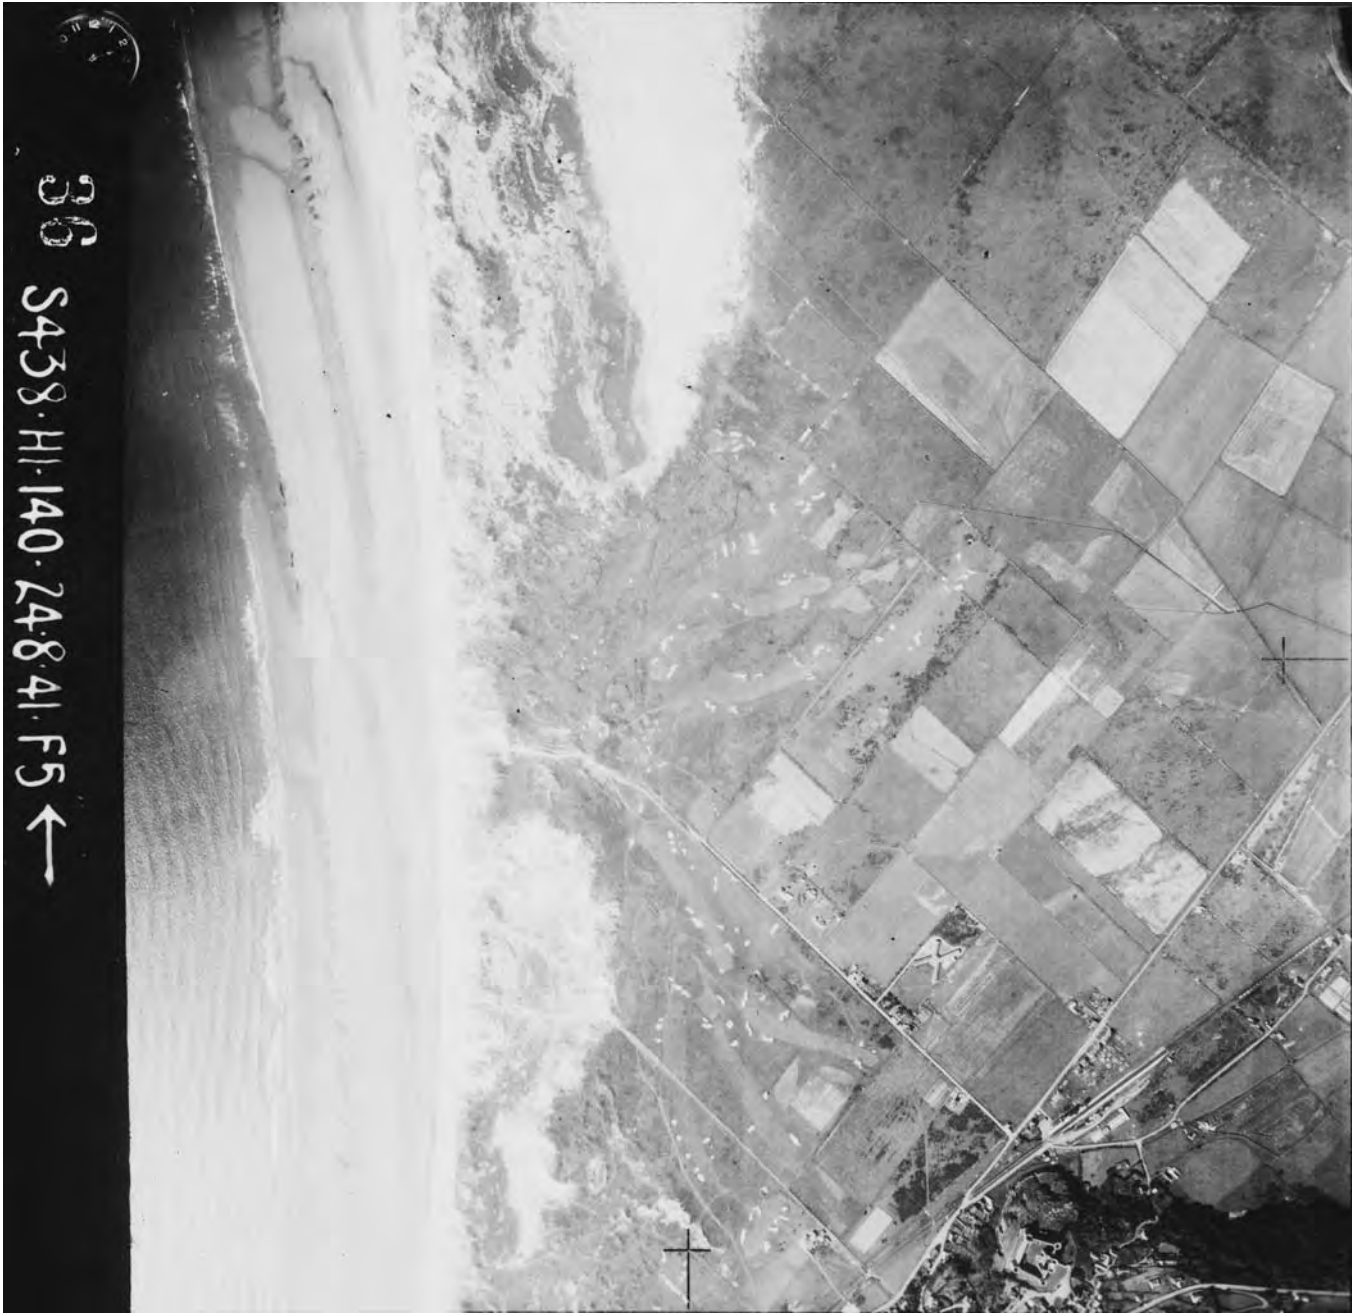
Plate 7. View of area in August 1941 prior to construction of target railway
(library no 4107/ M2962, sortie S/438, frame 36, date 24/08/1941) (north roughly to top)

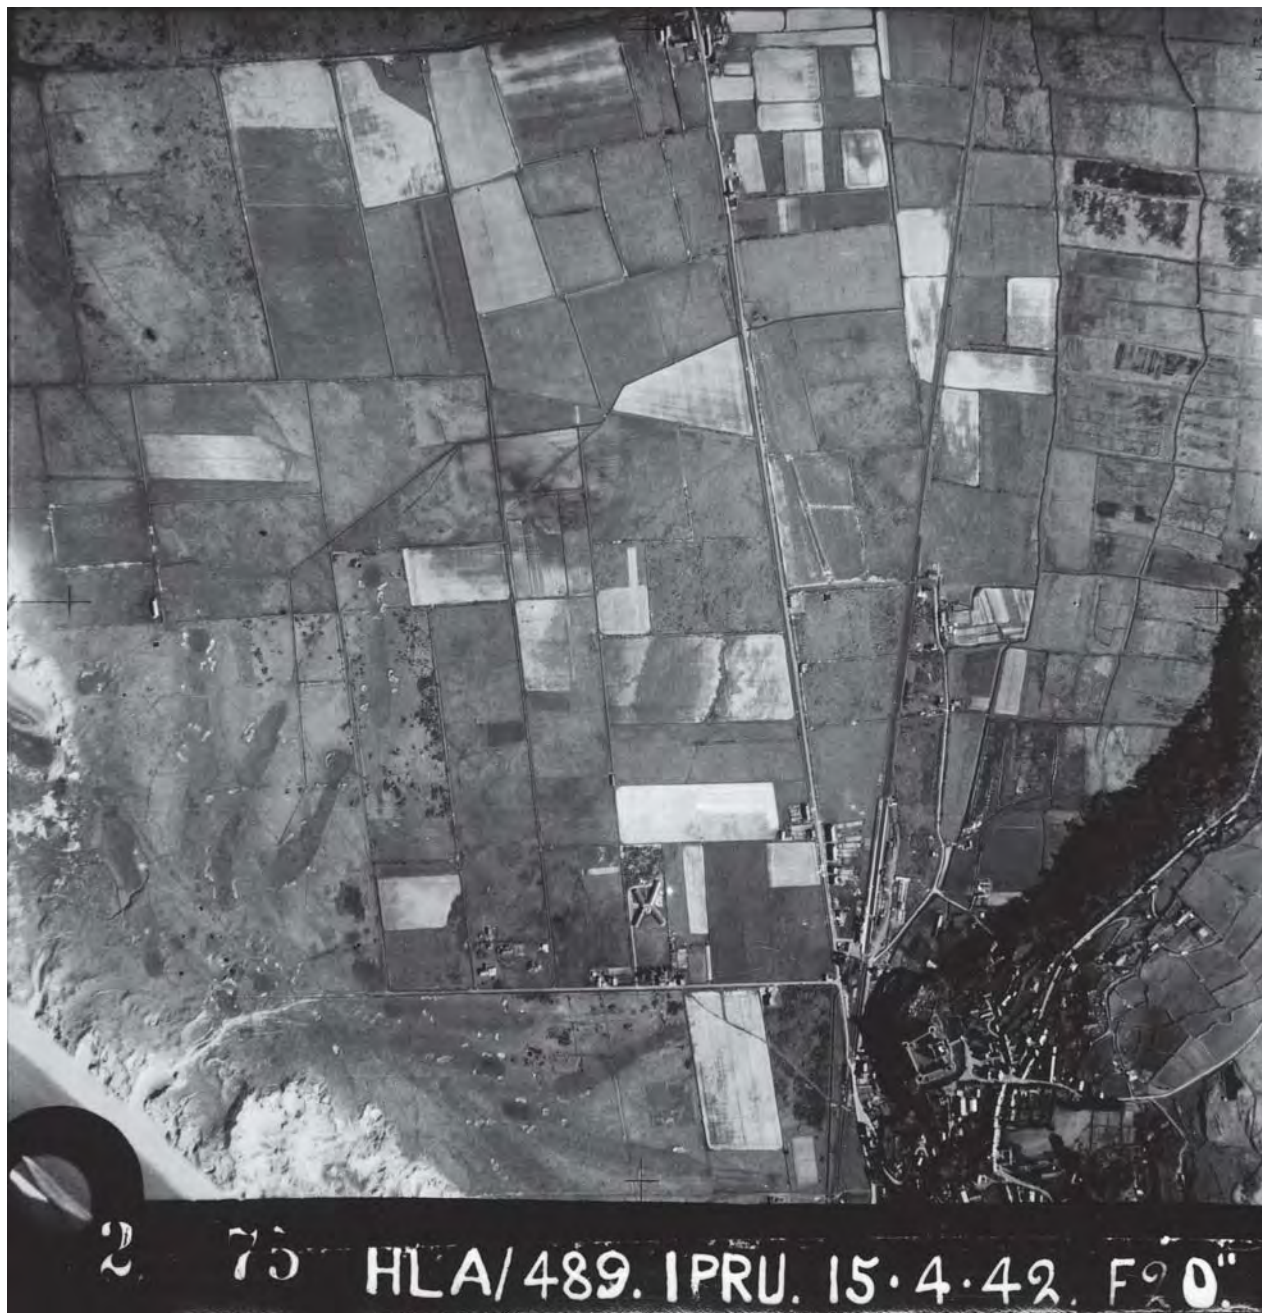
Plate 8. View of southern part of training area in April 1942, showing the target railway not yet built (library no 4206/M2324, sortie HLA/489, frame 2 75, date 15/04/1942)

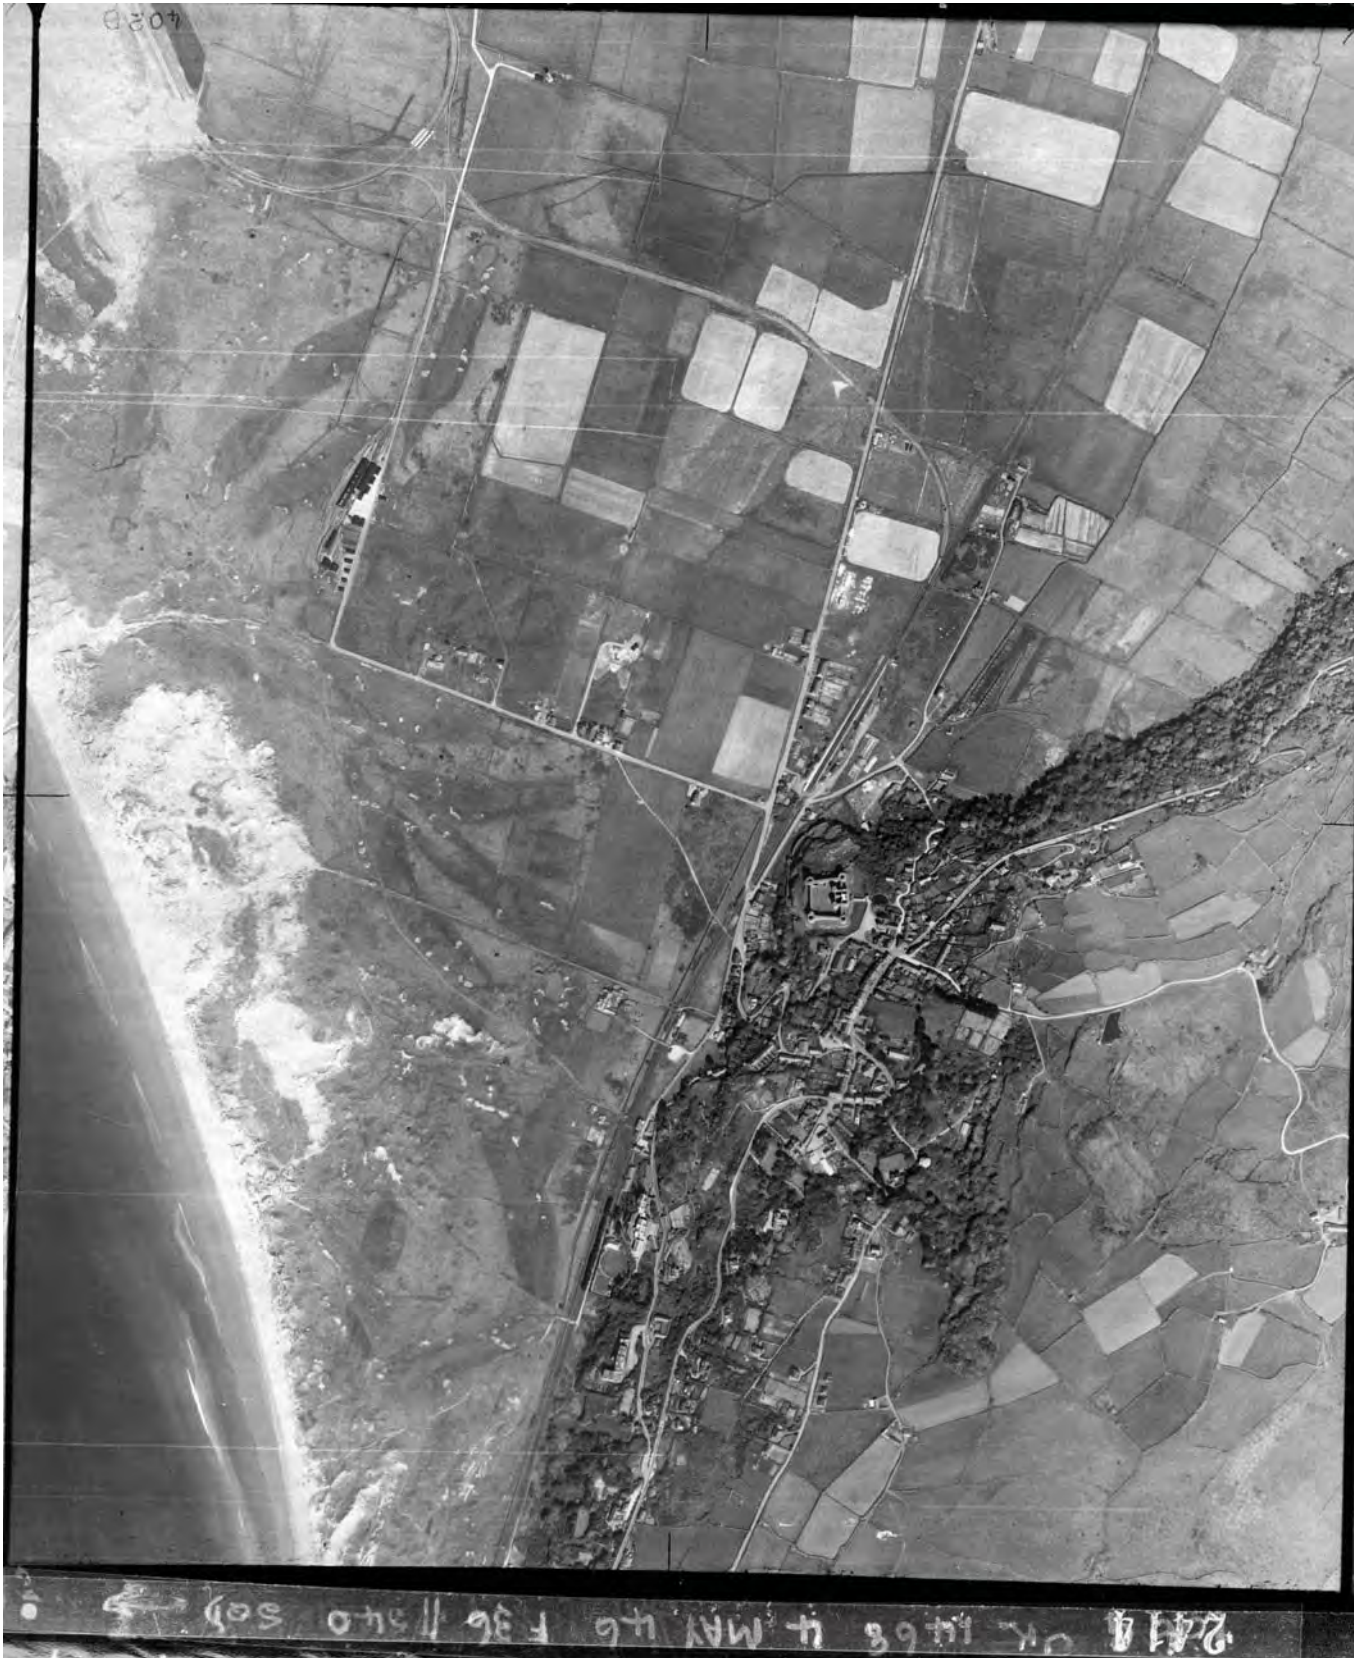
Plate 9. View of southern part of training area in May 1946, showing the target railway and military railway (library no 4631, sortie RAF 106GUK 1468, frame 2414, date 04/05/1946)

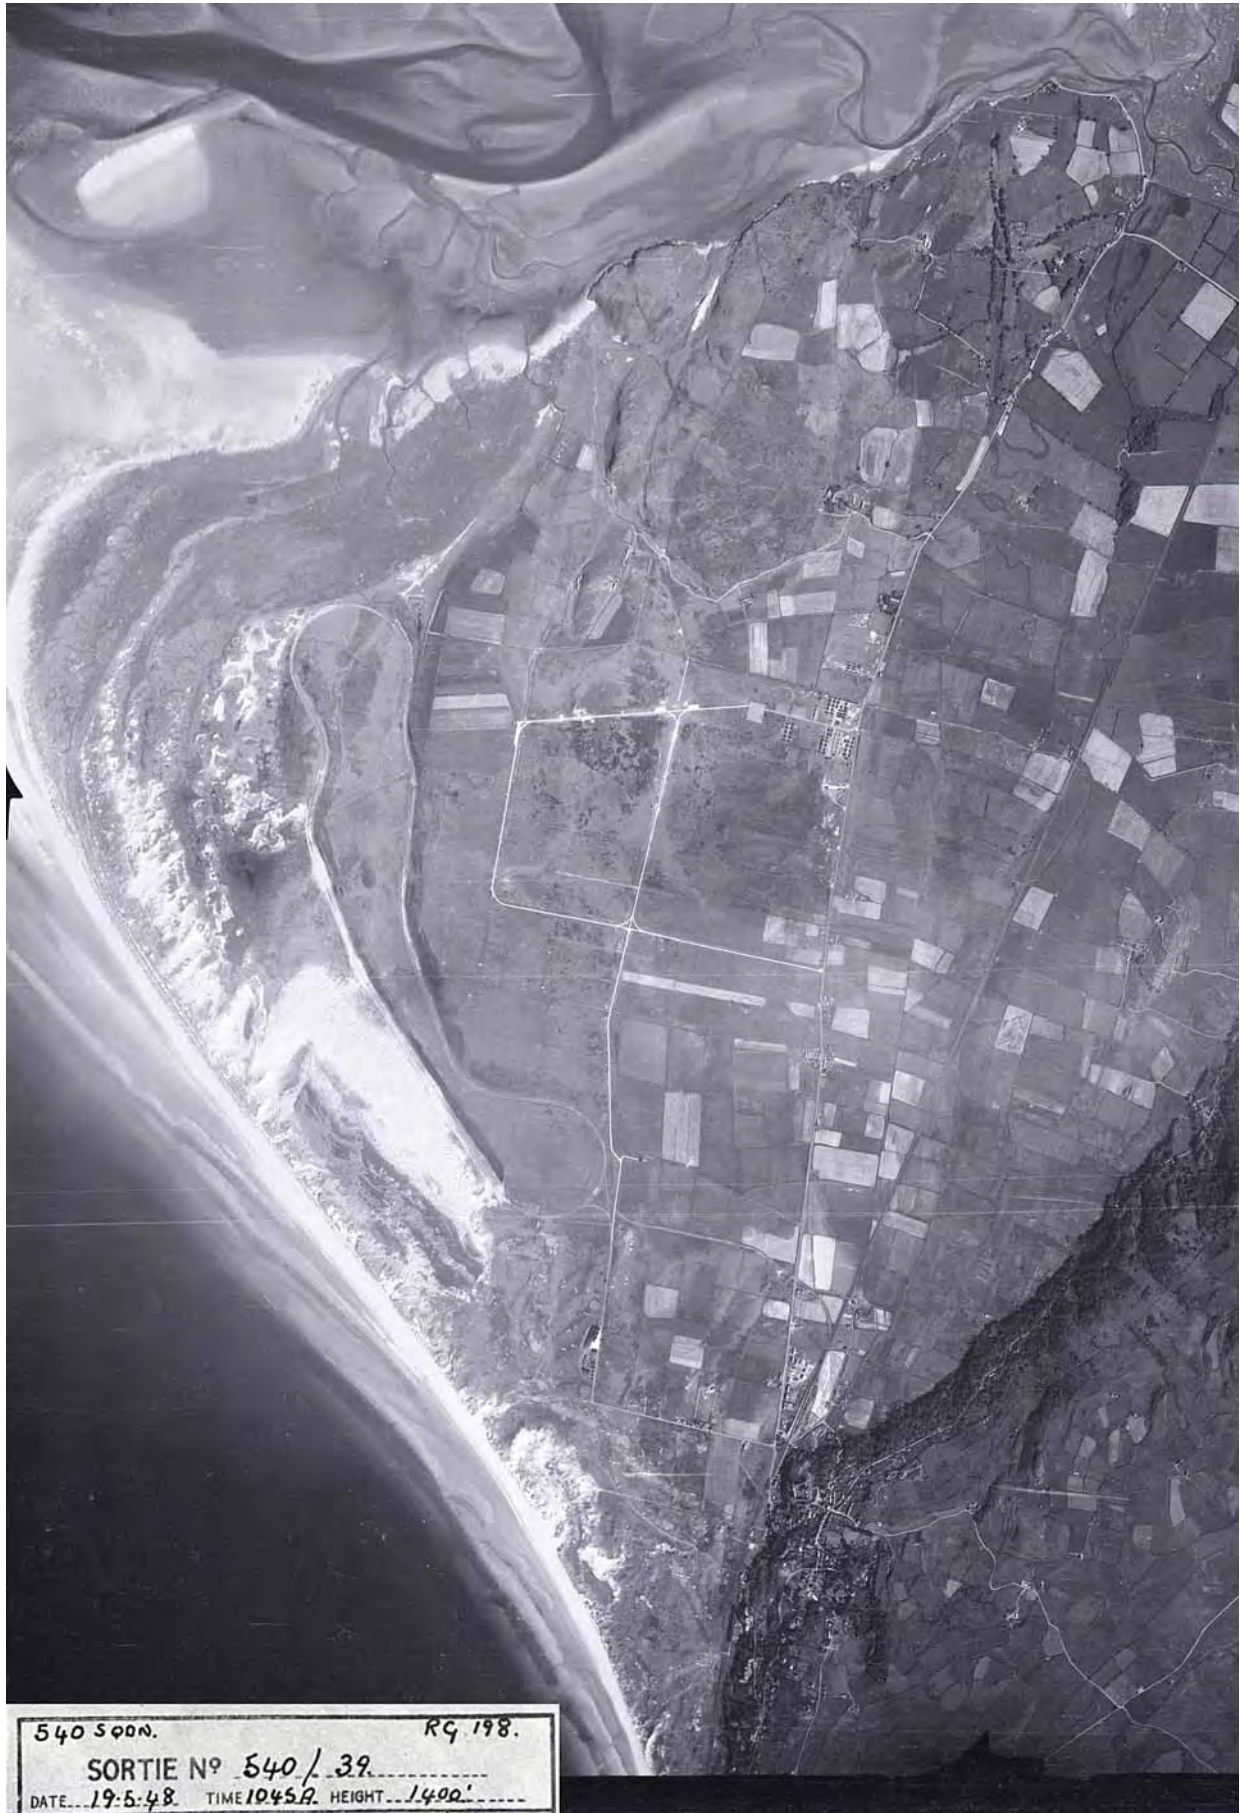
Plate 10. The whole of the training range in 1948, showing target railway, engine sheds, concrete road system and camp (library no 4841, sortie 540 RAF 39, frame 5071, date 19/05/1948)

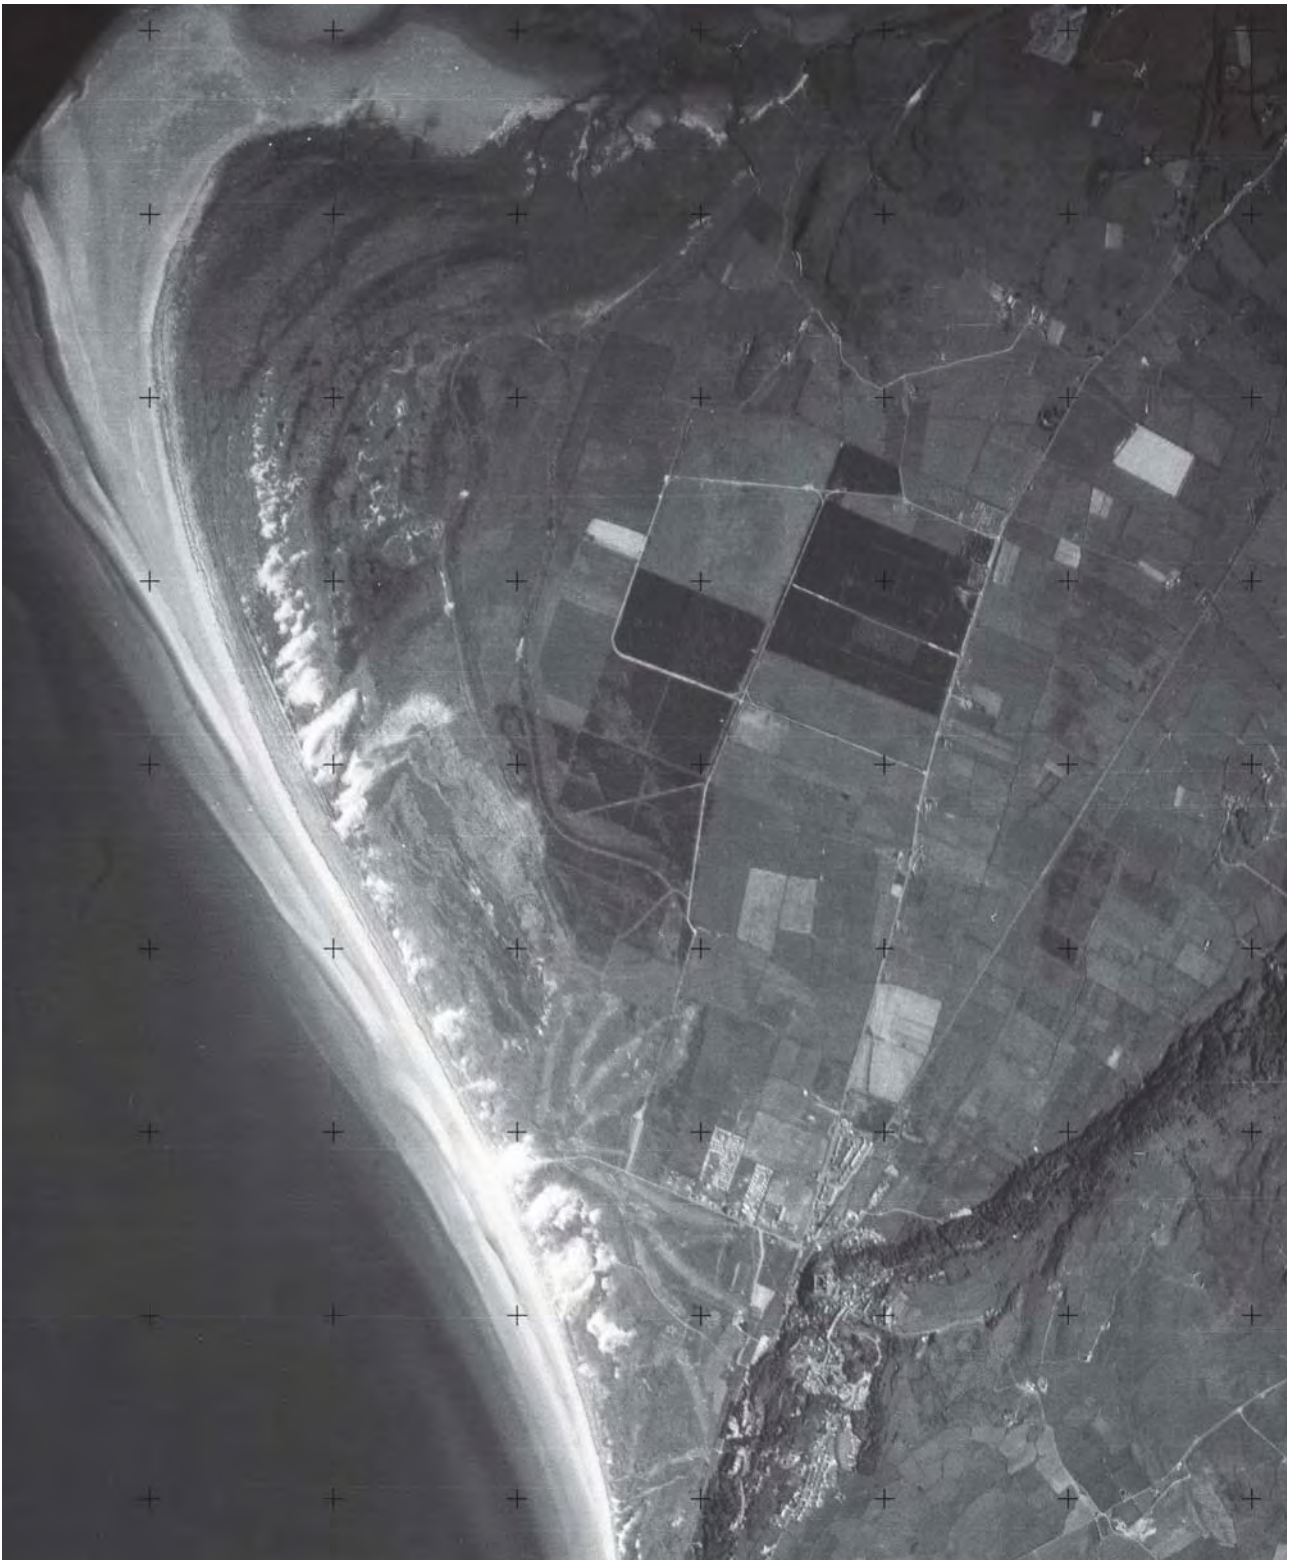
Plate 11. The whole of the training range in 1969, showing the extent of the forestry plantations (library no 6957, sortie 58 RAF 9682, frame 074, date 11/06/1969)

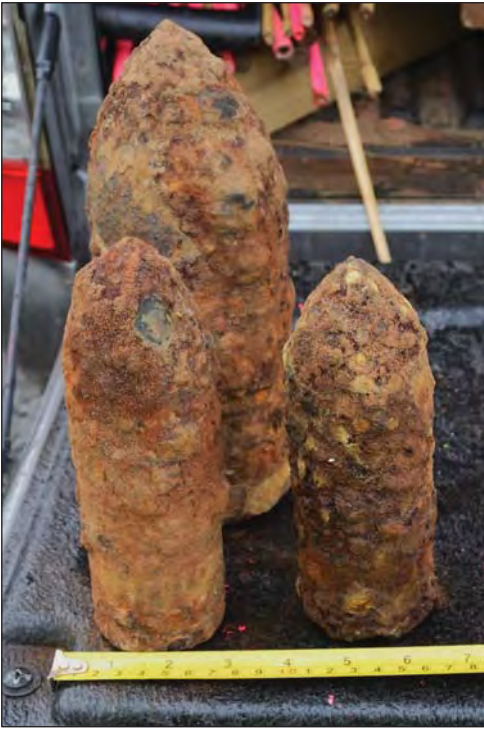
The type of weaponry used in training is indicated by the ordnance found during the UXO surveys for this project. In 2021 a survey was done of the area of the grazing compound by Marine and Land Explosive Ordnance Disposal. In this were found a 105 high explosive shell, a 2-inch mortar round, rifle grenades, an Energa anti-tank grenade, and solid shot armour piercing rounds (Hayward 2021, 16). The grenades were fired from a rifle. A survey undertaken by RPS in 2023 immediately in advance of the current works (Gargan 2023) found a 2-inch smoke mortar, a 2.36-inch anti-tank rocket, 2lb, 6lb, 17lb and 25lb solid shot projectiles (Plate 12), and a 3.7-inch solid shot projectile. The 2.36 rocket was a M7A1 practice variant, which was live and had to be disposed of by explosion. This was an American projectile fired from a bazooka. The 3.7-inch projectile was an adapted anti-aircraft projectile, and it is a rare find. These unusual projectiles may indicate the experimental use of new weapons at Morfa Harlech.

Plate 12. Examples of the solid shot projectiles found by RPS (photo ref: G2790_001)

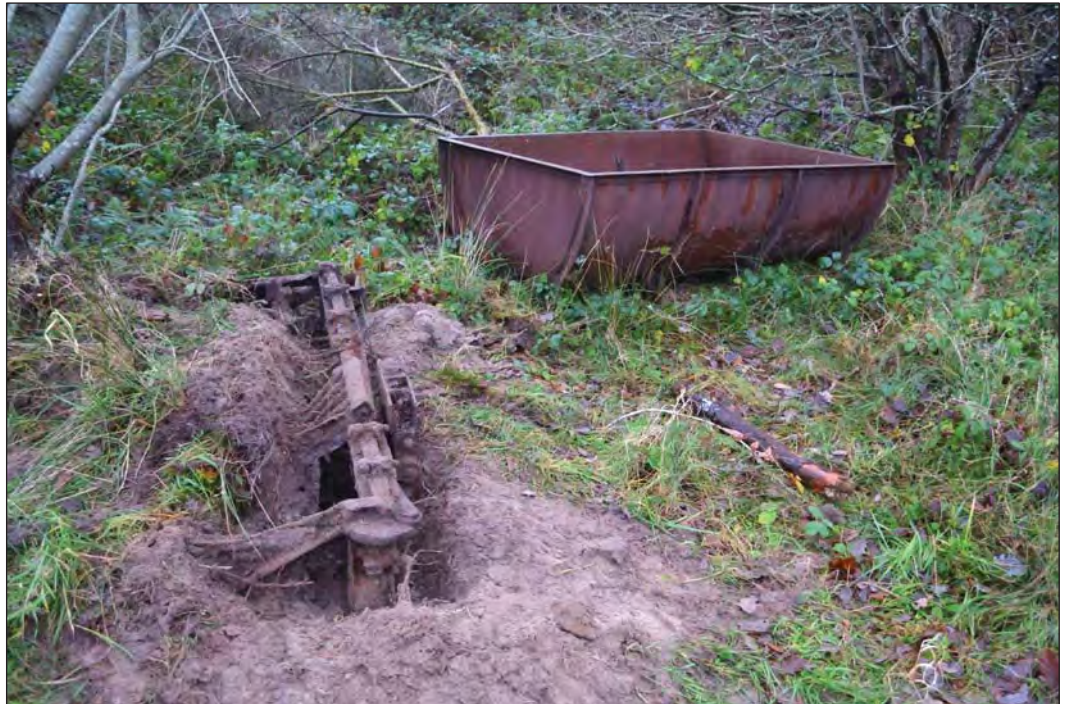
Plate 13. Bottom part of drum or container and possible wagon body (PRN 103564); view from NE (photo ref: G2790_120)

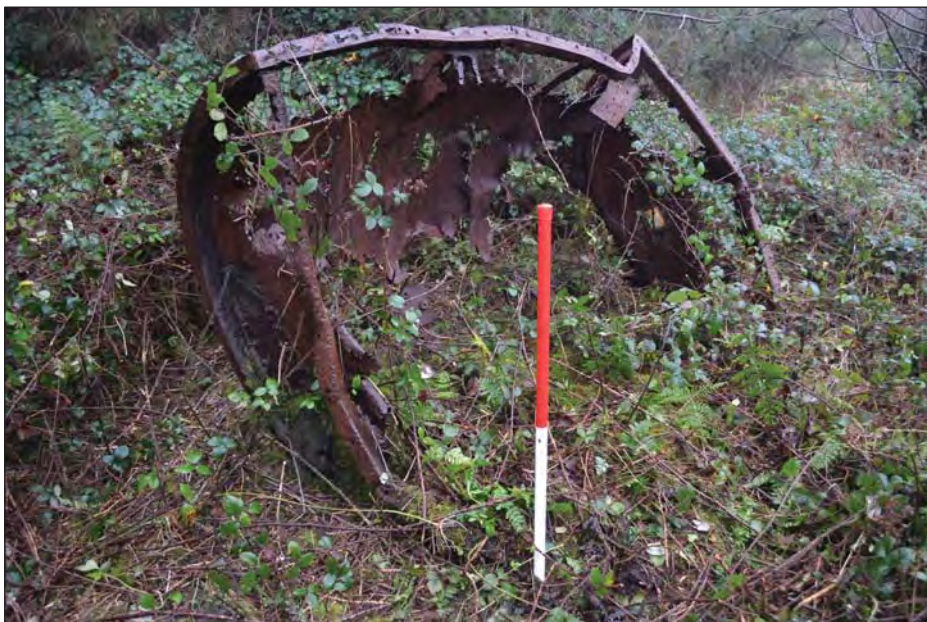
Description	The upper part of an iron drum or container. Semi-circular in cross section and resting upside down. Heavily corroded. One end had small Perspex window. Probably the upper part of the drum PRN 103564. Recording was restricted to basic photographs. Probably dates to after the Second World War.
Impact	None
Recommendation	None
GAT Photographic Archive Reference	G2790_104 to G2790_107
Plate Number	Plate 14

Plate 14. Top part of drum or container found next to one of the concrete tracks in the woods (PRN 103565); scale 1m; view from NE (photo ref: G2790_104)
