Twyni Byw - Sands of LIFE (SoLIFE) Gwaith Cadwraeth ym / Conservation Works at Morfa Harlech, Gwynedd

Desk-based Assessment and Archaeological Mitigation

Rhif Prosiect / Project No. G2790

Rhif Adroddiad / Report No. 1751

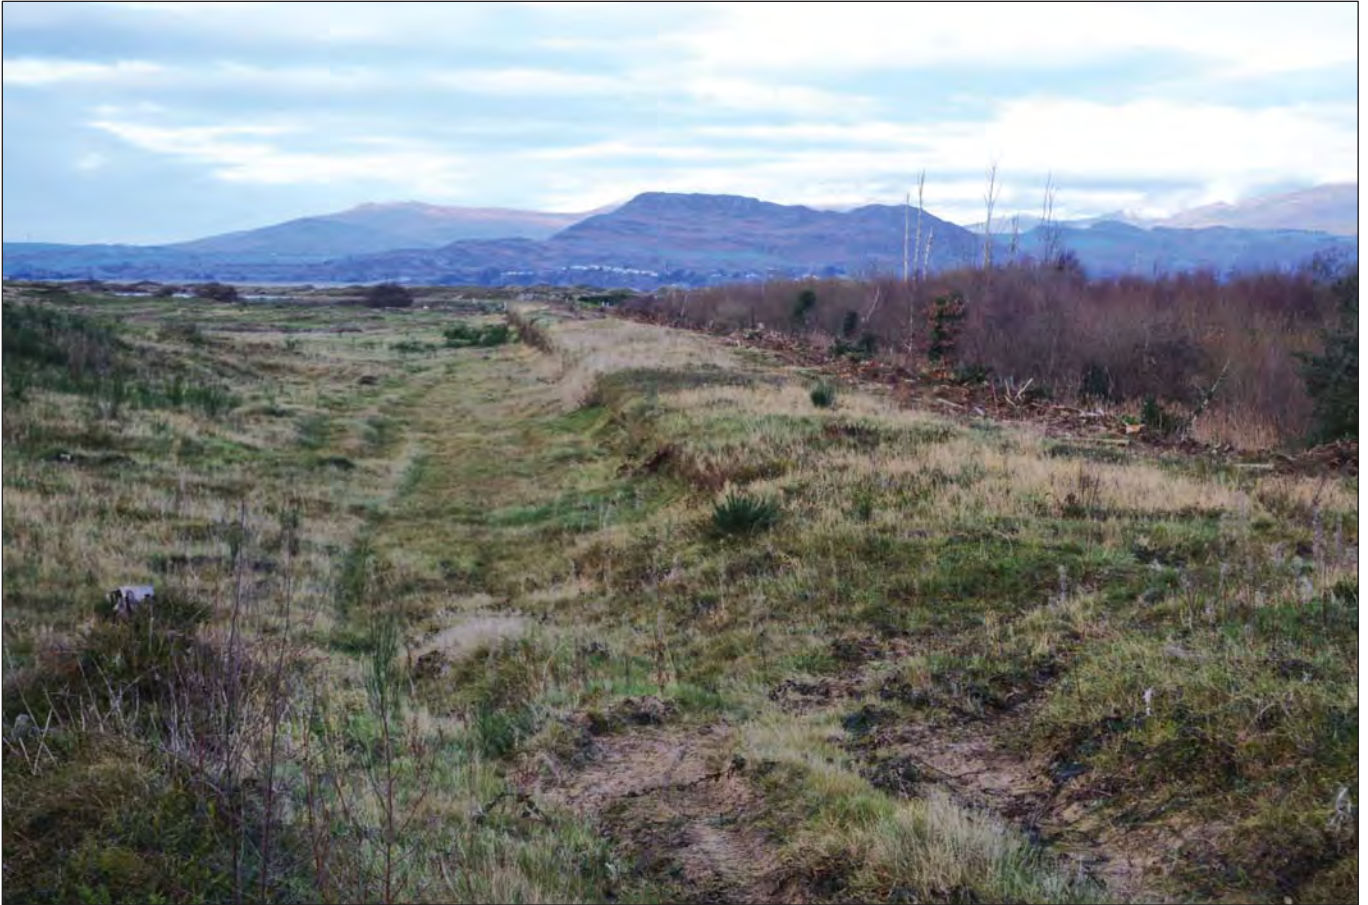
Plate 15. Target railway embankment north of sand encroachment with route of railway immediately to the left; view from S (photo ref: G2790_084)

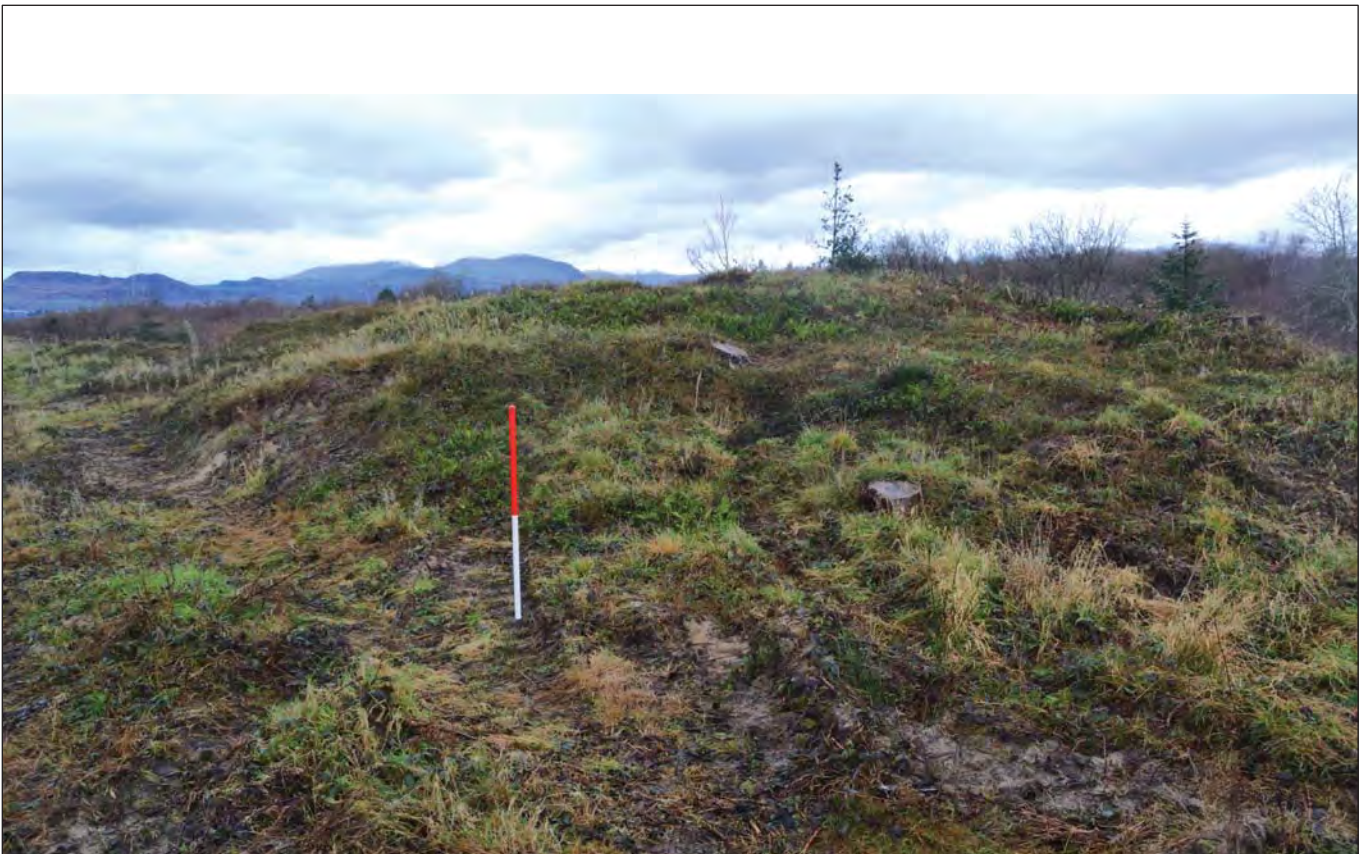
Plate 16. Small dunes built up over target railway embankment; scale 1m; view from SW (photo ref: G2790_027)

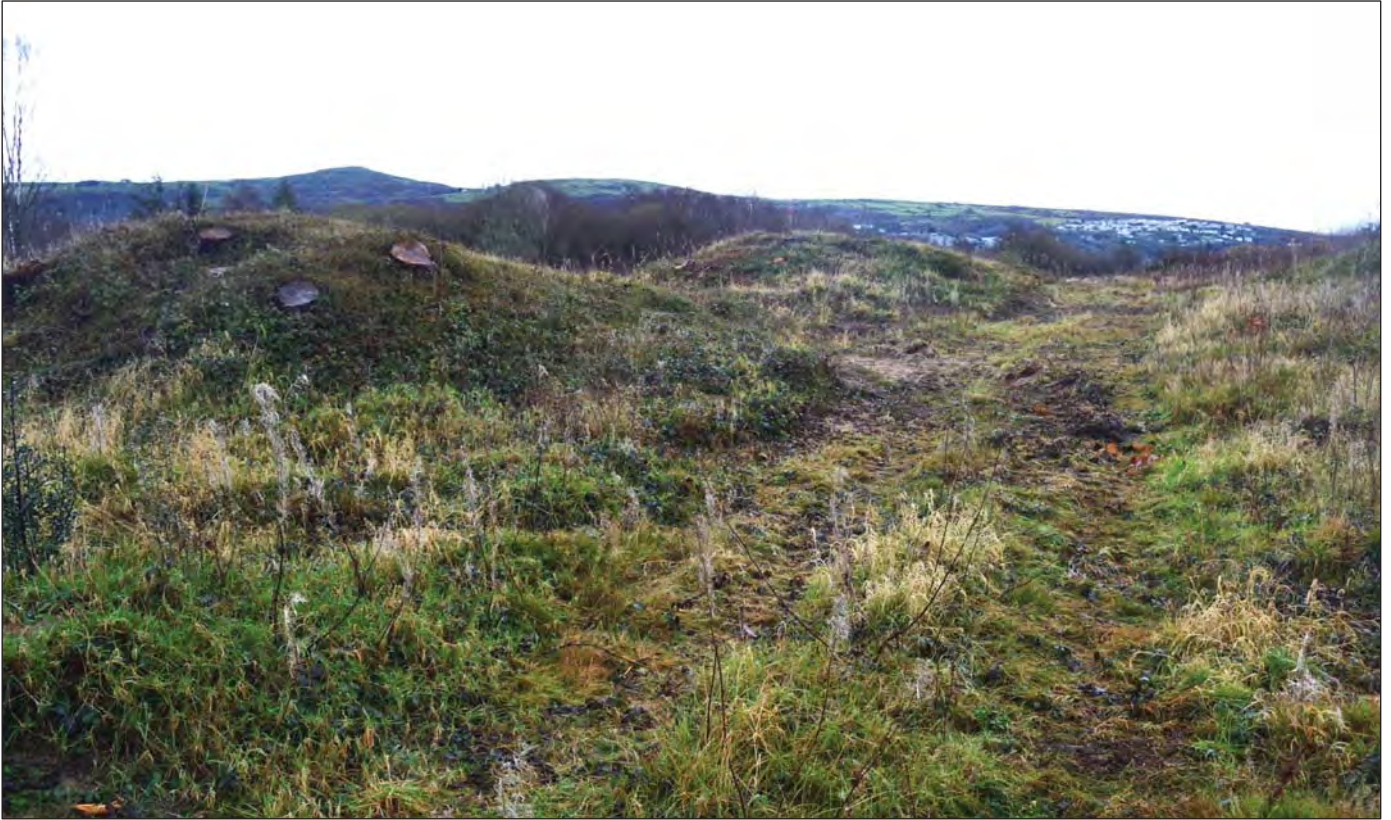
Plate 17. Small dunes built up over target railway embankment; view from NW (photo ref: G2790_028)

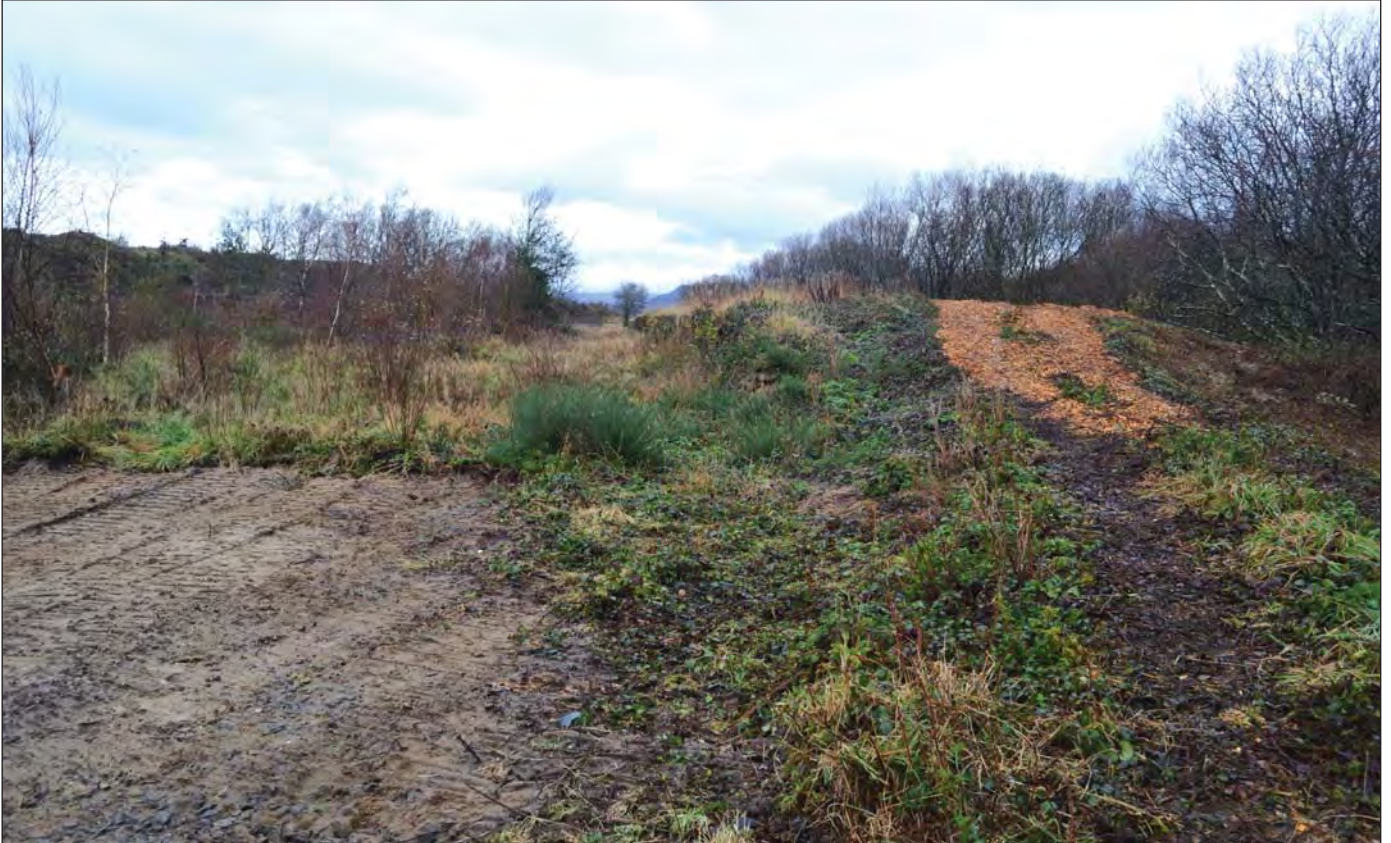
Plate 18. Ramp into southern end of embankment to allow access for forestry vehicles; view from SW (photo ref: G2790_008)

The southern part of the embankment has been used as a trackway by forestry vehicles. The start of this track at the southern end is shown on modern maps and can be seen on the ground as a deposit of dark grey, broken stone. The same stone has been used to create a ramp on to the embankment (Plate 18). Where the track across the area of sand encroachment the sand has been levelled and in one place stone and sand have been used to create a ramp taking the track down off the sand onto the route of the railway, which was used as the forestry track along the northern part of the surveyed section. Other trackways cut from the east onto the embankment in places (Plate 19), but these are where there has been sand encroachment and although there has been considerable disturbance caused by vehicles the sand has largely protected the embankment from erosion.

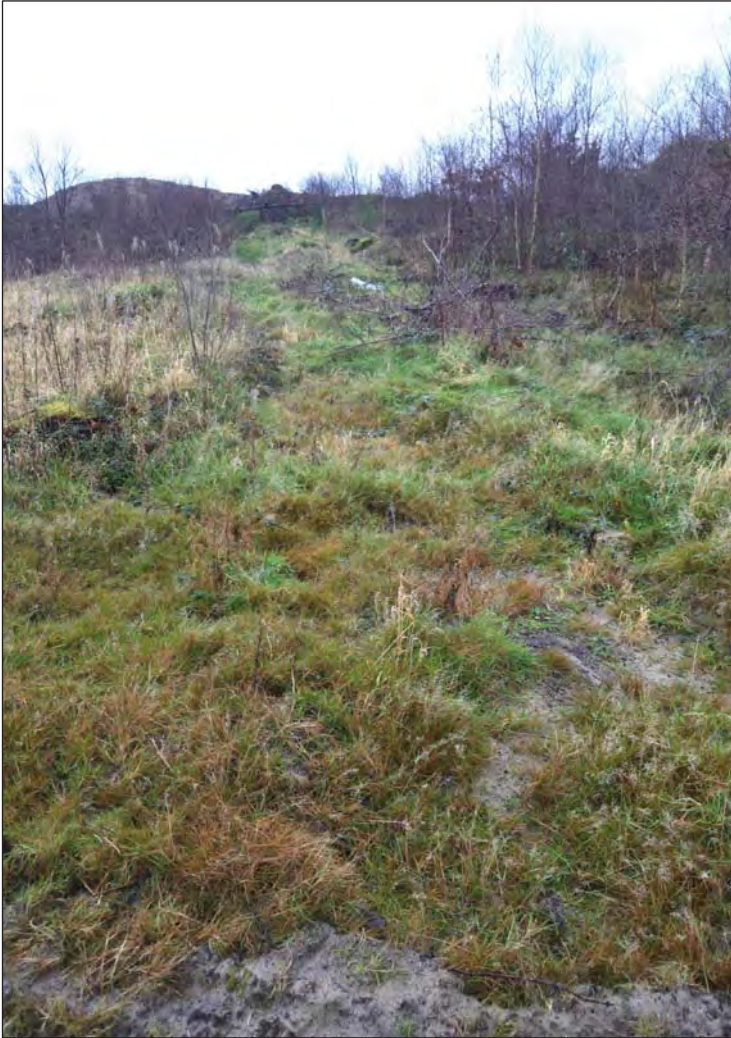
Plate 19. Forestry track running onto embankment from the east; view from NE (photo ref: G2790_023)

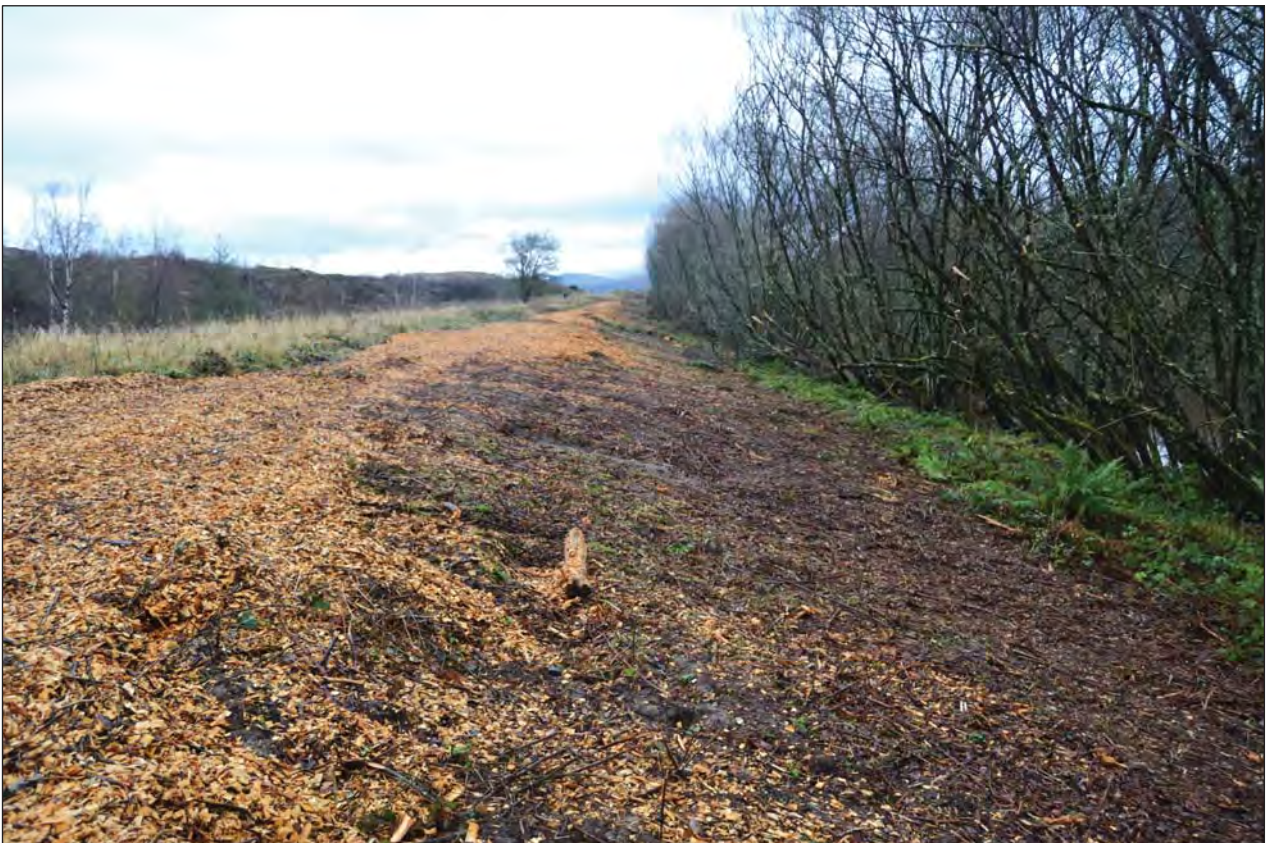
Plate 20. Gradually sloping eastern side of embankment; view from SE (photo ref: G2790_052)

The survey of the area within the grazing compartment has provided a detailed view of a part of the target railway and its protective embankment. This shows the sloping eastern face of the embankment to trap incoming shells and the revetment built of concrete in sandbags alongside the railway. The survey also included the southern end of the embankment in this area and showed where the railway continued unprotected into the semi-circular end of the loop, where targets were probably changed or repaired. The LiDAR suggests that there are remains of the railway trackbed all around this semi-circular end and future clearance of vegetation in this area may reveal more information on how the target railway worked.

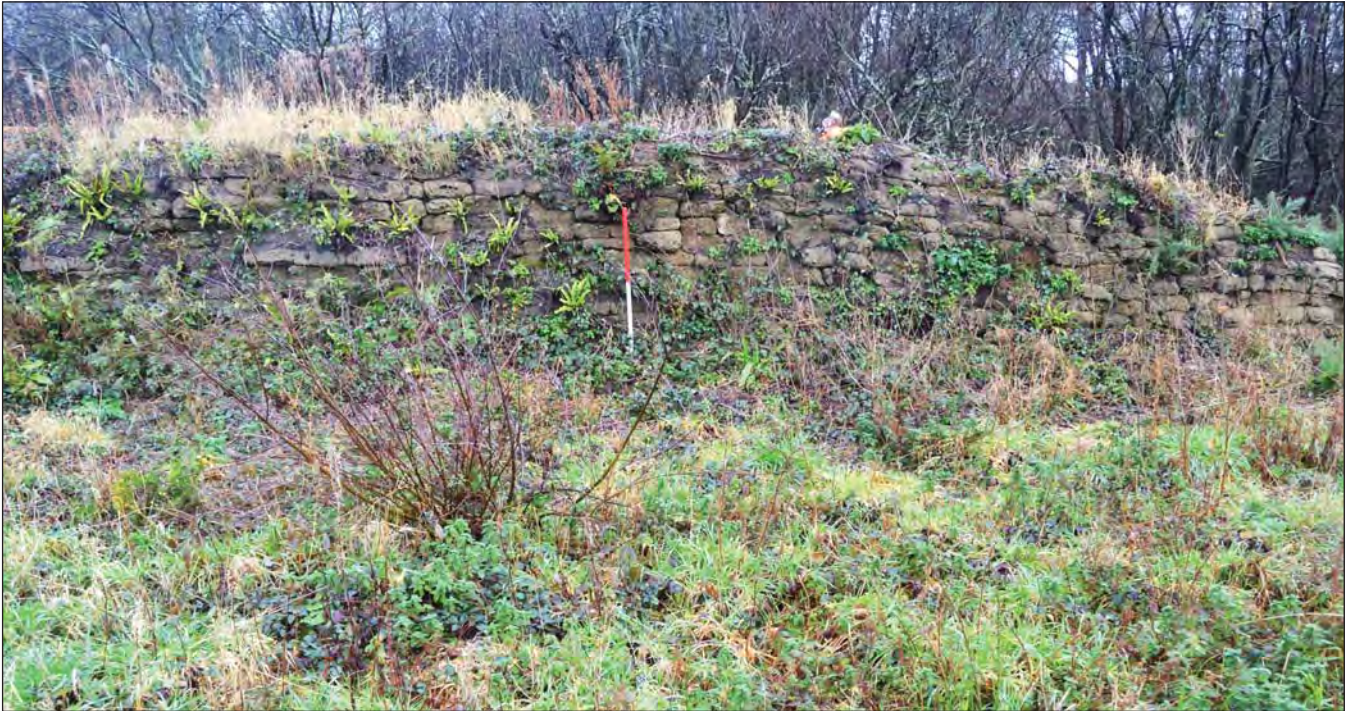
Plate 21. Revetment at southern end of embankment; scale 1m; view from SW (photo ref: G2790_010)

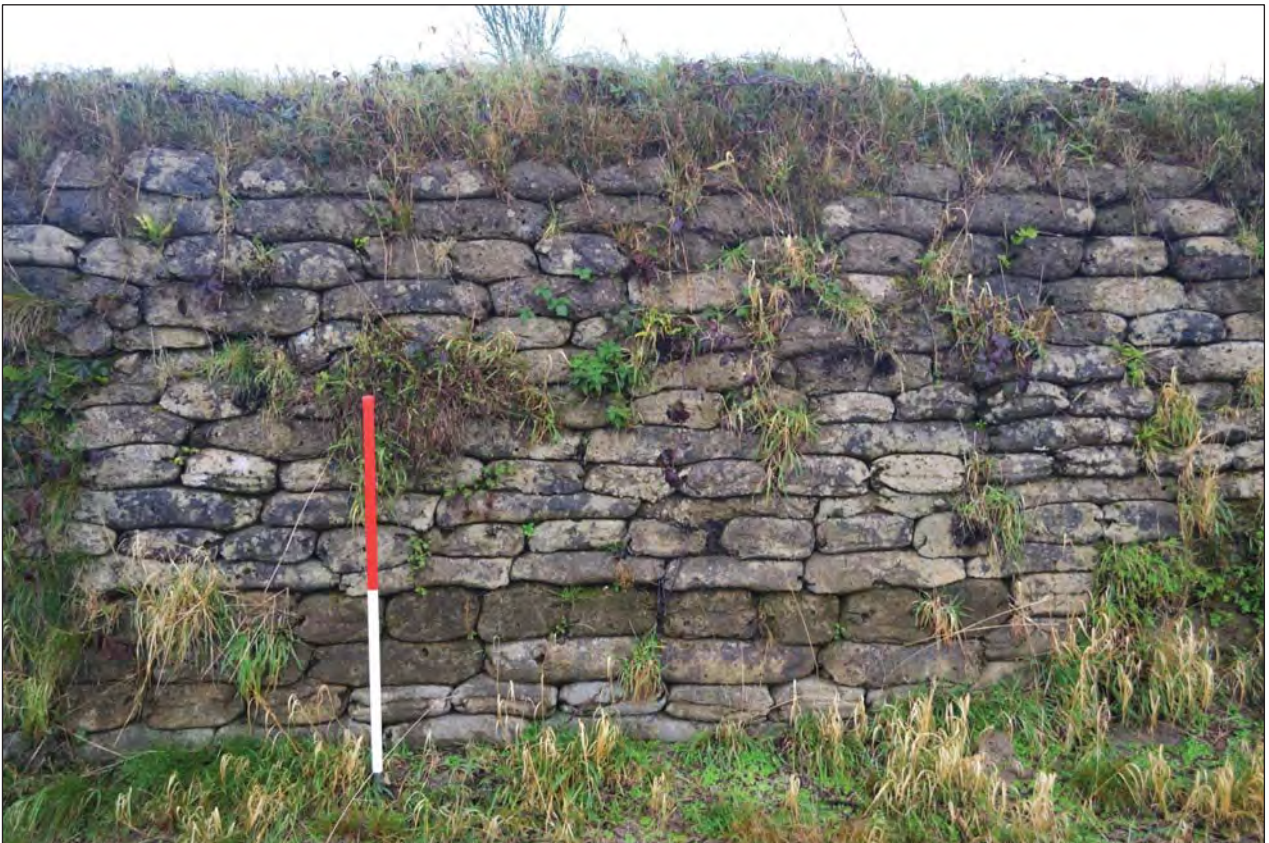
Plate 22. Revetment at northern end of embankment; scale 1m; view from S (photo ref: G2790_068)

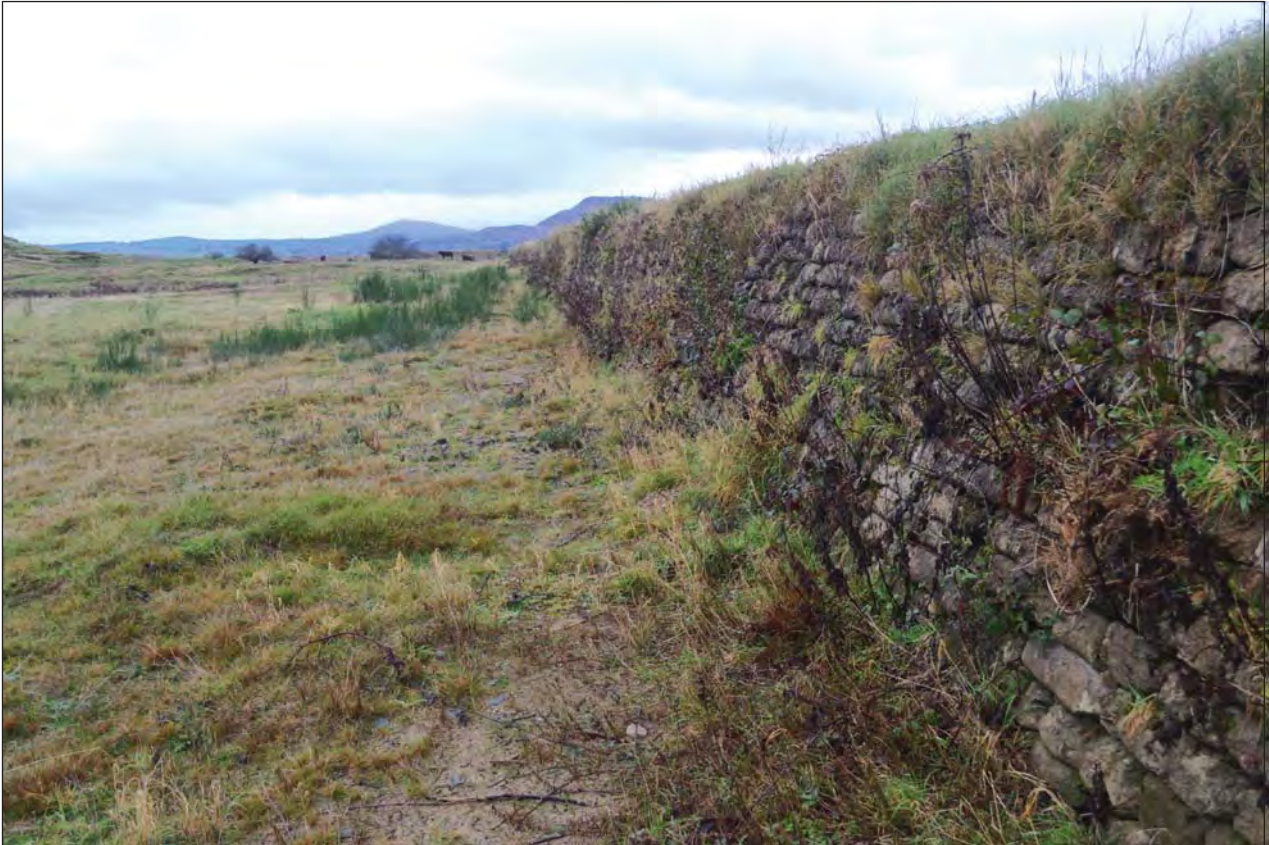
Plate 23. Revetment at northern end of embankment, showing the batter on the face of the revetment; view from S (photo ref: G2790_037)

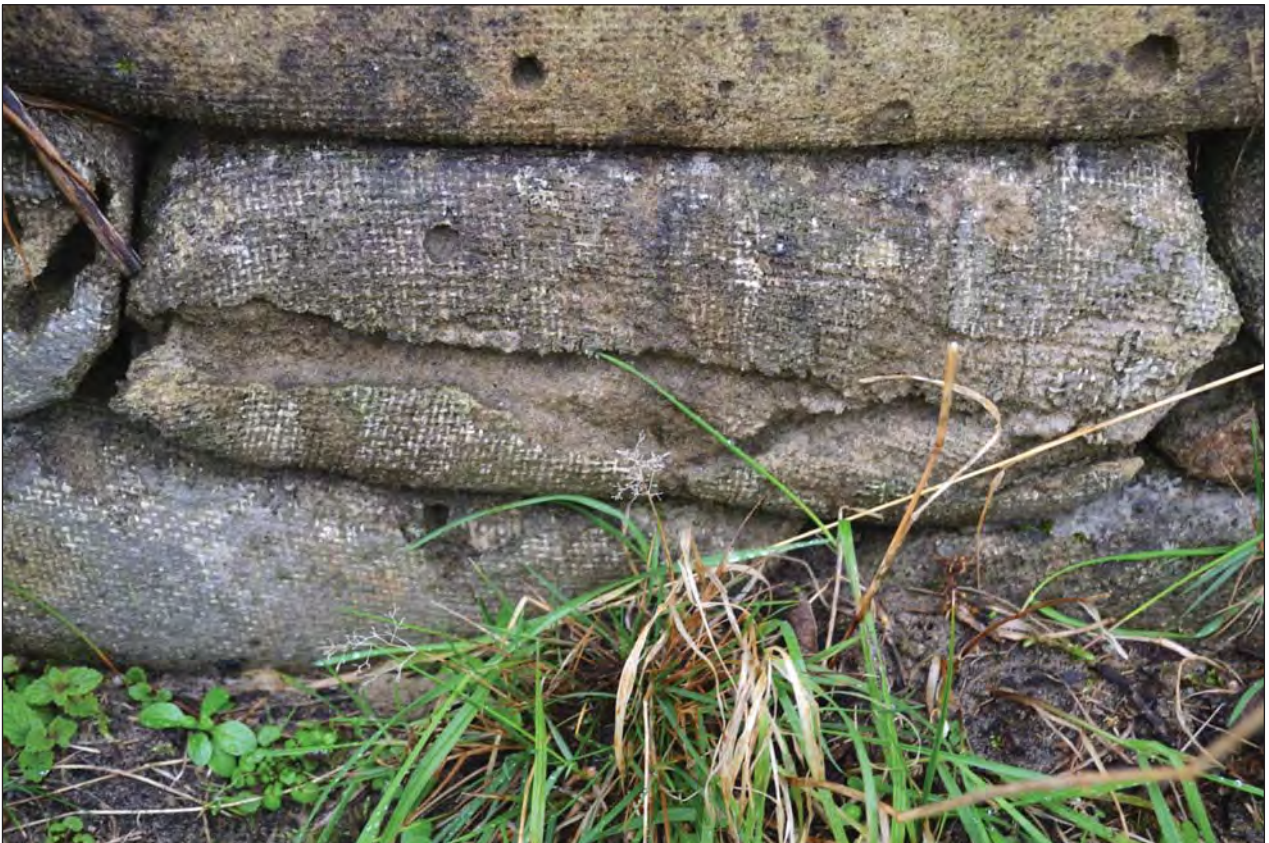
Plate 24. Cast of hessian sandbags in the concrete of the revetment; view from SW (photo ref: G2790_036)

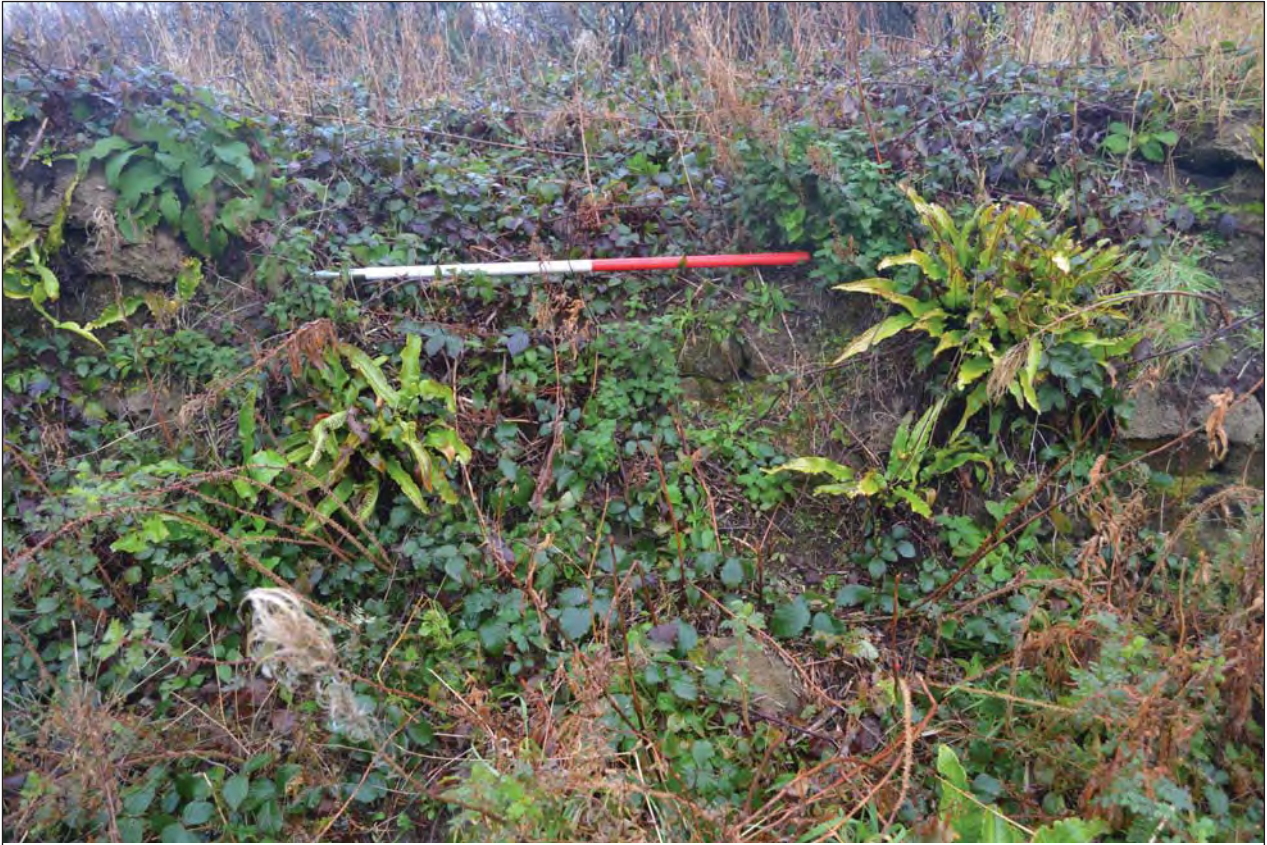
Plate 25. Heavily eroded and overgrown section of revetment; scale 1m; view from W
(photo ref: G2790_012)

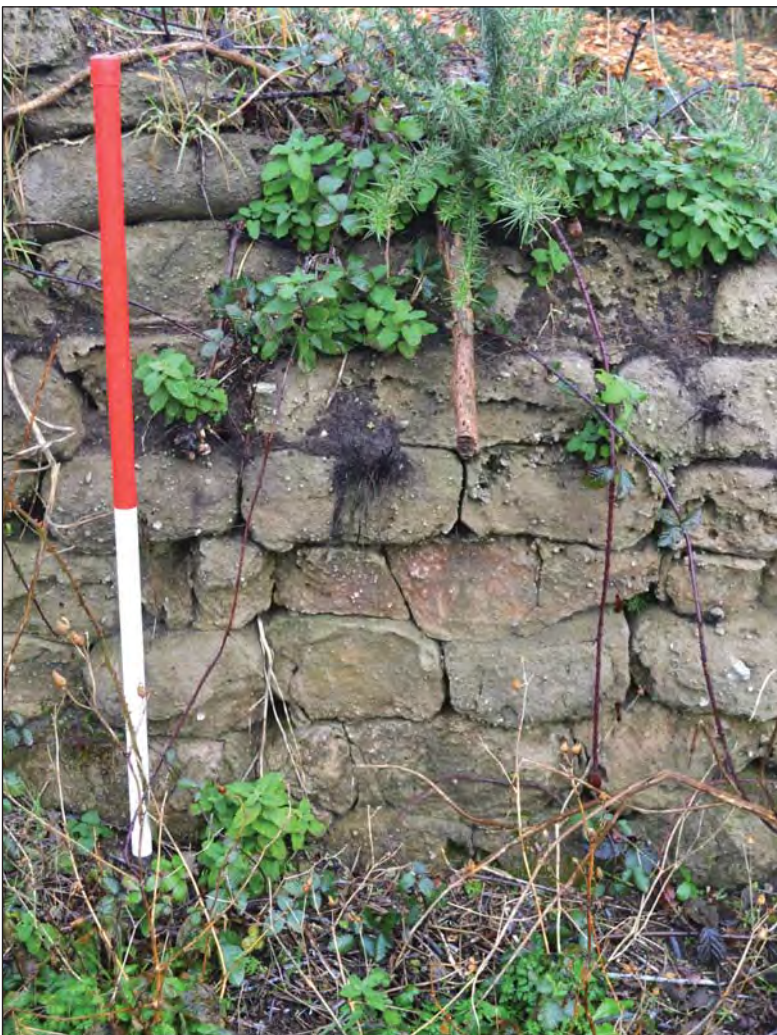
Plate 26. Example of section of revetment with surface erosion; scale 1m; view from SW
(photo ref: G2790_009)

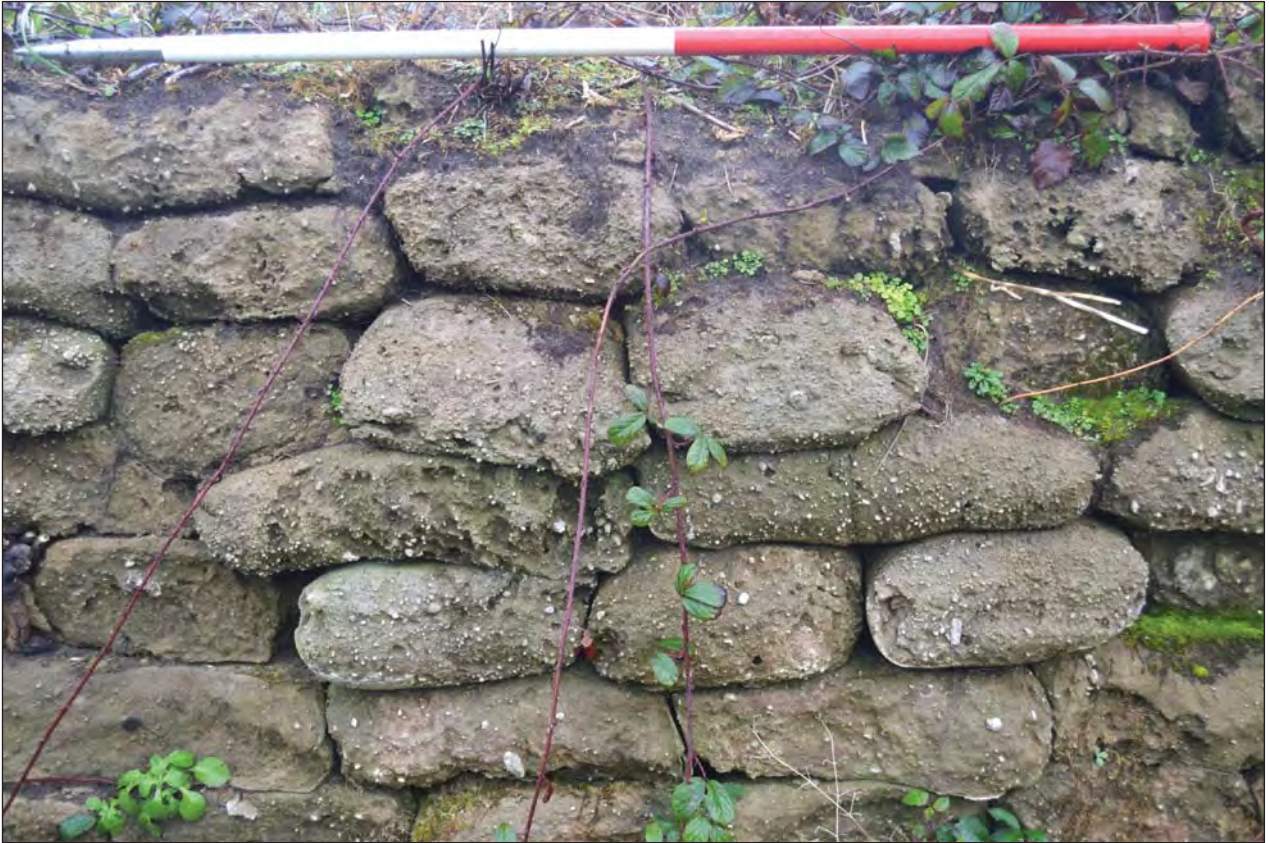
Plate 27. Example of concrete sandbags eroded to show stone content in the concrete; scale 1m; view from W (photo ref: G2790_013)

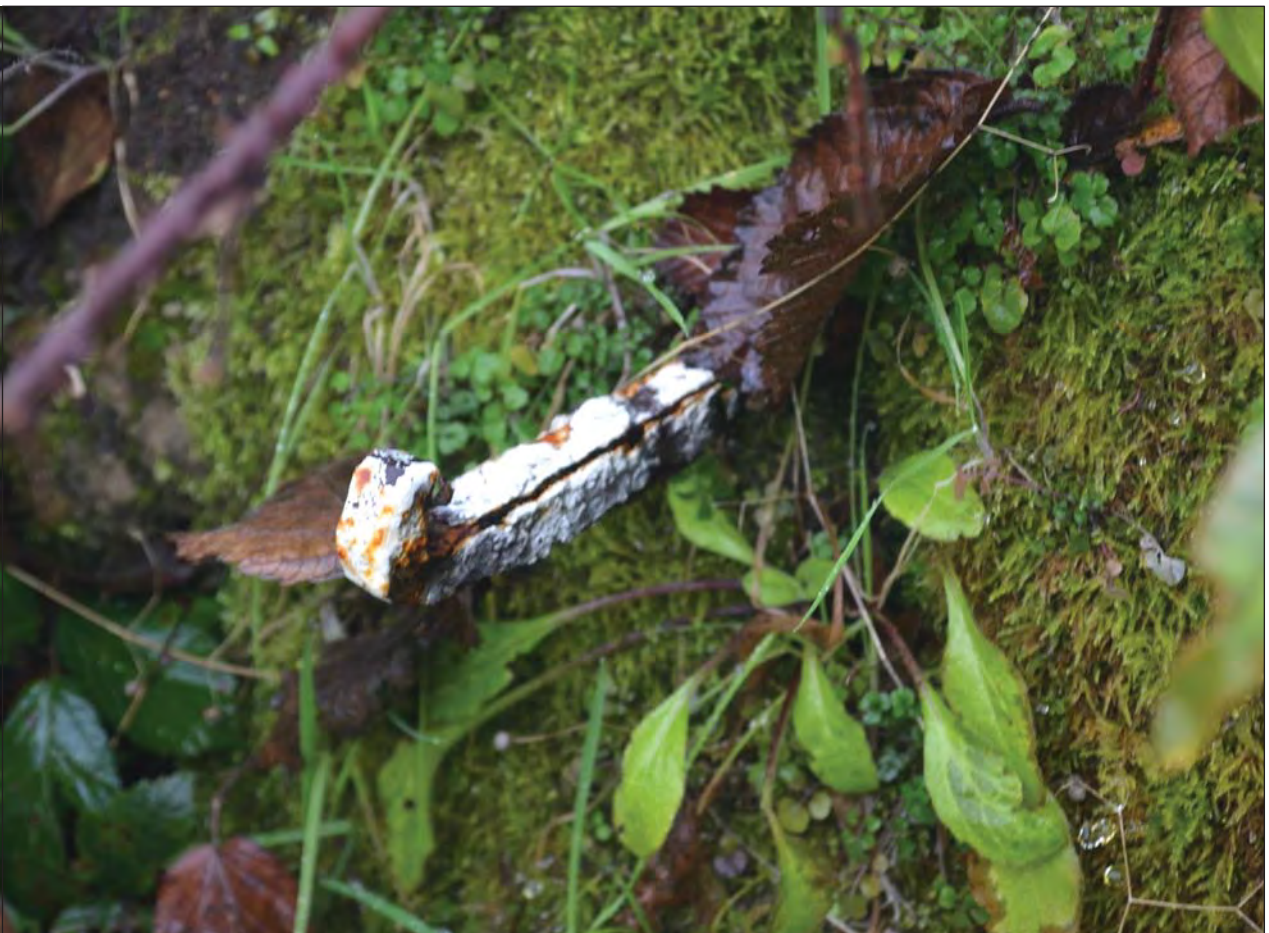
Plate 28. One of the iron fixtures or brackets projecting from the face of the revetment; view from SW (photo ref: G2790_014)

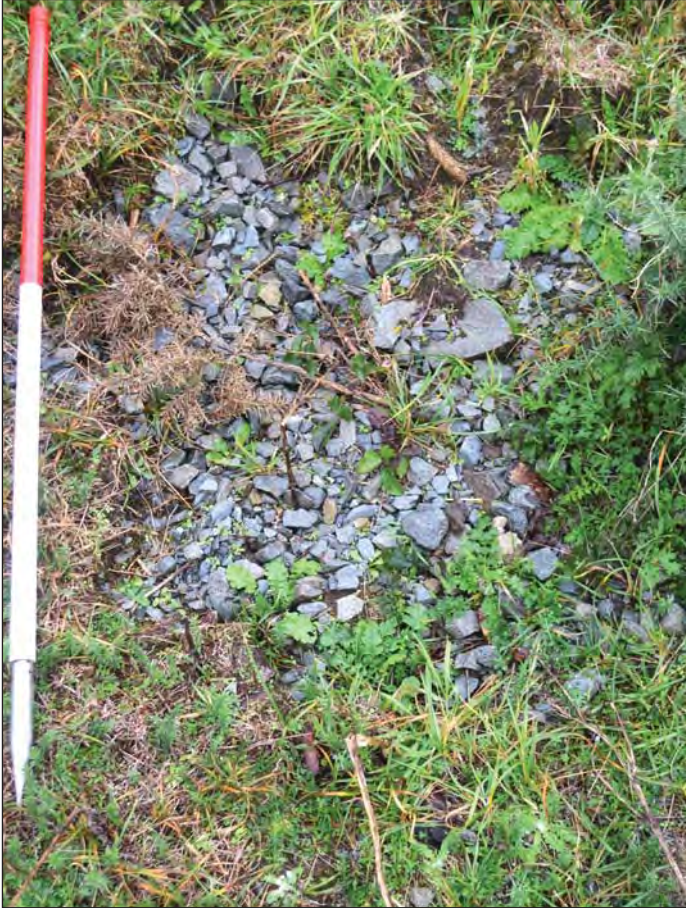
Plate 29. Area of granite chippings visible through the vegetation in the northern part of the surveyed railway route; scale 1m; view from N (photo ref: G2790_040)

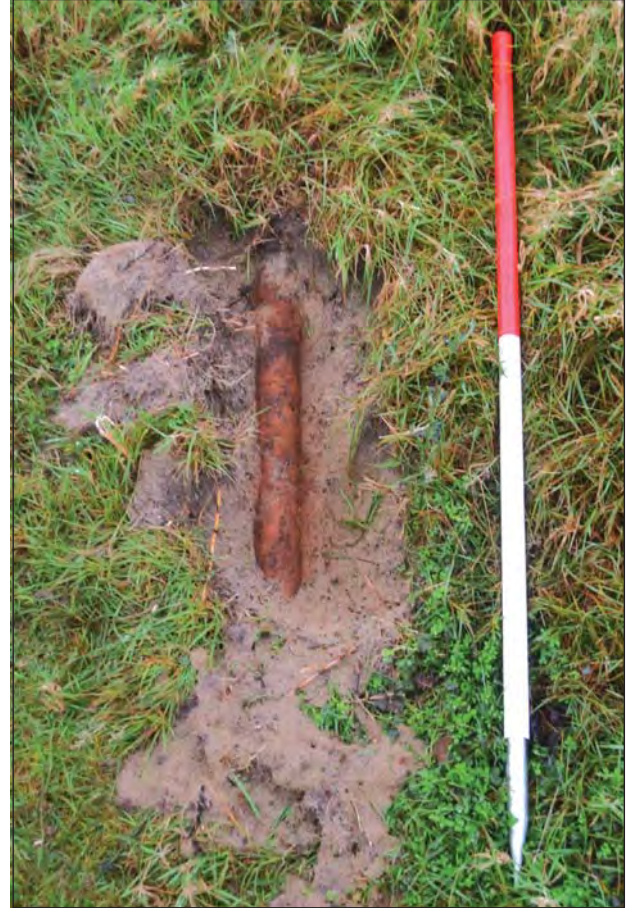
Plate 30. Iron pipe exposed by the UXO survey; scale 1m; view from S (photo ref: G2790_062)

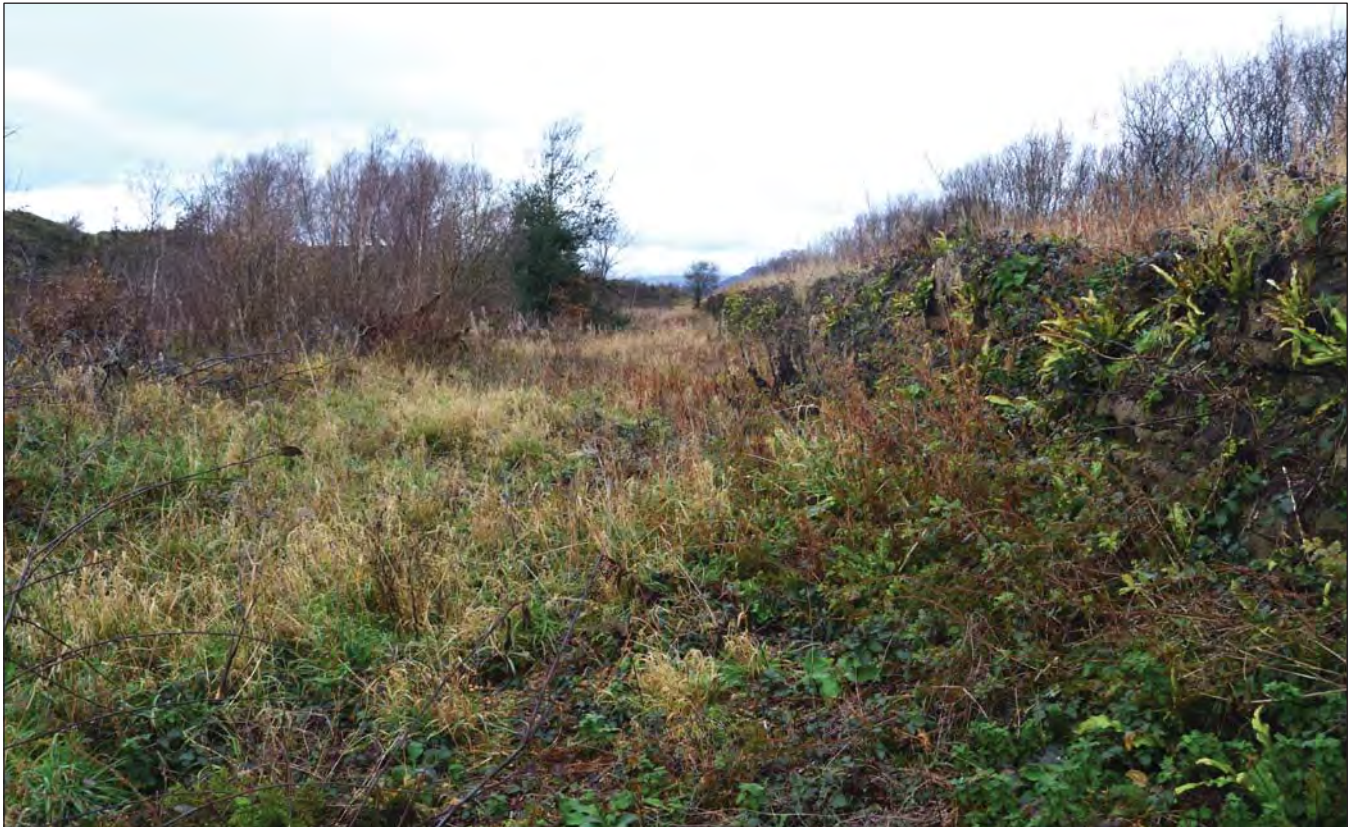
Plate 31. Location of railway running next to revetment of the southern part of the embankment; view from S (photo ref: G2790_011)

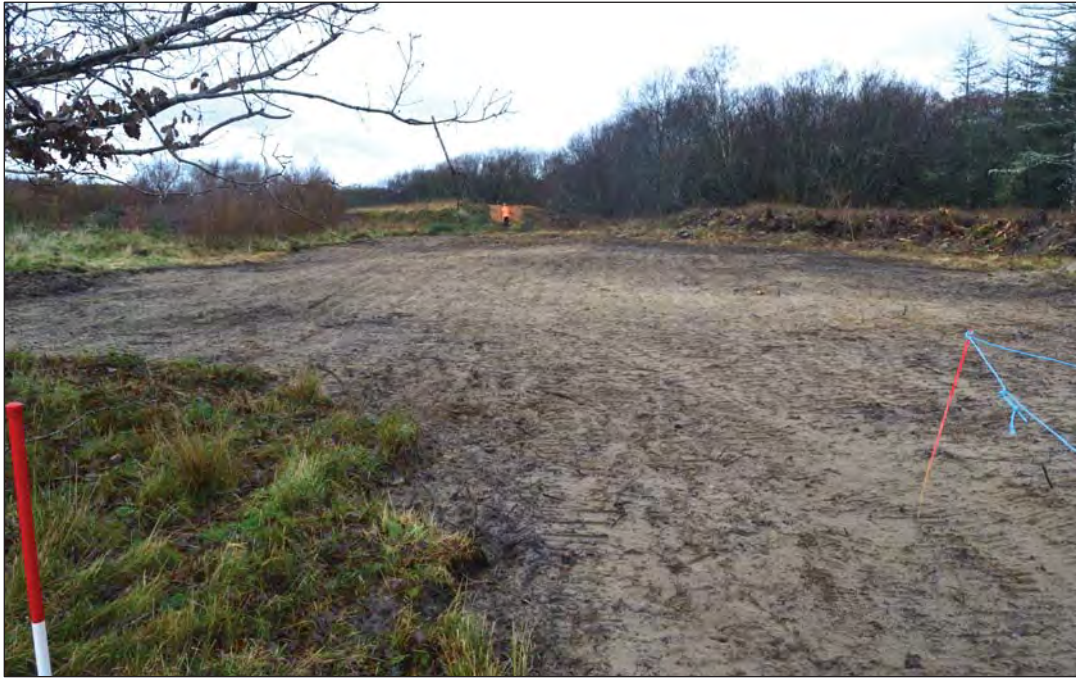
Plate 32. Topsoil stripped area in south-eastern corner of grazing compartment; view from S

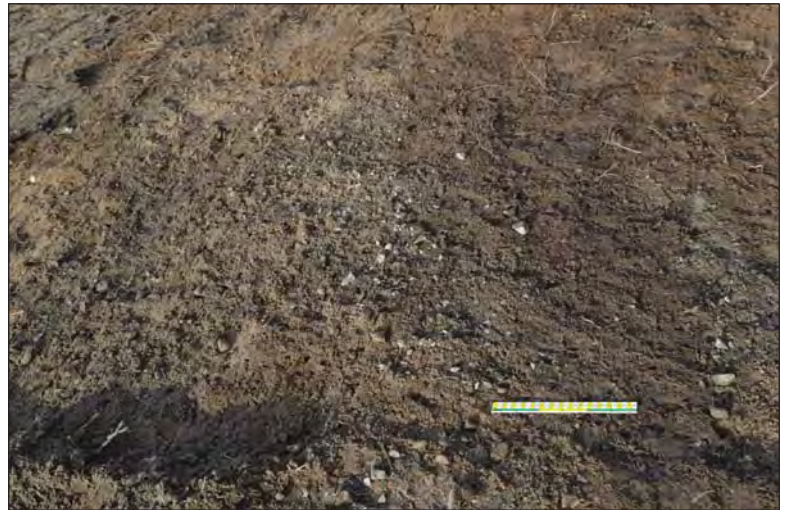
Plate 33. Cleaned up area of granite chippings forming railway track bed (context (06)); scale 0.3m; view from S (photo ref: G2790_068)

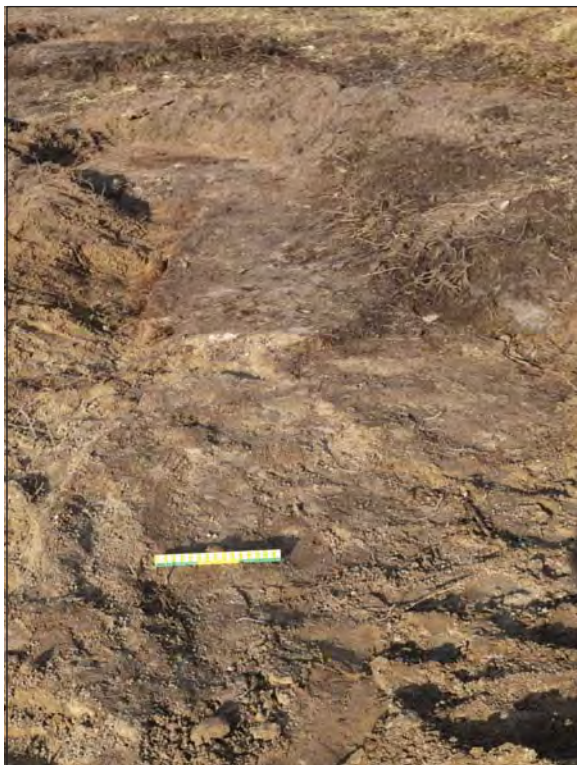
On the line of the railway were rough slabs of concrete (contexts (03), (05) and (09)) about 0.1m thick. These were roughly sub-rectangular in plan but had very irregular edges (Plates 34, 35 and 36). There was no trace of shuttering to create a defined form but in places there were straight edges and it appeared that the concrete had been poured into shallow depressions dug into the sand. The surface of the concrete was soft and very sandy and in places the concrete had almost entirely eroded into sand. However, elsewhere the concrete was harder and broken pieces showed it to be made with angular dark coarse sand and gravel. Most of these slabs were not fully exposed but it could be seen that they were not continuous. Another patch of concrete was just visible under a thin spread of sand in the northern part of the stripped area, but this was not cleaned up and recorded. To the west of the line of the other slabs was a similar path of concrete (context 07) measuring 2.6m by 2.0m and about 0.17m thick (Plate 37). This seemed to have stones underneath it to form a foundation but was cast in a shallow hollow in the sand like the others.

Plate 34. Concrete slab (03); scale 0.3m; view from S (photo ref: G2790_073)

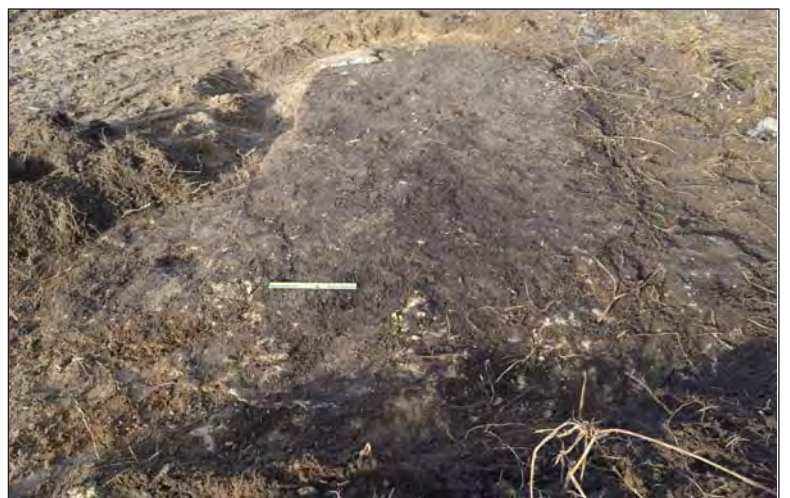
Plate 35. Concrete slab (05); scale 0.3m; view from S (photo ref: G2790_070)

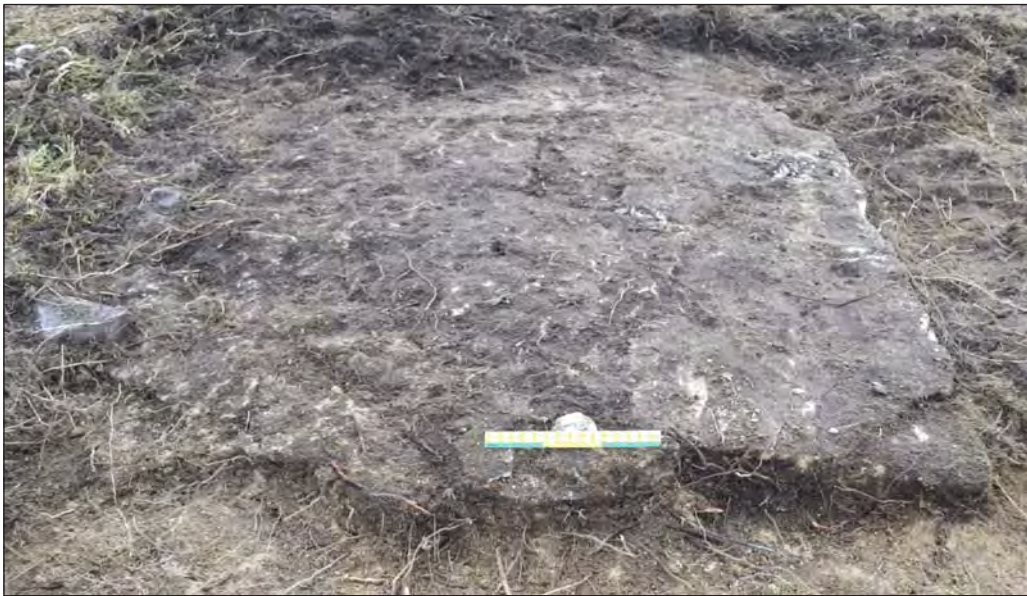
Plate 36. Concrete slab (09); scale 0.3m; view from NW
(photo ref: G2790_090)

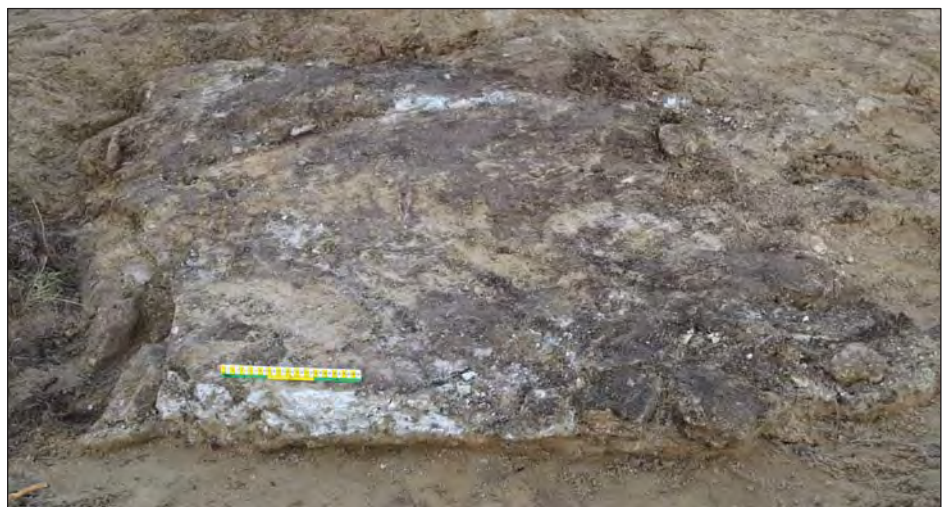
Plate 37. Concrete slab (07); scale 0.3m; view from SW
(photo ref: G2790_087)

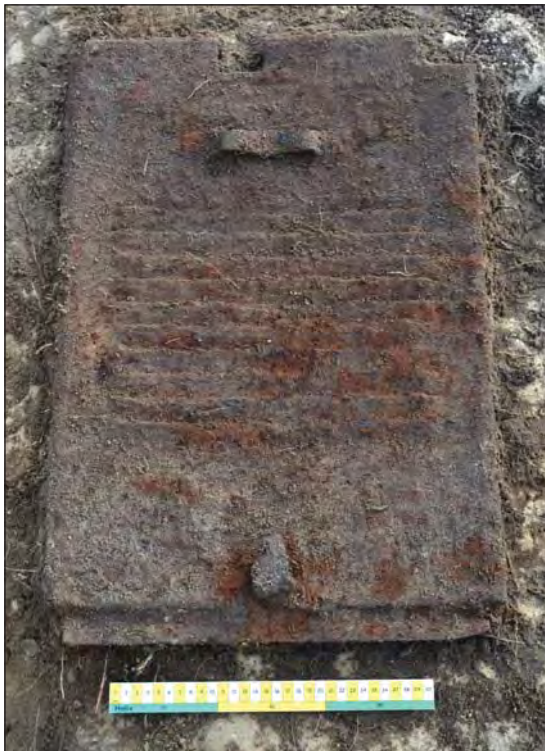
None of these concrete slabs had any fixings or attachments set in them or any other indication of their use. Lying flat on feature (03) was an iron door (context 04) with ventilation slits within it (Plate 38). The door measured 0.64m by 0.43m. It appeared to have been discarded on the surface of the slab and was not in any way fixed to it or related to its use. A metal plate was found buried in the sand nearby, uncovered by the UXO team (Plate 39). This is thought to be a plate that would have been fixed to the engine pulling the target for protection (Ray Gargan pers. comm.).

Plate 38. Iron door (04) found lying on concrete slab (03); scale 0.3m; view from NW
(photo ref: G2790_063)

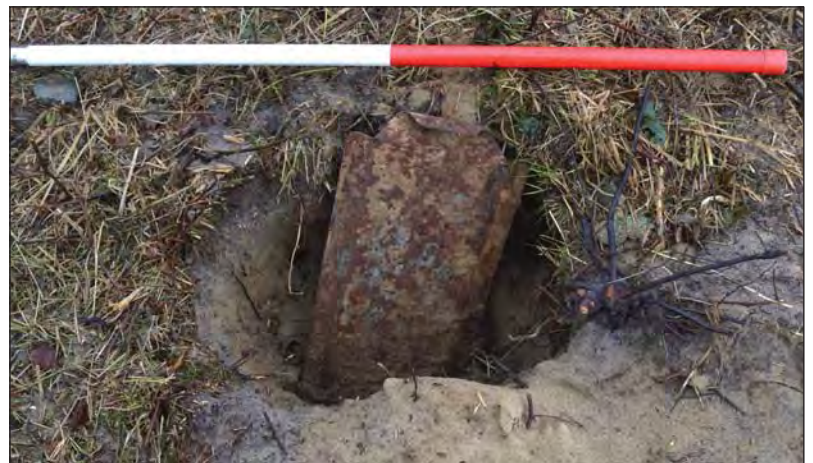
Plate 39. Metal plate, probable protective plate attached to engine towing the targets; scale 1m; view from W
(photo ref: G2790_006)
