Twyni Byw - Sands of LIFE (SoLIFE) Gwaith Cadwraeth ym / Conservation Works at Morfa Harlech, Gwynedd

Desk-based Assessment and Archaeological Mitigation

Rhif Prosiect / Project No. G2790

Rhif Adroddiad / Report No. 1751

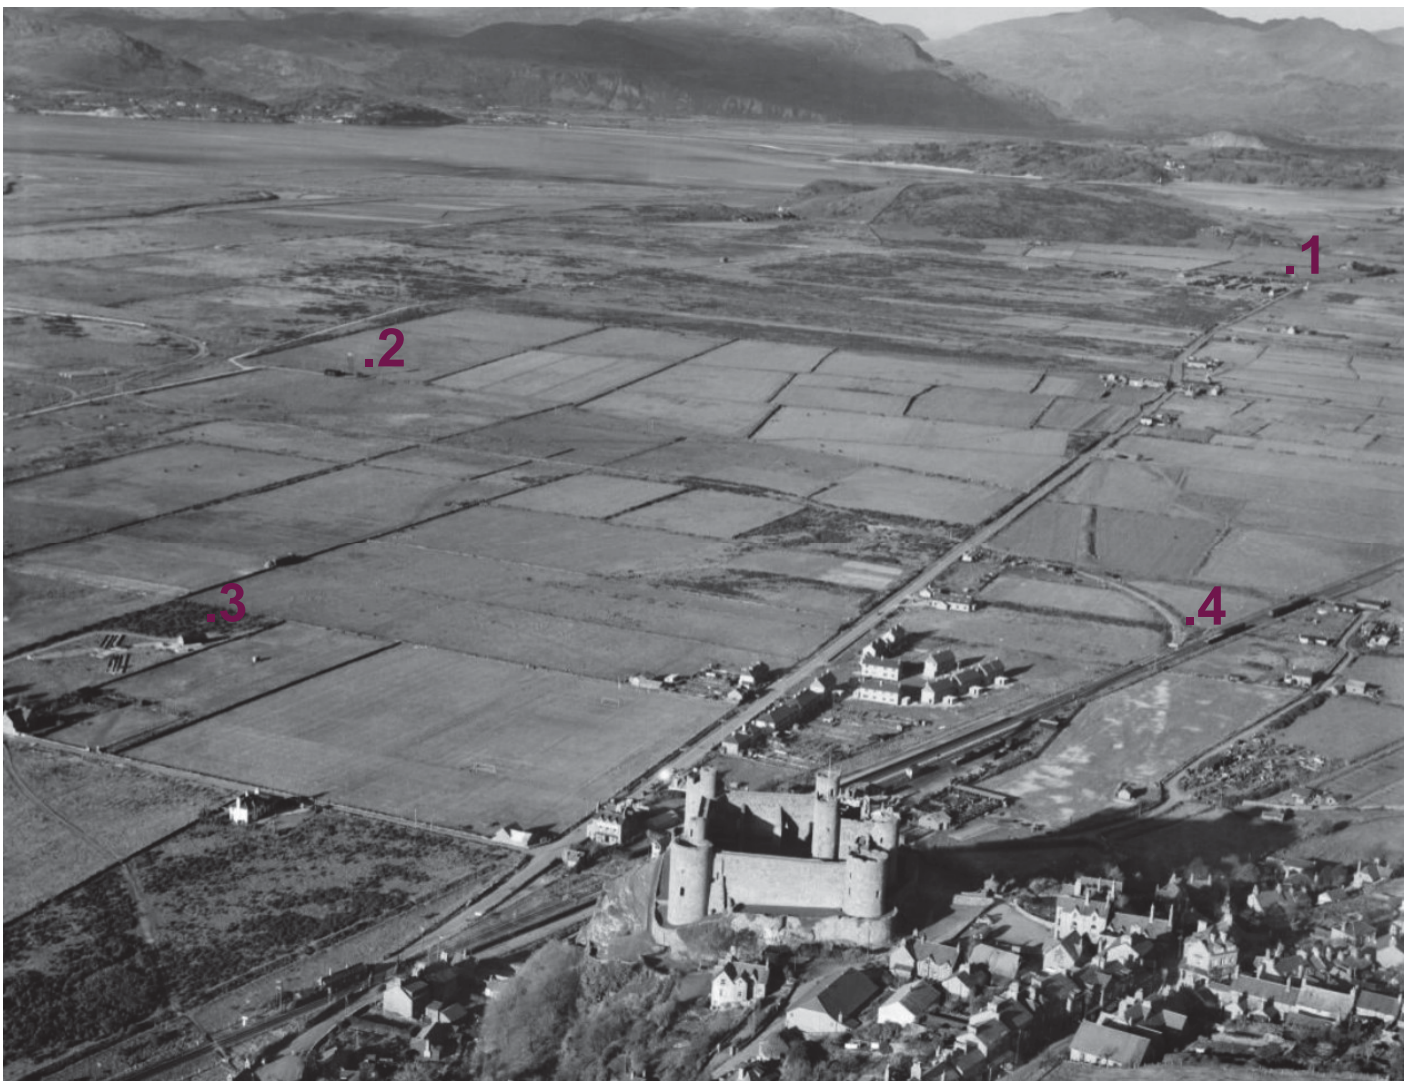
1948 Dated Oblique Aerial Imagery Detailing Points of Interest

Ser	Detail
.1	Harlech Camp
.2	Nissan Hut with outbuildings and water tower
.3	Nissan Hut with potential concrete firing position
.4	Rail siding leading to Military railway

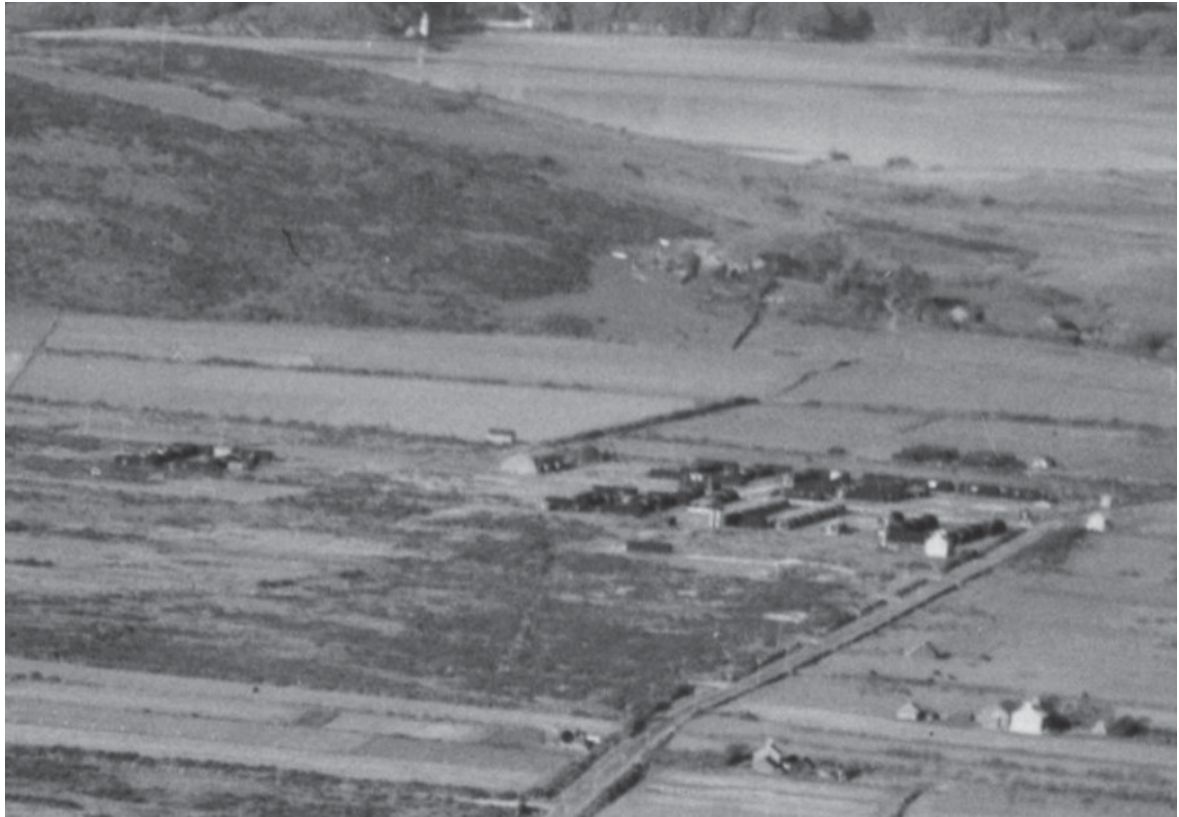
1. Harlech camp c.1948

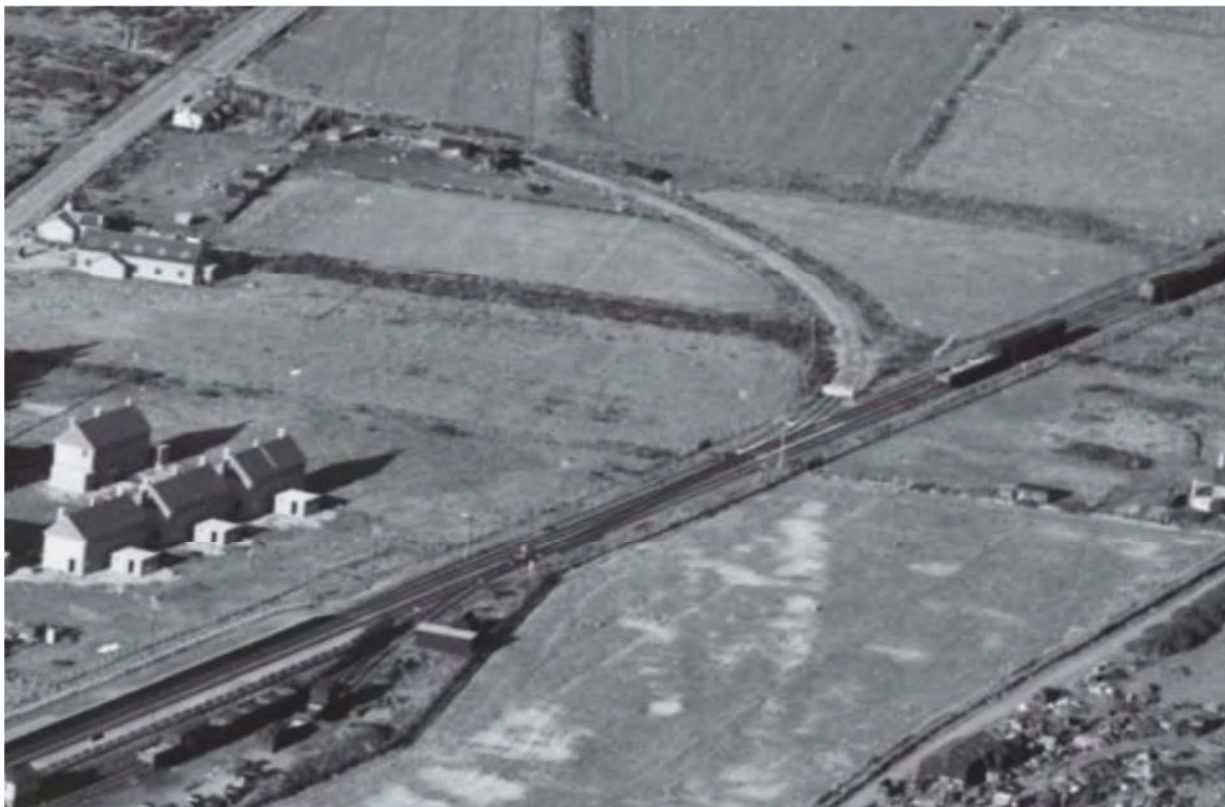
4. Rail siding leading to Military railway
