# Conwy Valley Flood Alleviation Scheme

## Archaeological Evaluation and Watching Brief

GAT Project No. 1877

Report No. 622

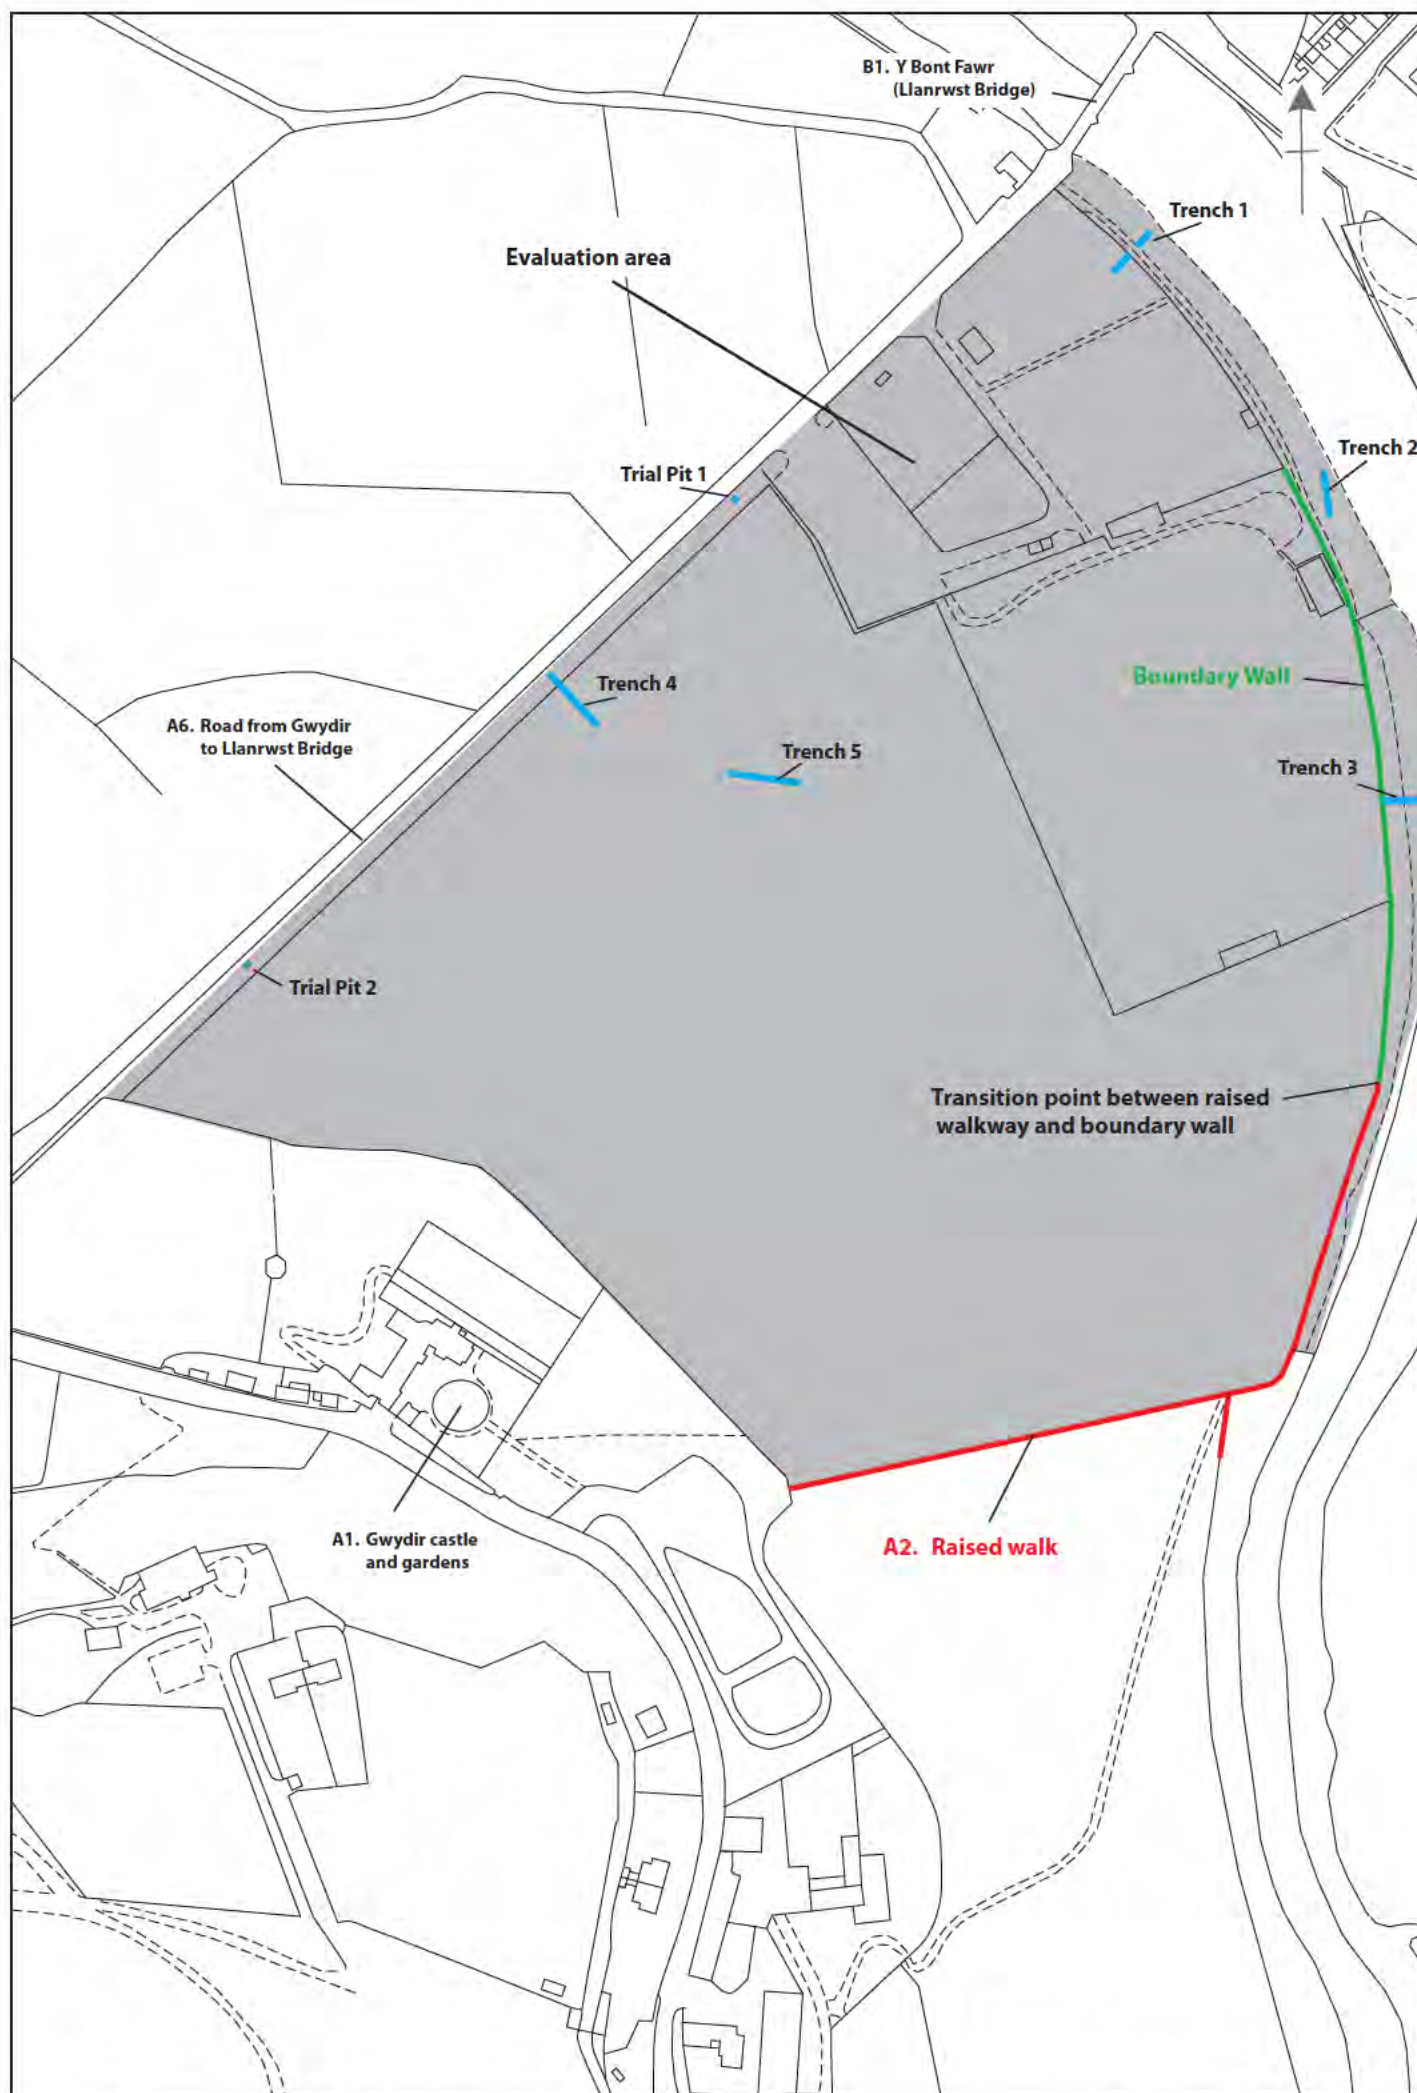
Figure 2. Location of evaluation trenches 1-5, trial pits 1-2 and identified archaeological sites. (Scale 1: 1250)

(Figure 2). Trenches 1 to 3 were located south of the bridge at Llanrwst (Y Bont Fawr; archaeological site B1 in GAT Report 618), along the west bank of the River Conwy, whilst Trenches 4 and 5 were located within a large enclosed field south of the road that originally ran from the bridge to the Gwydir estate, but that is now the connecting road between Llanrwst and Trefriw (Archaeological site A6 in GAT Report 618) (see Figure 2). The aim of the evaluation was:

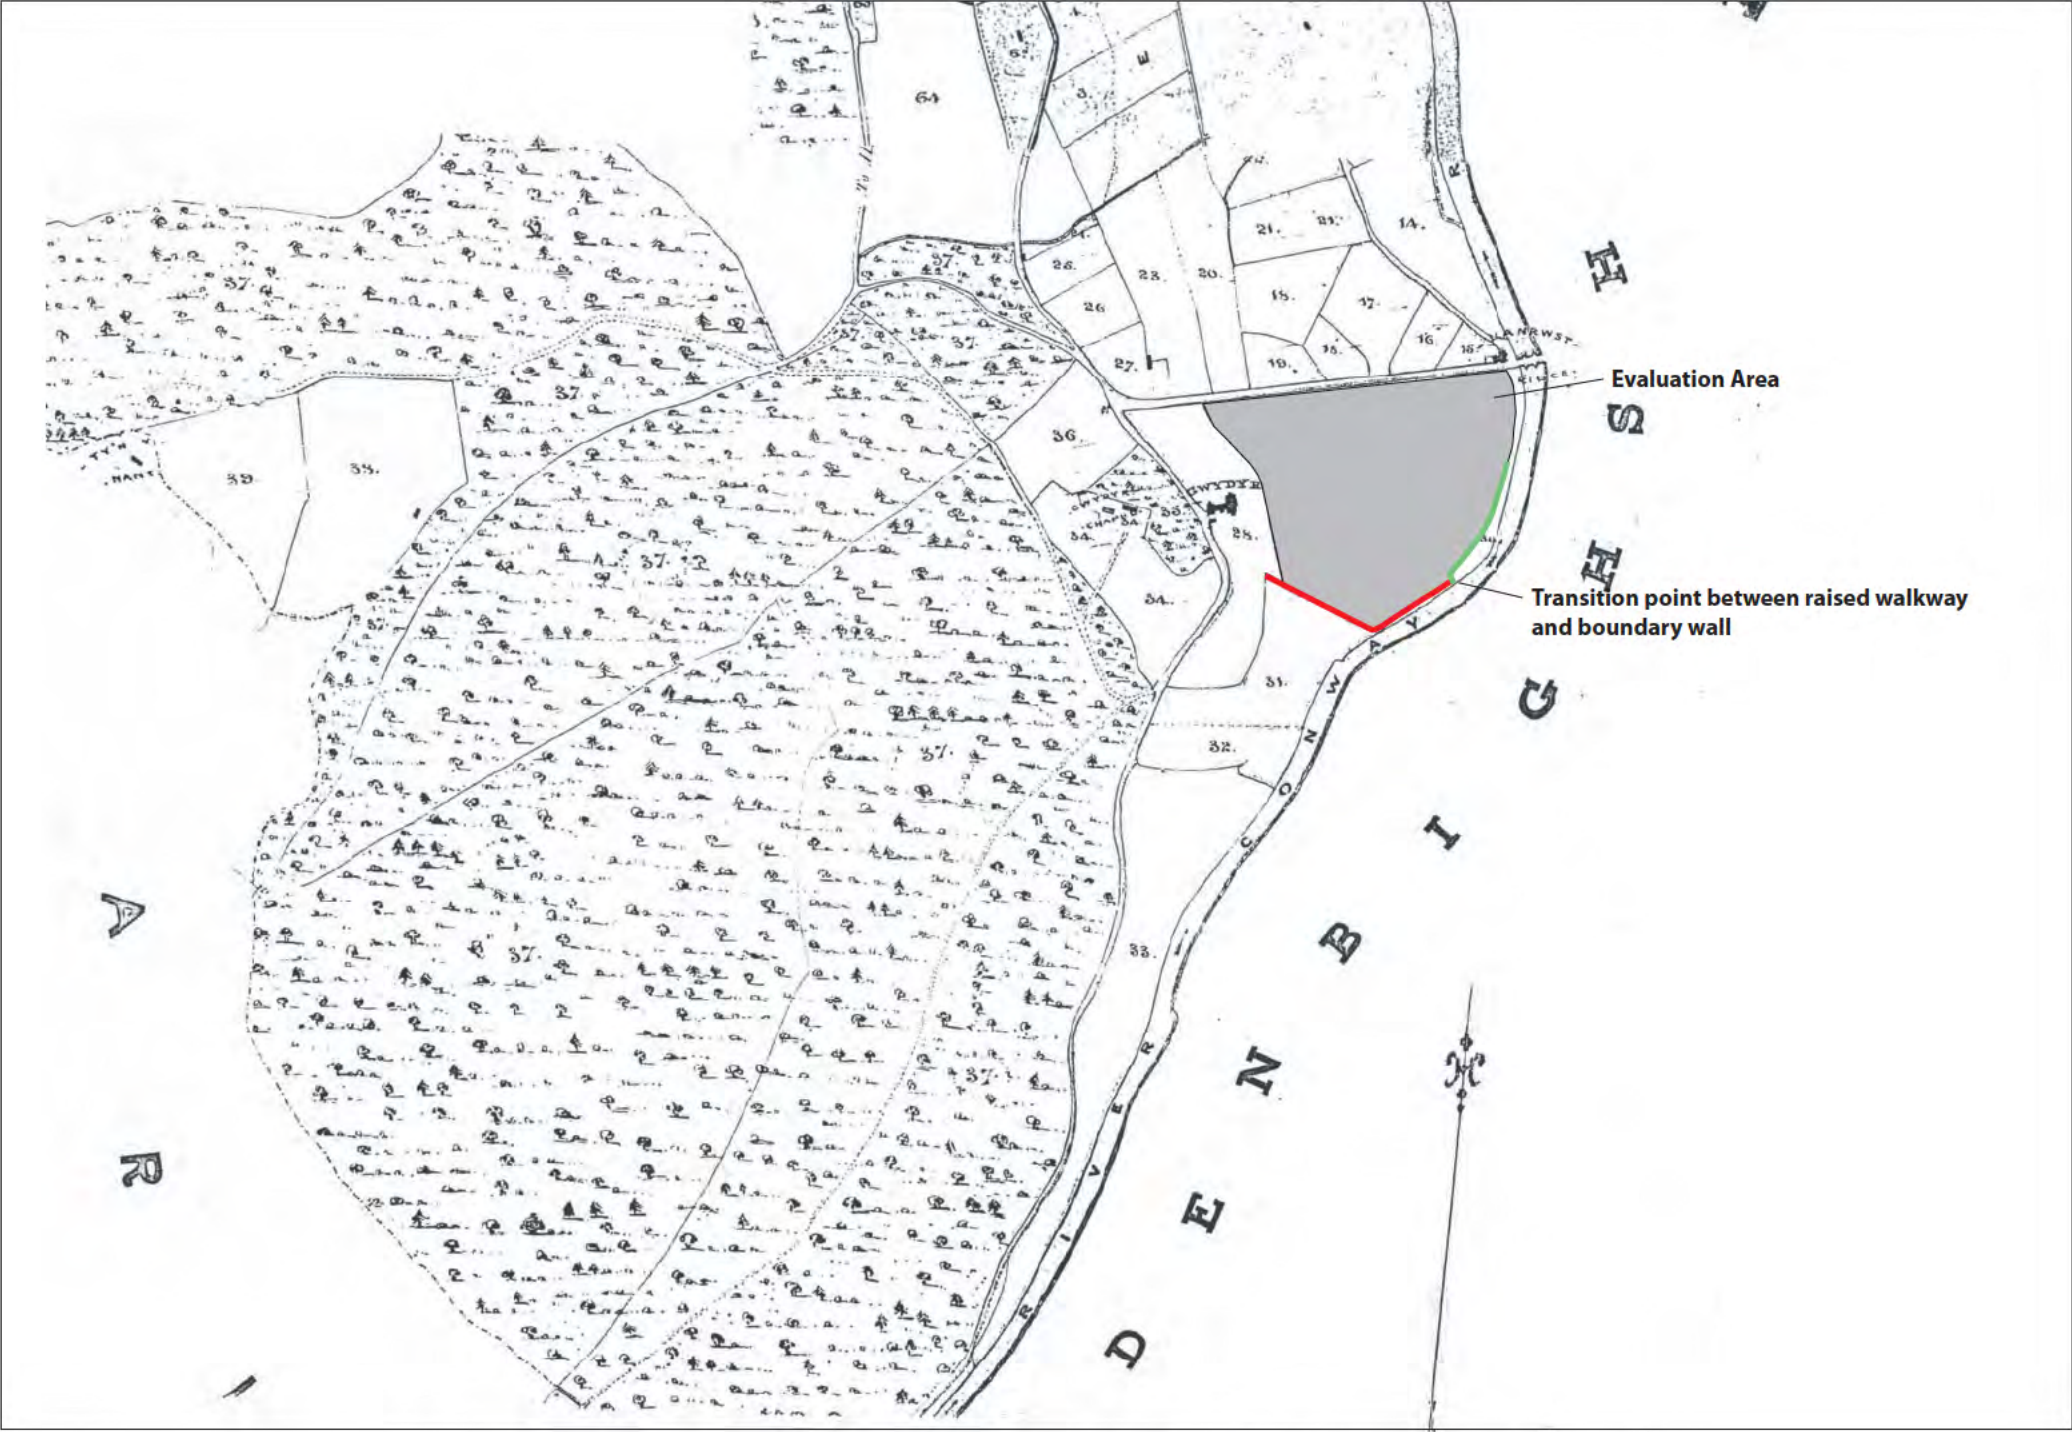
Figure 3. Tithe maps of Trewydir, Llanrwst and Trefriw. 1840-45 showing location of walkway and boundary wall

series of sand and gravel layers deposited to level out the riverbank. This construction layer was partially covering a redundant, disturbed wall (context 104). The wall was constructed from large sub-rectangular blocks of stone, with at least three surviving courses cut into and climbing the riverbank. The wall was at least 2.20m wide and 1.10m high. To the northeast of this wall, leading towards the river, was a deposit of stone (context 107) that acted as a riverbank reinforcement and was built from irregular sub-rounded and sub-rectangular stone. This feature was separated from the wall by a narrow gap backfilled with stone-rich clay-silt (context 109). This deposit was partially removed in an attempt to understand the temporal relationship between the wall and the stone surface. The section revealed that the stone surface did not extend any closer to the wall and that it had been built against the natural bank and that the surface had been built onto a construction layer of stone and gravel (Figure 3).

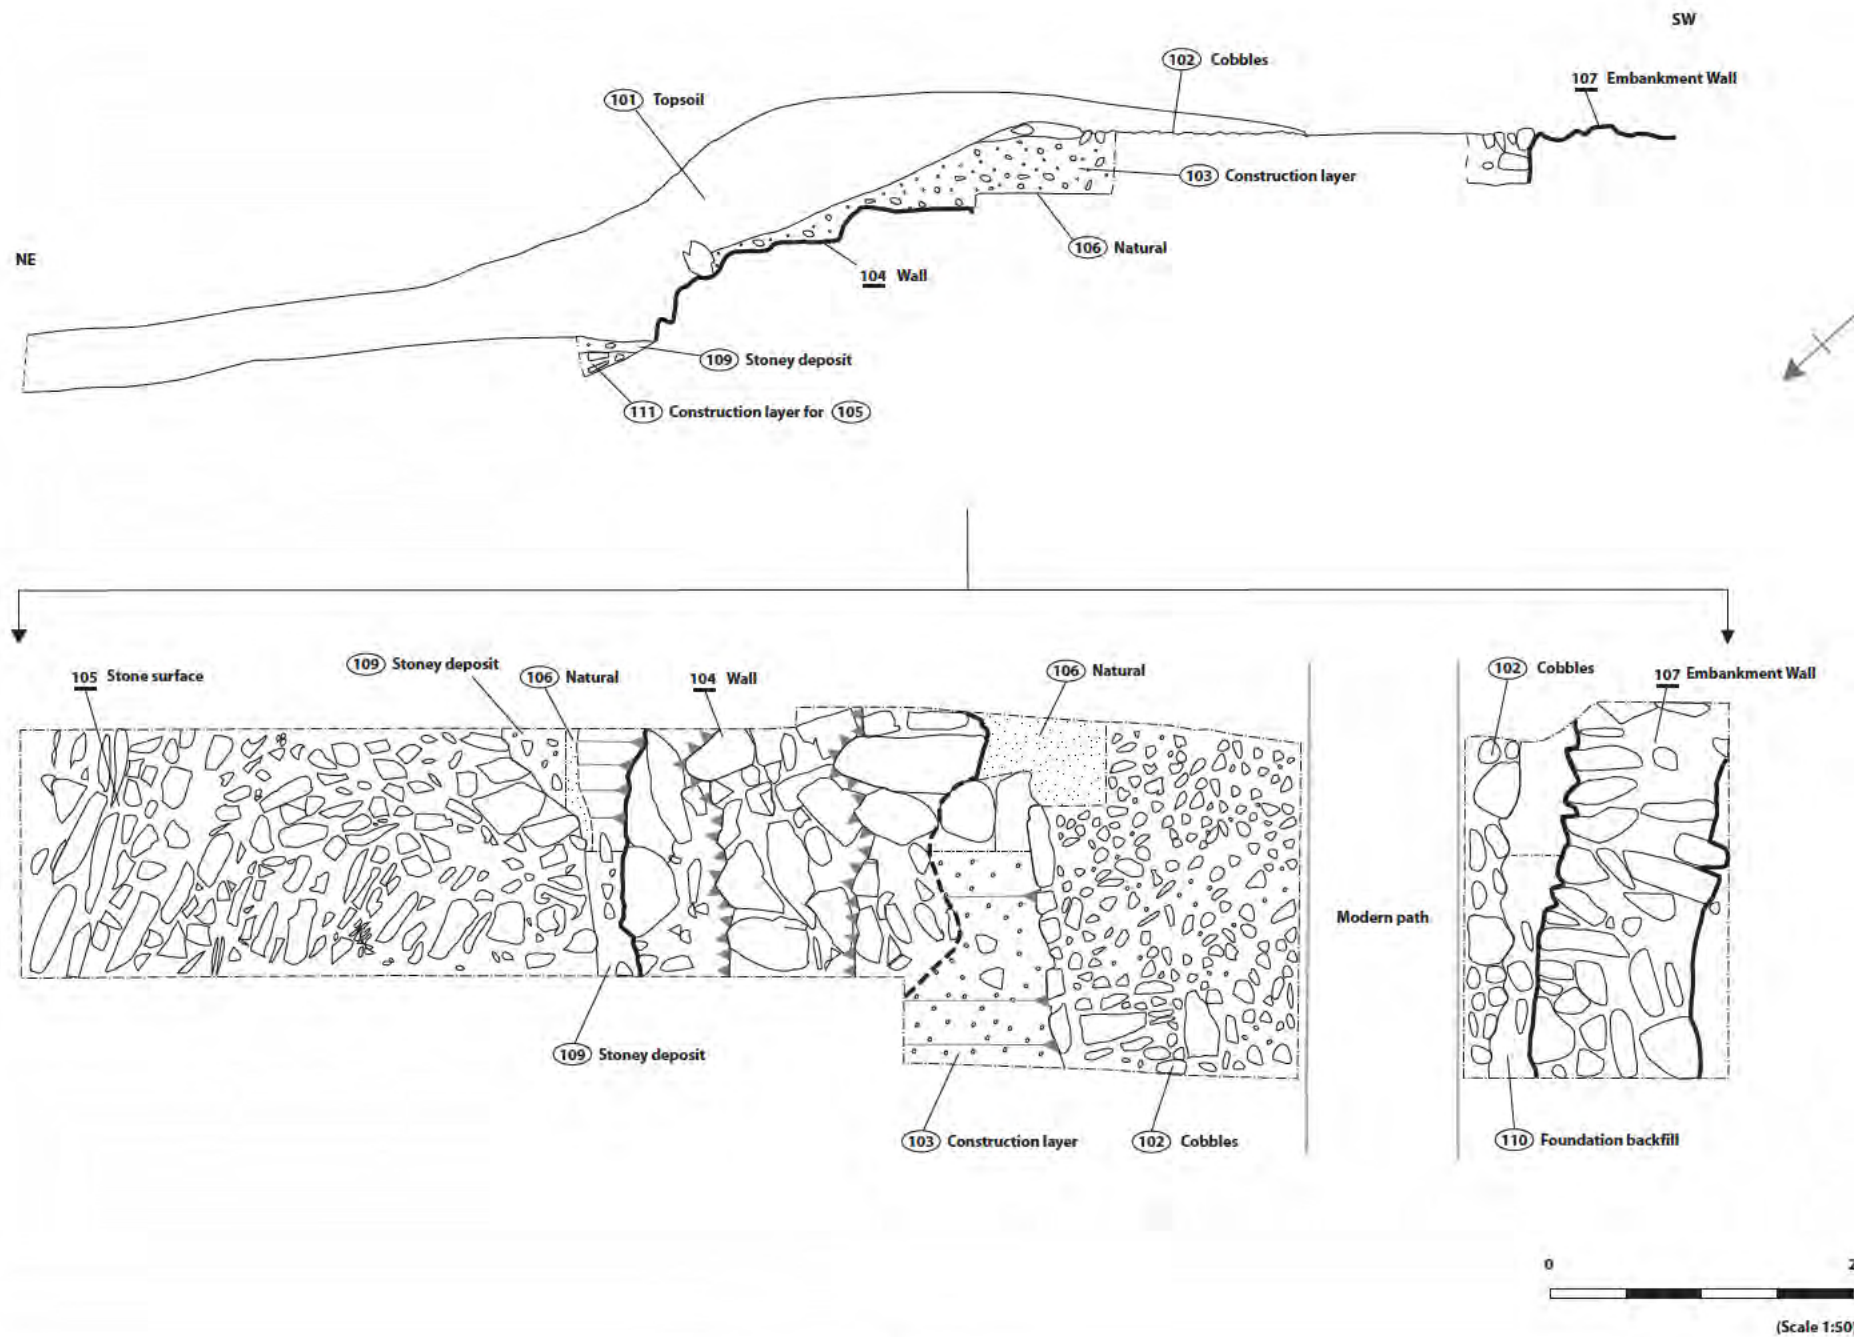
Figure 5. Trench 1.

Trench 1 was located c.20.0m south of Llanrwst Bridge on a southwest to northeast alignment. The trench was positioned to incorporate a 19<sup>th</sup> century flood embankment, a narrow modern concrete pathway running along the river and a wide terrace that slope down to the river (Plate 1). The terrace was visible running southwards along the riverbank for at least ninety metres until it reached a modern fence and public footpath gate. The terrace was thought to be the remains of a rough cobbled track visible from 19<sup>th</sup> century photographs (GAT Report 618, 7). The embankment stood to a height of c.0.50m and was built from irregular stone covered in earth that sloped southwestwards away from the pathway into local parkland. The embankment ran parallel to the pathway, curving gradually southwards for c.65m before being replaced by a 19<sup>th</sup> century stone wall. As stated above (para. 3.3), it was understood that the raised walkway built for the Gwydir Estate continued as far the bridge, but that it had been superseded by later improvements to the local area, including the flood embankment and the modernisation of the footpath along the riverbank. It was hoped the trench would reveal further information about the extent of the walkway, its proximity to the modern embankment and the extent of its survival. The trench was opened either side of the modern pathway, cutting through the flood embankment to the west side of the path and across the terrace to the east of the path towards the riverbank (Figure 3). The modern pathway was not removed as it was constructed from reinforced concrete. The embankment was constructed from a 1.00m wide stone built wall, which was cut into the natural silt. The wall stood to a height of c.0.50m and was sealed with a long sloping bank of earth. To the immediate northeast of the embankment wall was a cobbled surface (context 102), directly below the modern path. The narrow gap between the cobbles and the wall was filled with a deposit of stone-rich silt and was interpreted as a foundation cut backfill for the embankment wall. The opposite side of the path, also contained the cobbled path, which extended for 1.80m towards the river (Plate 3; Figure 3). The path was constructed from mainly sub-rounded pebblestones of various sizes, with larger elongated stones used along the edge of the path. There were no obvious signs of repair work at any point. The cobbled path had been built onto a thick construction layer (context 102), which contained a

The disturbed stone wall towards the centre of the trench could be interpreted as the remains of either a stone revetment to prevent the erosion of the river bank or the raised walkway, or indeed both. It was difficult to infer from the level of survival whether it was indeed the walkway as it did not have the distinctive large flat stones which characterise that structure, whilst a stone revetment is visible further south along the riverbank largely buried in the grass (GAT Report 618, 7), suggesting the wall may be part of the same structure. The cobbled surface is a later addition, partially built onto the wall and extending towards the flood embankment. It is presumably the same surface visible from the 19<sup>th</sup> century photographs (see Plate 2, GAT Report 618) and can be interpreted as forming the distinctive terrace which runs southwards from the bridge, acting as a precursor to the narrower concrete path. The stone surface at the base of the riverbank, sloping towards the river away from the wall, was presumably laid to prevent erosion of the riverbank. Its temporal relationship to the wall could not be determined and may have been at anytime since the inception of the Gwydir Estate.

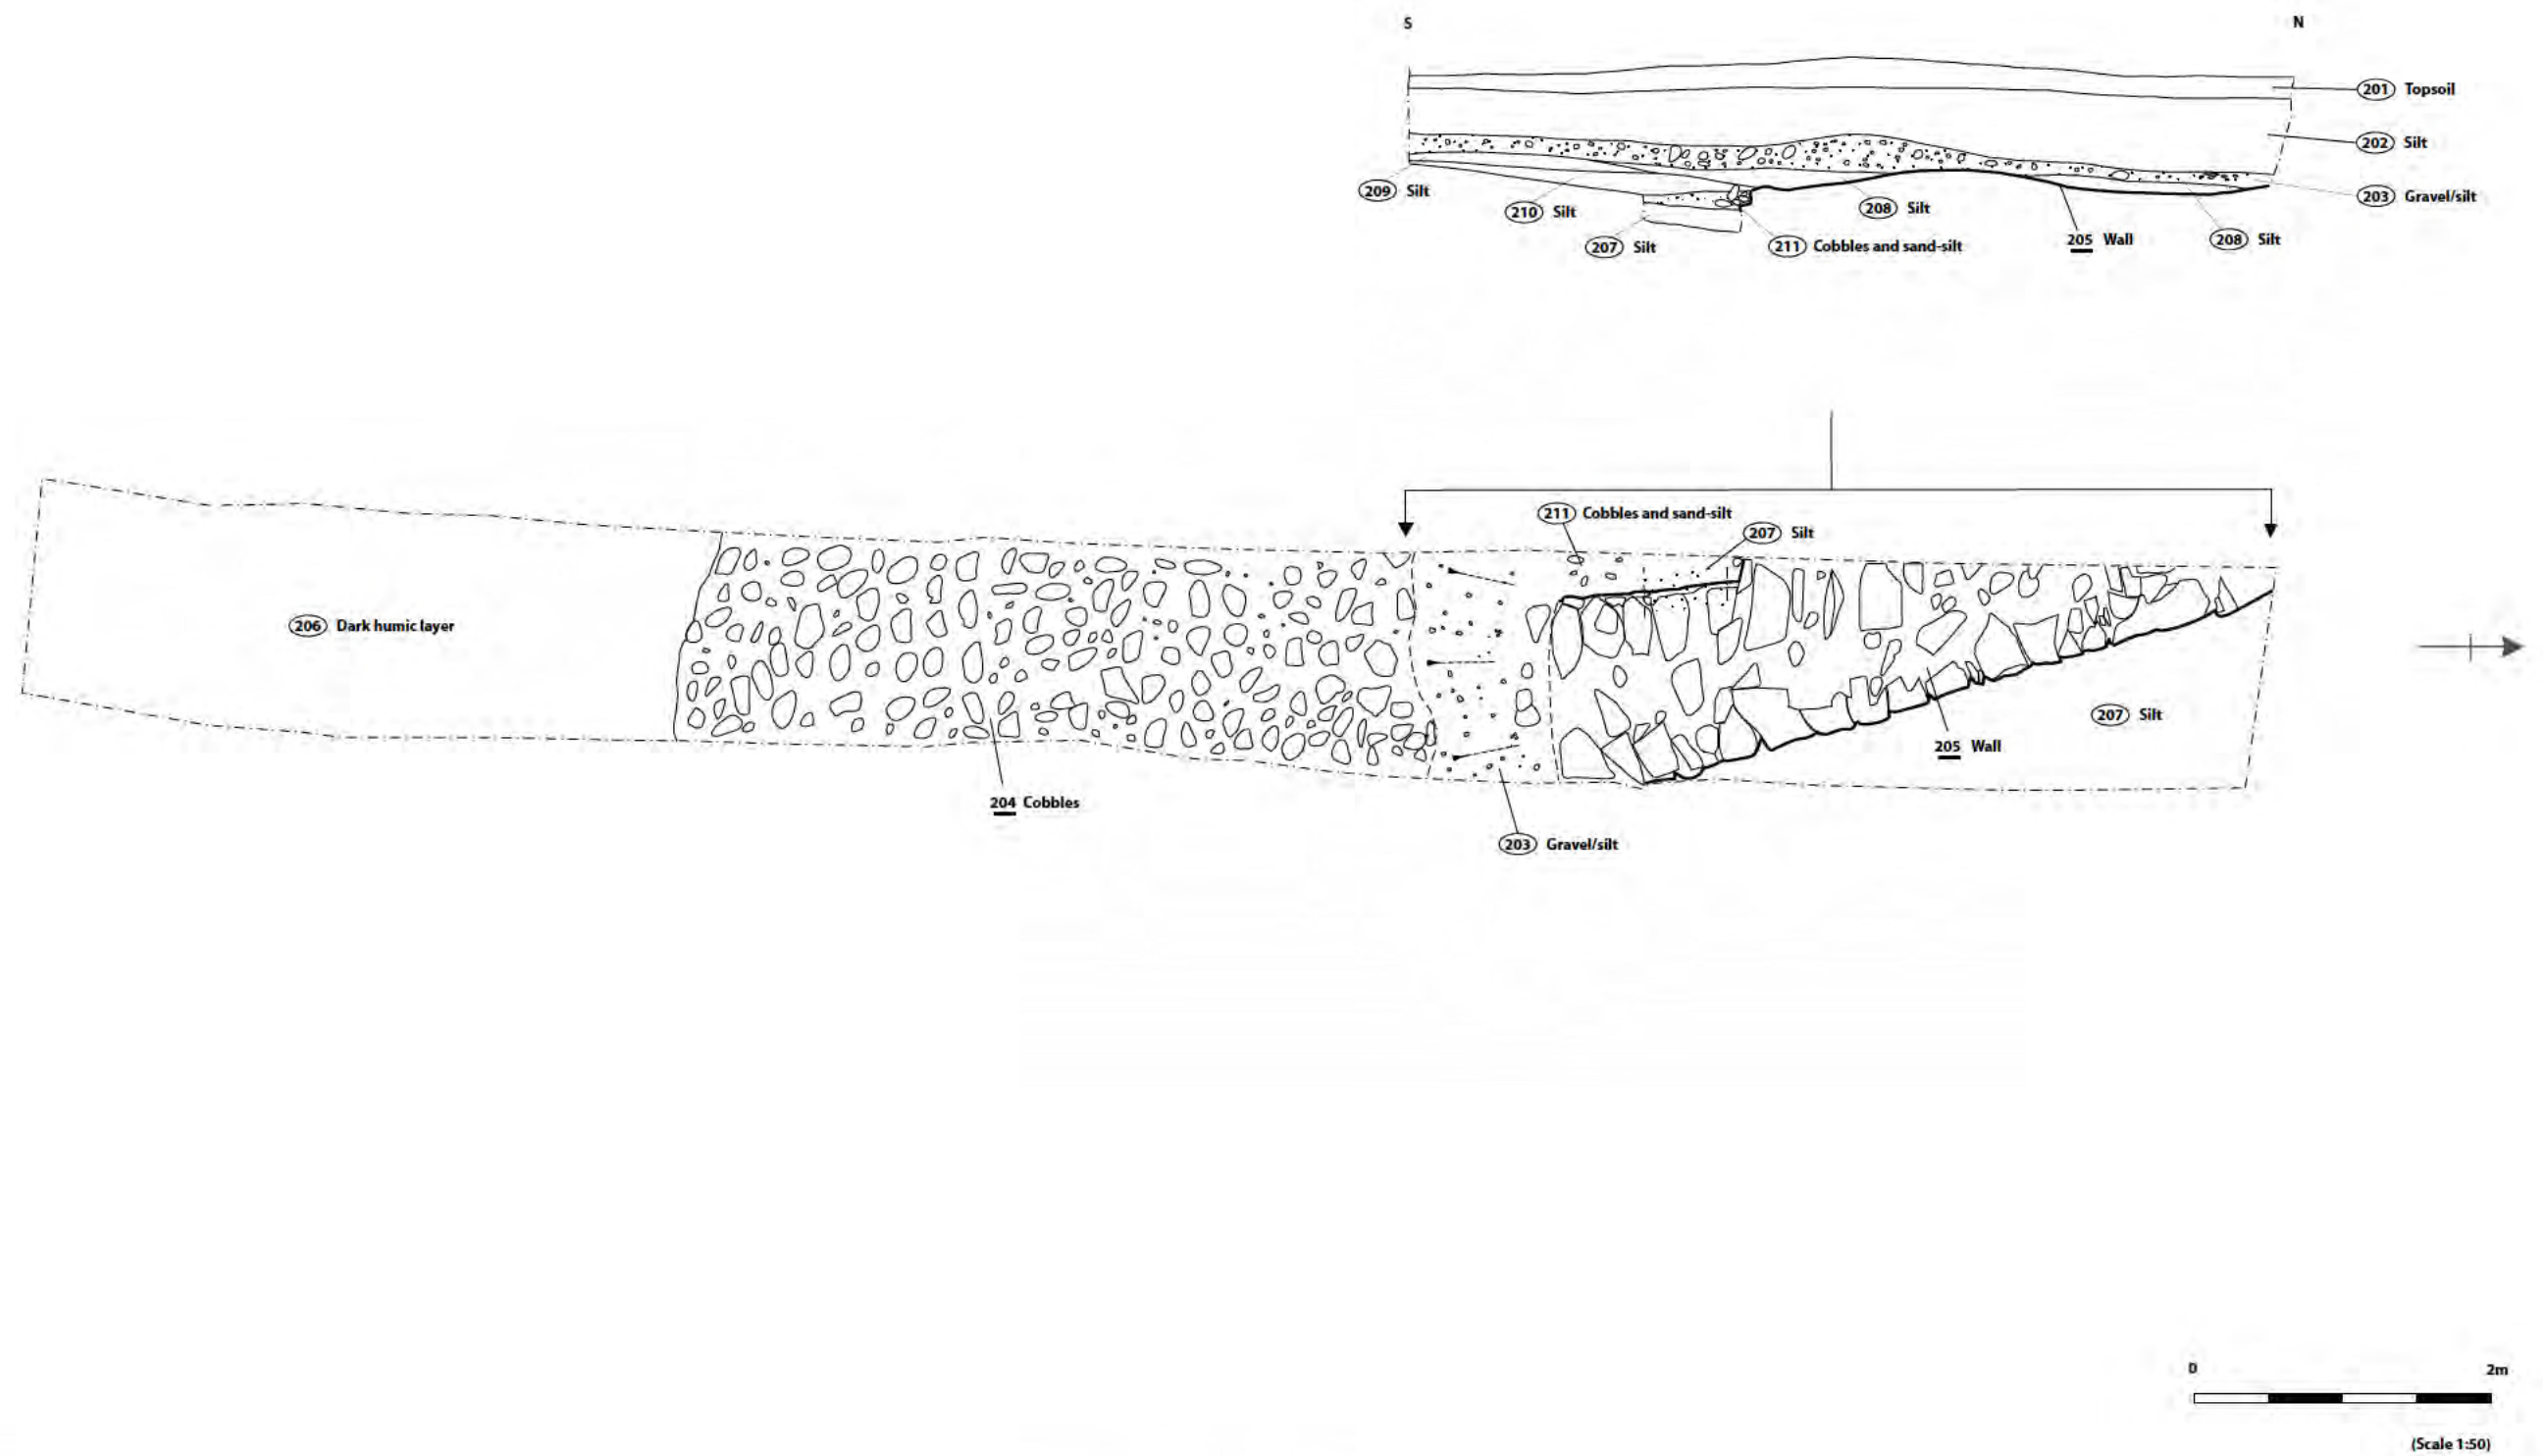
Figure 6. Trench 2.

Trench 2 was located 50m southeastwards of Trench 1, between the riverbank and a 19<sup>th</sup> century boundary wall (Figure 2). The trench was aligned north to south and was positioned to investigate the distinct terrace described above and to also locate any remnants of the raised walkway. The northern end of the trench contained a substantial stone wall, c.1.50m wide and extant to a length of 5.0m. The wall was constructed from irregular sub-angular stone and was aligned south-southeast to north-northwest. The full extent of the wall within the trench could not be determined as it was partly covered by a cobbled surface (context 204) built onto 0.30m thick construction layer of gravel and sand (Figure 4). The cobbles were partly disturbed but covered an area of c.5.5m. The remaining 4.5m of the trench at the southern end was dominated by a backfilled tree hole that contained modern rubbish material mixed into a dark, humic soil. An attempt was made to investigate the depth of the wall but was prevented by the friability of the silt deposit alongside the wall, which caused immediate trench collapse when excavated to any substantial depth.

This trench contained a relatively straightforward temporal relationship, with the wall succeeded by a cobbled surface, in much the same manner as Trench 1. The cobbled path had also been replaced in this area by the concrete path. The wall in this instance appeared to be a riverbank revetment.

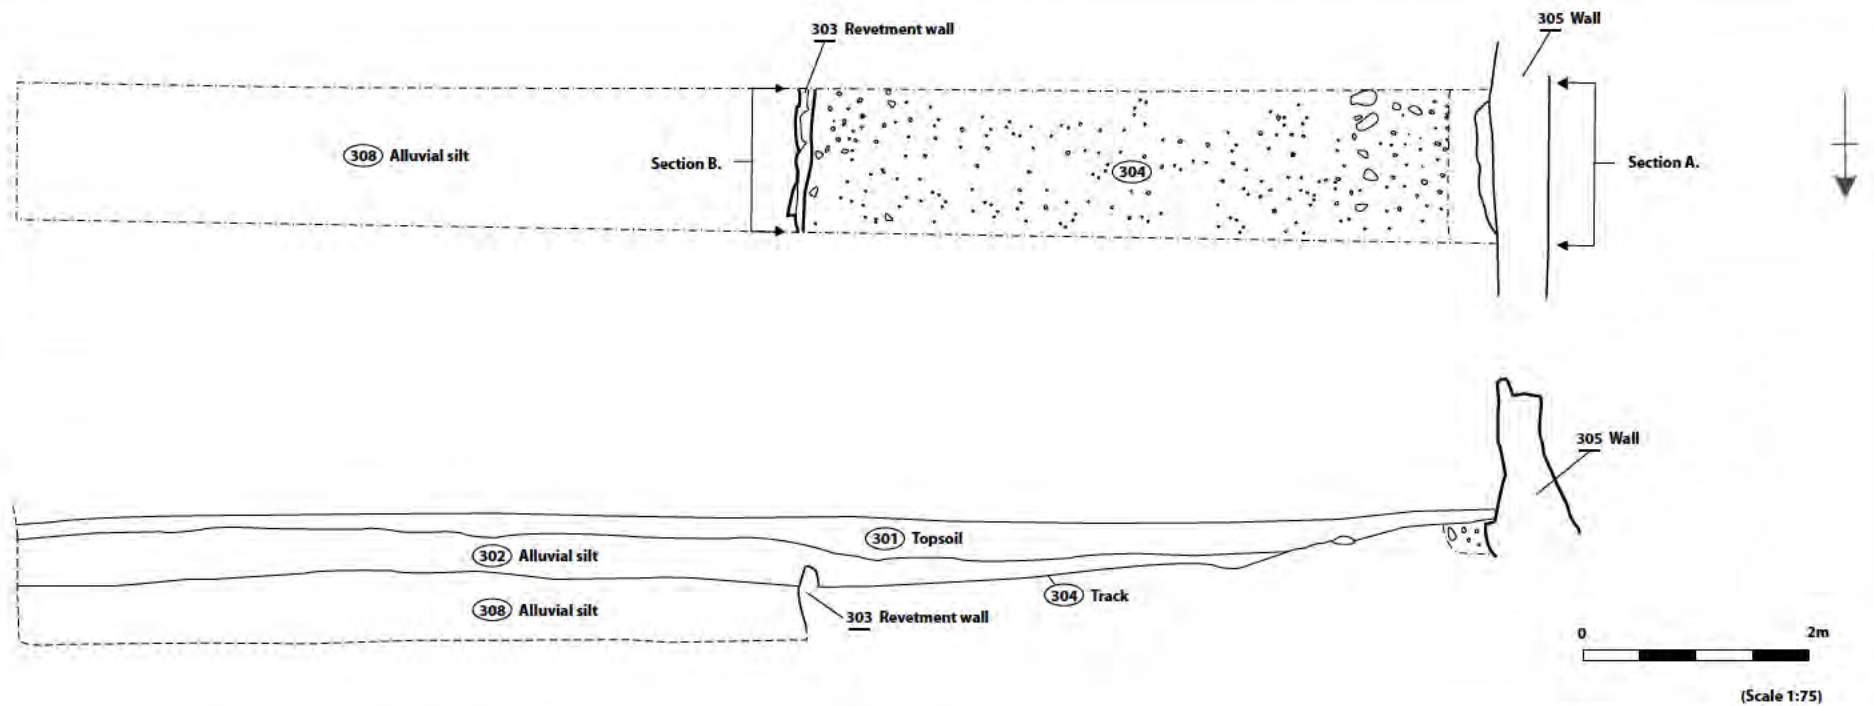
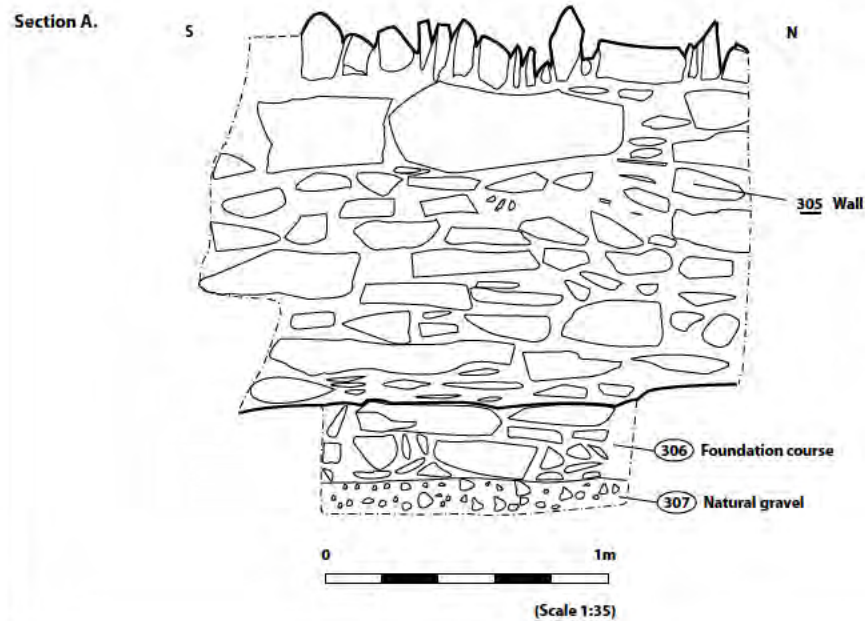
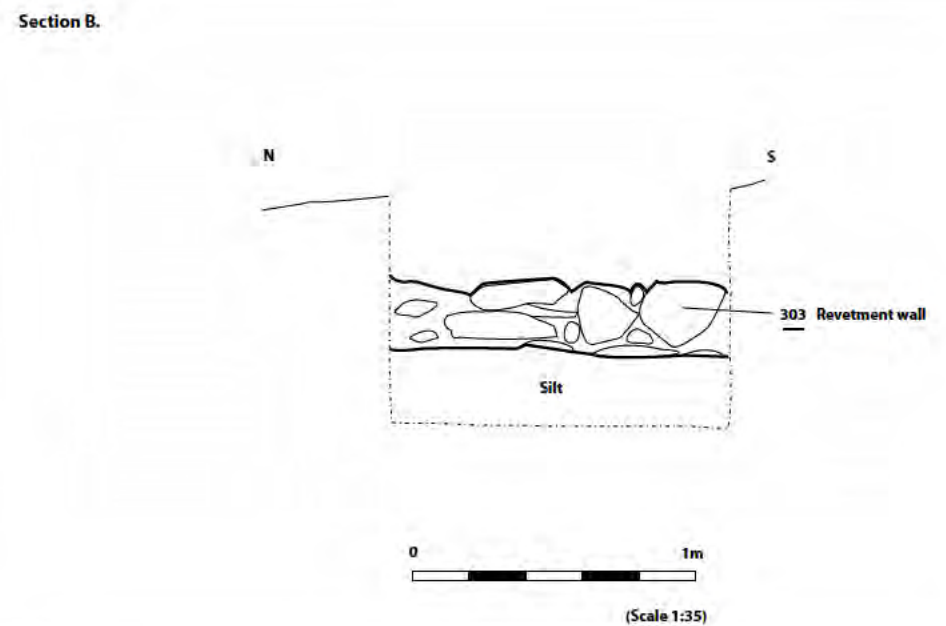
Figure 7. Trench 3.

Trench 3 was located 50m south of Trench 2. This area differed in appearance to that of Trenches 1 and 2: the distinctive terrace was no longer apparent and the riverbank was much flatter and wider and the ground more uneven due to alluvial activity. The modern path was replaced by a simple eroded path in the ground, whilst this area was fenced off from the area to the north containing the other trenches and was accessed by a simple gate. The trench was aligned east to west running from a 19<sup>th</sup> century boundary wall towards the river's edge. The intention here was to locate any evidence for the walkway, to see if it had been replaced by the 19<sup>th</sup> century wall. The wall was c.1.40m high, built from irregular sub-angular stone (Figure 5 and Plate 7). The trench was cut away from the wall, revealing that this structure had been built in one phase, with a 0.30m deep foundation course cutting the natural gravel. Running parallel to the wall, at a width of 4.6m was a gravel path faced at its eastern end by a narrow revetment wall, cut into alluvial silt (Figure 5; Plate 7). The wall was a simple construction, c.0.25m wide and 0.30m high, built from irregular sub-angular stone. There were no underlying structures beneath this path and the remainder of the trench was devoted to alluvial silts.

This trench did not match Trenches 1 and 2 in revealing evidence for major structural activity. From the confines of the trench at least, it did not appear that a revetment wall or a cobbled surface continued in this direction this far south. The simple gravel path that had been used did not continue below the boundary wall and was assumed to be contemporary or later to that structure.

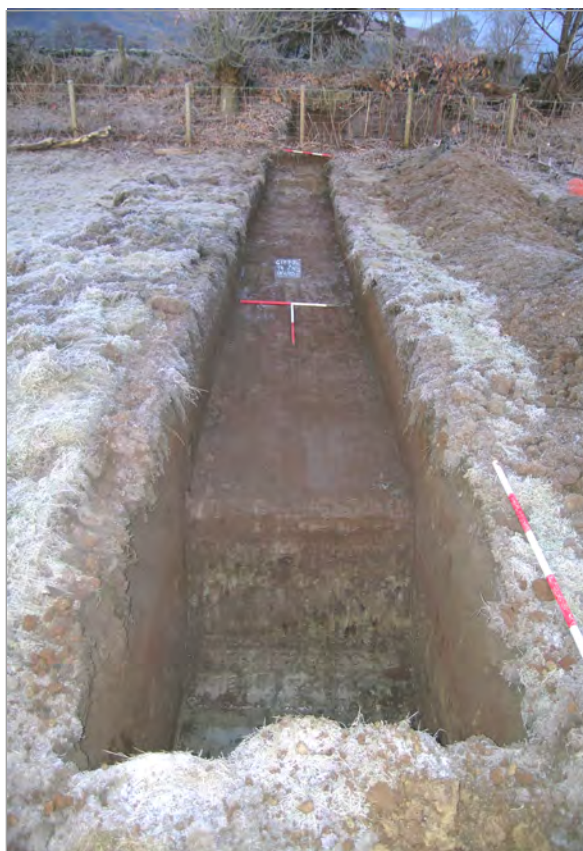
**Plate 8: View North of Trench 4**

Trench 4 was located in a large enclosed field that originally belonged to the Gwydir Estate and was positioned immediately south of the road running between Llanrwst and Trefriw (Figure 1). The road was originally built in the 17<sup>th</sup> century, to link the Gwydir Estate to the bridge and the trench was originally positioned to investigate the construction of the associated boundary wall and to understand the nature of the topography within the field that seemed to suggest a redundant tree line. Due to the ruined state of the wall and the proximity of a modern fence line and underground services, the investigation of the wall construction was abandoned and continued at a different location (see below). The trench was still used to investigate the apparent topographical features. The trench revealed that they were in fact little more than undulations caused by flooding and that the trench contained little more than a series of silt-rich layers above the natural (Plate 8).

There was no evidence for any activity within this trench other than that caused by flooding.

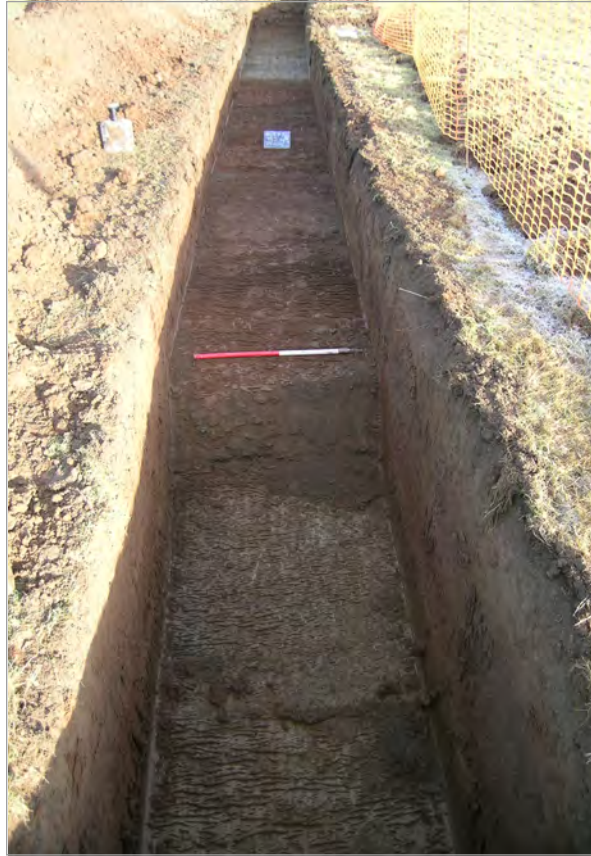
**Plate 9: View East of Trench 5**

Trench 5 was located to the southeast of Trench 4 and was positioned to investigate a pronounced topographical feature that appeared as a wide depression running north south across the field. The trench was opened but revealed little more than a series of silt-rich layers atop a probable paeleo-channel (Plate 9).

This trench was identified as archaeologically sterile.

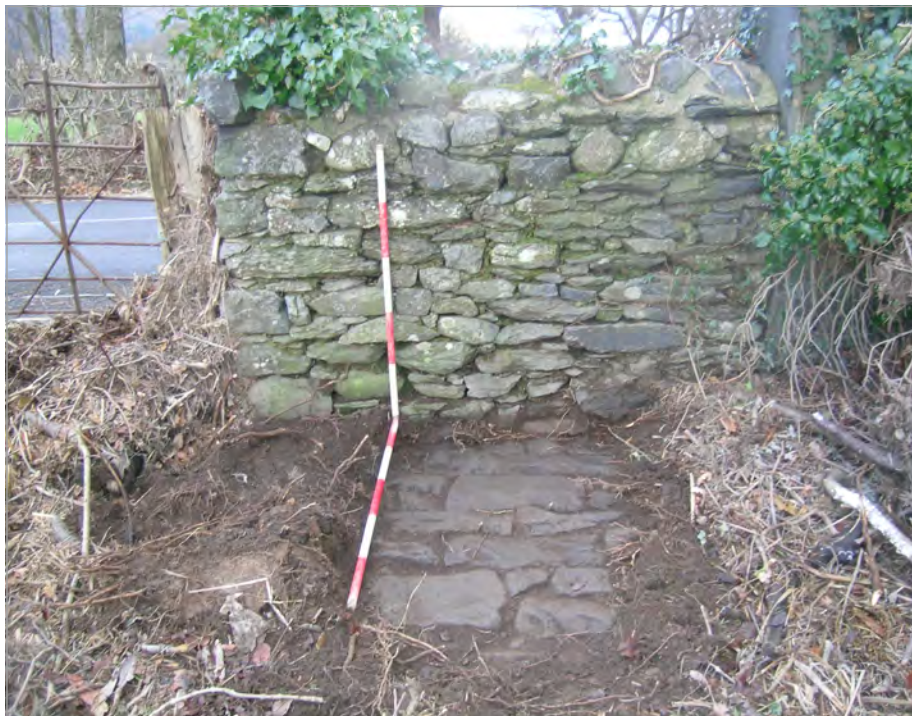
**Plate 10: South facing Elevation of Trial Pit 1**

Two small trial pits were dug at either end of the boundary wall to investigate the construction process behind the boundary wall (Figure 2). As stated above, the original aim was to investigate the wall as part of Trench 4, but this was hampered by a number of factors. The trial pits were dug by hand at the most accessible and convenient locations. Trial pit 1 was located at the eastern end of the boundary wall, close to a gate. The topsoil was removed, revealing a stone surface that was presumably laid to prevent the area around the gate entrance from eroding (Plate 10). The stone surface was not removed. Trial pit 2 was located at the western end of the boundary wall, revealing that the wall was built onto a 0.30m deep foundation course of irregular sub-angular stone. There did not appear to be any evidence for repair and the structure appeared to be a single phase.

The wall has been dated to the 17<sup>th</sup> century (GAT Report 618, 8) and it appeared that the what was visible was the original construction phase.

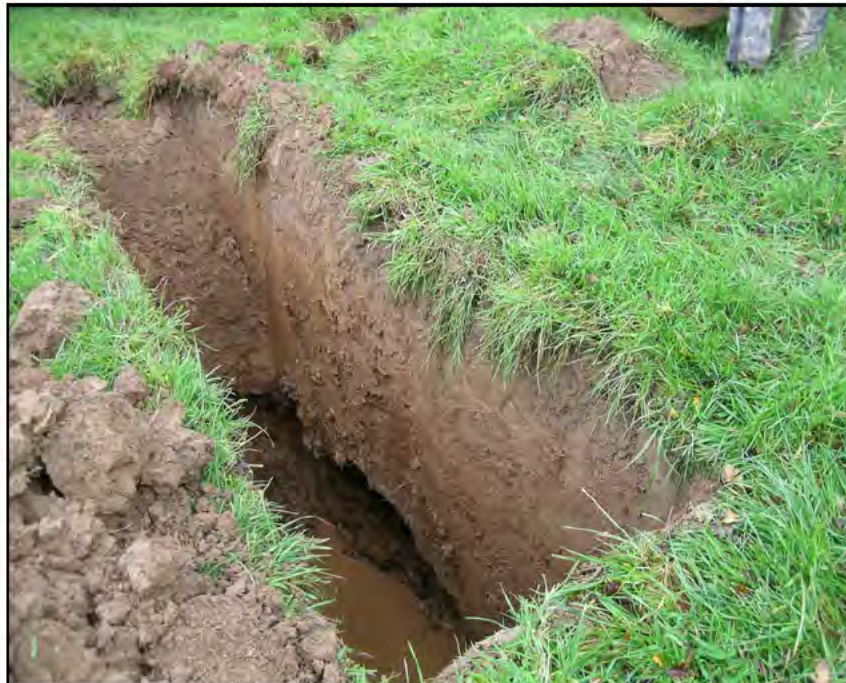
Plate 12 : Test Pit 325

The test pit was located c.300m northeast of test pit 323 within a rectangular enclosed field near to a field boundary, also on the flood plain (Figure 1). The field was virtually flat and was used for pasture. The topsoil differed to that identified in test pits 322 and 323, appearing more light-brown in colour with a finer silt-rich matrix, extant to a depth of 0.50m, atop a clay-rich deposit of silt of similar depth. The final metre within the trench comprised a series of alluvial deposits.

The test pit was archaeologically sterile

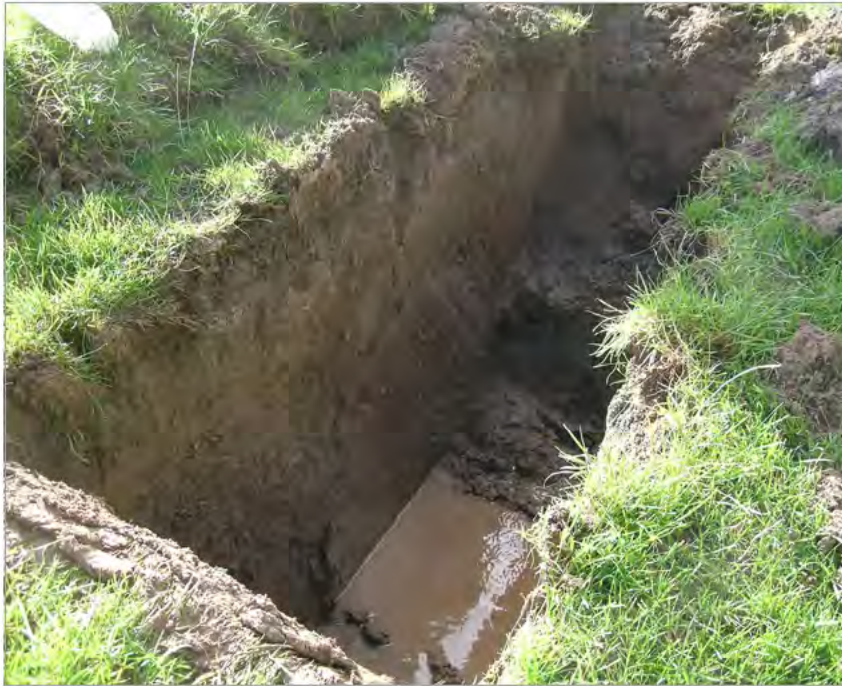
Plate 13: Test Pit 338

The test pit was located to the south of TP337 in the same enclosed field, near a southern field boundary (Figure 1). The topsoil was extant to a similar depth as TP337, followed by 0.30m of light brown alluvium. A 0.20m thick deposit of grey alluvium followed this deposit, with the remaining depth characterised by a grey-rich clay-silt.

The test pit was archaeologically sterile

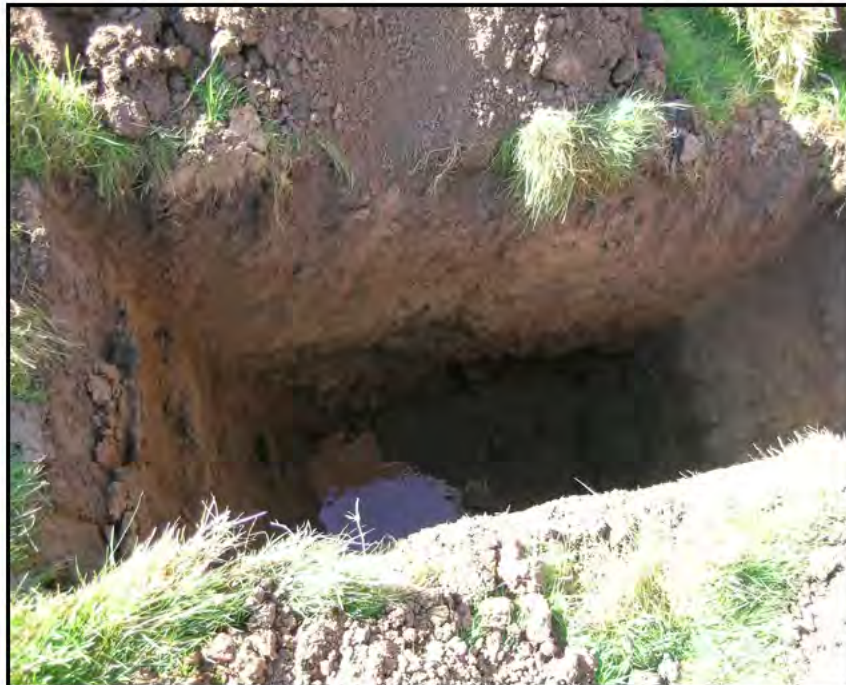
Plate 14: Test Pit 341

TP341 was located 50.0m south of TP340 (Figure 1). The topsoil was extant to a depth of 0.40m; this was followed by alluvial gravels, 0.40m deep; this was followed by alluvial cobbles 1.10m deep, with terrace gravels at 2.00m.

The test pit was archaeologically sterile.

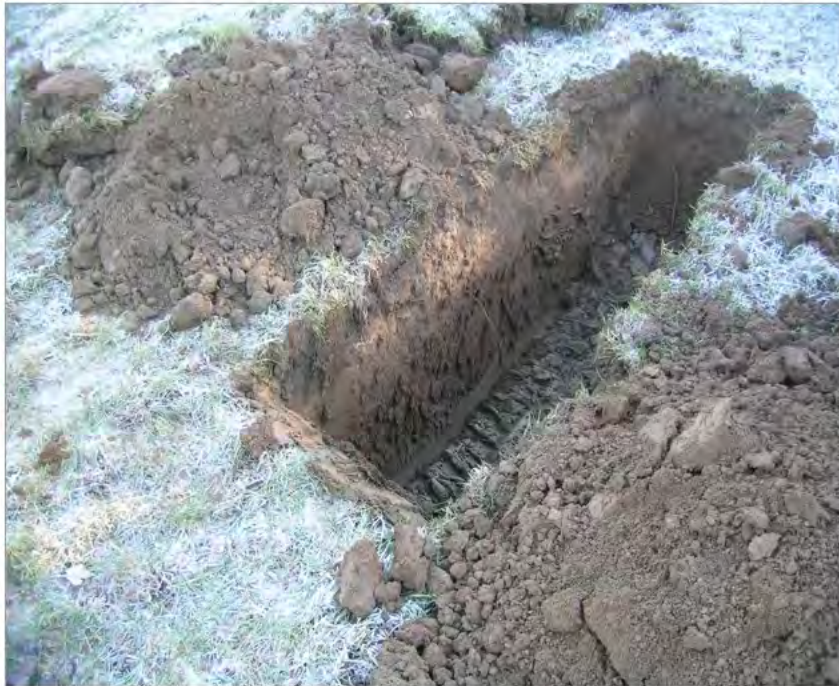
Plate 15: Test Pit 345

TP345 was located in an enclosed field to the southeast of TP344 (Figure 1). The test pit was dug to a depth of 1.80m, with the 0.20m thick topsoil followed by a succession of clay-rich alluvial deposits.

The test pit was archaeologically sterile.

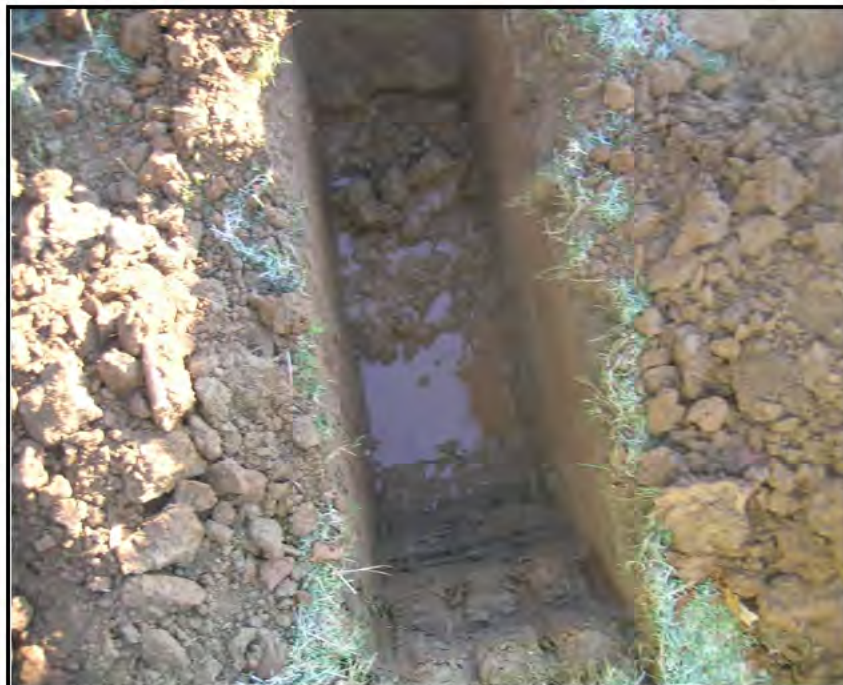
Plate 16: Test Pit 350

TP350 was located west of TP349 (Figure 1). The 0.20m thick deposit of topsoil was followed by a 0.80m thick deposit of clay-silt, with further alluvial silts extant for the remainder of the test pit.

The test pit was archaeologically sterile save for a sherd of nineteenth century glazed pottery.
