# Conwy Valley Flood Alleviation Scheme

## Archaeological Evaluation and Watching Brief

GAT Project No. 1877

Report No. 622

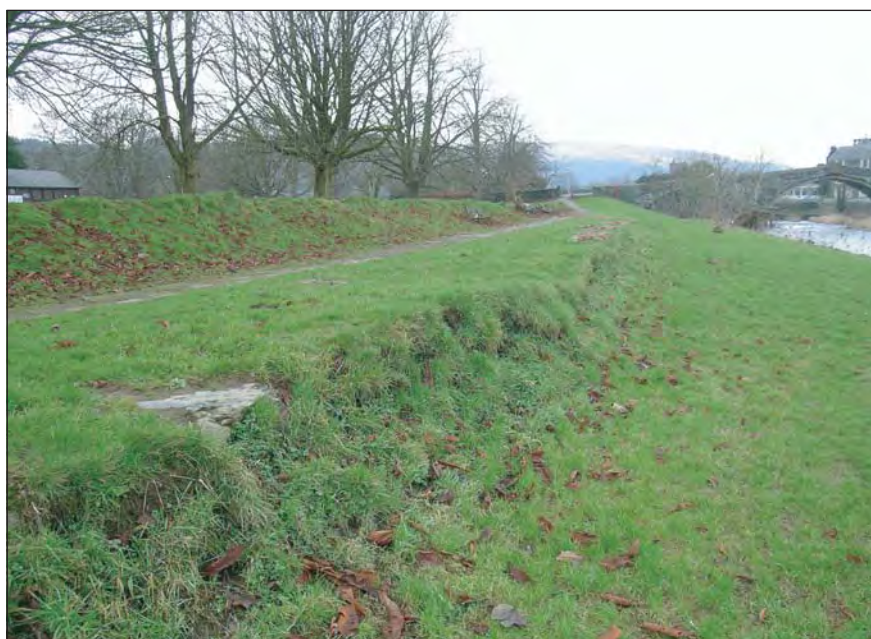
**Plate 20: Terrace Line South of Bridge. Note Capping Stone of Wall Protruding From the Grass**
