# Observation Building Trawsfynydd Military Camp

## Archaeological Survey

GAT Project No. G1974

Report No. 709

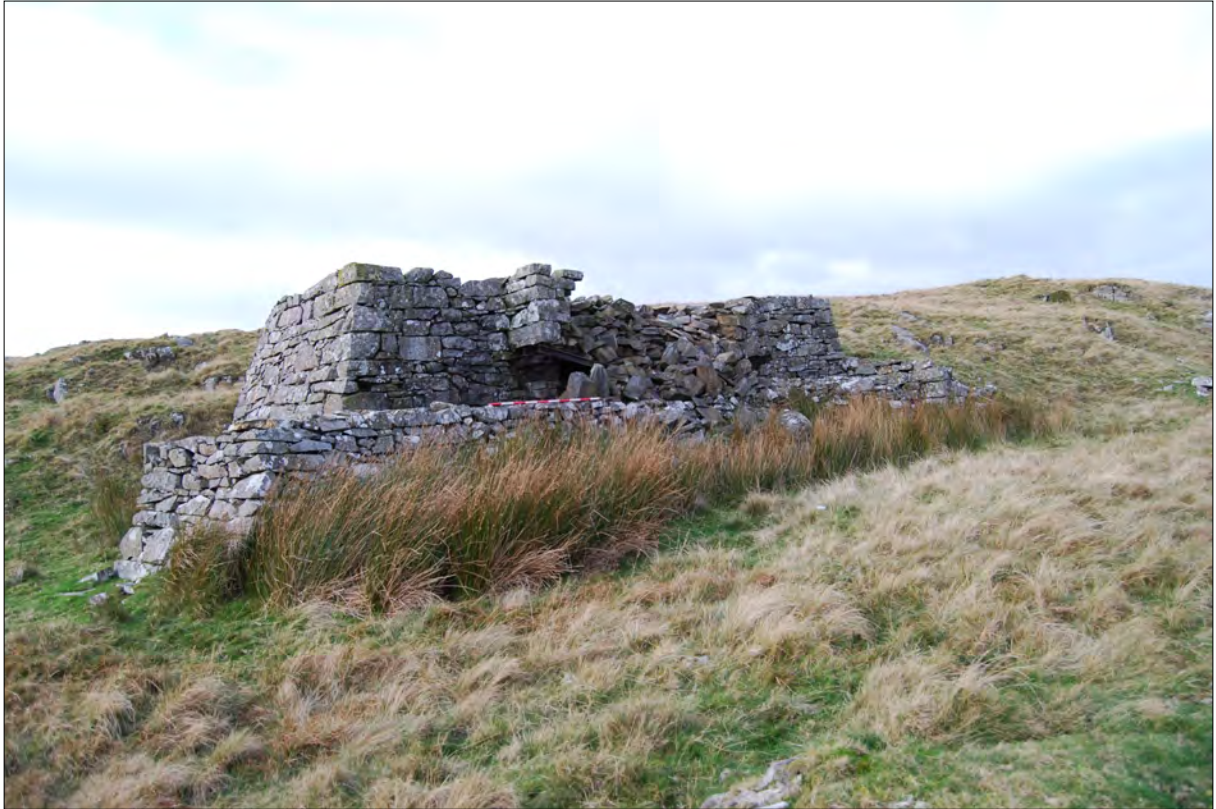
Plate 3. North west facing image of the Observation building showing the collapsed canopy.

The structure is drystone built from locally sourced stone and utilises the local topography to provide suitable shelter from artillery fire. The proposed renovation work includes the reconstruction of the east facing entrances, viewing area and protruding protective canopy which have partially collapsed. The canopy is constructed from stone, with reused railway I-beams acting as lintel supports. Figure 4 shows the extent of current collapse, with detail of the material used. Internal access was prohibited due to the state of collapse.

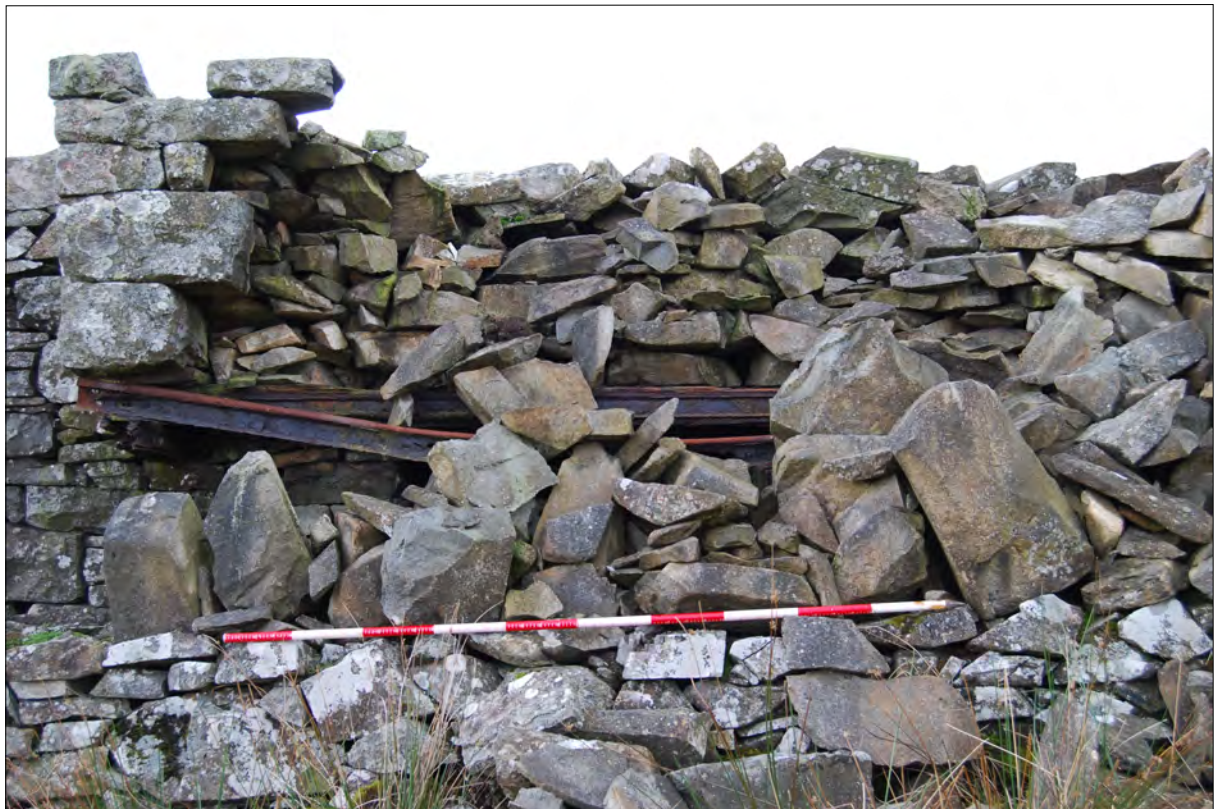
Plate 4. West facing image of the Observation building showing the collapsed canopy and railway I-Beams.

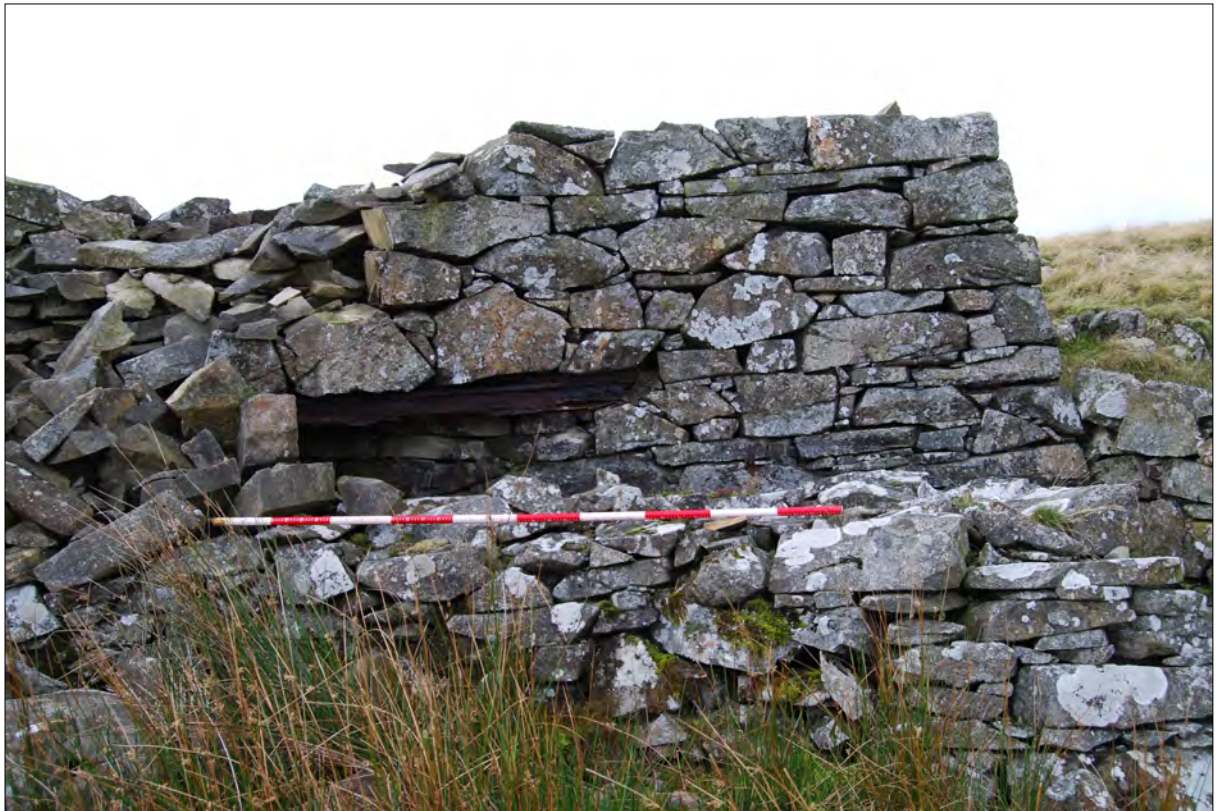
Plate 5. West facing image of the Observation building showing the collapsed canopy and railway I-beams.

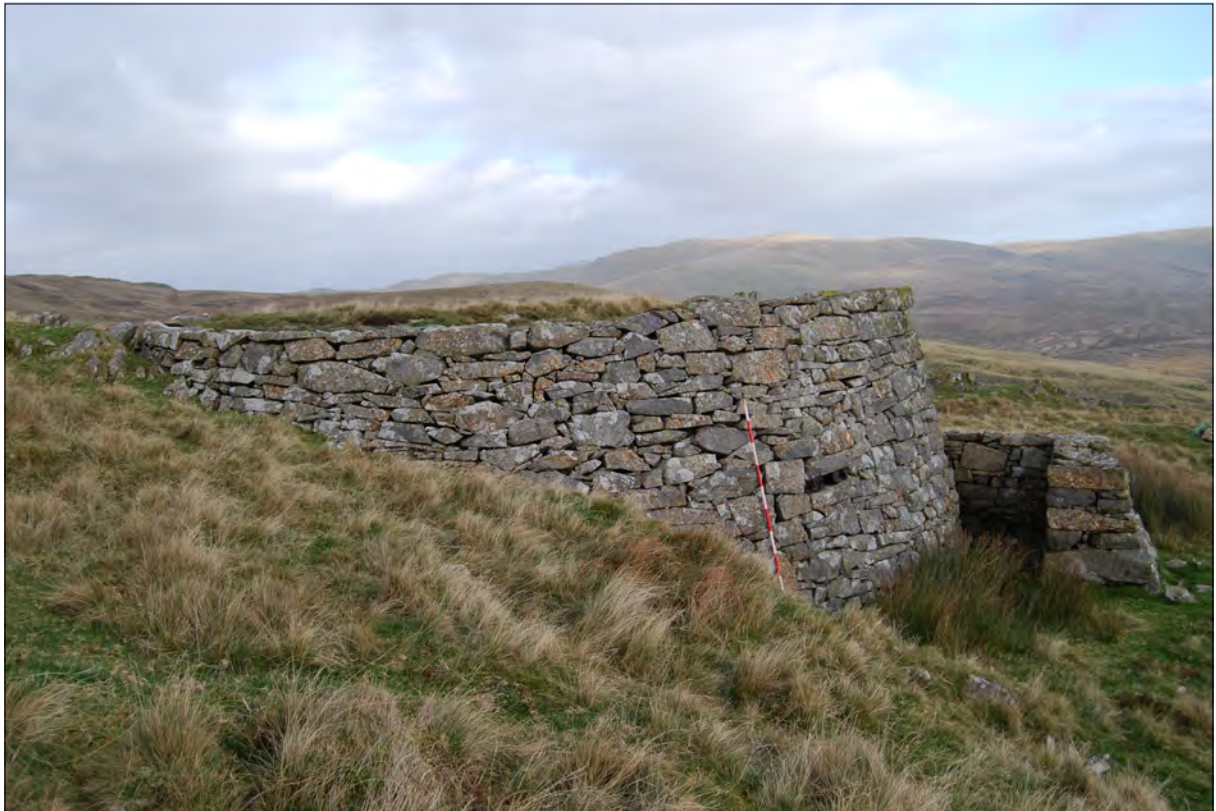
Plate 7. North east facing image of the Observation building showing the observation hole.

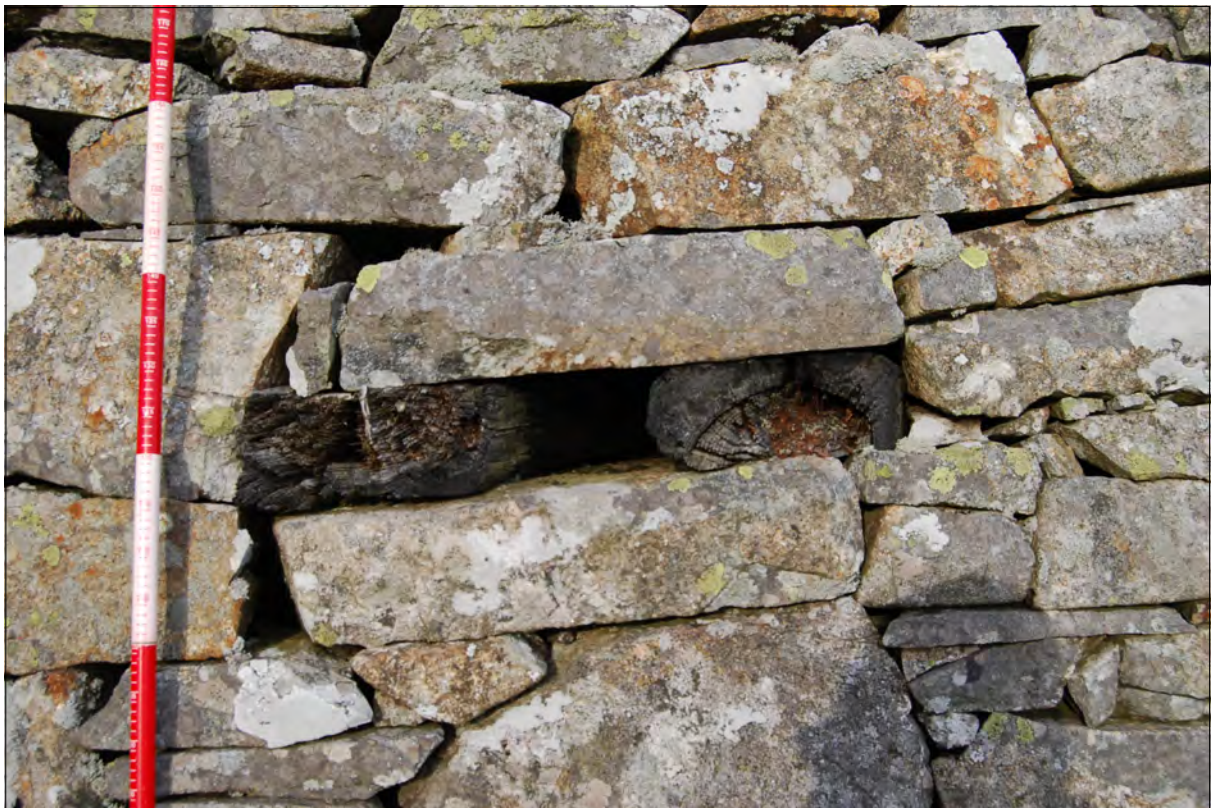
Plate 8. North facing image of observation hole presumably used to observe communications to the west

open with a canopy shelter and fore-wall at the east facade to allow viewing. A narrow look-out tunnel is presumed to have allowed a line of sight to some kind of communication or warning system such as a flag indicating the start or completion of shelling.
