# Llanymynech Heritage Area

ARCHAEOLOGICAL SURVEY

CPAT Report No 618

Report for Oswestry Borough Council

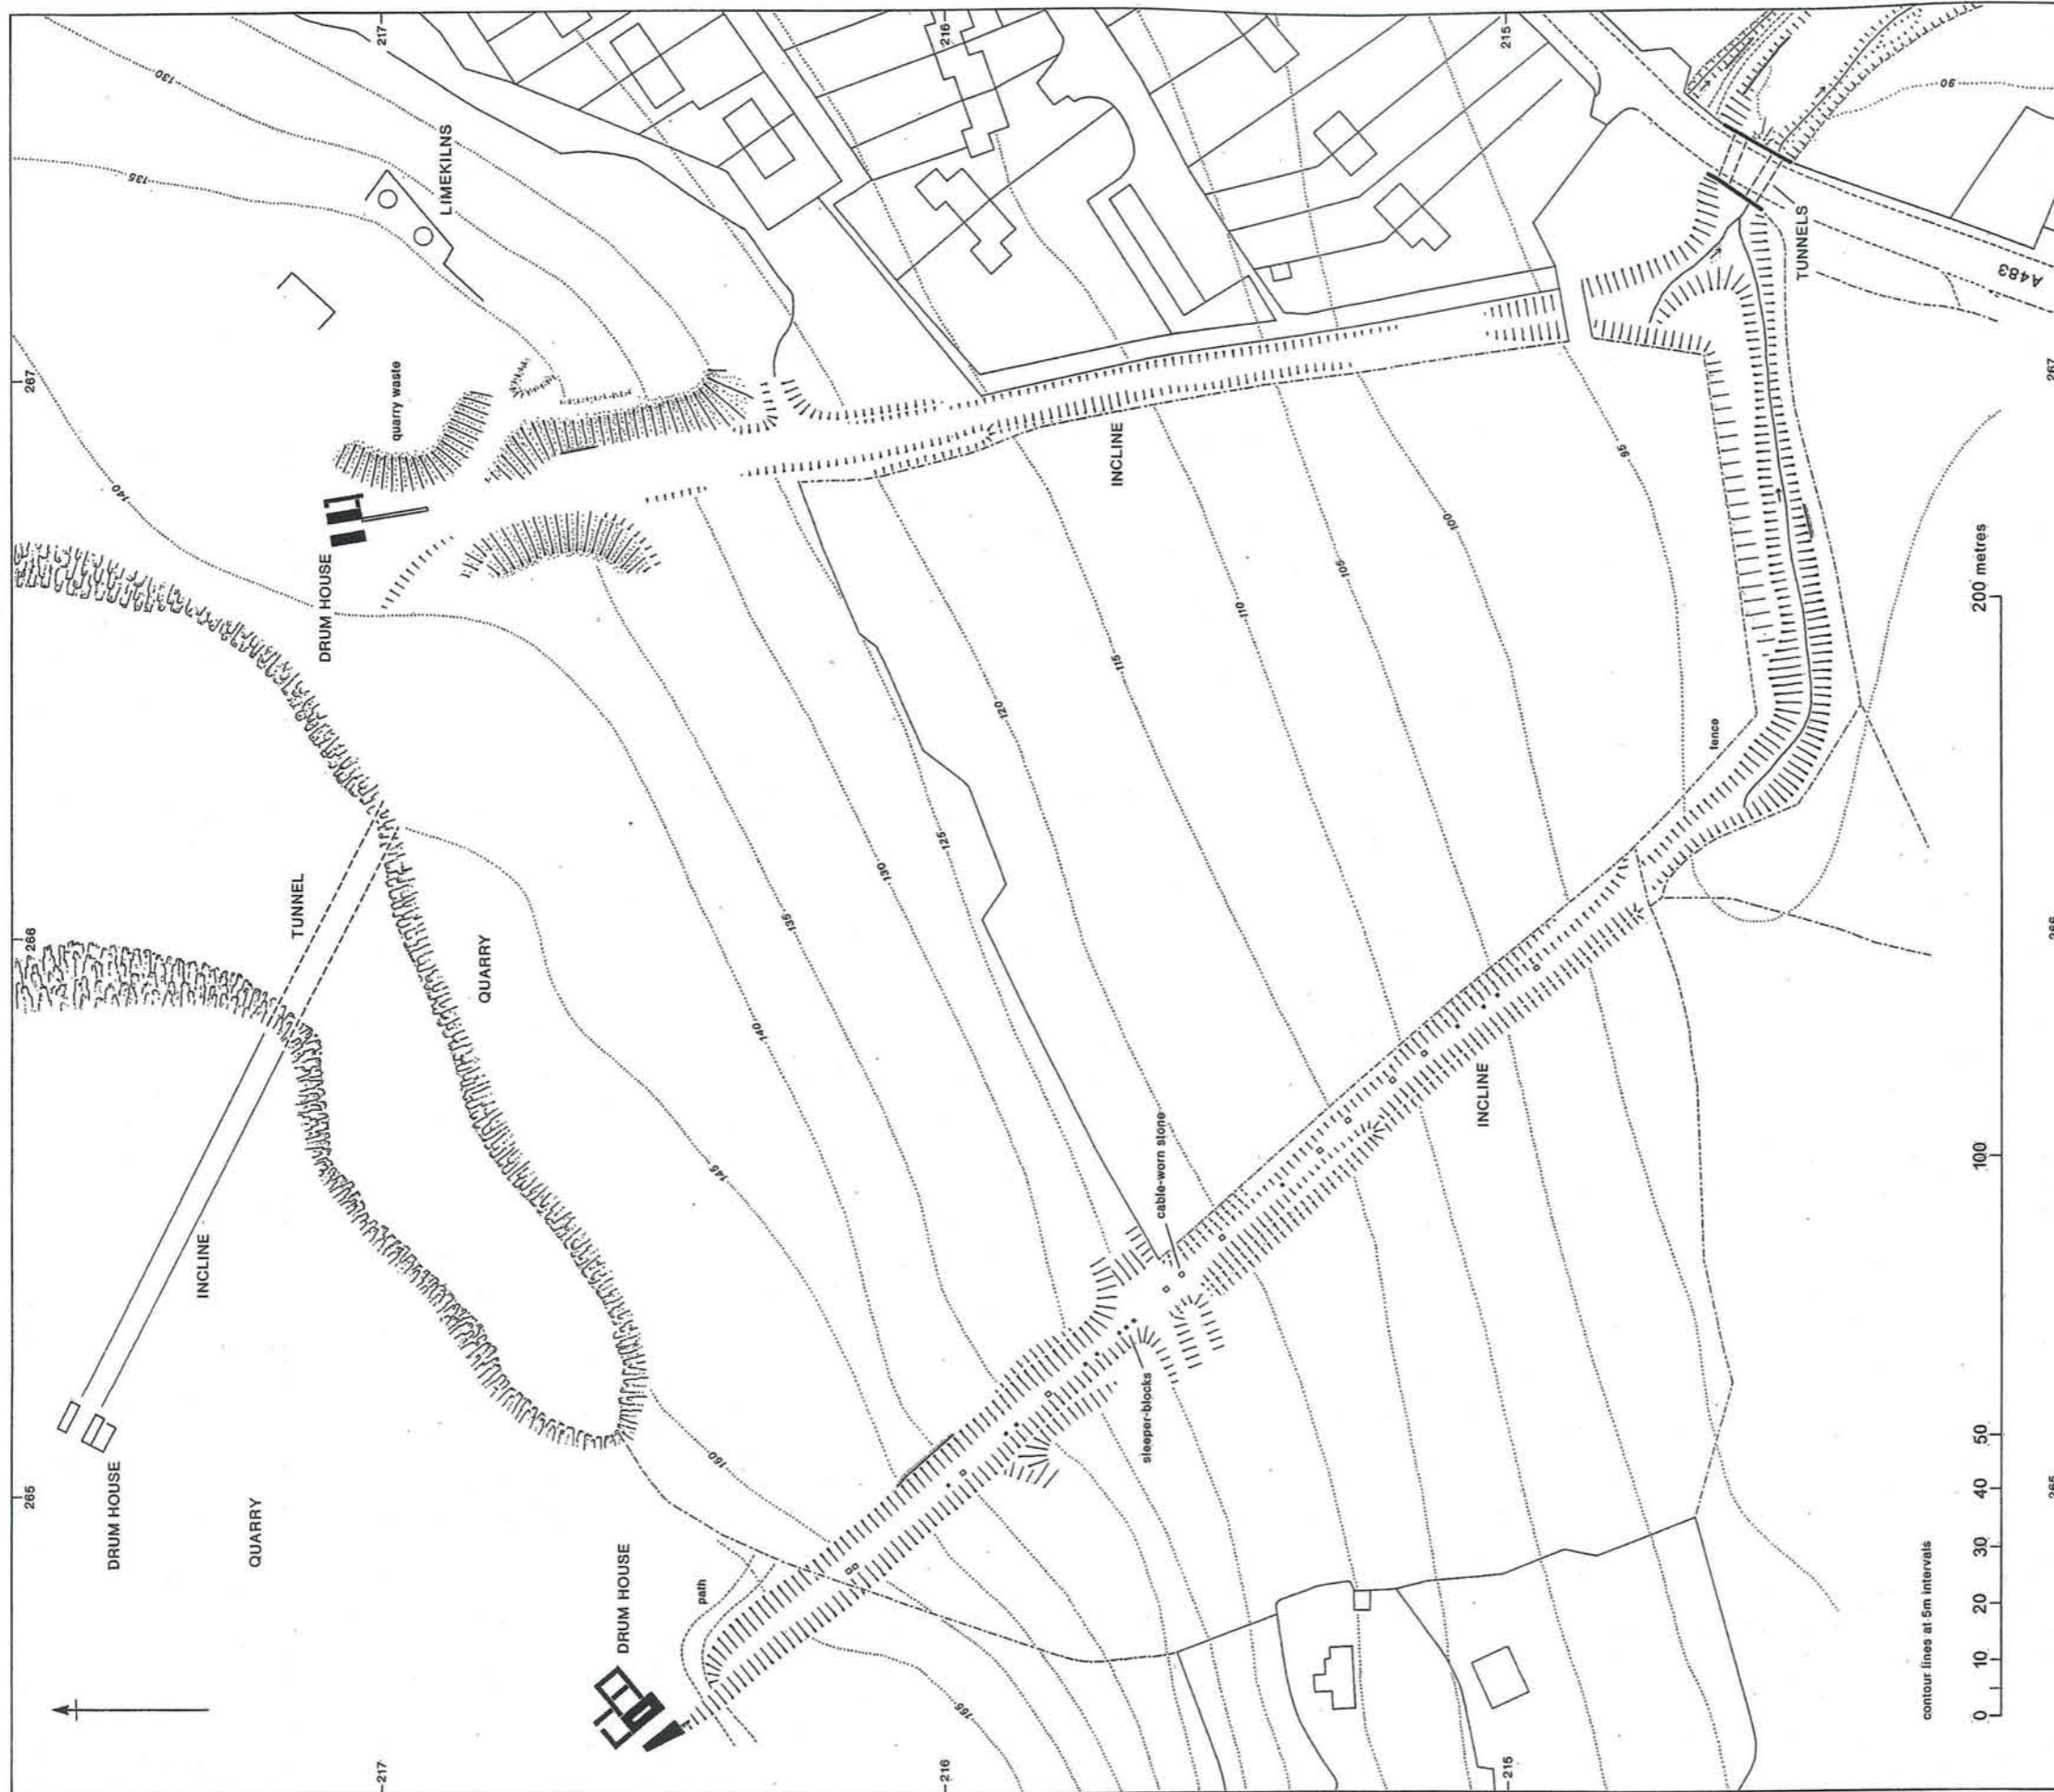
Fig. 7 Measured survey of the inclines

- 5.6 The results from the measured surveys have been used to produce a series of conventional drawn plans (Figs 7-9), as well as computer-generated images (Figs 10-11). In addition, the digital data have been provided to the client in GIS (Arcview) format, including a level of interpretation (see Fig. 12).

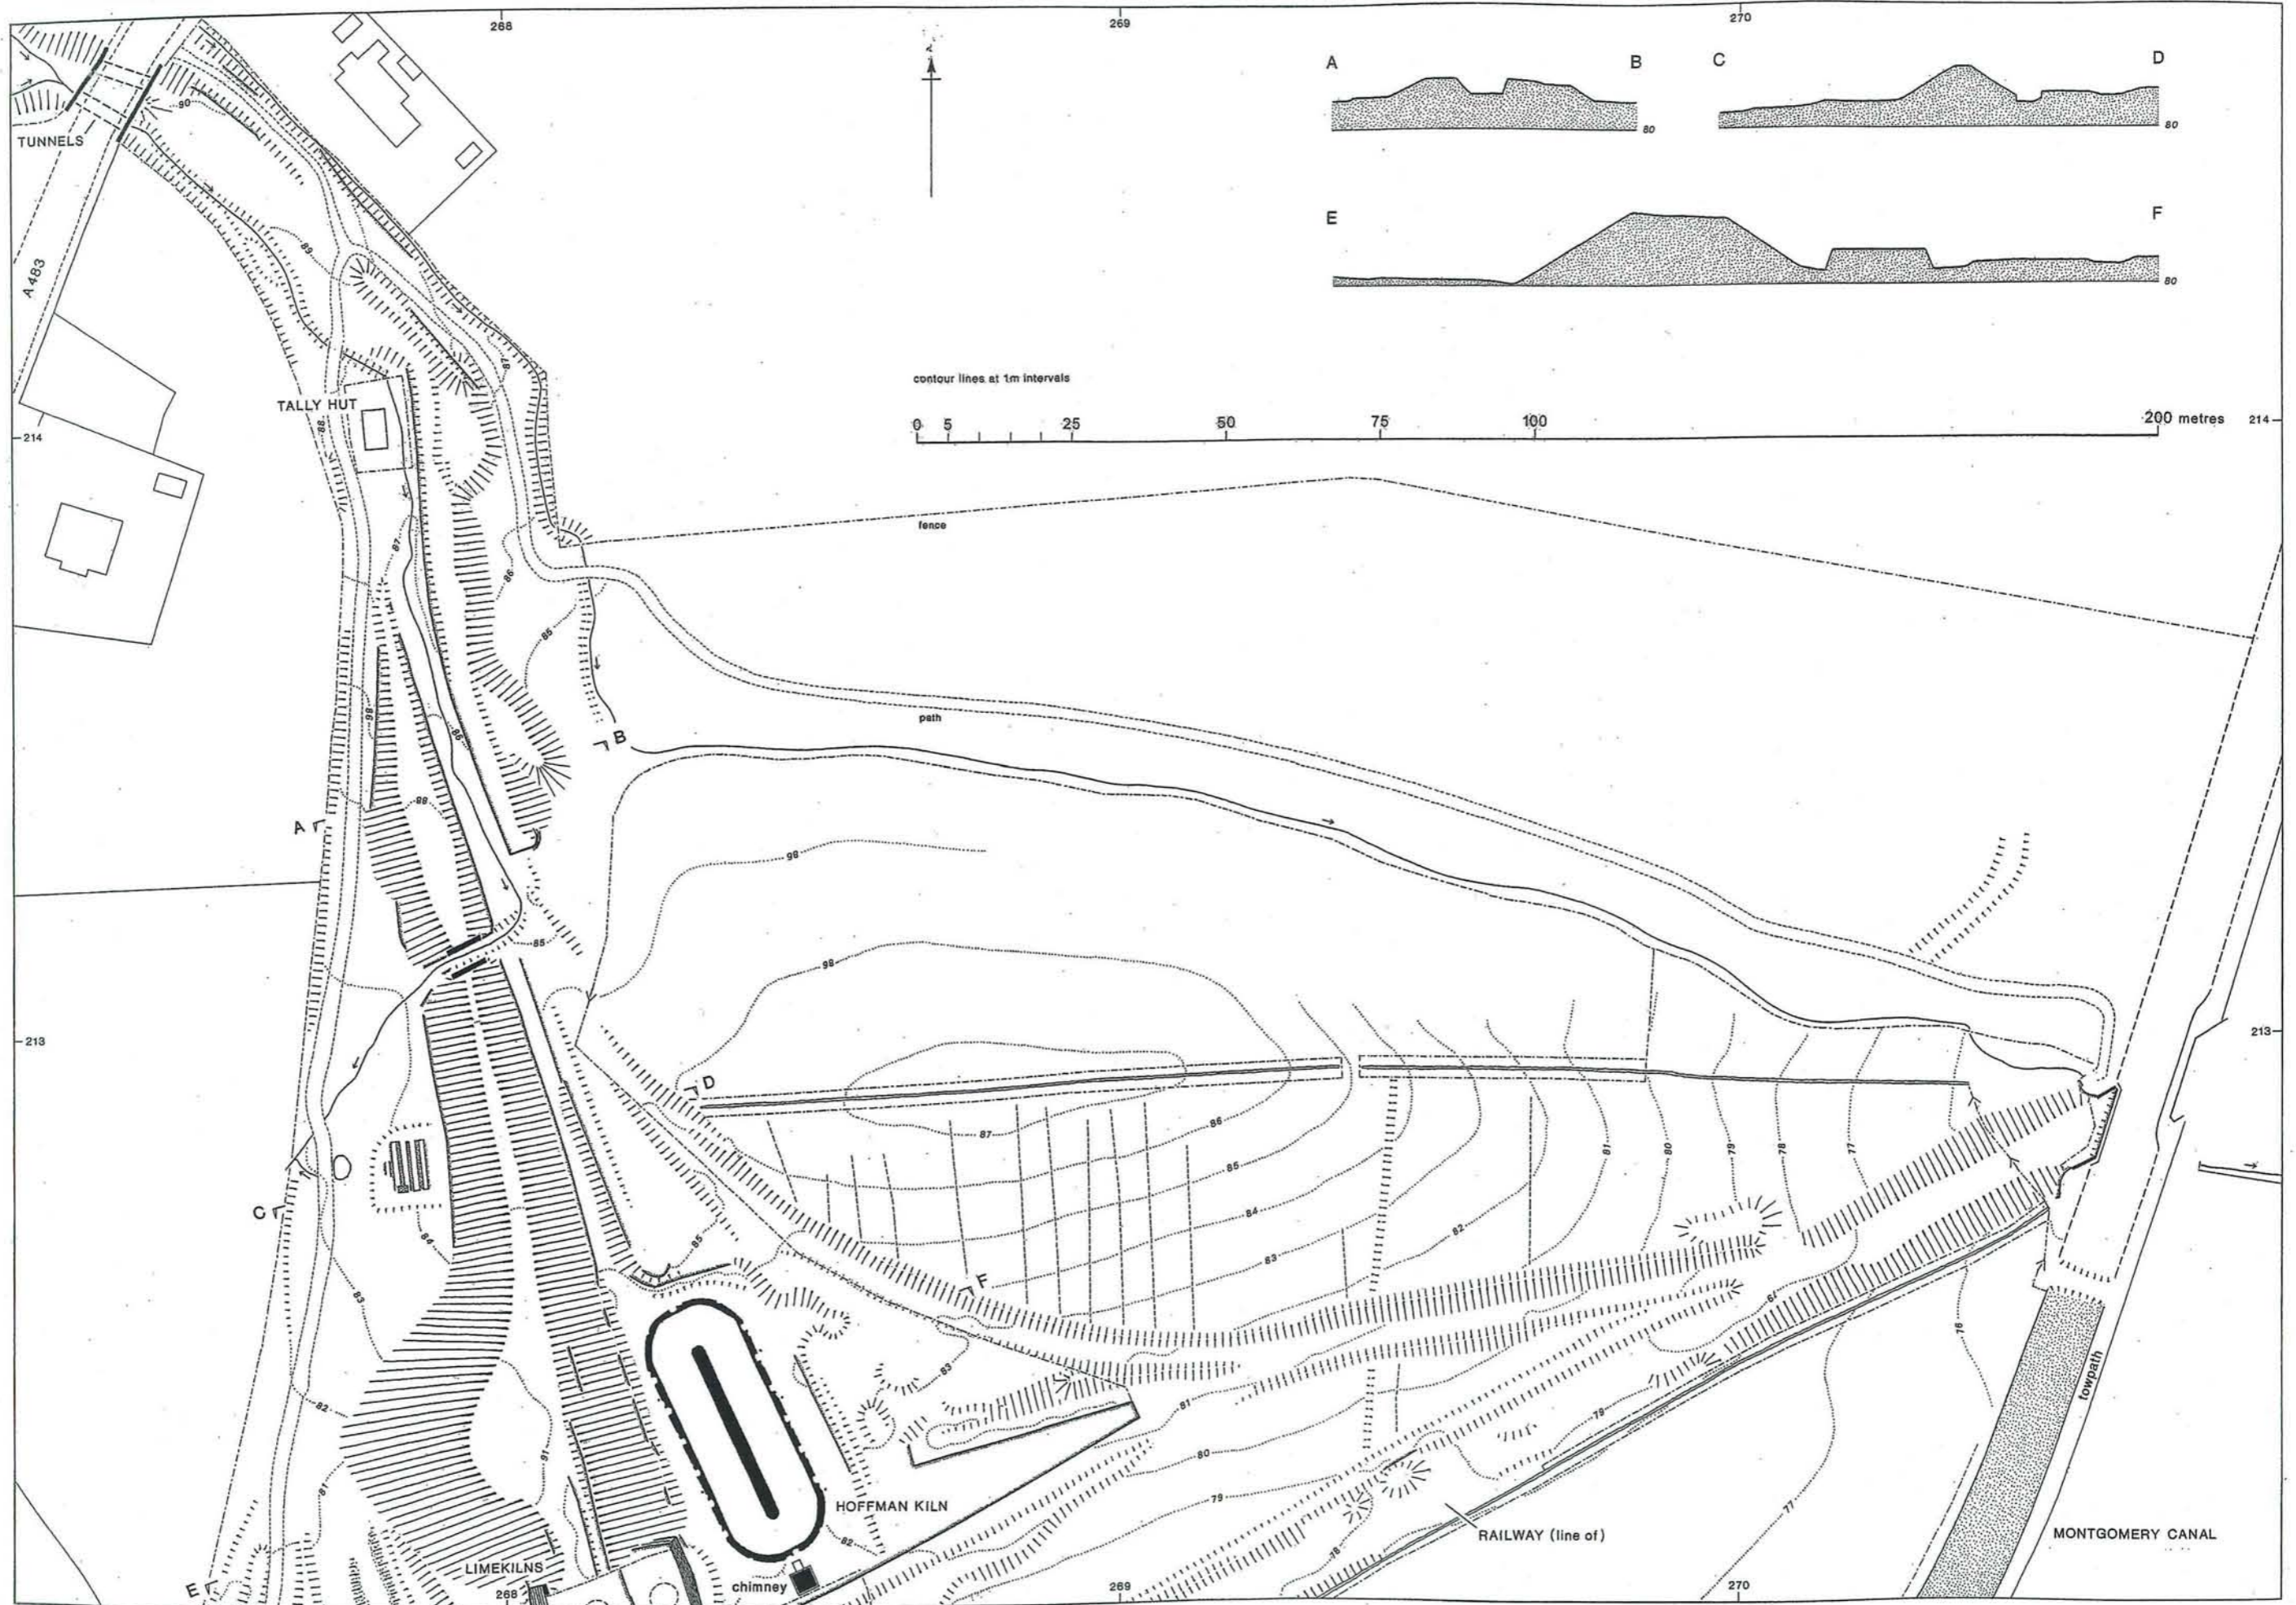
Fig. 8 Measured survey of Heritage Area (north)

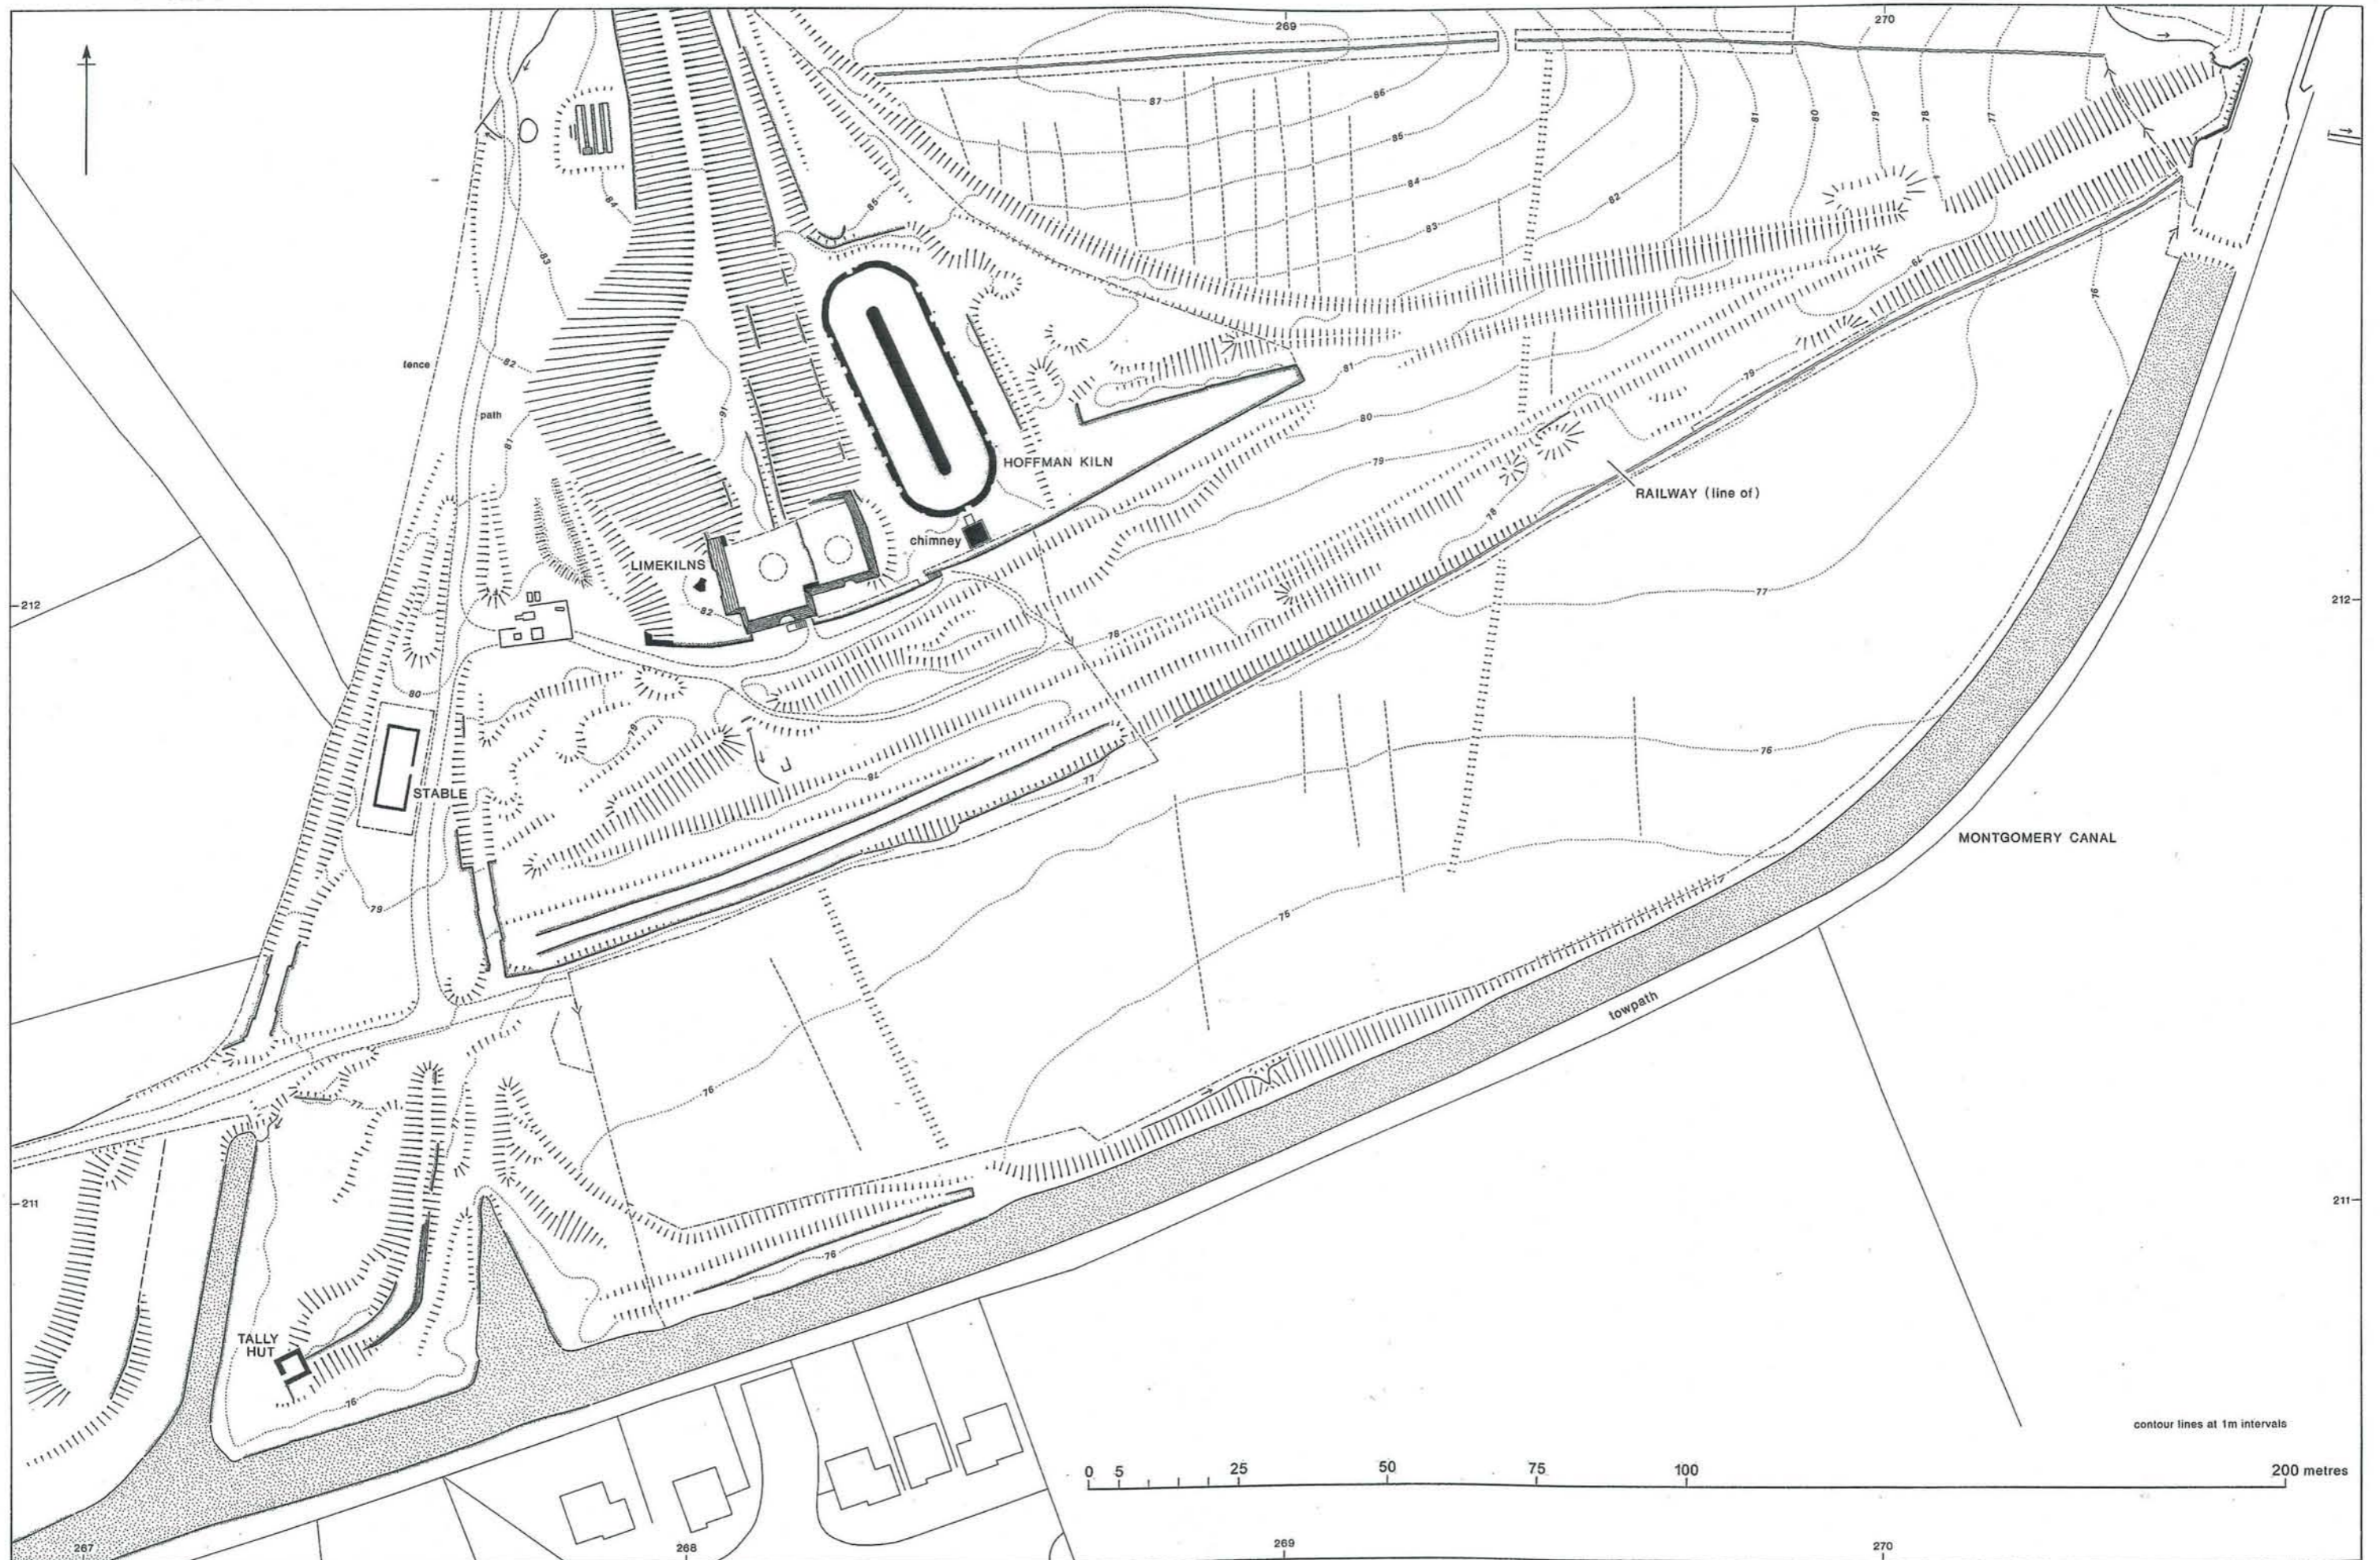
Fig. 9 Measured survey of Heritage Area (south)

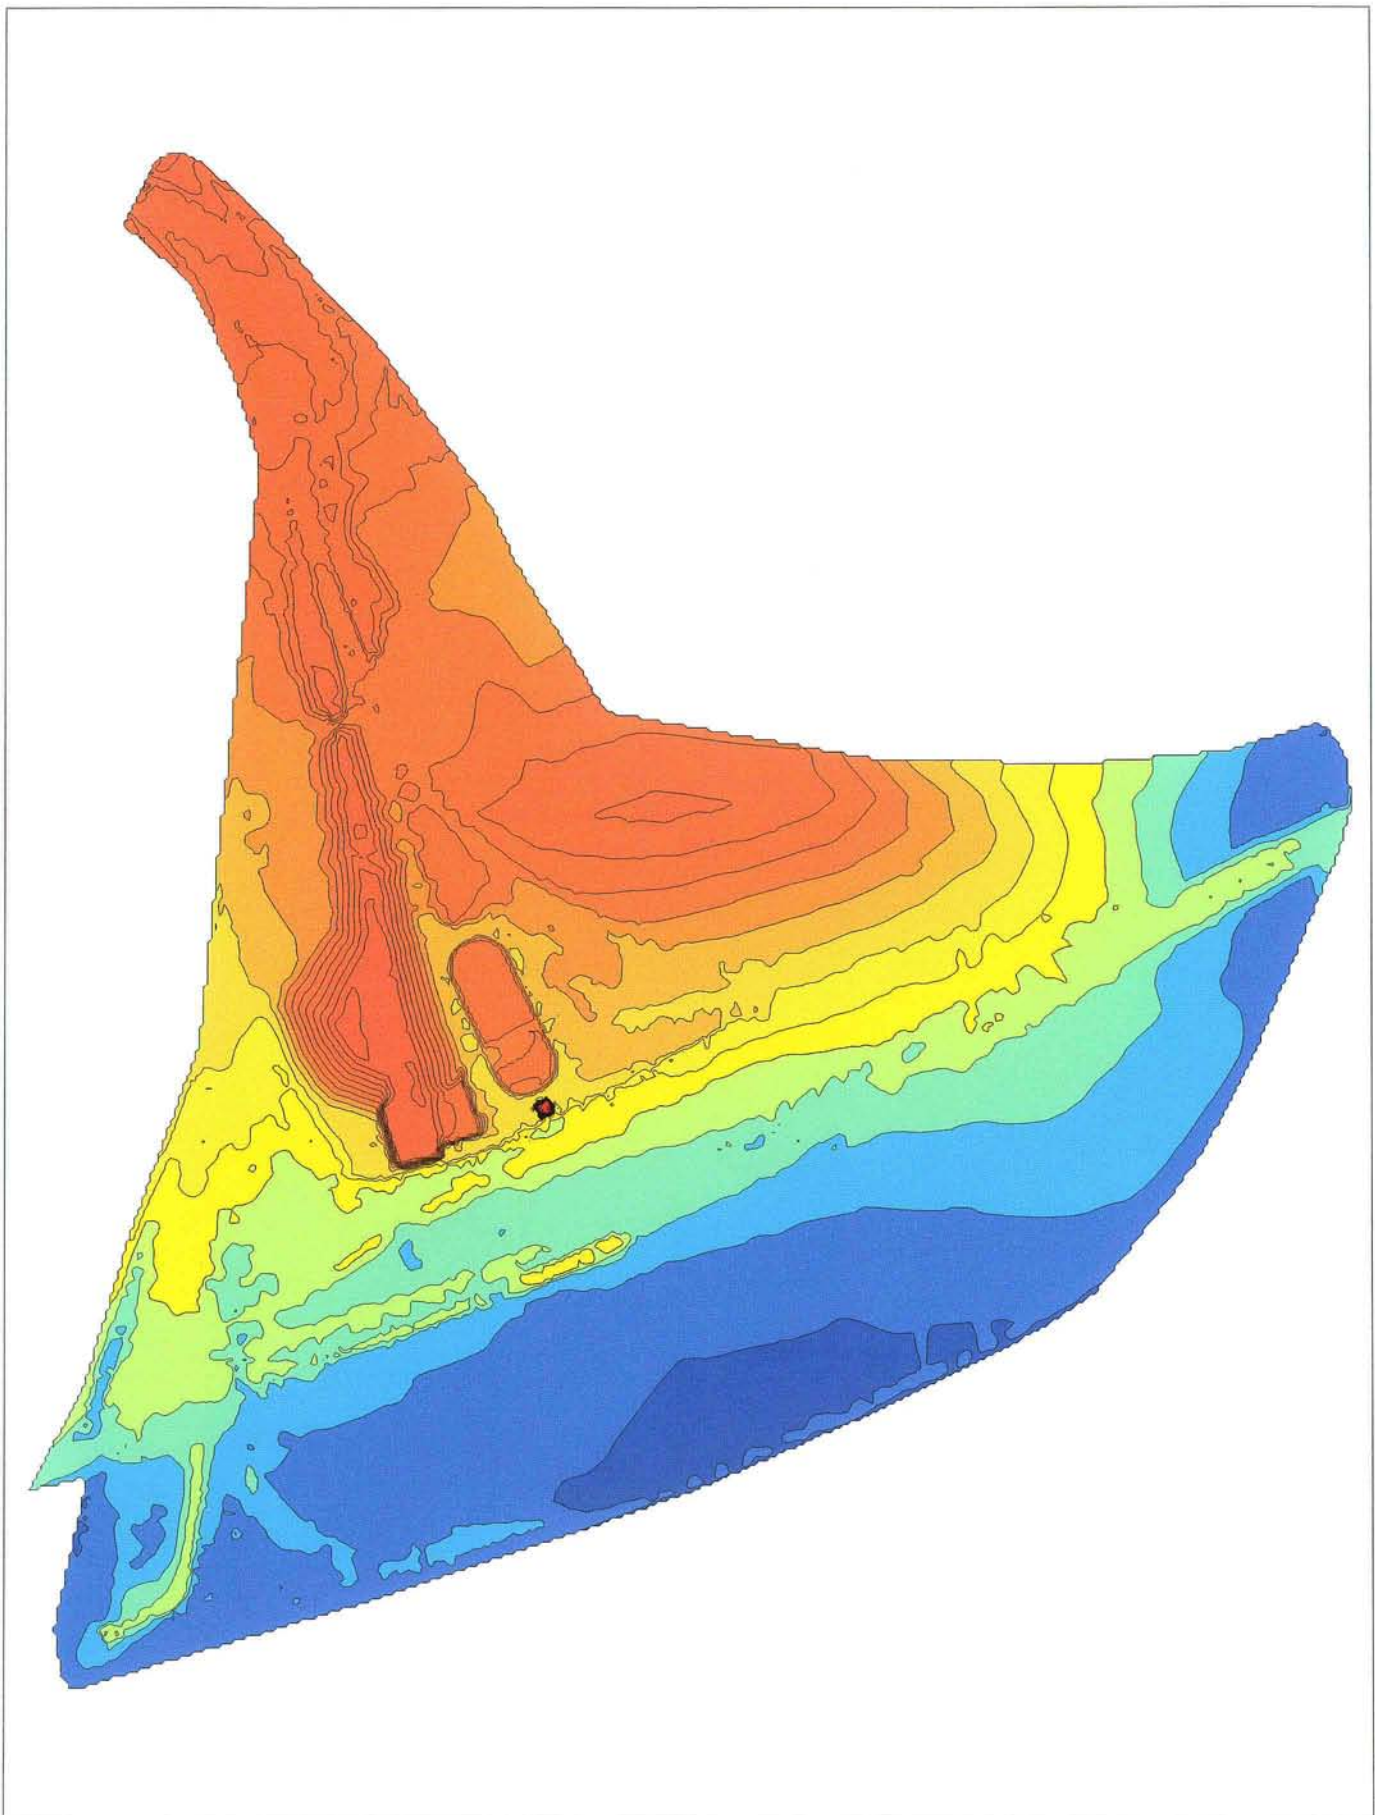
Fig. 10 Digital contour model at 1.0m intervals, scale 1:200

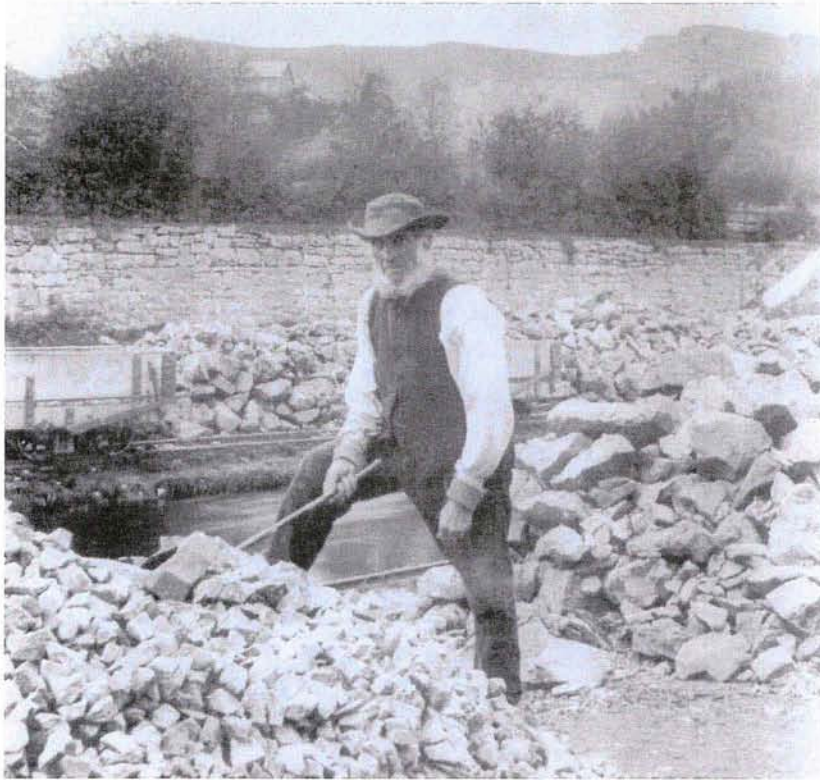
Fig. 16 Photograph of John Roberts, foreman, breaking stones on the western canal wharf. Undated, but probably late 19th century.

- 7.7 The quarried limestone would have been unloaded from the tramways onto the canal wharf, where it was stockpiled and broken by hand. A remarkable photograph survives showing one of the foremen, John Roberts, breaking limestone alongside the western wharf, with tramways visible on either side of the canal wharf (Fig. 16).
